## **INDUSTRIAL TRAINING FIELD REPORT**

**Company Address: UTILITIES GEBENG, GAS PROCESSING &  
UTILITIES DIVISION, LOT 139A, GEBENG INDUSTRIAL AREA,  
PHASE III, 26080, KUANTAN, PAHANG**

## Utilities Gebeng Cogeneration Optimization Strategy: Reinstating UG H2RG System Supply from PDH

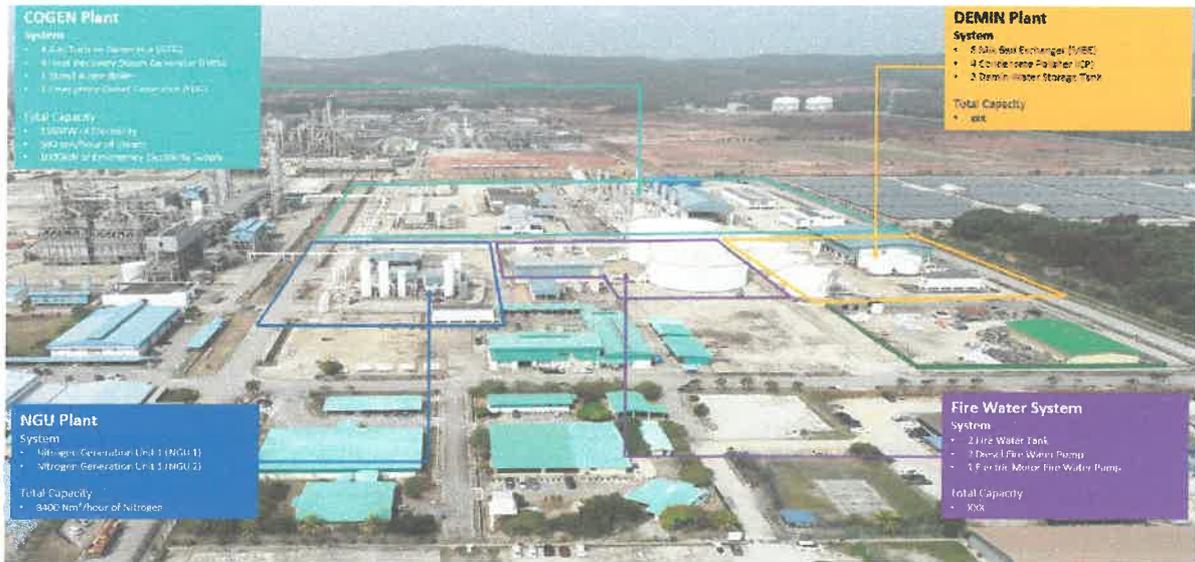
Figure 3 Utilities Gebeng Layout

There are four separate division within Utilities Gebeng. Firstly, there is a Fire Water System that includes two fire water tank, two diesel fire water pump, and an electric motor fire water pump, this plant is capable of supplying cooling water at 3900 Nm<sup>3</sup>/hr. Then, there is the NGU Plant that produces nitrogen at the rate of 8240 Nm<sup>3</sup>/hr. They also have a Demineralised Water Plant that produces raw water, potable water, and demineralised water, at the rate of 1200 m<sup>3</sup>/hr, 22 m<sup>3</sup>/hr, and 550 m<sup>3</sup>/hr, respectively. Last but not least, the Cogeneration plant, the largest in terms of scale. This plant produces mainly steam and also electricity. The systems involved in Cogen include four Turbines, four Heat Recovery Steam Generators, a boiler, and an emergency diesel generator. This plant is capable of producing electricity and steam at the rate of 136MW and 580 ton/hr, respectively. Cogen can also provide 1000kW of Emergency Electricity Supply. The utilities produced will be supplied to nearby plants and for its own use.

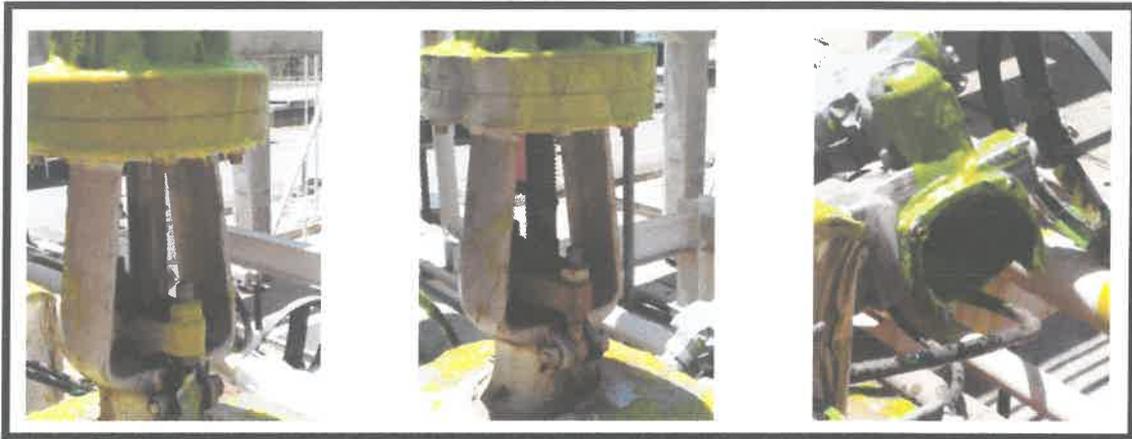
Figure 11 MOV 1D06 and MOV 1D07 broken and dislodged.

If there were no meetings for the day, my supervisor would let me join brainstorming sessions. For instance, I assisted my supervisor alongside some other engineers and operators in a Root Cause Failure Analysis (RCFA) to discuss MOV 1D06 and MOV 1D07 being broken and dislodged that caused Boiler D to be unavailable and incurred maintenance cost. Other than that, I also worked on pending tasks or assignments on my daily working hours. Some tasks were time consuming as it requires a lot of focus. That was all pretty much how my daily routine went.

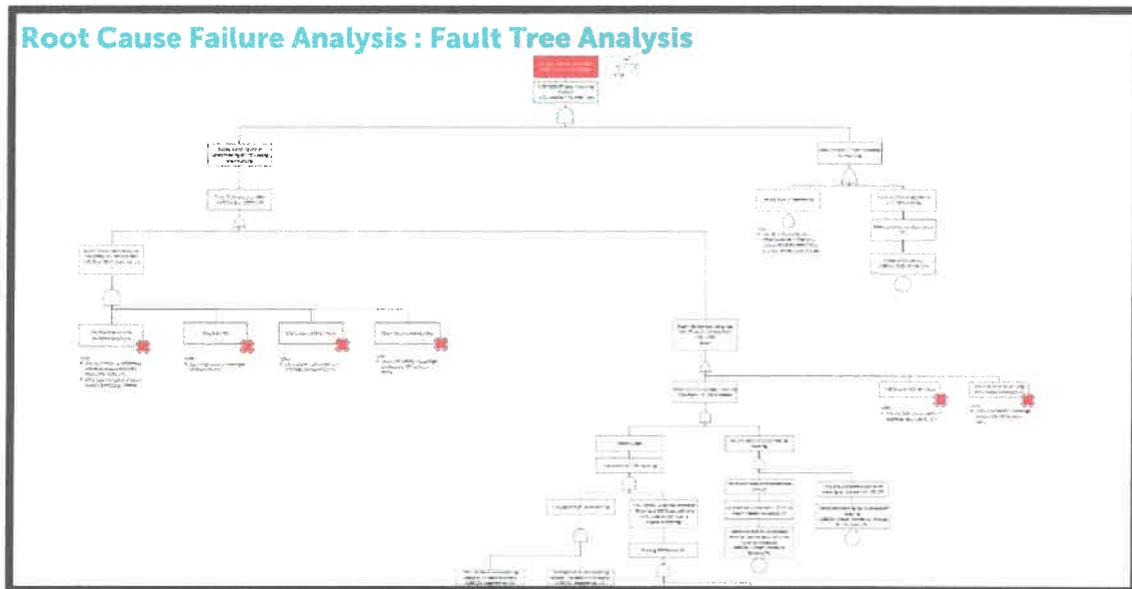
Figure 12 Fault Tress Analysis method of determining root cause.

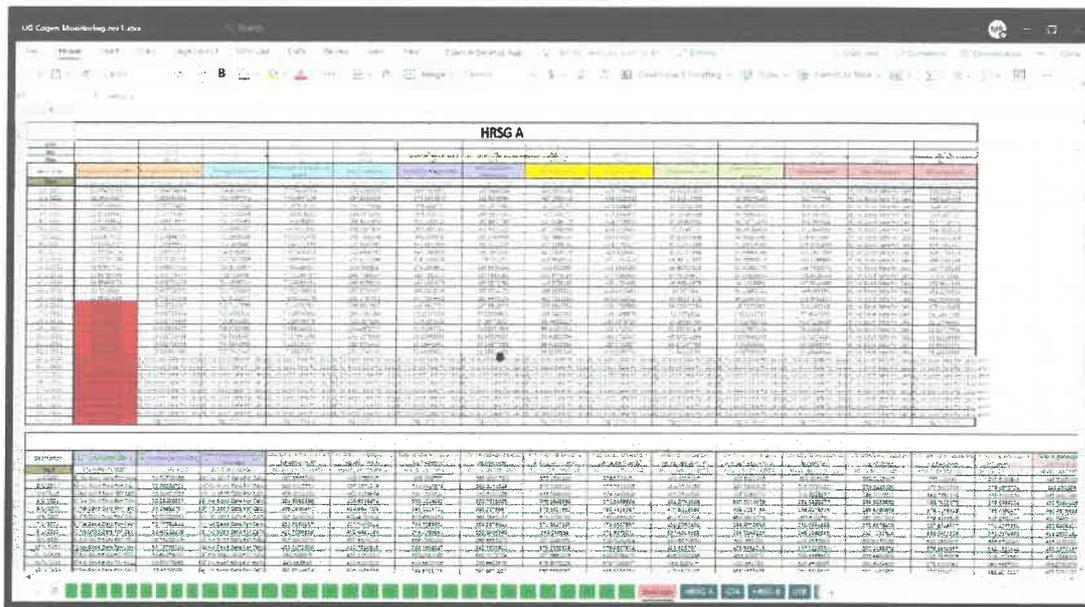
Figure 20 Average data before improvements

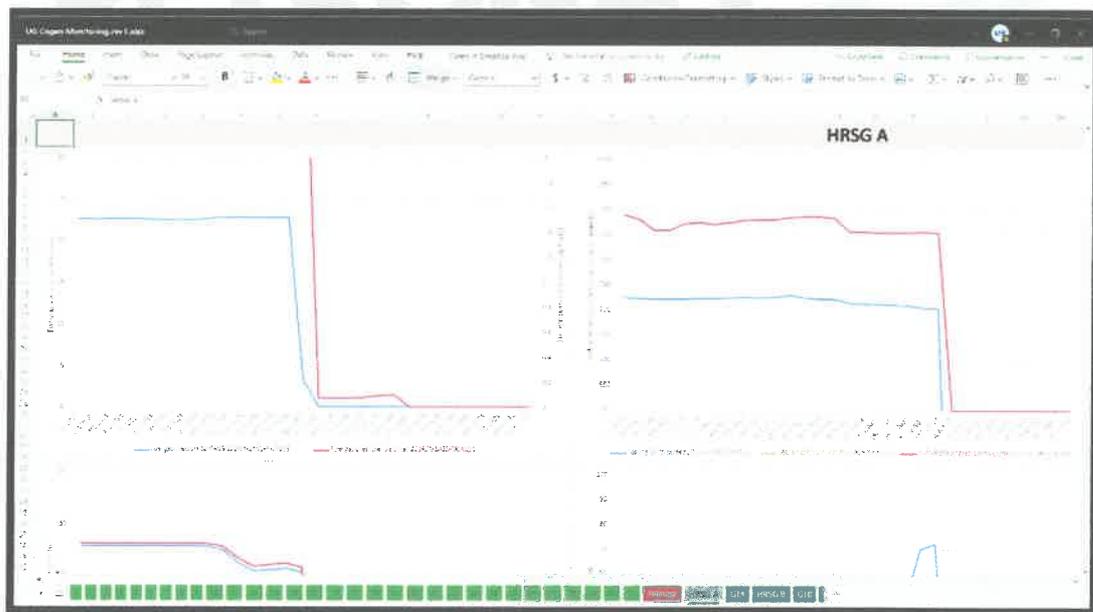
Figure 21 Graph representation before improvements

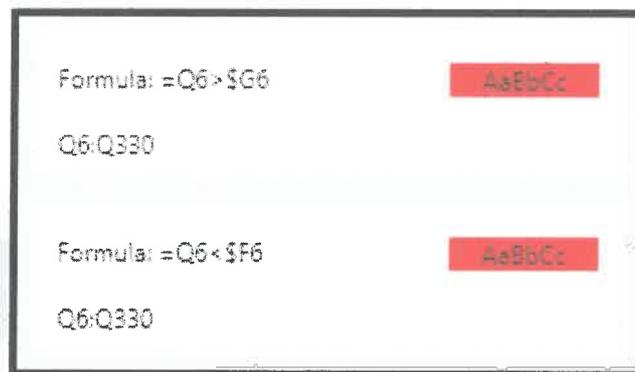
The first thing I was tasked to work on was the conditional formatting on the daily data. The database is automatically updated by a server. The automated data are listed in the 'Average' column. Each of the data has its own normal operating parameters that it has to obey. If the data for the actual exceeds maximum or depletes below minimum normal operating units, it should be highlighted to indicate the abnormalities. Therefore, the logical approach would simply be developing a conditional formatting that obeys the normal operating units for all of the components. Below is an example of the formatting used to highlight cells that disobey the normal operating units.

Figure 22 Conditional formatting on daily data

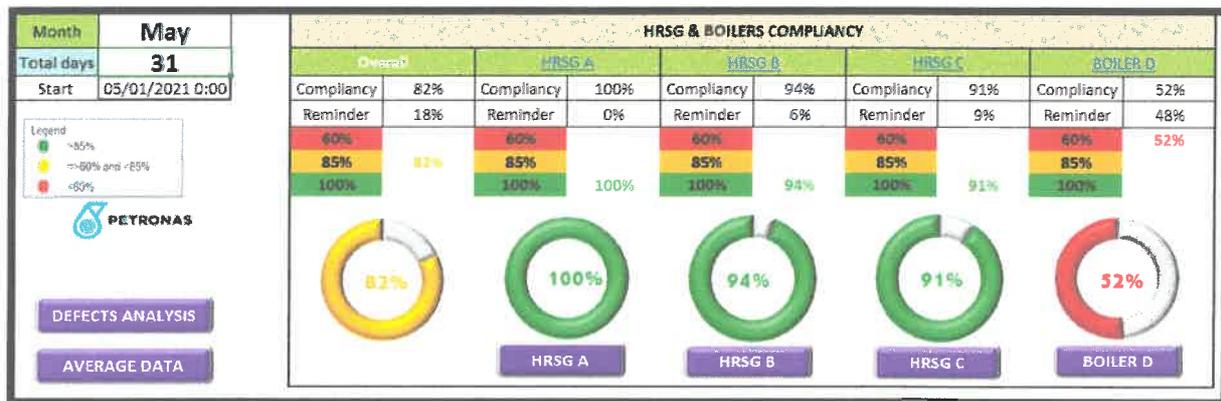
Other than that, the improvement I have made includes creating a frontpage that displays compliancy of the main equipment in Cogen. The frontpage of the database is easily accessible as it is interactive. One can simply key in the month and year of the desired data to access the complete information. Shortcuts buttons were also added on the page to make browsing effortlessly swift. Previously, panel operator can only monitor 50 tagging at most at a time. Now, that the database has been improved, they can now monitor all 324 tagging at a time which made the process six times more effective. Below is the screenshot of the frontpage constructed in action.

Figure 24 Front page of Cogen plant monitoring database

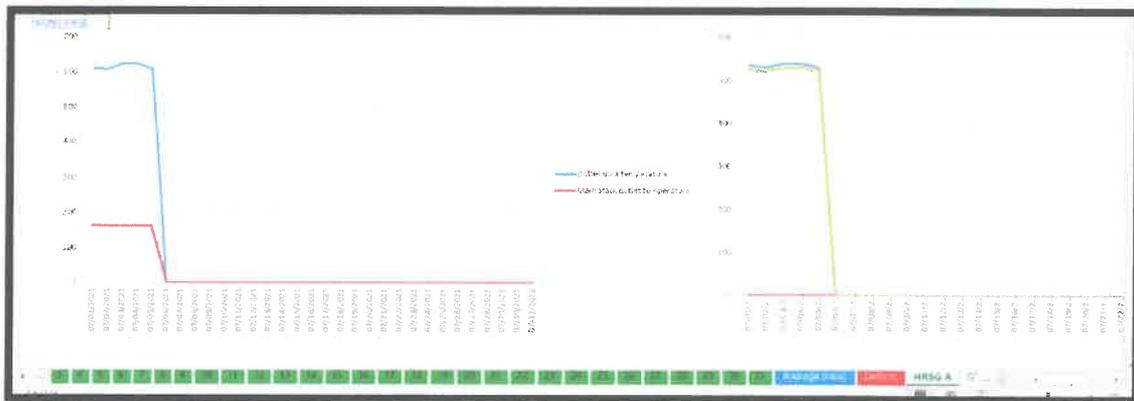
Furthermore, the graphs are now correctly linked and display intelligible patterns and better scaling. For instance, during a shutdown process all equipment will not be operating, therefore the graph will be y=0 during the shutdown process as shown in the screenshot below.

Figure 27 Improved graph representation.

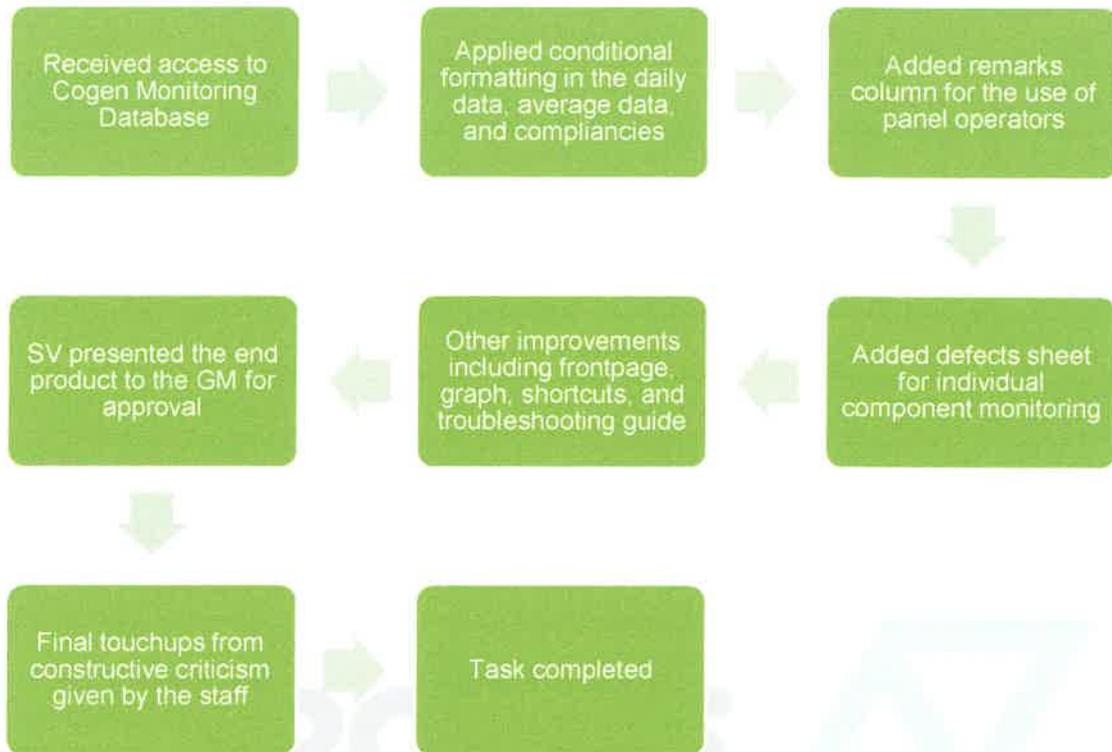
Figure 30 Flow chart of UG Cogen Plant Monitoring database improvement

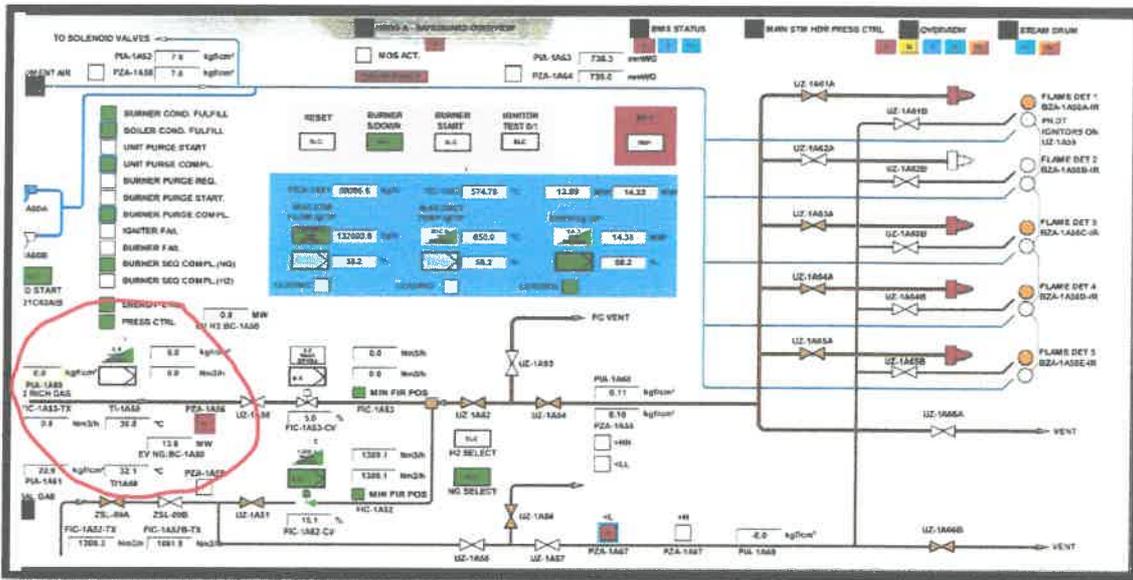
Figure 33 Existing H2 Rich Gas supplementary firing system in HRSG as per design

The action was deemed strategic due to several sound basis. Firstly, UG has existing H2RG system facilities that have not been utilized since March 2009 because of unstable supply of H2RG from PDH. Meaning, we already have all the main components to make it work. Secondly, PDH has confirmed that they can now supply a stable and continuous flow of H2RG at 2000 Nm<sup>3</sup>/hr. Other than that, the HRSG is designed to have H2RG as its primary source of supplementary burners. Which would not require any changes to its design. Lastly, since we have low demand of steam from customers at the moment, we need to find an alternative substitute for natural gas as our fuel for HRSG to reduce price of non-conformance.

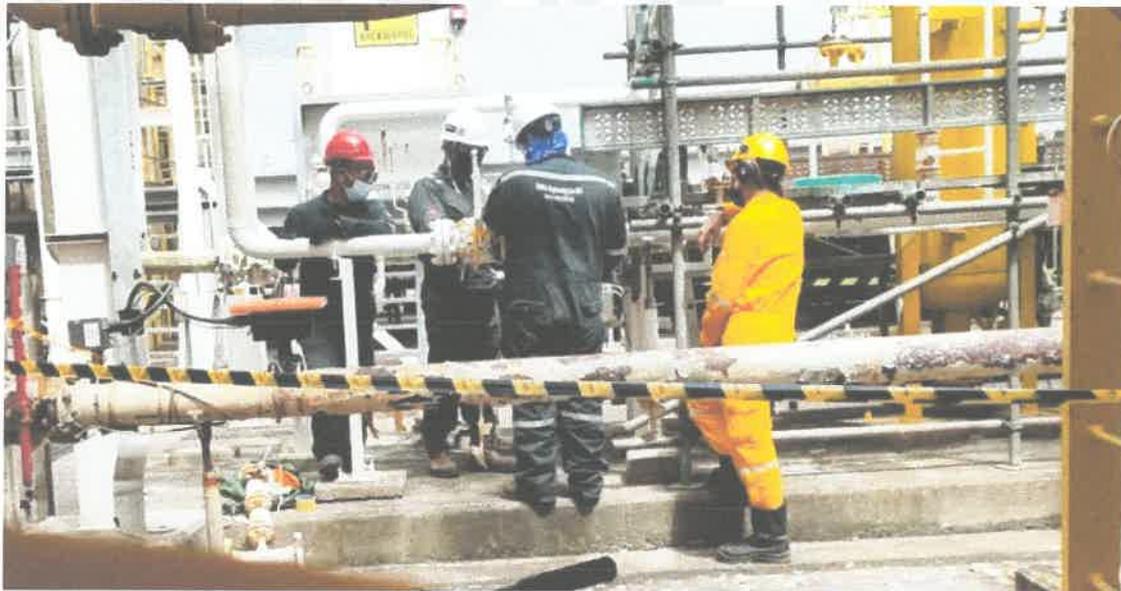
Figure 34 Contractors removing insulation on the pipeline.

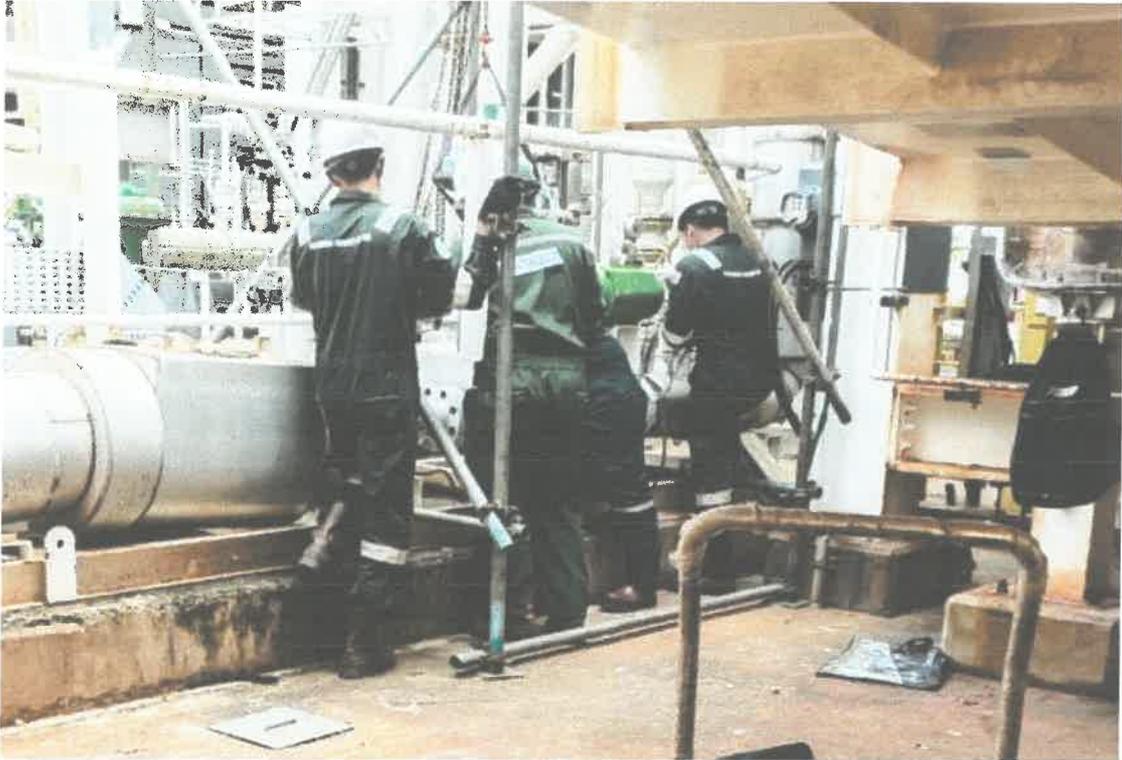
Figure 35 Operators conducting maintenance on existing supplementary firing system for H2RG pipeline.

Once finished with the inspection, the Control and Inspection (C&I) team assessed the existing hydrogen rich flowmeter, which was finished on June 23<sup>rd</sup>. Once finished with the inspection, some pipelines will be isolated and depressurize so that the transmitter can be tested and calibrated. Calibration of the transmitter was done simply by adjusting the pressure and temperature by using hand-held digital communicator, where the transmitters were injected with currents. This was done to remove any errors in data reading, and to ensure a suitable condition to handle the H2RG. After the inspection is finished, operators installed back any insulation that had been removed. When all of the tasks had finished, operators began nitrogen purging through the pipeline to rid it of any debris or unwanted substance - mainly residual hydrogen from previous run. Nitrogen was chosen for the process because of its characteristic of being inert, that is non-reactive and can simply be discarded without issues to the environment. The purging process could be very noisy, and any leaks of the nitrogen might danger any person nearby, therefore prior to the commencing, the area must be cleared from any personnel and every staff within the radius of the pipelines must be alerted of the noise to minimize hazard.

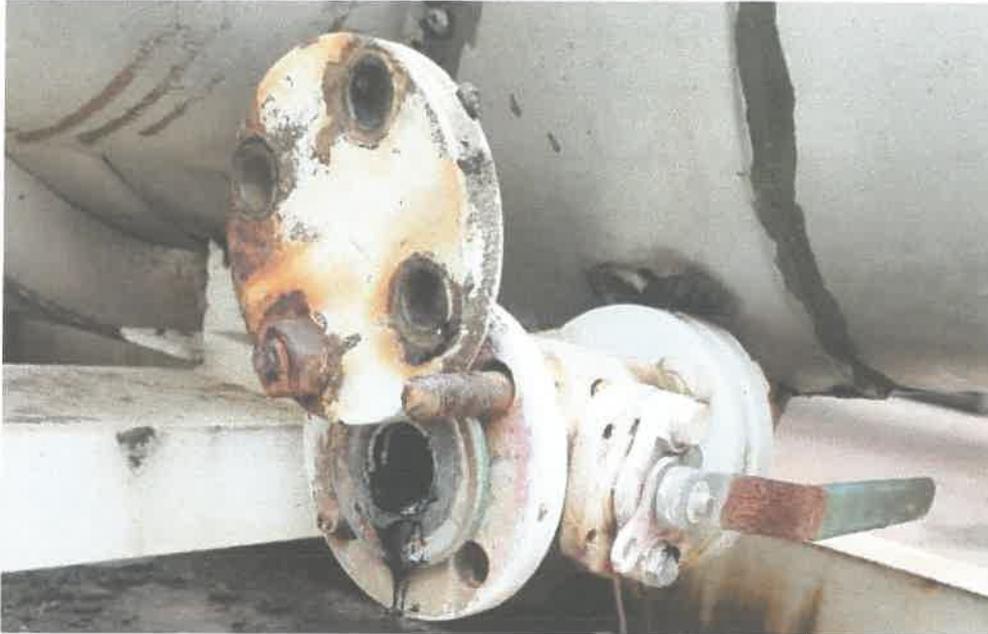
After finished with nitrogen purging, operators must inspect the pipelines once more for an integrity check and to run a gas test for hydrogen. During the integrity check, liquified residual gases from previous run can be seen pouring out at the flanges of the pipelines, and gas testing showed zero hydrogen gas. Therefore, the nitrogen purging was considered a success.

Figure 36 Liquified residue removed from the pipeline via nitrogen purging.

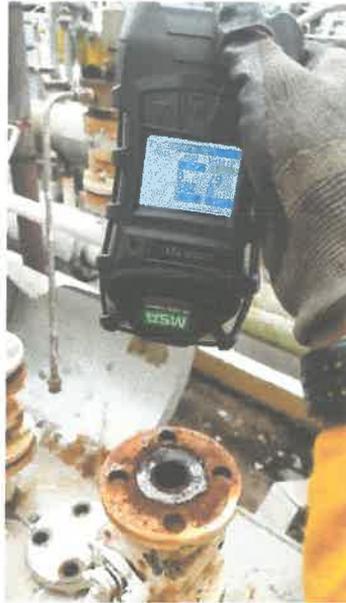
Figure 38 Gas testing indicates zero H<sub>2</sub> during both nitrogen purging and leak test.

With that, test run can now begin. The HRSG can now start-up to allow the H<sub>2</sub>RG to flow smoothly through the pipelines. The flow was slowly pressurized, and thorough monitoring was done throughout the process. Any abnormalities will be recorded to ensure excellent performance. Other than that, leak test must be performed concurrently while the HRSG is running. This test is crucial when handling any type of gas that is flammable or toxic. If a pipeline is cracked and flammable gas leaked out, a small spark can trigger an explosion. Leak test can be done by using gas tester, which is the same device used after purging for residual hydrogen. The test will be done at all flanges on the pipelines. Gas tester used must be able to detect the presence of the gas, which in this case hydrogen gas. Another integrity check includes monitoring the flame intensity of the burner, and the shape of the flames.

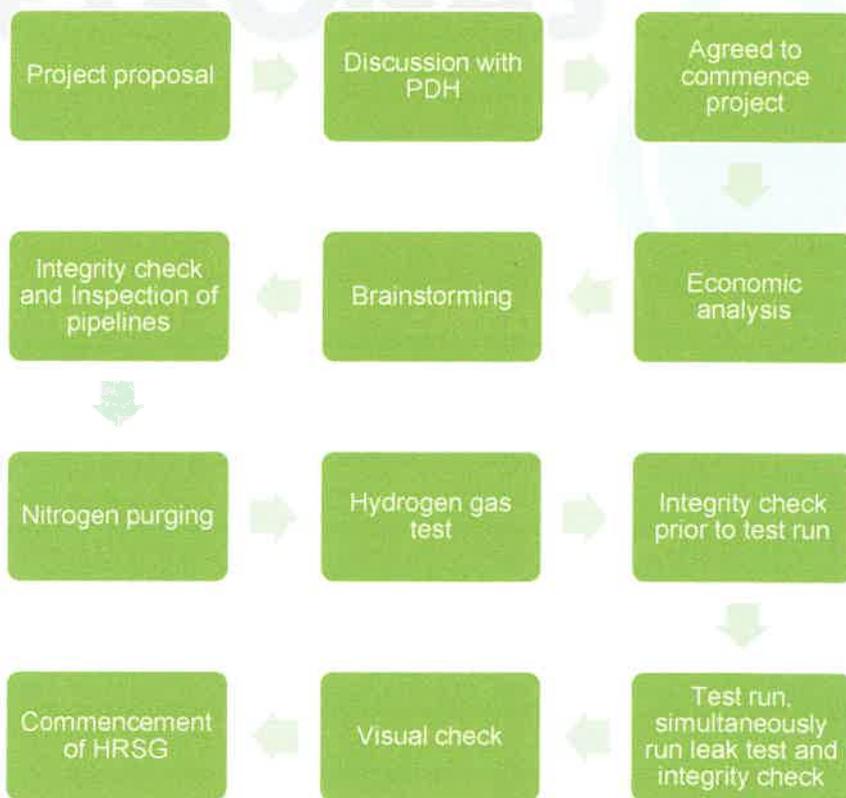
Figure 37 Flow chart for Reinstating H<sub>2</sub>RG system supply from PDH project
