1st INTERNATIONAL
E-CONFERENCE ON
GREEN & SAFE CITIES
2022

CONTRIBUTING FACTORS AND MAIN AGENTS AFFECTING BUILDING DEFECTS IN THE COASTAL ENVIRONMENTAL OF MALAYSIA: A QUALITATIVE STUDY

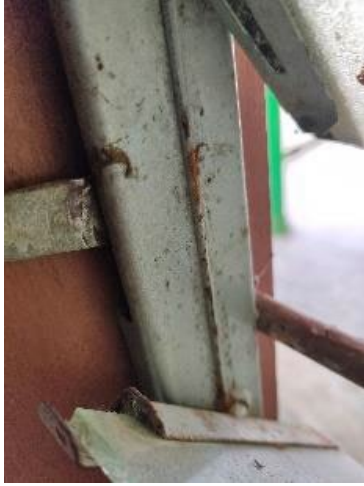
Building 1

Corrosion of Louver windows

For Building 1, the corrosion of louver windows and door hinges in buildings built near the seaside are subject to seawater intrusion. This is a result of the coastal area's wind direction and speed (salt air) affecting the building.

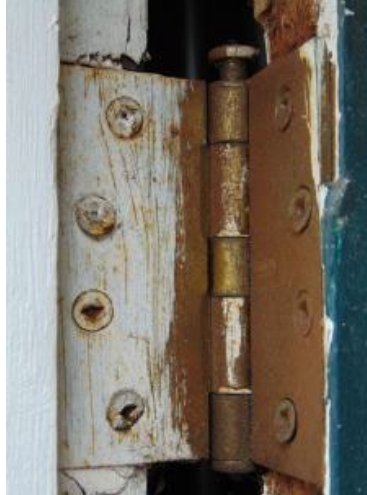
Corrosion of Door Hinge

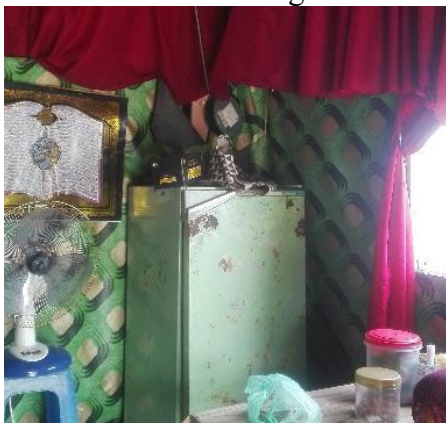
Building 2

Corrosion of electrical equipment and door hinge

Meanwhile for Building 2, the corrosion of electrical equipment and door hinges is caused by the exposure of saltwater to electrical appliances in the building. This form of corrosion occurs when two different metals with physical or electrical contact are immersed in a common electrolyte (such as salt water) or when a metal is exposed to different concentrations of electrolyte. The seawater that condenses on building elements will finally evaporate, but the salt in the water will remain. This also results in the decay of the timber wall and its surface to be sticky.

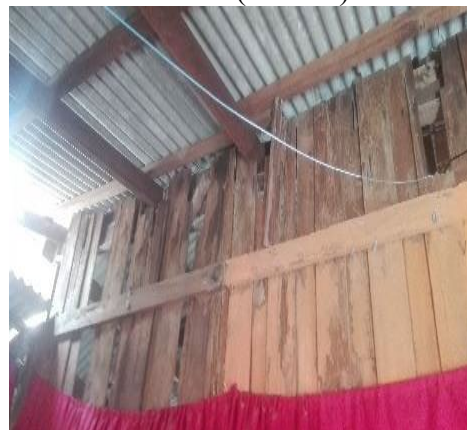
Decay on the timber wall and sticky surface (sea salt).

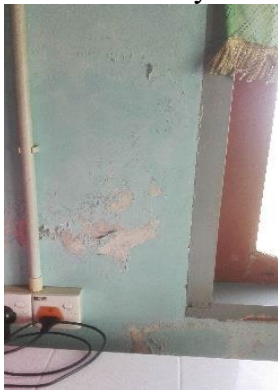
Building 3

Peeling of the paint due to dampness and sticky surface (sea salt)

Next, Building 3, is subject to seawater intrusion. The peeling of the paint due to dampness, sticky surface, and the corrosion of louvers windows are the symptoms that can be found in building 3. This is a result of the coastal area's wind direction and speed (salt air). The speed and the direction of the wind is determined by the weather of the area.

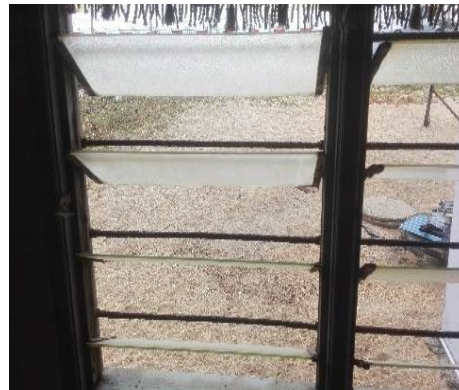
Corrosion of Louver windows

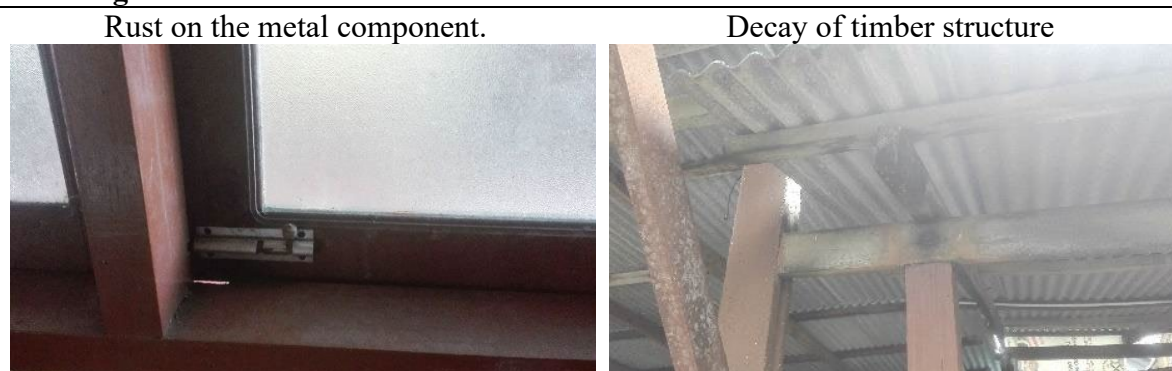
Building 4

Rust on the metal component and decay of timber structure can be found in Building 4. In the coastal area, the quantity of moisture present in the air is higher than in the deserts. Hence, rusting of iron objects is faster. Biological damage to above-water parts of waterfront structures is caused directly or indirectly by the activity of fungi and insects that utilize wood for food or nesting material.
