**DEPARTMENT OF BUILDING
UNIVERSITI TEKNOLOGI MARA
(PERAK)**

**THE CONSTRUCTION OF STAIRCASE AT GENTING MALL,
GENTING HIGHLAND**

**Prepared by:
AHMAD KAMAL EZANY BIN AZIZAN
2013245982**

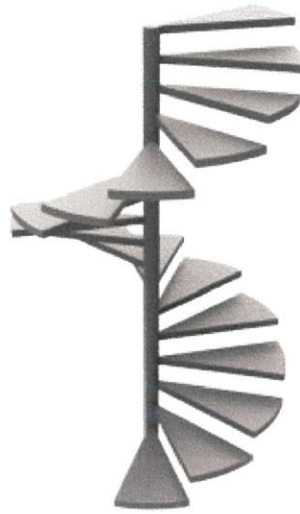
Picture 1.3 : Spiral stairs

Spiral stairs are a often confused with curved stairs. Although, both types of stairs follow a helical arc (like the shape of a spring), spiral stairs usually are made very compact and the treads radiate around a center pole.

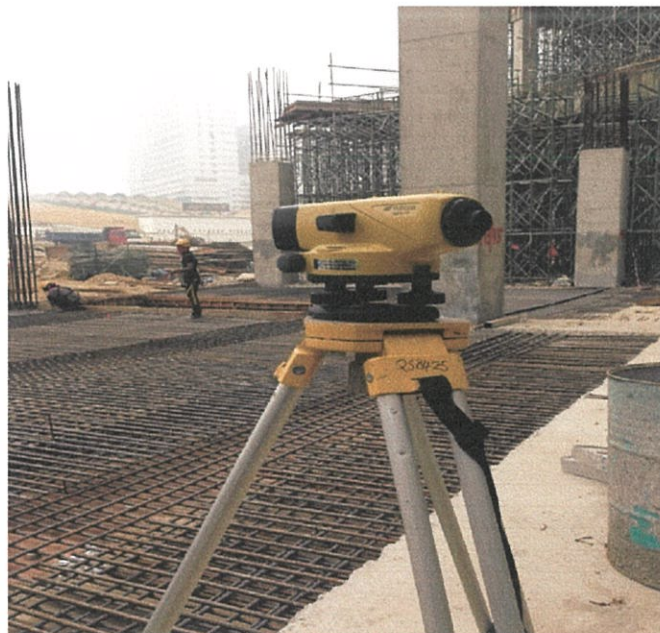
Picture 3.5 : Theodolite

This one is the most used by surveyor to take a level or make a transfer level. It supported by tripod which is its leg. It also provided with bubble level to make it horizontally straight.

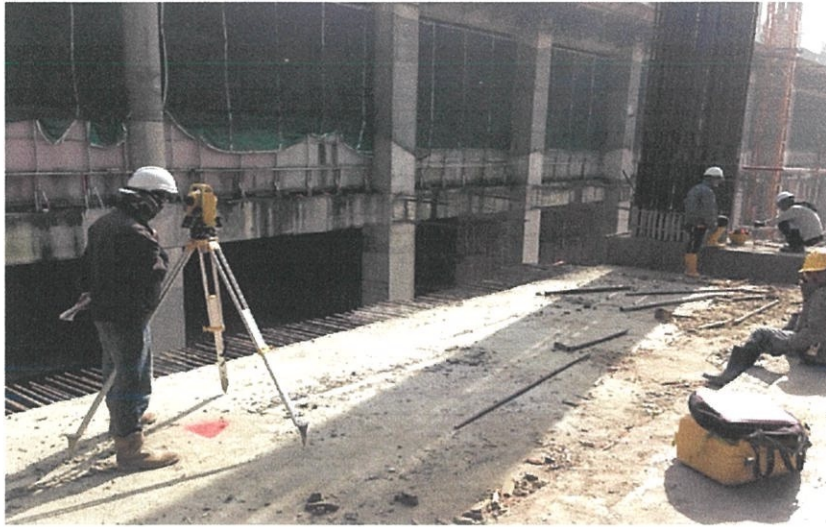
Picture 3.6 : Surveyor on work

On the early stage of the construction, work started by surveyor who mark and measure the distance for staircase also the rise of high. Most of staircase here not bear on cassion pile or column, it stands on slab and beam and for the landing and flight was supported by stiffener. The tools used by surveyor was tape, theodelite, and reflector.

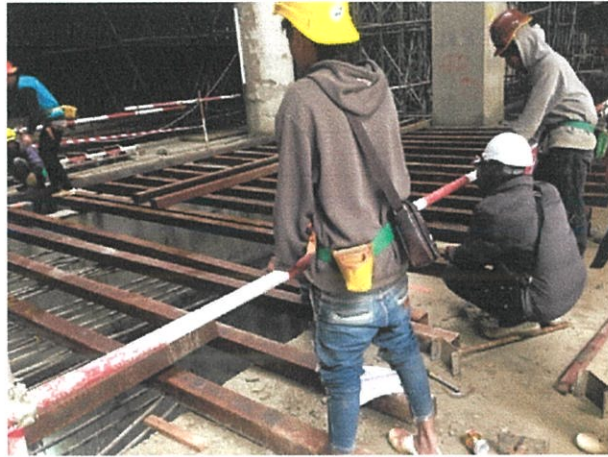
Picture 3.7 : Staging work

Before the installation of formwork, the staging and scaffold must be done first. So, scaffold works done by carpenter and sometimes by general labour. The installation of scaffold and staging must follow the mark that had be done by surveyor for the height, distance of flight and landing.

- a) Hollow section
- b) Scaffold
- c) Jack base
- d) U base
- e) Jointing

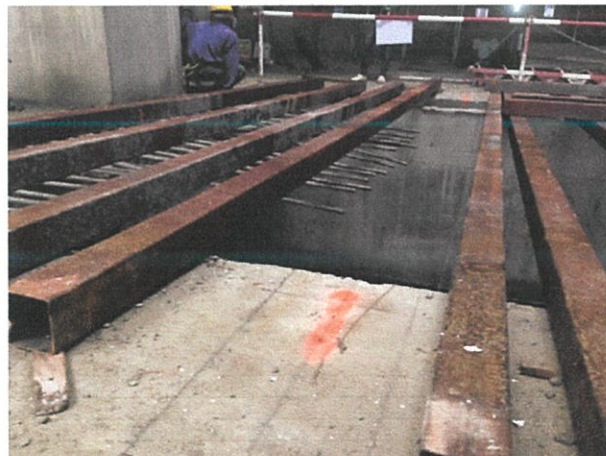
Picture 3.8 : Mark made by surveyor

In case if the staircase was construct on a void, a safety barricade must be install first for the sake of safety. A carpenter will guide his worker during the staging installation. The staging normally made by hollow section, indeed the hollow must be on good condition as it will act as the main stage to sippont the load during construction of staircase.

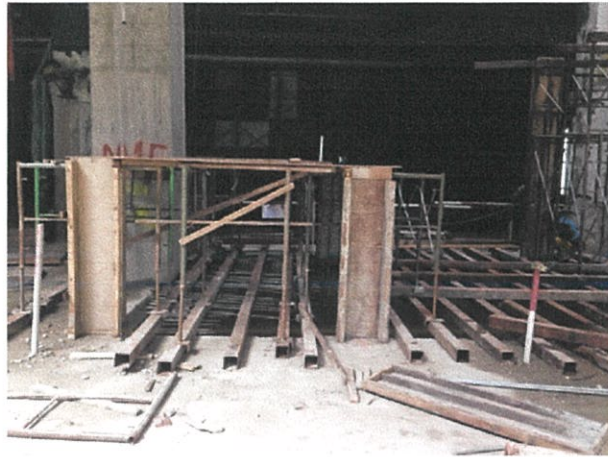
Picture 3.9 : Formwork for staircase

After staging installation is finish, scaffold will be install for landing and flight platform. This work need a strict monitoring and guiding work by supervisor or person in charge as it affect the rise of the flight and the level of the landing.

The scaffold come with jack base as it foot to suite the hollow section for grip purpose and prevent it from collapes. For the jack base, it high must not exceed 450mm as stated by safety department. This is reliabile because if the heigh of jack base increase, it tend to bend when force applied to it and soon it will collapse.

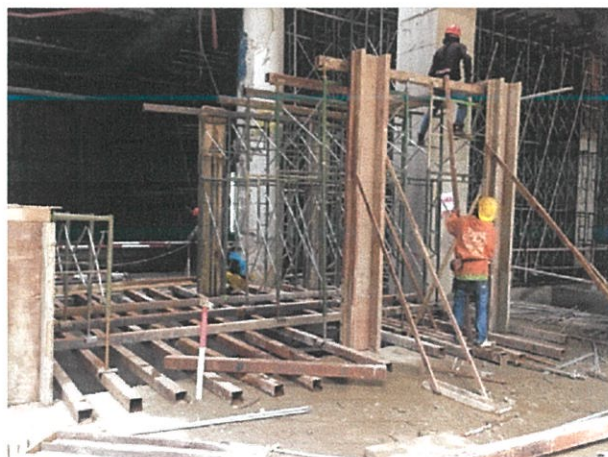
Picture 3.10 : stiffener formwork

The formwork for stiffener must be proceed with only 3-sides first. If it fully proceed with 4 sides, there is no space to install the bar soon. The verticallity of stiffener need to be check

before beam and slab can be proceed. It is because if the stiffner not in verticallity, it have a potential to collapse soon and the design will look ugly. Normally, verticallity frequently asked to check by architect. It for the sake of design and soon it will affect the whole design.

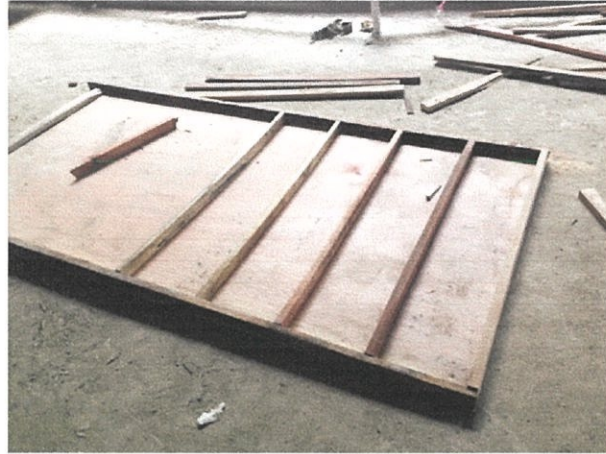
Picture 3.13: Plywood supported by a 2x3 wood

This formwork had enough strength since it complete its specification which is a plywood must be supported by a 2x3 or 2x2 wood.

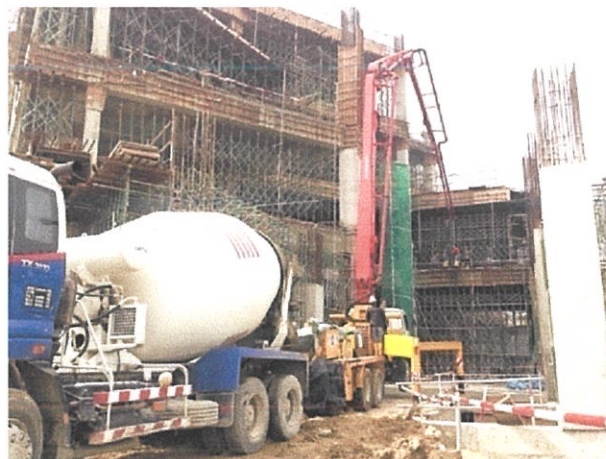
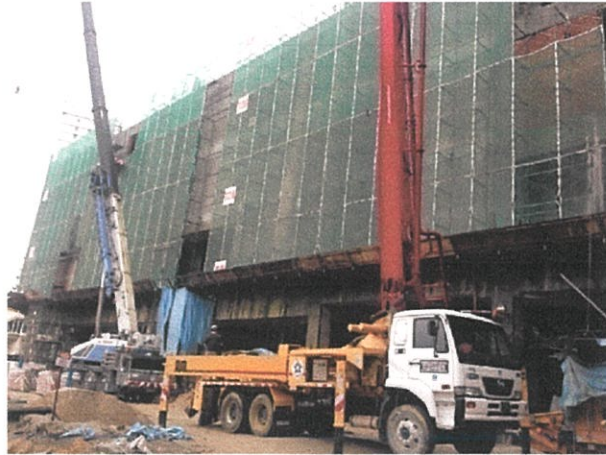
Picture 3.14 : Elephant pump

Elephant pump was catogorise as heavy machinery. It is the smartest way to concrete a staircase because it easy to handle can reduce a workers energy during concrete casting process. Its pipe lenght is about 38m can reach the target easily. It was control by a single operator with help of his assistant/signalman.

But this machine must be provided with easy access to park and enough space to pull out its pipe.

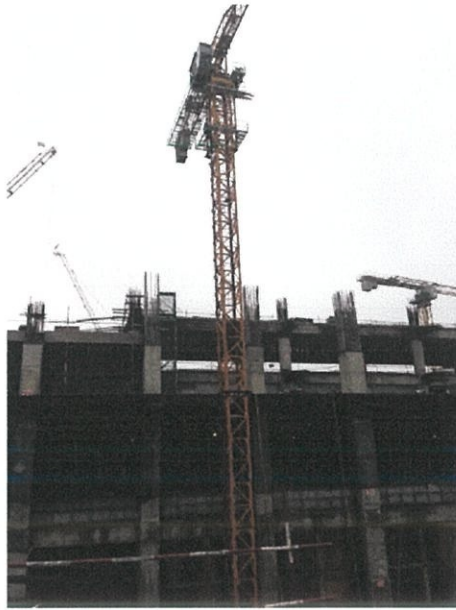
Picture : 3.16 : Tower crane

Usually the last choice machine that use to concrete a staircase. As known, tower crane is a heavy machinery. All tower crane here can bear a load up to 3 tonne. This machine will be hook a bucket to it lump. There are two types of bucket here which can carry 0.5m cube and 1m cube.

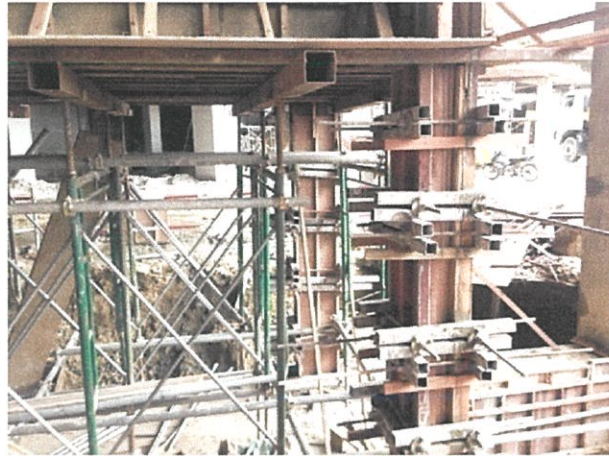
Picture 3.19: Wrong size of stiffener need to be open

This is the most problem during the construction of staircase. There are many case that staircase need to be reinstall because of error in formwork work and mostly it comes from landing beam and it stiffener. They did not follow exact drawing and frequently construct wrong size of landing beam and steps.

It very difficult and wasting time to reinstall the staircase that the formwork had finished and be locked. This problem continuously happen if workers cant read the detail of drawing very well.

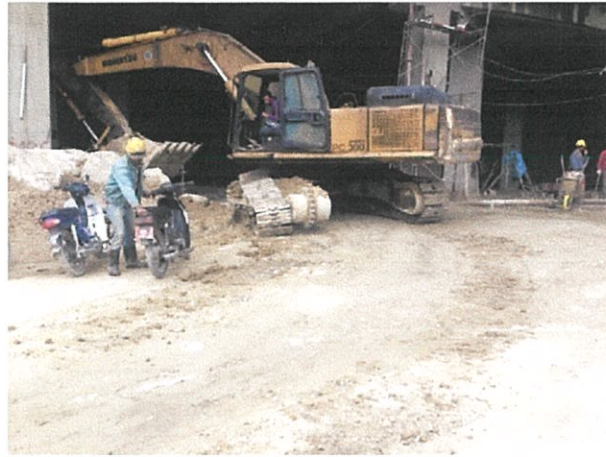
Picture 3.21 : Excavator accidently hit staircase

this excavator was accidently hit the staircase cause it roller chain was slide-out from it roller. It is clear that this excavator have a problem and need a maintainence but it still on site and frequently used.

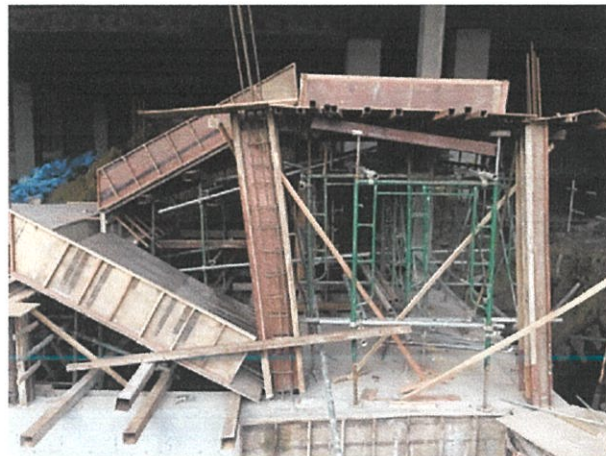
Picture 3.22 : Staircase were hitted

This one cause a waste of material (wood) to make a new one and also a cost to repair a machine. It also delay a time when it near to fully finish and can be concrete, hence a lot of work to do including report, safety aspect, rebuild and mentainence.

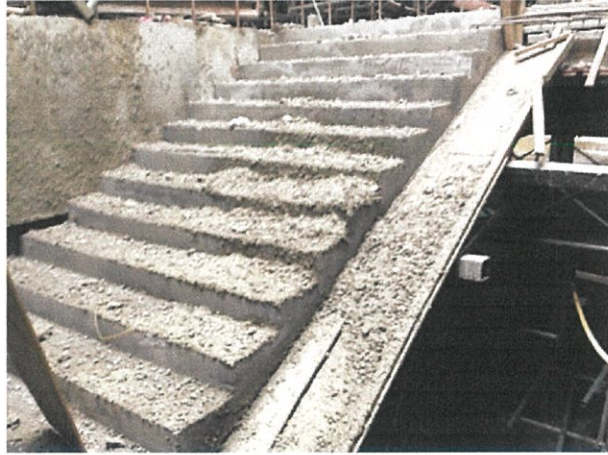
Picture 3.23: Concrete poured from upper floor

This problem come from a concreting machine, spider machine. It accidently explode and concrete blasting anywhere. Since this staircase was exposed, it take a hit.

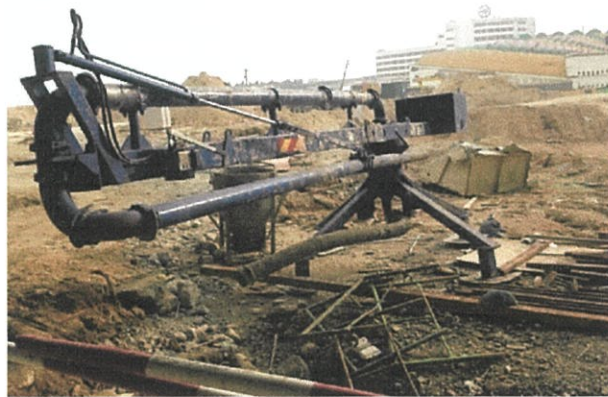
Picture 3.23 : Spider machine broken

In other word, a maintenance is important for machineries to avoid unwanted situation and case happen. There are lot of benefit if construction free from accident.
