**DEPARTMENT OF BUILDING
UNIVERSITI TEKNOLOGI MARA
(PERAK)**

METHOD OF WALL PLASTERING

**Prepared by:
FATIN NURSYUHADA BINTI AZMI
2019445078**

FEBRUARY 2022

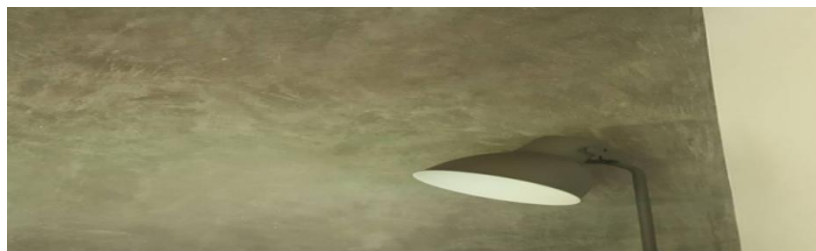
Figure 1.1: The attractive plaster.

Other than that, plastering also can make the house more attractive and appealing in the construction industry. The example of the attractive plaster has been shown in figure 1.1. There are many designers that chose to use plaster to make the house have an aesthetically vibes than any other material. Plaster wall finishes have quietly replaced other options such as paint, wallpaper, or exposed brick as the preferred choice for high-end home renovations (Andrews, 2019).

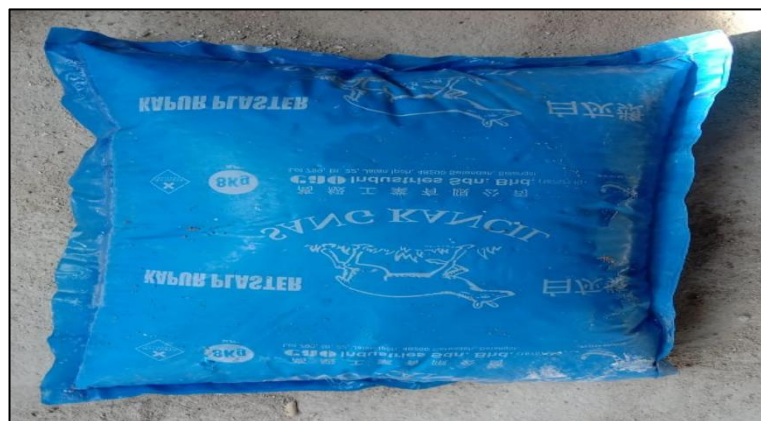
Figure 3.2: The lime used in the plastering work.

Lime is the main material used to produce the lime plaster to be used in the plastering work. Lime will help absorb and release all the moisture in the house to stabilize the internal humidity. This will produce a more comfortable environment in

the house that will satisfy the owner of the house. Furthermore, the function of the lime is to reduce condensation in the wall and helps to stop mold growth that can affect the appearance of the house.

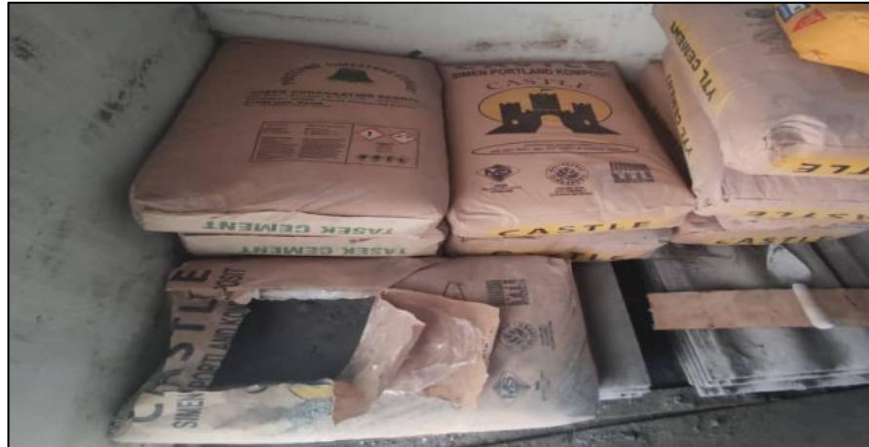
Figure 3.3: The cement used in the plastering work.

Cement will be used to mix with gravel, sand, and water to produce the concrete. Cement is the material that sets and hardens other materials. Moreover, cement also acts as a binding agent that helps to stick other materials together. The cement used in the plastering work has been shown in figure 3.3.

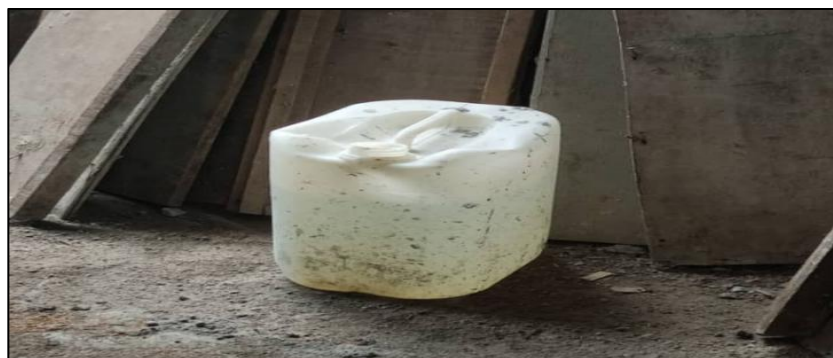
Figure 3.4: Water used for the concrete.

Water is one of the materials that is used to make concrete. It is important to use the right amount of water to get the right consistency of the concrete. Hardened

properties of concrete are controlled by the amount of water in it including workability, compressive strengths, permeability, durability, weathering, drying shrinkage, and cracking potential.

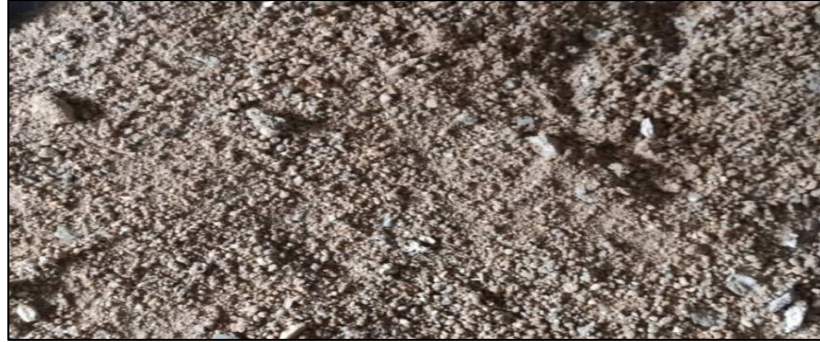
Figure 3.5: Sand use in the concrete.

Fineness of the sand is important to produce the best durability of concrete because it affects compressive and structural strength of the concrete. Sand is produced from crushed rocks or natural gravel deposits and is the material that acts as a filler to add density to the concrete. Furthermore, sand will increase more volume of the concrete and make it more economical. Moreover, sand also will be used in lime plaster for higher strength and durability.

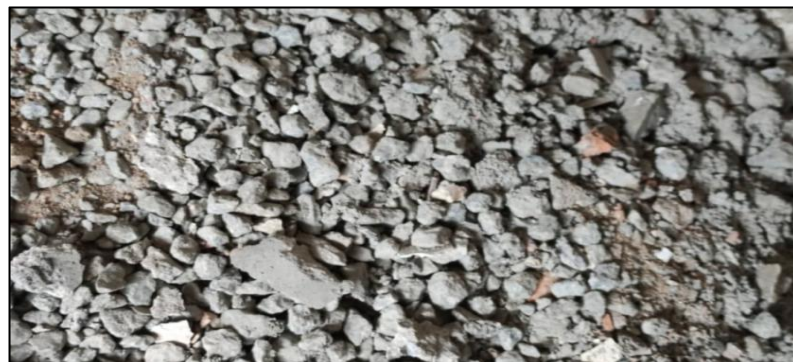
Figure 3.6: Gravel used in concrete.

Gravel act as a filler in concrete. Furthermore, it also adds more volume to the concrete that will cause less air and make the concrete stronger. The size of the gravel

also influences the strength of the concrete. Larger gravel pieces cause more friction and make mixing more difficult, but it will also produce a stronger concrete.

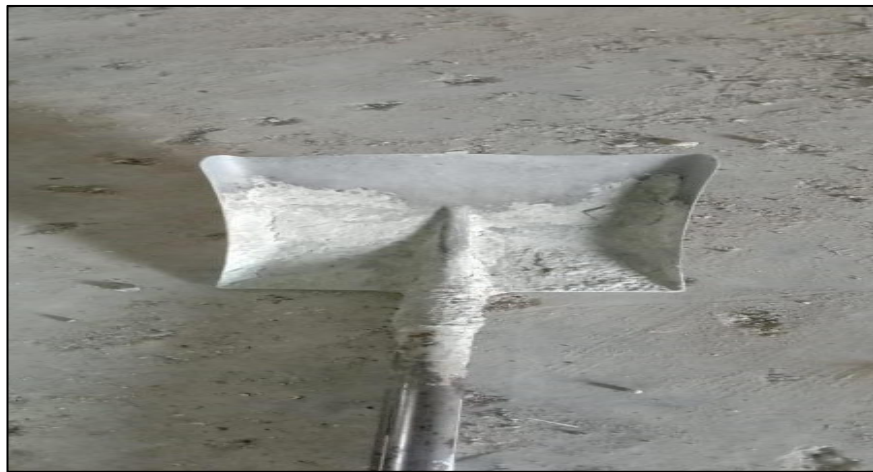
Figure 3.7: Shovel used in the plastering work.

Shovels are one of the hand tools that are used in the plastering work to move the sand, gravel and the concrete that has been produce from one spot to another. Furthermore, it is also used to mix the sand, gravel, cement, and water to produce the concrete. Shovel blades are made from steel that are very strong and the shaft are made from the metal and complete with handle grip that will make it easy to lift the material.

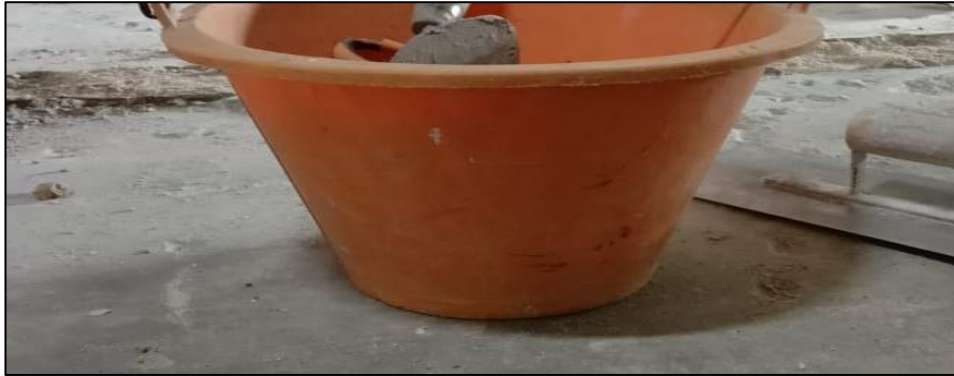
Figure 3.8: Bucket used in the plastering work.

Bucket is used to deliver the mixture of lime plaster and concrete from the first floor to the second floor. It is to make it easier for the labor worker to bring the lime plaster and concrete to the brick wall that needs to be applied with the mixture. Moreover, a bucket is also used as a spot to mix the lime and sand to produce the lime plaster. It is made from a polyvinyl chloride and is complete with a handle grip.

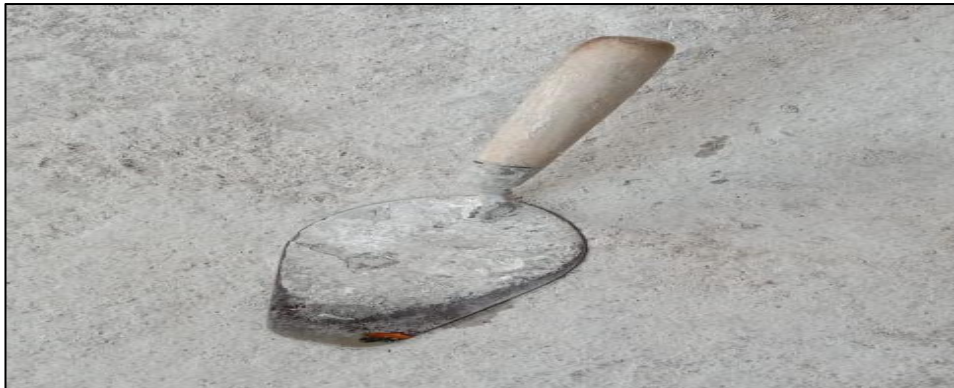
Figure 3.9: Trowel used in the plastering work.

The trowel blade is made from steel and also known as point-nosed trowel will make it easy to mix the material of because of the blade shape. Trowels are used in the installation to mix the lime and cement to produce the lime plaster. Other than that, the trowel that is shown in figure 3.9 also has been used to deliver the cement to the bucket with the right quantity.

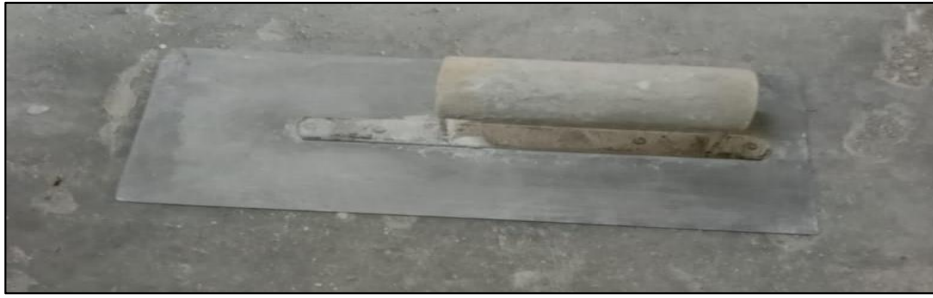
Figure 3.10: Finishing trowel used in the plastering work.

The Finishing trowel in figure 3.10 is a tool that is used to apply and smooth out the finishing of lime plaster and the concrete to the wall. Moreover, it is also used to level the concrete and lime plaster to produce a perfect finishing because it has a rectangular shape of blade. Furthermore, the edge of the blade will make it easier for concrete or lime plaster to be applied at the corner of the wall.

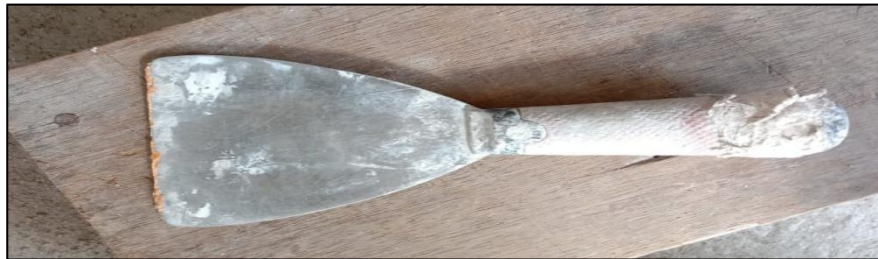
Figure 3.11: Scraper used in the plastering work

The scraper has a metallic blade and has a handle that is made from wood. Scrapers are used in this installation to remove any dirt or other material on the brick wall before the concrete can be applied. This is important to avoid any air that can cause cracks to the concrete. Furthermore, it is to make sure the finishing of the concrete will be smooth to make it easier to apply the lime plaster.

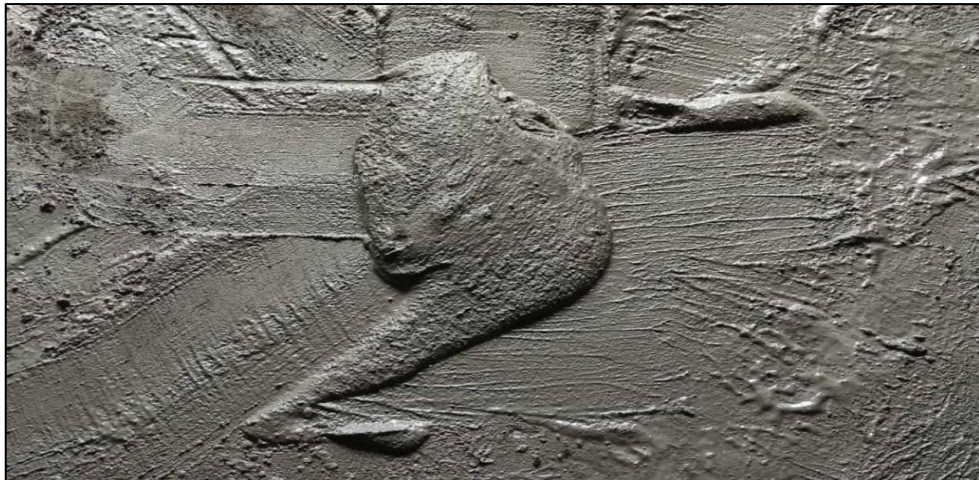
All the material that has been measured was put in one spot to make it easier for the mixing works. Then, 27.5 liter of water has been pouring slowly every 3 minutes and all the material, which is cement, sand, and gravel, was mixed together by using a shovel until the right consistency of the concrete has been achieved. The concrete that has been successfully produced is shown in figure 3.12. The concrete has been put in the bucket by a shovel and trowel to be delivered for the brick wall on the second floor.

Figure 3.12: The concrete mixture used for the project.

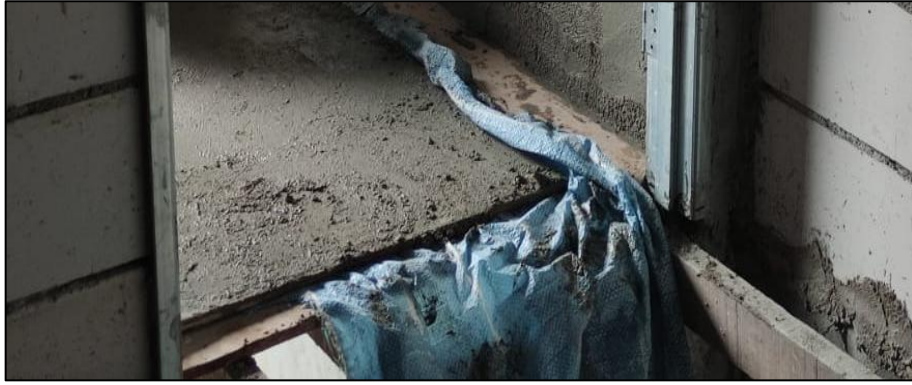
The second part of this process is concrete pour. The floor has been covered with the canvas is the first step of this part that has been shown in figure 3.13. This step is important to protect the floor from the concrete when the coating process. Then, the brick wall was scrapped with a scrapper to remove any substances that stuck to the wall.

Figure 3.13: Canvas that has been used to protect the floor.

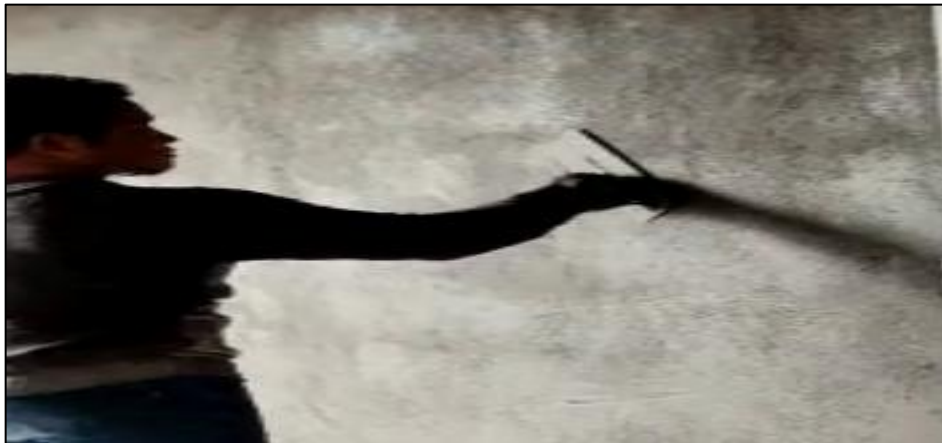
The half of the finishing trowel was filled with the concrete that came from the bucket that has been delivered from the first floor. Then, the concrete has been applied to the top of the wall by using a finishing trowel. The concrete was spread to achieve 19 millimeters of thickness by using the finishing trowel through all the parts of the wall. Next, all the concrete excess was removed in a scraping motion by using the edge of a finishing trowel. The finishing trowel was used to smooth the coat of the concrete has been shown in figure 3.14.

Figure 3.14: The finishing trowel was used to make sure the coat of the concrete is smooth.

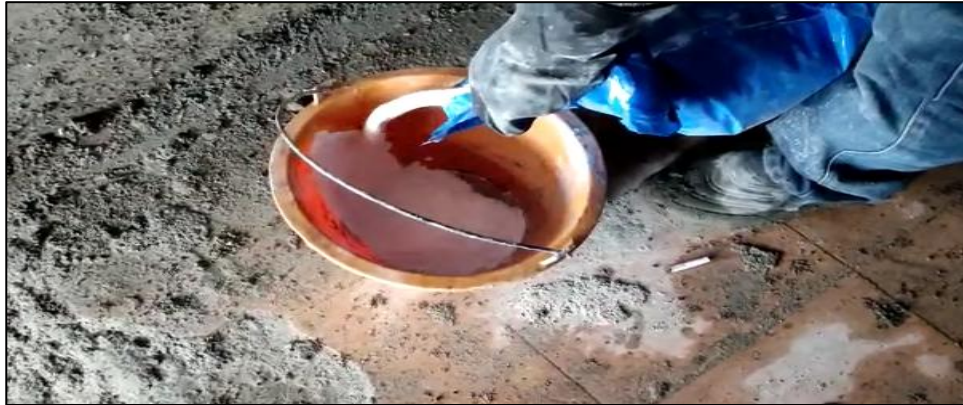
The third part of this process is the lime plaster mixture. Lime plaster is made from lime and sand. The ratio of the mixture that has been used is 1:3. 1 stand for the lime and 3 stand for the sand. 3 ratio is suitable for the sand to prevent the wall from cracking. 1 bag of lime, which is 8 kilograms and 3 scoops of sand by using a trowel, is a quantity of the material that has been used for the mixture. The first step of the

mixture was to pour the lime in a bucket as shown in figure 3.15, and slowly sprinkle the 3 scoops of sand on by one and mix it by using a trowel. Then, the bucket of lime plaster has been delivered to the wall that has been applied with the concrete at the second floor.

Figure 3.15: The lime been poured in the bucket.

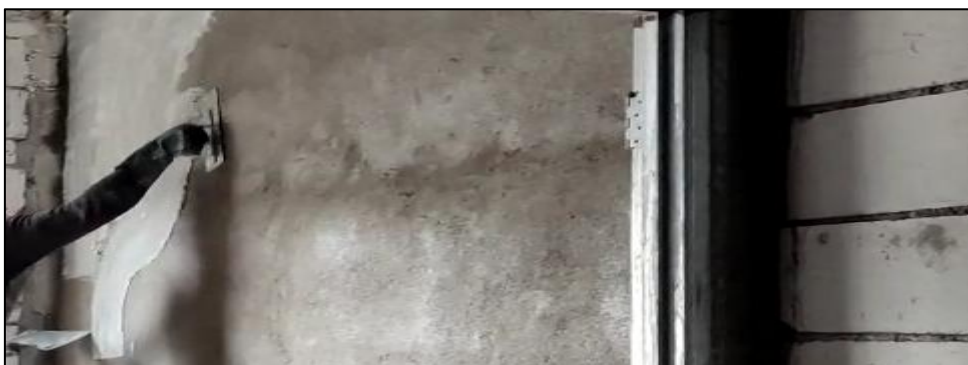
The last part is lime plastering work. The finishing trowel was filled with the lime plaster that has been delivered by a bucket from the first floor. The first coat of lime plaster has been applied to the wall by using a finishing trowel before the concrete has dried. The thickness of the first coat was 6 millimeters and has been applied to the whole wall by beginning at the top of the wall, with scraping motion has been shown in figure 3.16. The second coat of the lime plaster was 6 millimeters has been applied before the first coat dried with the same finishing trowel. The third coat of the plaster has been applied and the thickness of this finishing coat is 3 millimeters by finishing trowel. The result of the whole process has been shown in figure 3.17.

Figure 3.16: The first coat of lime plaster was being applied.

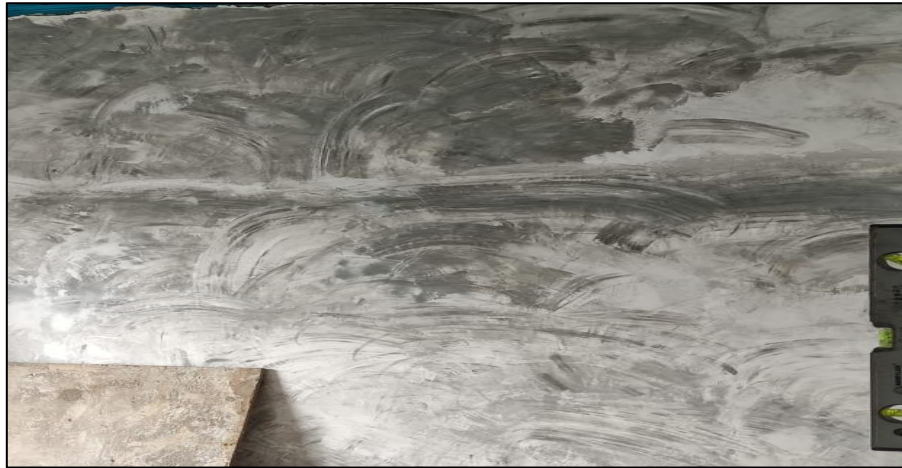
Figure 3.17: The result of the whole wall plastering work

All this work is a little bit different with the theory. On construction site of the case study, the first layer of plaster will be installed on a layer of wet concrete and there is no curing during this process. Based on the theory, the finishing coat for lime plaster, which is the third coat need to be installed after 5 to 7 days, but on the construction site, the third coat is installed with a first and second coat. All of this happen to save time at the construction site and there is no problem occur because the installation runs smoothly.

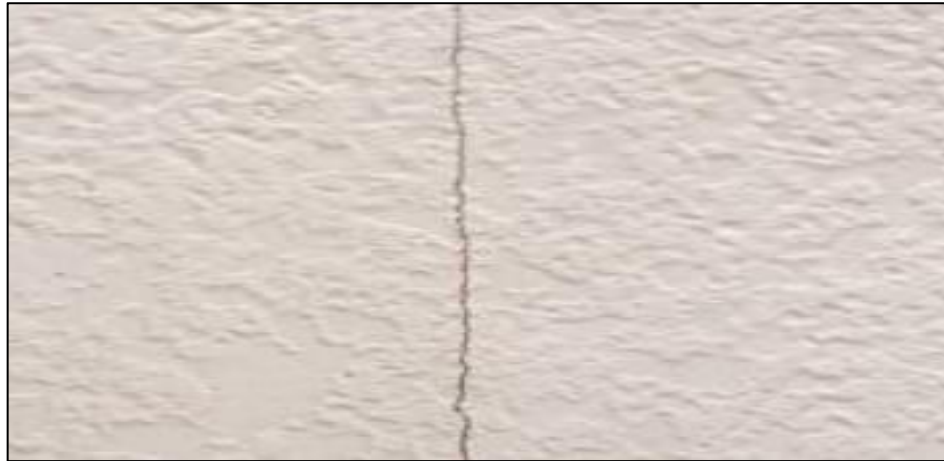
There are two common problems in wall plastering which is crack and discolored plaster. There are three types of cracks, which are hairline crack, settlement crack and delamination crack that can happen in this case study wall plastering. The thin hairline crack is a minor crack that can affect the appearance of the house as shown in figure 3.18. To prevent this from happen, the labor worker in this case study have make sure the quantity of sand in lime plaster mixture was not exceeding 3 scoops of trowel and do not use very fine sand because it needs more water and can cause cracking in the future. This type of crack can be fixed if it happens in the future by filling holes or cracks, by using a lime-based putty and rub the filler by using a sandpaper to make it have a smooth finishing.

Figure 3.18: The hairline crack.
(Source: <https://cutt.ly/WTcvbfu>)

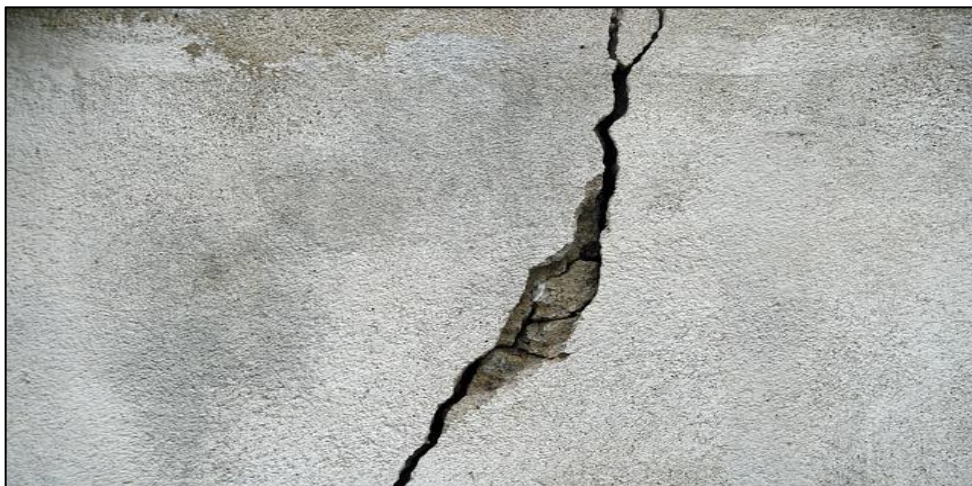
The settlement crack usually happens to renovate house. These cracks can be identified by groups of cracks going on in one direction and should be monitored because it is structural crack and need professional help. This type of crack is likely to occur because of large differences in foundation settlement caused by varying soil and loading conditions. The delamination crack is a sign of plaster pulling away from the wall or ceiling stud behind it. These cracks typically run parallel to both ceilings and walls, and there is a risk of the plasterboard to collapsing. These should be repaired or replaced as soon as possible.

Figure 3.19: The settlement crack.
(Source: <https://cutt.ly/5TevOtc>)

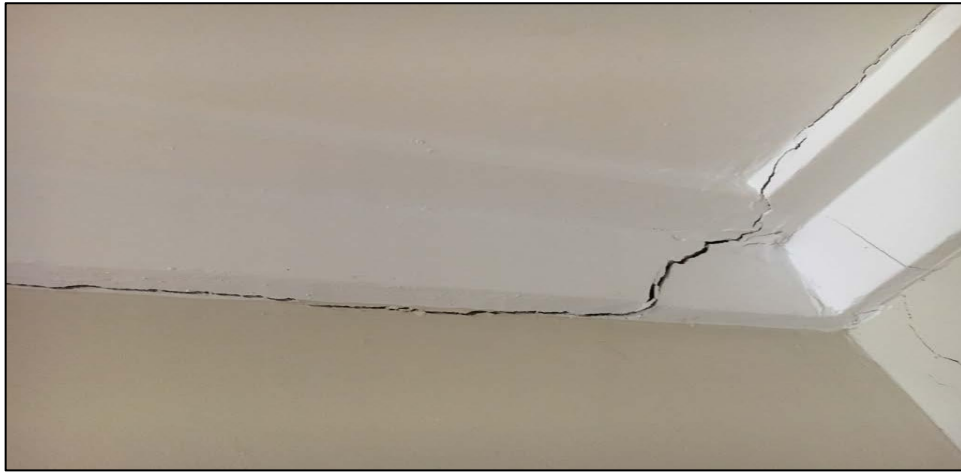
Figure 3.20: The delamination crack.

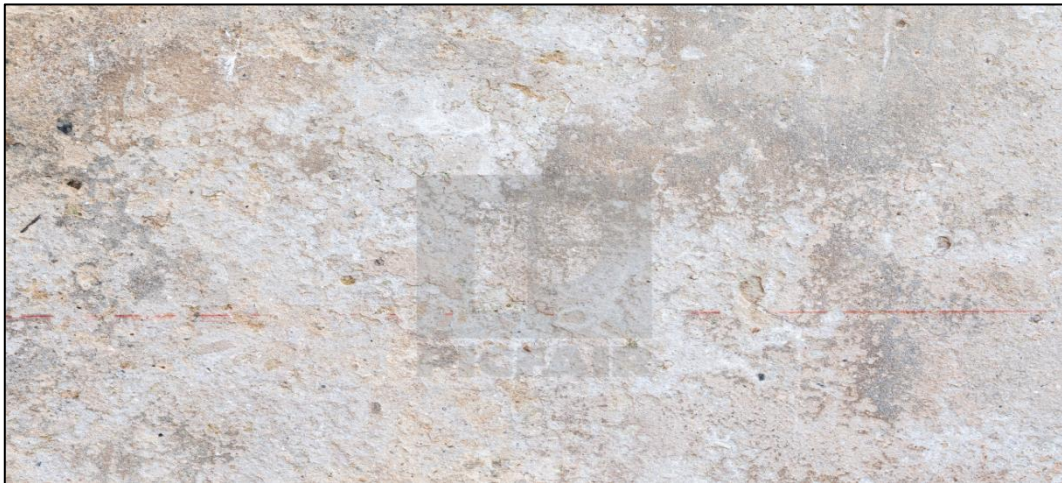
Besides that, discolored plaster is also a common problem in wall plastering. This problem is caused by a leak. Brown stains will appear and can affect the appearance of the house. The way to solve this problem is, to find the leaking part and should not just repair the layer of the plaster because the same problem will happen.

Figure 3.21: The discolored plaster.
