**DEPARTMENT OF BUILDING  
UNIVERSITI TEKNOLOGI MARA  
(PERAK)**

**INSTALLATION OF ROOF BEAM**

**Prepared by:  
MUHAMAD KAMIL BIN RAMLE  
2019244444**

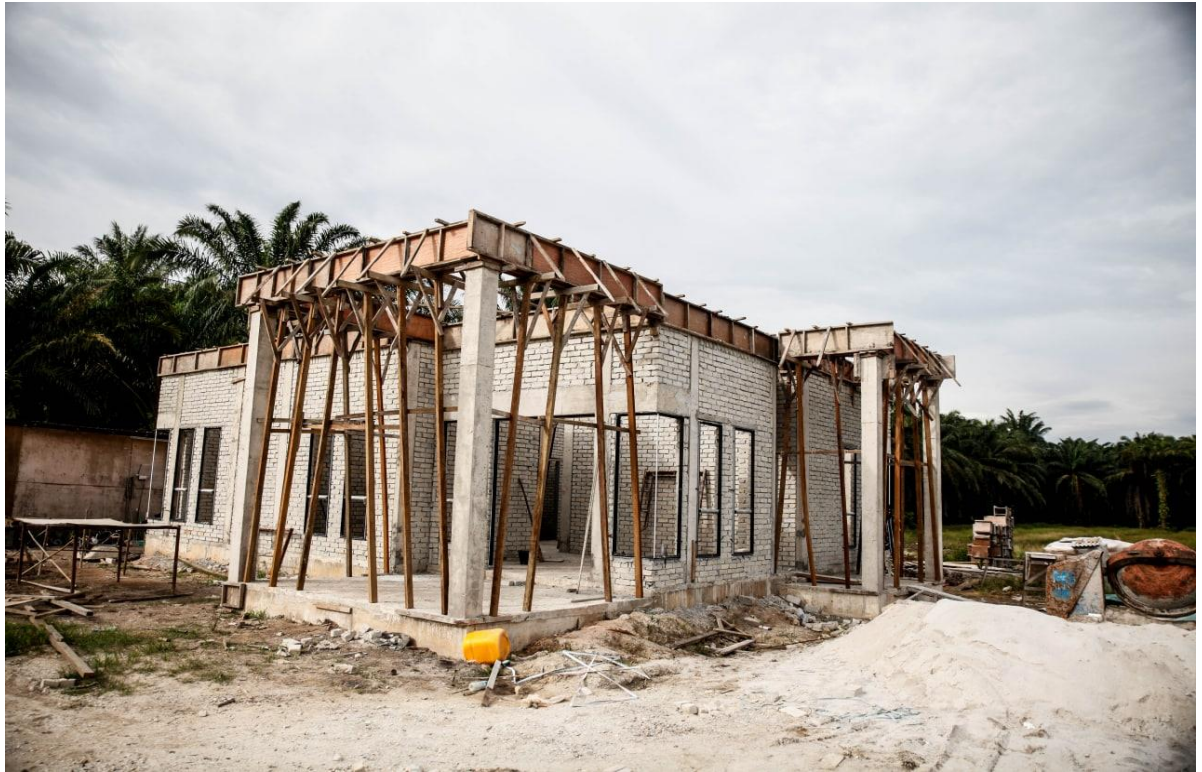
**Figure 3.4 : Process Installation of Roof Beam at Site Chenderong Balai.**

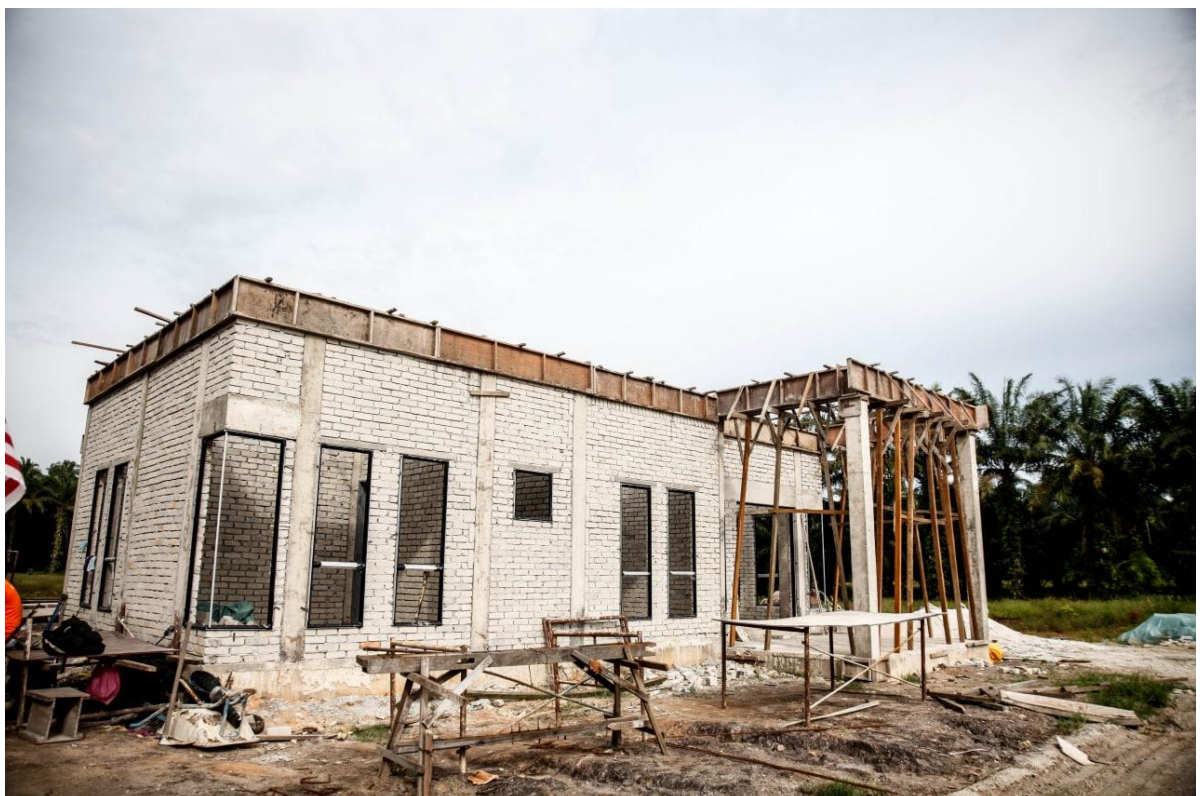
**Figure 3.5: Process Installation of Roof Beam at Site Chenderong Balai.**

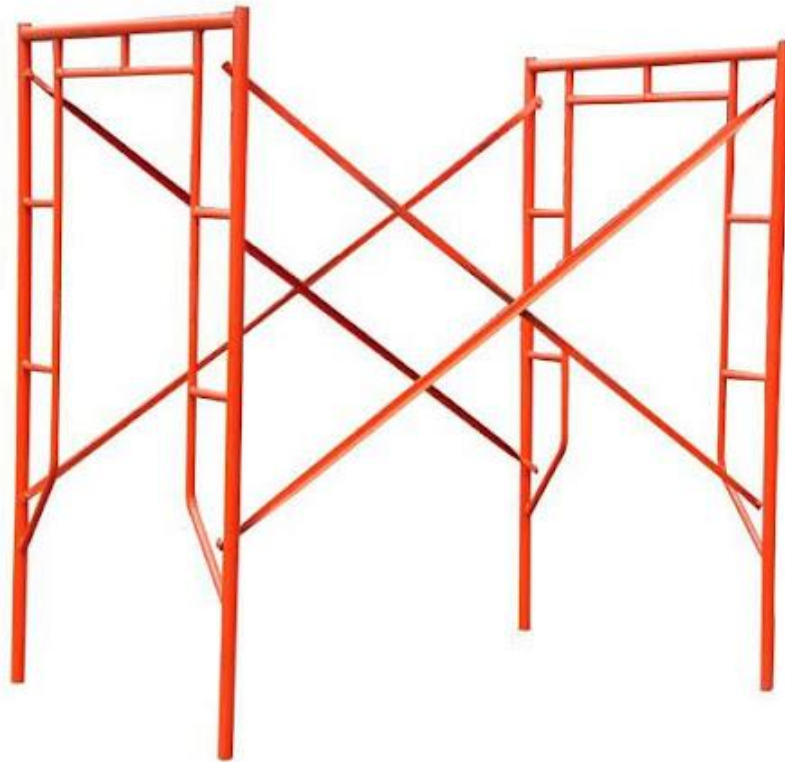
Figure 3.6: The example of staging that used

Firstly, roof beam element is an element that need to be done at a high place. To make sure the safety of the workers at site, the workers need to install the staging before the work for this element start. This way, hazard won't happen. By hazard, it can be the workers may fell to the ground using used woods as stairs.

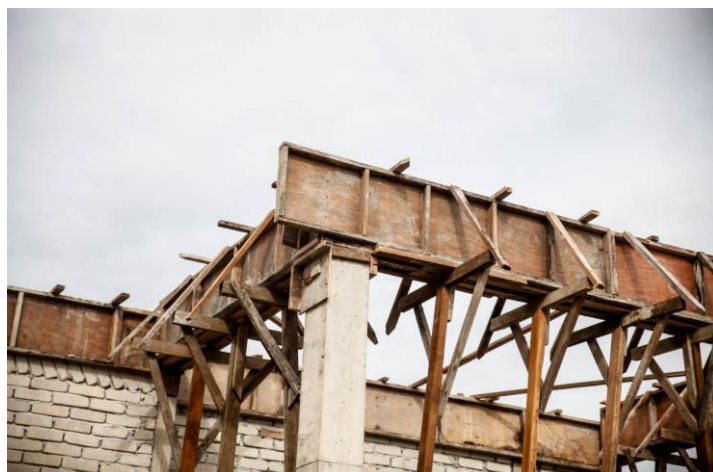
Figure 3.7: Formwork of Roof Beam

Formwork for this element is using plywood, 1/2 wood and 2/2 wood. This formwork can be used several times. It also can be used for ground beam. The materials of plywood and wood is high quality of materials. Usually this formwork can be used again at the next 2 or 3 project. This process took 3 days to complete.

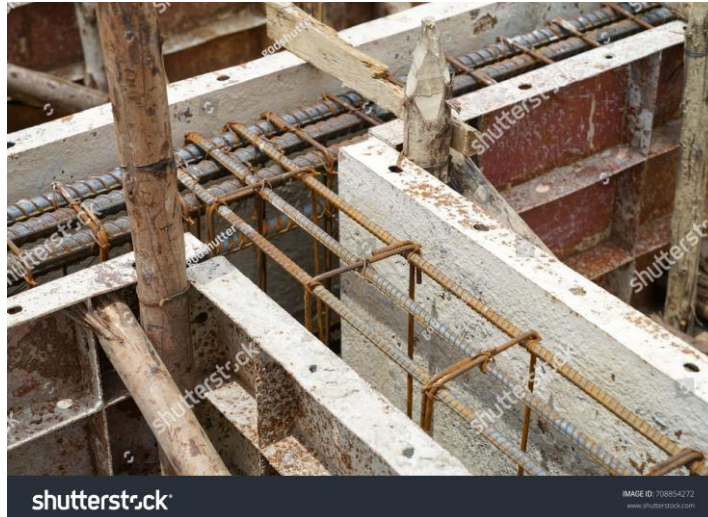
Figure 3.8: Example of reinforcement bar in roof beam

Reinforcement bar installation is using y10 steel, r6 link steel and galvanized wire or iron wire. This process is to make the great strength of concrete. The steel for roof beam is connected with column steel. Longitudinal rebars are placed to withstand the bending tensile stresses that appear along the beam axis while stirrups are used to carry the diagonal tensile stresses caused by shear. The beam load will go to the base of the pad through the column. This process took 3 days to complete.

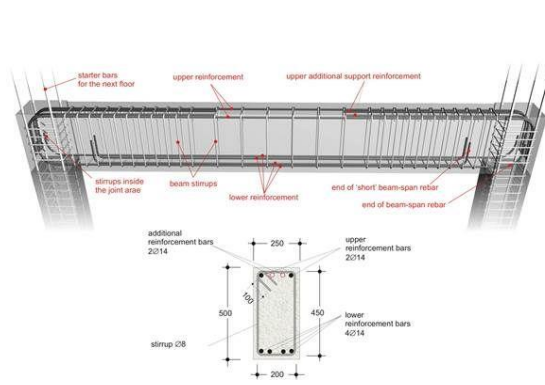
Figure 3.9 : Example of the steel in roof beam

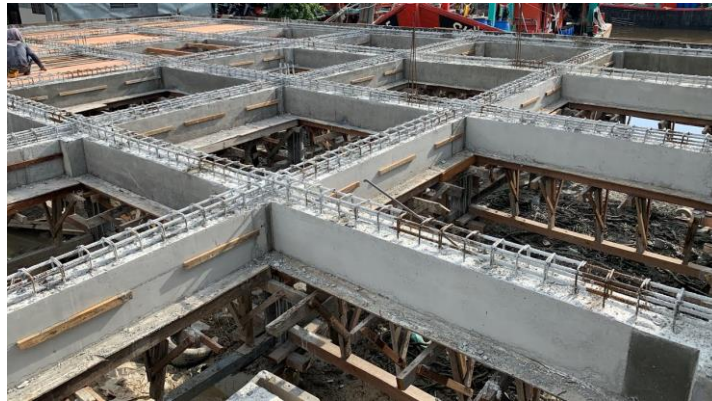
Figure 3.10 : Example of concreting work of roof beam.

Concrete that be used for roof beam is grade 25, which is the ratio of the concrete is 1 :1 :2. The materials for concrete is cement, rough sand, aggregate and water. According to the ratio, 1 equal to cement, another 1 equal to rough sand and 2 equals to aggregate. The concrete that usually used at site project is ready mix concrete or mix at construction site by workers. Concreting work took 1 or 2 days to complete. After concrete, the formwork can't open for the next 3 days to ensure the concrete is hard enough and durable.

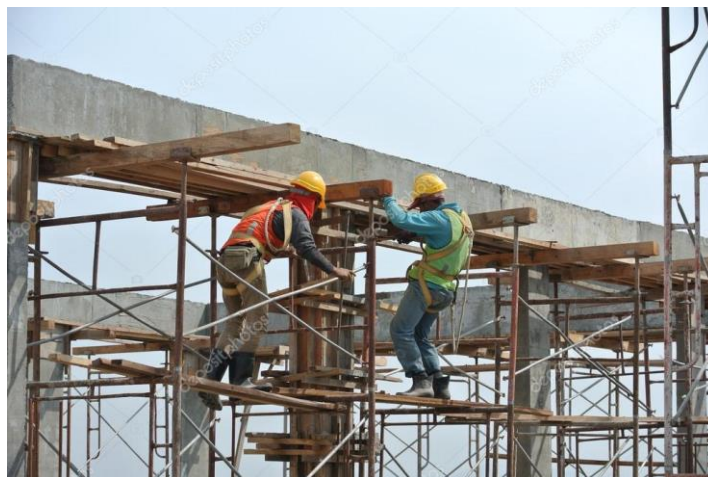
Figure 3.11: Example of dismantling formwork of roof beam

To ensure the concrete is hard enough, the workers will wait for 3 days before opening the formwork. After dismantling the formwork, workers will check the formwork first to make sure the formwork can be used at next project or not. If the

formwork can be used, workers will keep the formwork at the site store. The formwork that can no longer be used, workers will be dismantling the formwork and segregate the plywood and wood to workers can used for others work at site project. This work usually took 1 or 2 days to complete.

After dismantling the formwork, the workers will check the concrete to make sure concrete have to curing or not. If the concrete uneven, workers have to curing the beam before start next element which is roof element.
