**DEPARTMENT OF BUILDING  
UNIVERSITI TEKNOLOGI MARA  
(PERAK)**

**CONSTRUCTION METHOD OF ABOVE GROUND  
LEVEL SWIMMING POOL**

**FEBRUARY 2022**

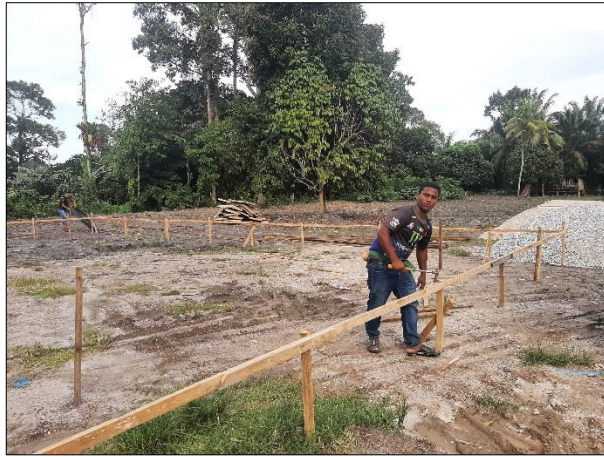
levelling the land. Then, all the necessary materials like pegs, nails, ropes, or string lines, hammers, measuring tape, and marking tools were prepared. After that, profile boards were built around the proposed site for this swimming pool using wood with the size of 1" x 2" as shown in figure 3.4. The profile boards represented the setback and also used to take some marking on it using a nail as a guide based on the setting out plan. After that, the rope or line are used in order to determine the position of the first pegs which will be located at the corner of the swimming pool. Figure 3.5 show the Site Supervisor (SV) inspected the setting out work.

Figure 3.4: workers installed profile boards

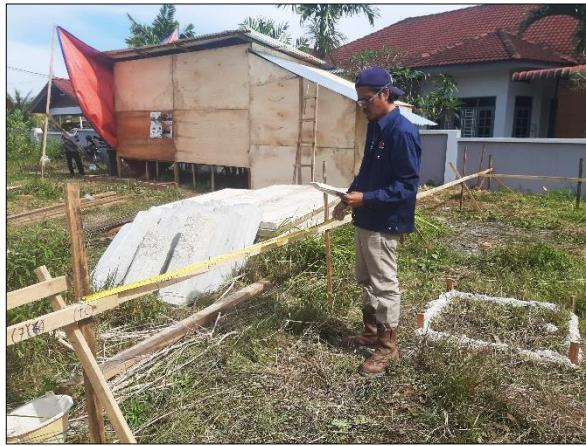
Figure 3.5: Inspection by Site Supervisor for setting out work

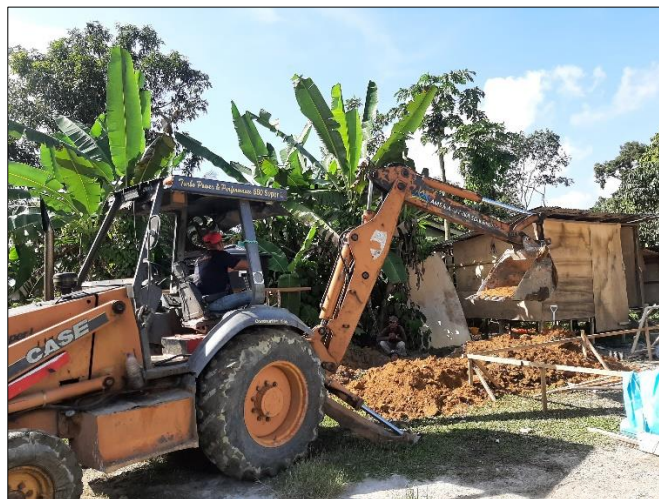
Besides, before any excavation work started, the layout and perimeter of this pool has been double-checked according to the proposed setting out plan to make sure that there was no error because once the excavation process begins, it will be difficult and costly to make any changes. Then, the work of excavating the soil was done using a backhoe to remove the soil within the perimeter of the swimming pool layout. During the excavation, the soil was excavated within 2 feet of depth from the ground level and the excavated soil from the swimming pool site was moved out using a lorry to the other site as the soil can be reused for other purposes. The dimensions of excavating the soil were accurately based on the perimeter and the design plan to make sure that the swimming pool will be correct in dimension and position. Figure 3.6 shows the excavation work is done by using a backhoe.

Figure 3.6: Excavation work was done using backhoe

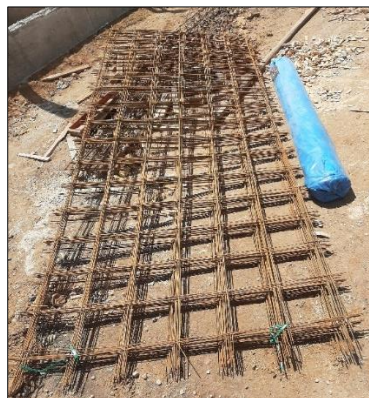
Firstly, for the slab reinforcement of this swimming pool, the type of steel used was Welded Wire mesh, or “BRC Fabric” as shown in figure 3.7. BRC Fabric was suitable for the reinforcement of concrete slab whether for the suspended or non-suspended slab. In addition, this steel was a prefabricated steel reinforcement material that has been electronically welded into flat sheets with square or rectangular grid patterns. Apart from that, the type of BRC used for the slab of this swimming pool was BRC A10. Furthermore, for the eight rectangular shape columns for this swimming pool, the type of steel was Y10 steel bar as the main reinforcement and R6 steel bar as a link for the column reinforcement.

For the installation of reinforcement on this swimming pool, the BRC A10 was laying on the swimming pool base with only one layer of reinforcement as the slab of this swimming pool was from a non-suspended slab type. Then, for the column, steel cage reinforcement was cast by the worker at the bar bending table. Based on the structural plan, four pieces of Y10 steel bar held vertically with the spacing between Y10 steel bar was 170 mm center to center for the length of the column and for the width, the spacing was 60 mm center to center. After that, the Y10 steel bar was held by the R6 steel bar as a link with spacing 120 mm center to center as shown in figure 3.8. Then, the column reinforcement was held in place and tied together with the slab reinforcement using galvanized iron wire to prevent movement of the reinforcement.

Figure 3.7: BRC A10 for the reinforcement of swimming pool slab

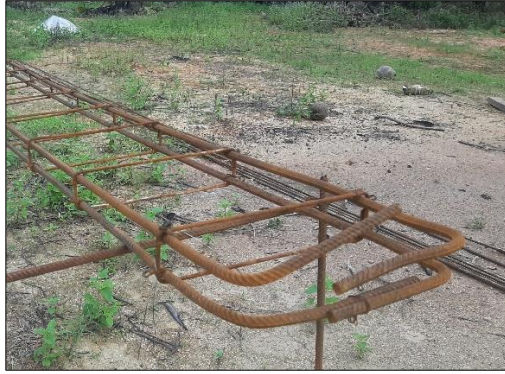
After that, the formwork was cast using the plywood and wood size of 1” x 2” based on the size of the column which was then placed into each column of the swimming pool. The support was installed to the formwork to retain the wet concrete and resist the initial hydrostatic pressure caused by the wet concrete. For

Figure 3.8: Casting of the column reinforcement

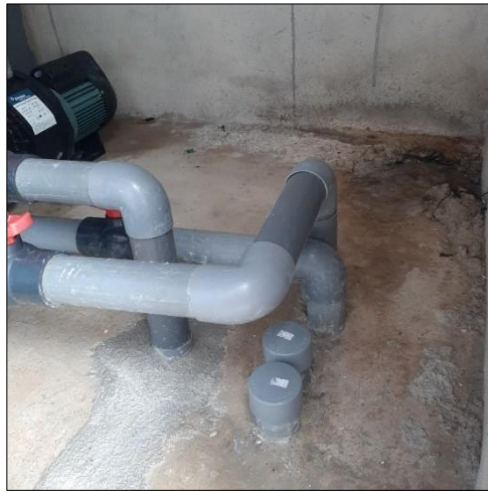
Next, after providing steel reinforcement, the plumbing work was done. The pipe was installed underneath the reinforcement. Grey PVC pipe was used as it was very durable and for the connection pipe, PVC ball valve was installed together with PVC pipe that function to control the flow of the water either water from the pool or from the fresh water into the pool. Besides, this swimming pool was complete with the filter system and pump that was arranged together in one station which was located in the pump room near the swimming pool. Plumb lines and the hole for the water inlet and outlet were made and installed before the concrete is poured. This pipe was used to move the water from the pool to the filter system and back to the pool through the water outlet. Furthermore, in order to provide fresh water to the pool, the filter system and pump were also connected to the municipal water line. The arrangement is required to restore pool water lost due to splash out or evaporation. The pipes were capped to prevent any materials from entering them during the next stage of construction. Figure 3.11 show the hole inlet while figure 3.12 shows the hole outlet for this swimming pool.

Figure 3.9: Connection of PVC pipe with PVC ball valve in pump room

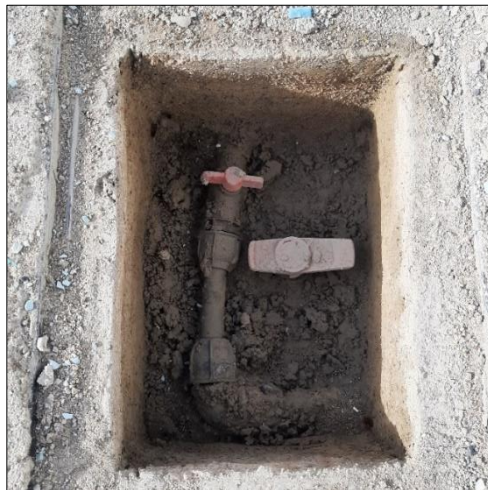
Figure 3.10: freshwater pipelines to the pool

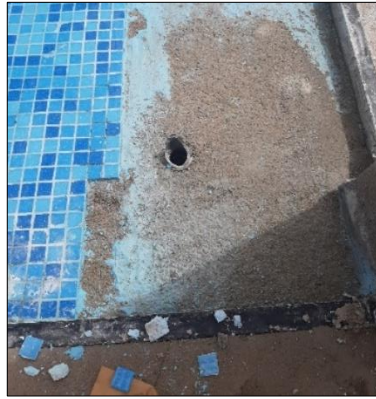
Figure 3.11: Hole inlet

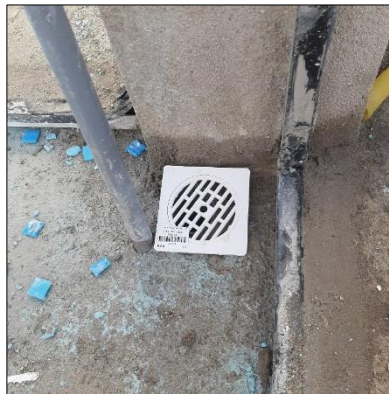
Figure 3.12: Hole outlet installed with floor trap

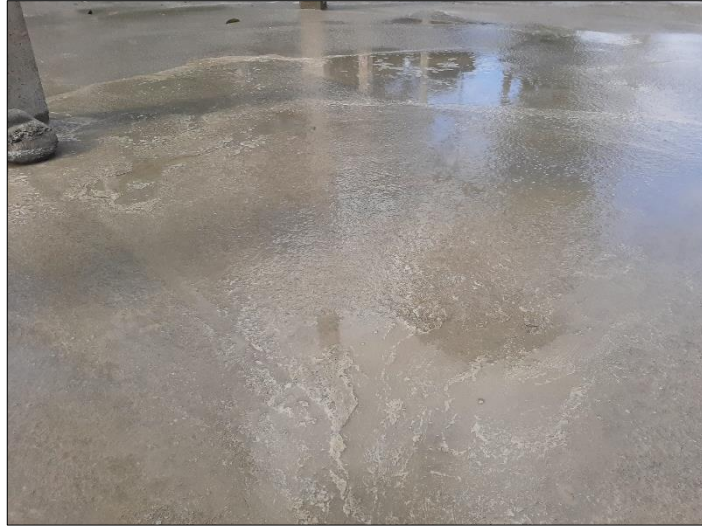
For the placement of the fresh concrete, the fresh concrete was poured into the formwork of the slab and column using concrete bucket. The mobile crane was used to lift the concrete bucket from the concrete mixer truck to the work area. Square shovel was used to spread the wet concrete on the slab. Furthermore, in order to remove the air void from the fresh concrete and prevent the formation of honeycomb, concrete vibrator machine was pushed into the wet concrete slowly and evenly to all concrete area. After the placement process was done, the screed board was used to screed and level the top of the concrete for the slab. This process was required as it helps to compact and smooth the concrete. Figure 3.13 shows the complete process of screeding work on the wet concrete of the swimming pool slab. Then, the curing process was done after that where the concrete was left and began to harden. The formwork for column was opened 3 days after the concreting work for column was done. Then, light spray of water was applied to the swimming pool slab and column for 5 days. Curing process was very important to the fresh concrete to avoid any cracking and help to retain the moisture in the concrete. Figure 3.14 shows the complete process of concrete work.

Figure 3.13: screeding work on concrete of swimming pool slab done

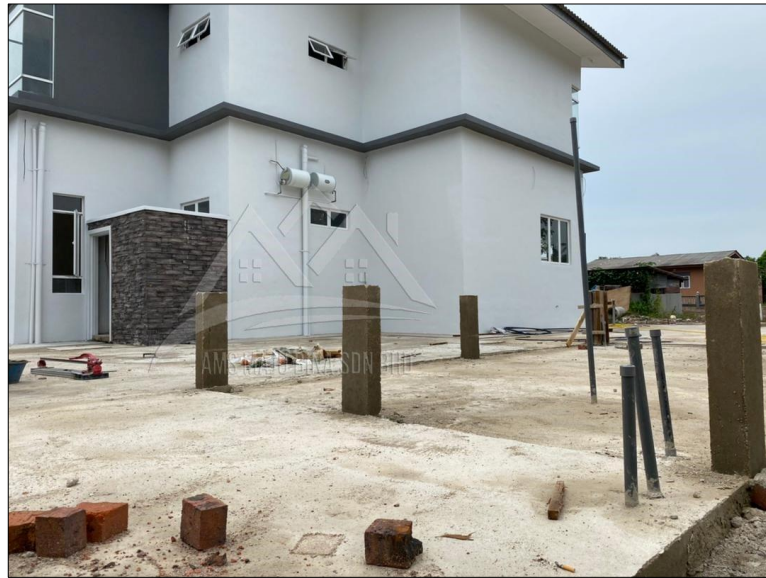
Figure 3.14: Completed process of concrete work

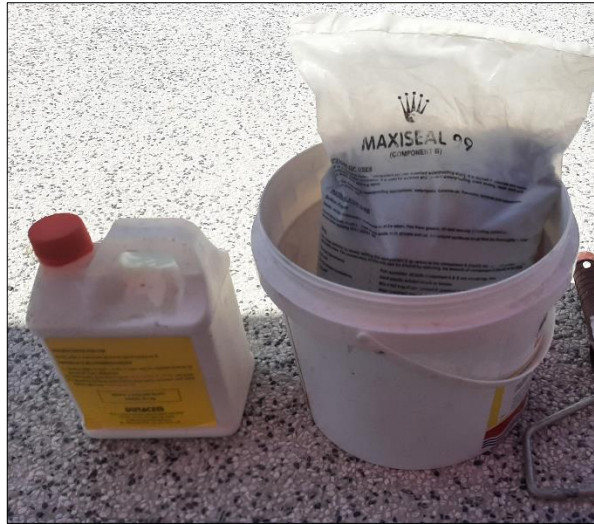
The waterproofing of the above ground level swimming pool was applied after the curing process of concrete are done. For this project, the waterproofing types that was used was Maxiseal 99 with the 2 component of polymer modified waterproofing slurry which was component A (Liquid) and Component B (powder) as shown in figure 3.15. The method of waterproofing used was the non-exposed systems which was concealed from exposure after finished of application. Waterproofing was done to the slab and column of this swimming pool to make it watertight and prevent water infiltration.

Figure 3.15: Component A and B of Maxiseal 99

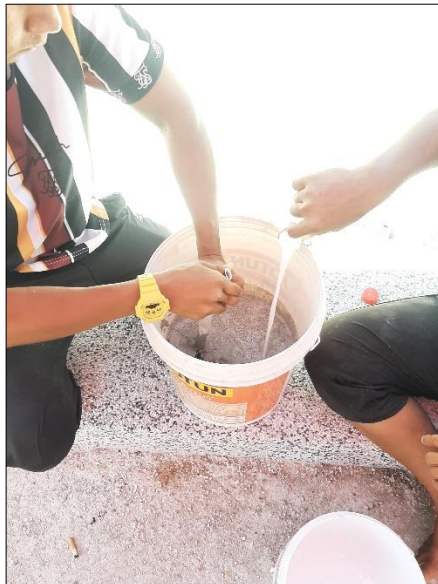
Before the waterproofing work started, the concrete surface was clean and free from grease, oil and loosely adhering particles to make sure that the waterproofing slurry stick and bond to the swimming pool concrete surface. Then, the component A (liquid) was slowly mixed with the component B (powder) in clean container as shown in figure 3.16 until the waterproofing slurry was formed. For this swimming pool, 3 coats of Maxiseal 99 applied on concrete surface of slab and column using the brush technique. For the application, the first coat of Maxiseal 99 was applied using hard plastic bristle brush. The slurry was rub well throughout the surface and then leave to harden for 6 to 8 hours before applying the second and third coat. For the floor of this swimming pool, there was a drop of 5 inch from the ground level after the concrete work. On top of that, the drop also needs to waterproof with the 45 degrees in the corners to ensure that the water will not penetrate throughout the corner of the pool. After the waterproofing work done, test was done into the slab to identify weather there was any leaks founds on the slab of this swimming pool. The water was fill into the slab that have 5 inch deep and the heigh of water loss was recorded to conclude the test.

Figure 3.16: Mixing the Component A and B

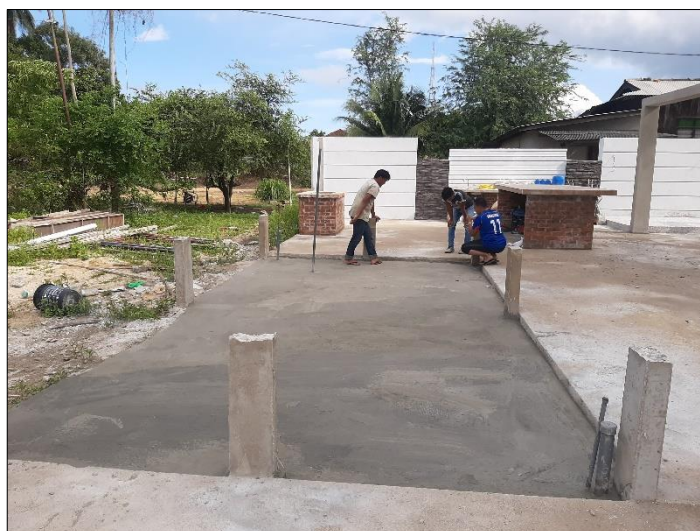
Figure 3.17: Applying waterproof to swimming pool slab

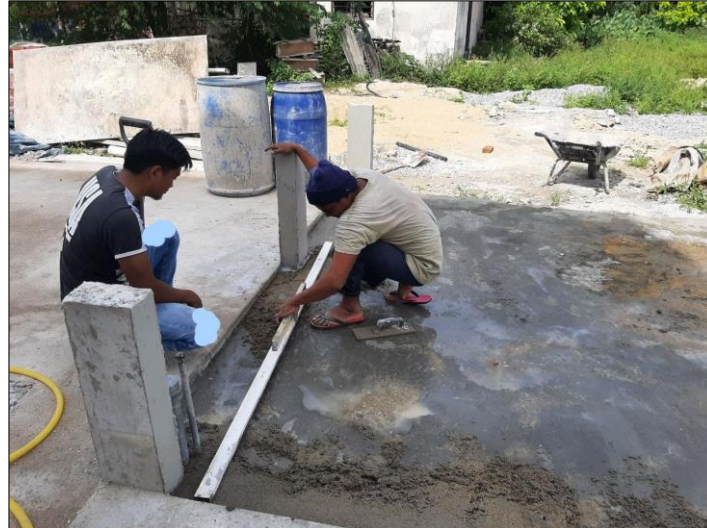
Apart from that, the material used for rendering the floor of the pool was cement that mixed with the sand and water. First, the surface was clean from dust and sand to ensure the cement render bond perfectly with the floor surface. Then, cement and sand mixed together using flat shovel which water was added slowly to form the semi-dry cementitious types of screeds. This mixture was spread and level to the entire floor surface of this swimming pool using screed board with the thickness of 5 cm as shown in figure 3.18.

Figure 3.18: Rendering work on the swimming pool floor

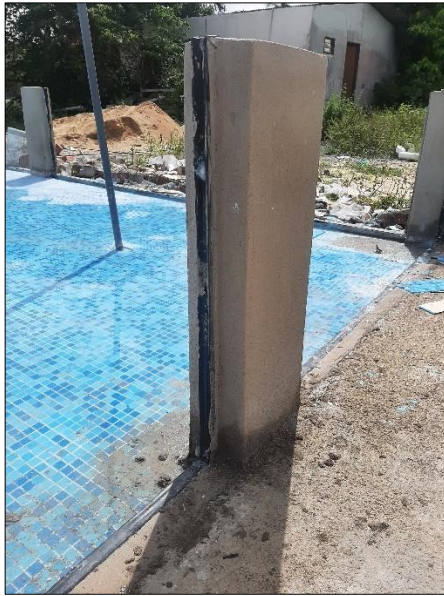
For the installation of aluminium frame, firstly, hand drill was used to pilot the hole into the side of the concrete column based on the length of the wall plug. Then, the wall plug was inserted to the hole before attached the aluminium frame to the column using screw. Figure 3.19 shows the complete installation of aluminium frame. After that, the black tape was installed to each aluminium frame as a protective layer before starting the plastering work to the concrete column for this swimming pool. The plastering of concrete column was done using the mixture of cement, fine sand, and water. The plastering trowel was used for spreading the plaster as well as create the smooth finish to the column. The purpose of the plastering work was to close the small gap situated between aluminium frame and concrete column. Furthermore, this work can prevent the water from seeps through the gap. Figure 3.20 shows the complete process of plastering work to the swimming pool column.

Figure 3.20: plastering work for column completed

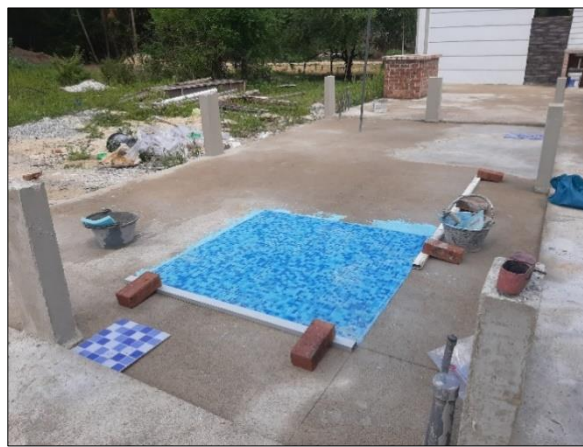
Apart from that, before the installation of the mosaic tile to the swimming pool slab was started, the rendering work on the slab was done to ensure the surface was perfectly flat and smooth. The tile layout as shown in figure 3.22 was planned by using the string lines to find the intersecting, perpendicular lines on the pool surface based on the mosaic tile size to enable a perfect square grout. Next, a layer of thin-set adhesive was applied at the center of the layout line cross using a notched trowel. The first mosaic tile sheet was applied into the corner of first quadrant which then was arranged and adjusted based on the tile layout to ensure that the grout spaces remain uniform. Figure 3.23 shows the installation of a mosaic tile sheet on the adhesive layer.

Figure 3.22: set the tile layout for the first quadrant

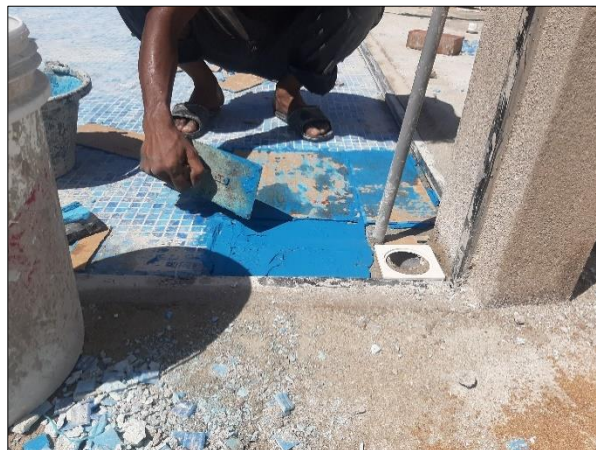
Figure 3.23: installation of a mosaic tile sheet on the adhesive layer

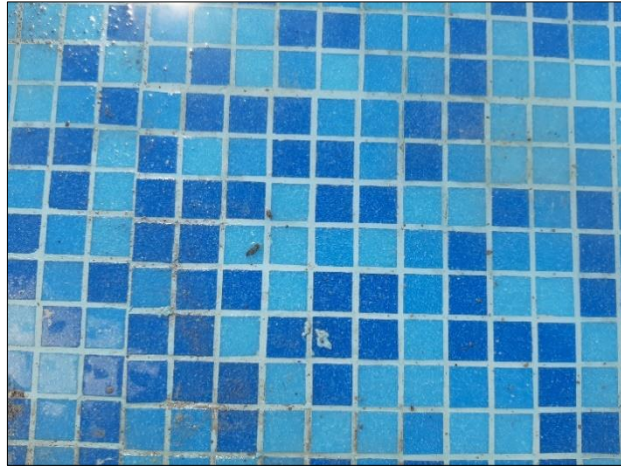
The next step was set the mosaic tiles. A small piece of plywood was pressed gently on the mosaic tile sheet until the surface became smooth and flat with another. On this stage, after adhesive of the mosaic tile was fully cure, the wet sponge was rub to the paper sheet on top of mosaic tiles to ensure the paper absorbed the water before the paper-face can peel away from the mosaic tile. For the small area like water outlet, the individual mosaic tile was trim to match the size that required. This step of installing the mosaic tile was repeated to the entire surface of this swimming pool slab. Then, after the mosaic tiles was harden, the grout was applied into the joint spaces between mosaic tiles using rubber grout float with the 45-degree angle position. After the grout slightly harden as shown in figure 3.24, the mosaic tiles surface was cleaned using the sponge to remove any excess grout. Figure 3.25 shows the complete process of installing mosaic tile to the swimming pool slab.

Figure 3.24: Grouting on the mosaic tile completed

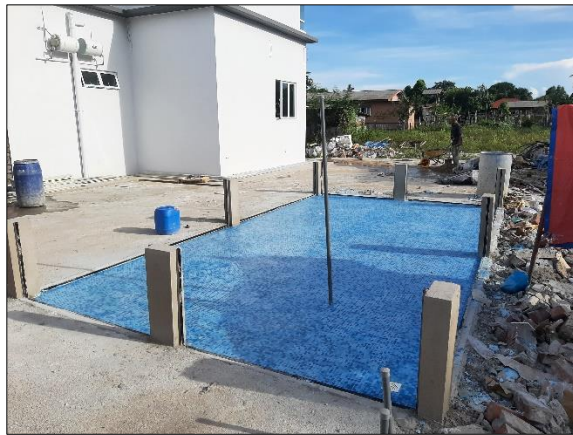
Figure 3.25: mosaic tiles installation complete

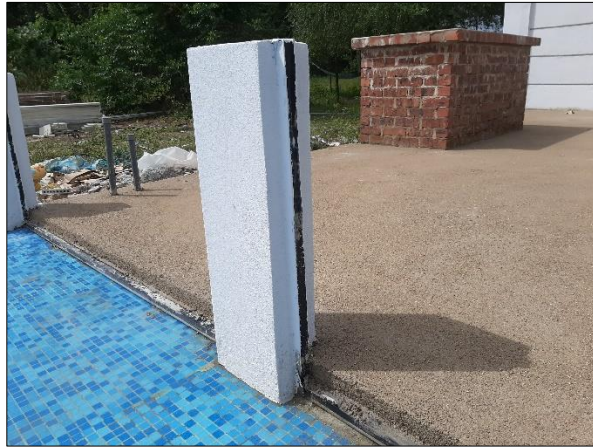
For the installation of the tempered glass, two workers from AMS Aluminium and Glass Department were responsible. Before the installation of tempered glass was done, each column of this swimming pool was paint with white colour as shown in figure 3.26. The types of paint used was from Jotun Jotashield Colur Extreme as this type of paint have anti-algae & anti-fungal and water-resistant feature thus made it suitable to be used for this swimming pool. After that, the black tape on the aluminium frame which act as a protective layer during the plastering and painting work was removed using utility knife. Then, the surface of the u-shaped aluminium channel was cleaned from the dust and sand before placing the rubber block in each end at the bottom of aluminium frame. The rubber block will function as a cushion and also to centre the glass. Next, the 12 mm clear tempered glass was lifted and placed into the aluminium frame using glass suction plate. The tempered glass was slide carefully through the aluminium frame from top to the bottom, resting on top of the rubber blocks. After fixing the tempered glass properly into the frame, clear silicone sealant was installed on the gap between the tempered glass and aluminium frame using silicone sealant caulking gun as shown in figure 3.27. The types of silicone used in this project was x'traseal SA-117 (RTV Acetic Silicone Sealant). Figure 3.28 shows the detail of the tempered glass installation.

Figure 3.26: column painted with white colour

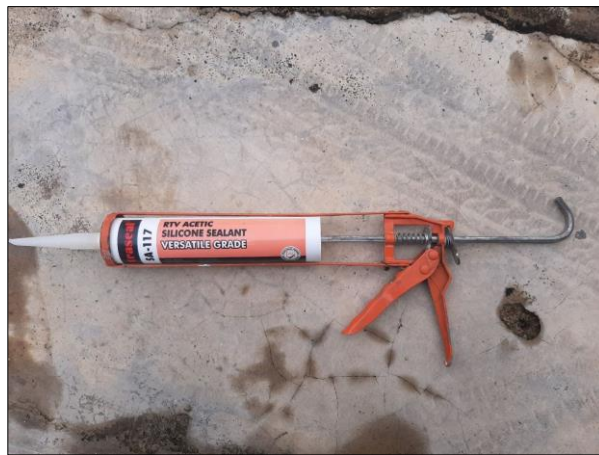
Figure 3.27: silicone sealant caulking gun

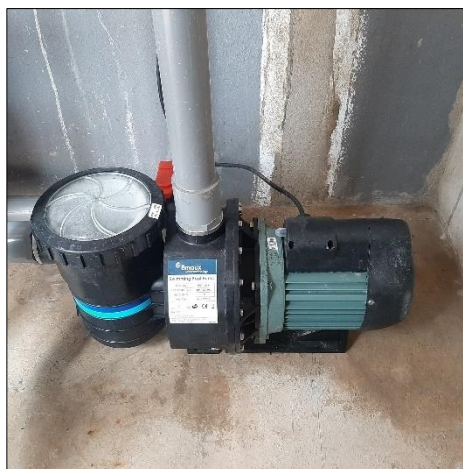
Pump and filter system was very important and essential part for the swimming pool. Swimming pool pump can be referred as the heart of the pool system. For this swimming pool, the operation of pump and filter system was started from the swimming pool where the pool's water was pump to the pump room and back to the swimming pool. Pump was used to suck the water and create the flow of water from the pool hole outlet in the bottom of swimming pool to the filter. The pump was connected to the filter's intake valve to flow the pool's water through the filter. After that, the filter will transfer the filtered water back to the swimming pool's hole inlet through the output valve. This circulation process was necessary for the pool water so that the water was effectively sanitize and clean all the time.

Figure 3.29: pump used for above ground level swimming pool

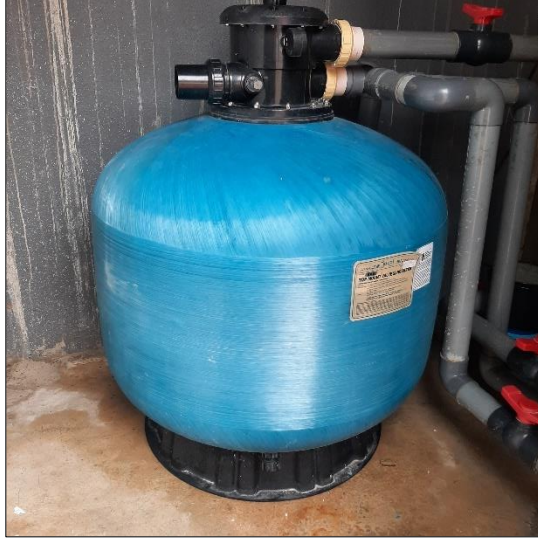
In this project, the type of filter used for the above ground level swimming pool was sand filter. Sand filter was a traditional type of filter as it used sand usually sand silica to filter the particle as small as 20-microns that contain in pool water. Beside the intake and output valve on the sand filter, this filter also has the third valve for backwashing which was connected to the wastewater line. For the installation, the pump and filter were installed together in a small room namely as pump room that was built 5-meter away from the swimming pool. In the pump room, all of the swimming pool's water line was connected to pump and filter. Besides, the pump room also complete with the electrical socket in order to run the pump.

Figure 3.30 sand filter

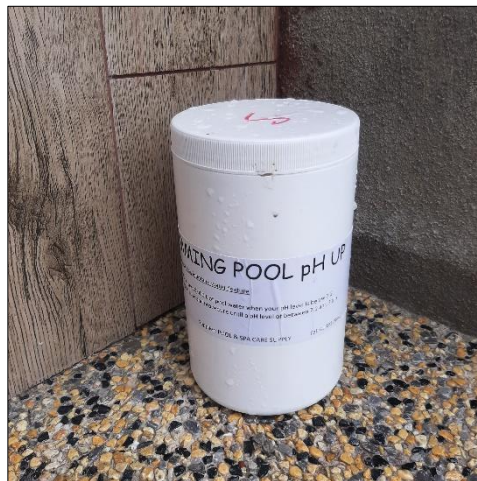
After the installation of every element of the above ground level swimming pool completed, the process of testing and commissioning were done. This process was to ensure that all the system and components was operated properly based on the requirement. Apart from that, this swimming pool was fill with fresh water and the pump and filter system was test before it was ready to be used by the client of this project. Furthermore, the chlorine as shown in figure 3.31 was added into this swimming pool water to kill germs which can cause disease. Then, pH level was checked using pH chlorine water quality test as shown in figure 3.32.

Figure 3.31: Chlorine used for swimming pool

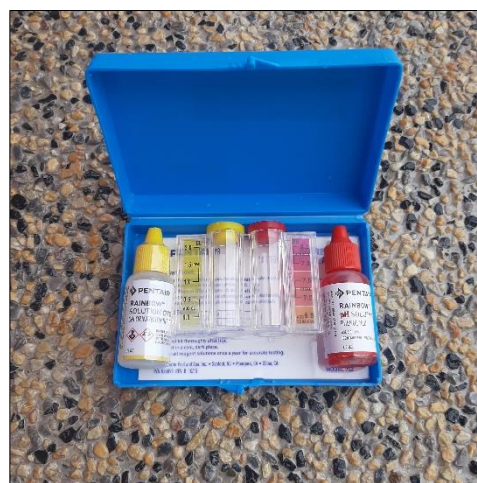
Figure 3.32: pH chlorine water quality test

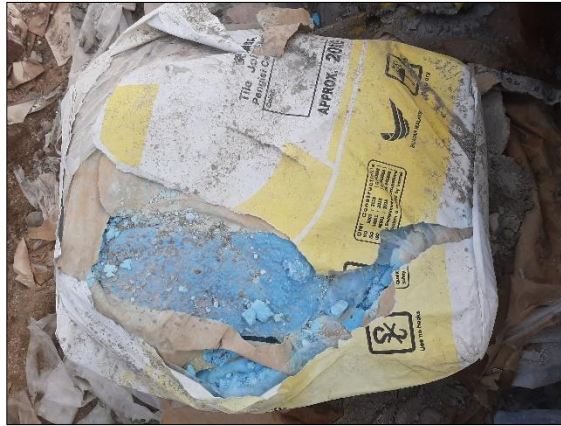
In the construction of this swimming pool, the construction material that commonly get damaged was the mosaic tile and the tile adhesive. In this project, some of the paper-faced mosaic tile that came in box package was get damaged before it can be used to be installed on the swimming pool slab. Same goes to the tile adhesive where it became harden due to the moisture and rain as shown in figure 3.33. This happens due to the mishandling of the package. Besides, this material was not properly stored in dry place and not protected from the rain and moisture. As a result, the paper sheet on mosaic tile that function to hold the small pieces of mosaic tiles started to peel off thus made them not practical to be used for the installation work. Figure 3.34 shows the damaged of paper-faced mosaic tile. Moreover, this problem has increased the cost of the construction due to the wastage of the mosaic tile. The solution for this problem was by properly stored the mosaic tile and tile adhesive in a dry and enclosed structure. The waterproof sheets like Polythene Sheet can be used to cover this material from rain and moisture. Furthermore, it was recommended to order at least 15% extra of mosaic tiles as this tile has a lot of wastage during the installation and to ensure the project run smoothly.

Figure 3.33: Tile adhesive harden

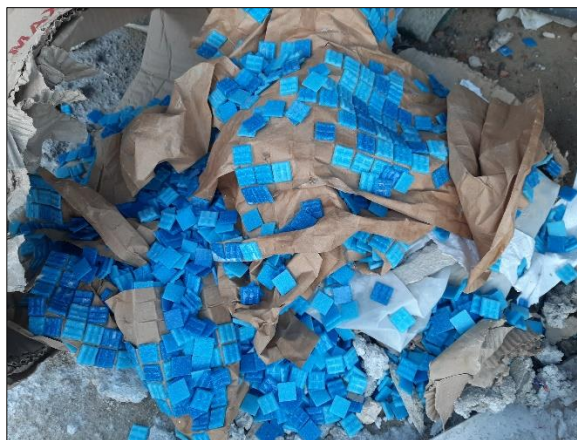
Figure 3.34: damaged of paper-face mosaic tile

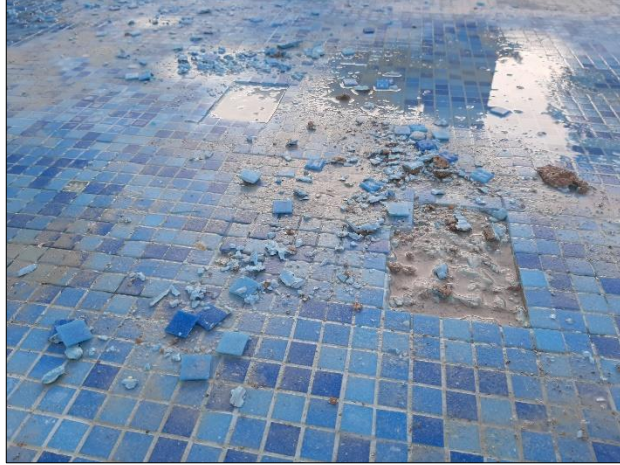
The next problem occurred during the construction work of above ground level swimming pool was the mosaic tiles start falling off. This problem occurred to a certain part on the installed mosaic tile. This happens due to the improper installation technique by the worker. The improper installation technique was one of the caused to this problem. The mosaic tile was not set properly at certain part as the plywood was not pressed evenly to all surfaces of the mosaic tile. After the adhesive started to harden, the bond between the mosaic tile and the adhesive became weak which made them easy to fall off on certain part. Thus, the solution for this problem was to install again the new mosaic tile to the damaged part with proper technique. Site Supervisor play the important role to supervise the work during the installation of mosaic tile to ensure that the worker follow the right technique and avoid any further damage on the mosaic tile. Figure 3.35 shows the certain part of installed mosaic tile start falling off.

Figure 3.35: Certain part of installed mosaic tile start falling off
