**PRACTICAL TRAINING REPORT
BGN310**

METHOD OF RENOVATING SCHOOL TOILET

**DEPARTMENT OF BUILDING
FACULTY OF ARCHITECTURE, PLANNING AND SURVEYING
UNIVERSITI TEKNOLOGI MARA
(PERAK)**

AUGUST 2021

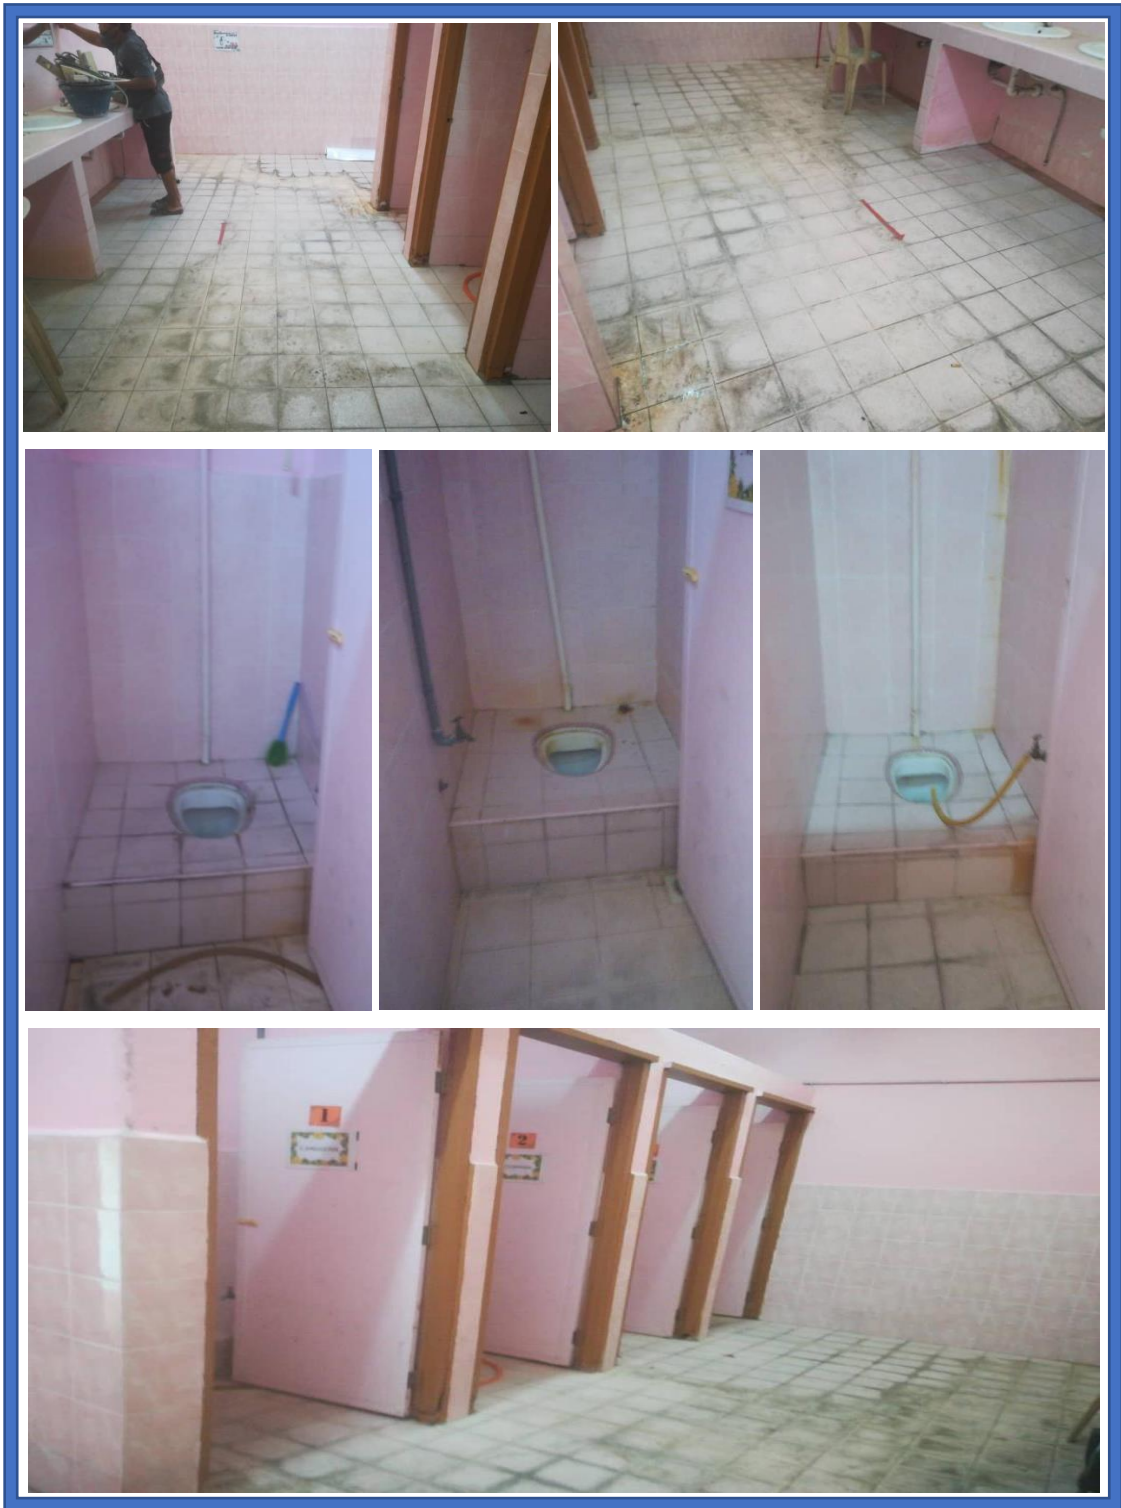
Site visits are a component of the tendering process. It involve visiting the site where the services are going to deploy, for the purposes of gaining in-depth information. During the site visit, the school toilet is observed. In the observation, the toilet space, state, condition, and the time to finish the project are examined. Besides that, the manpower, tools, and machineries can also be determined for example, a longer plug extension is needed to power the tools and machineries because the toilet did not have any outlet nearby. Time is very important for the success of a renovation. By referring the tender document of the work, the time that was given is 6 weeks. This uneasy work needs to be handled by skilled workers to deliver the work quality for satisfy the client. The machineries and tools that involved in this renovation are demolition hammer, drill, roller paint brush, wheelbarrow, trowels, hawks, bucket, and measurement tape. Without wasting any time, all fixtures are provided the day before the renovation start. The fixtures include 4 two-piece ceramic toilet, 4 aluminum door frame, 4 door leaf, 300mm x 600mm x 8mm anti-slip homogenous tiles, cement, and waterproofing liquid membrane. The color of tiles must be approved by the client. On top of that, the picture also can be taken to show the ‘Before, During, and After’ process to claim the payment from the JPWPKL.

Figures 3.3.1: The condition of the toilet's tiles, cubicles, and doors.

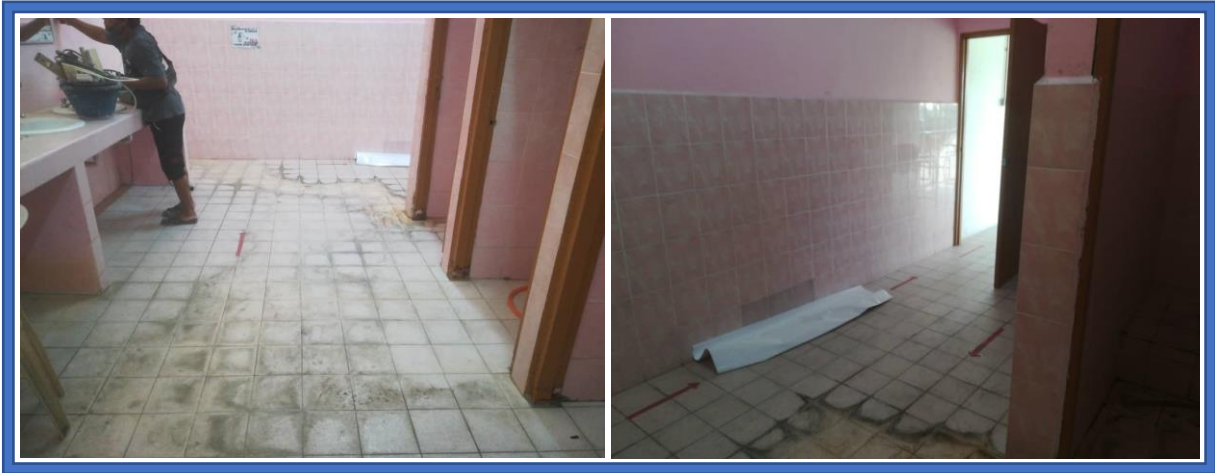
Figures 3.3.2.1: Before the Site Preparation.

Site preparation means demolishing, removing, and cleaning structures and fixtures to make way for new renovations. Based on this project, site preparation includes demolishing the old and worn-out tiles, dismantling, and removing the sinks, mirrors, old squat toilet and its cistern carefully, and cleaning the broken tiles, concretes, and debris from the site to do the further works. The first thing to do during the site preparation of this project is turn off the water system inside the toilet and removing the old door and its frame. After that, remove the squat toilet cistern. To remove it, the top cover of the cistern must be open and using the drill to unscrew the wall-mounted screw that connected to the wall from insides the cistern. After that, unscrew both flush valve lock nut and the water intake locknut, and the chisel can be removed spontaneously.

The next process is demolishing the old tiles. The correct way to demolish the old tiles is by using hammer and a bricklayer's chisel. It is the cleanest and the quiet ways to removing the tiles. But in this project, demolishing hammer are used to fasten the work. Besides that, under the COVID-19 situations, students are persuaded to learning online from home. Because of that, the sound of the demolition hammer is not a disturbance for some times. To demolish the tiles, the demolition hammer are used from the top of the wall mounted tiles, down to the bottom. During the demolition process, the naked wall are hacked or strike to create an exact technical bind between the structure and plaster on the next process.

After all the tiles are removed, the next process is removing all the squat toilet from all the toilet cubicles. To remove it, the first thing to do is cover the squat toilet's hole using old news paper to prevent any debris or fragment from entering it because it can cause damages like blockage or clogging. Next, demolition hammer are used to demolish the concrete around the squat toilet bowl and simply remove the toilet bowl. After that, demolish the toilet platform by using the demolition hammer to make the toilet cubicle surface flatten and even. Lastly, clean the toilet by remove the concrete fragment, fixtures, debris, and any types of trash away from the toilet, to prepare the site. Make sure to store the unequipped fixtures at a storage room given by the school's principal.

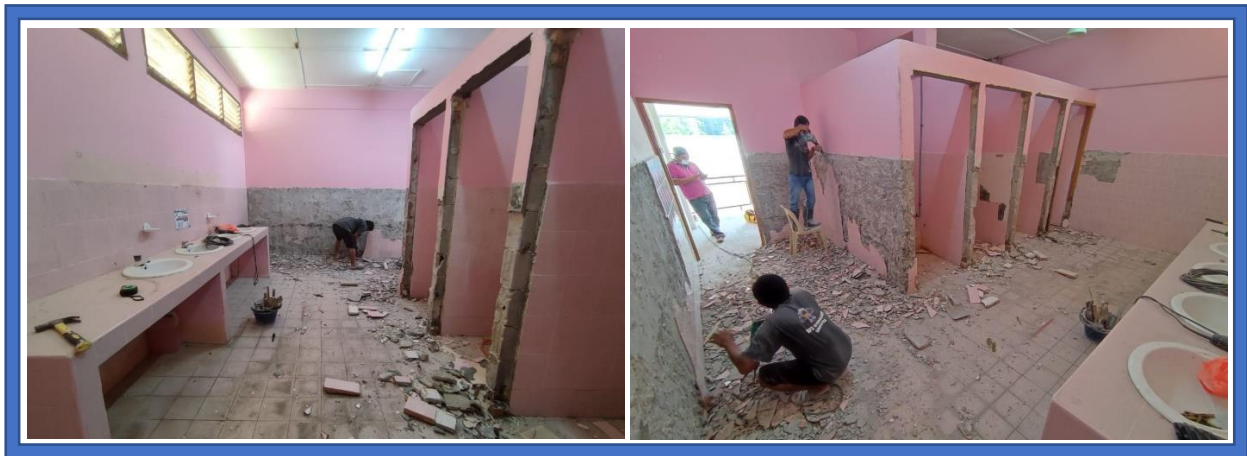
Figures 3.3.2.2: During the Site Preparation.

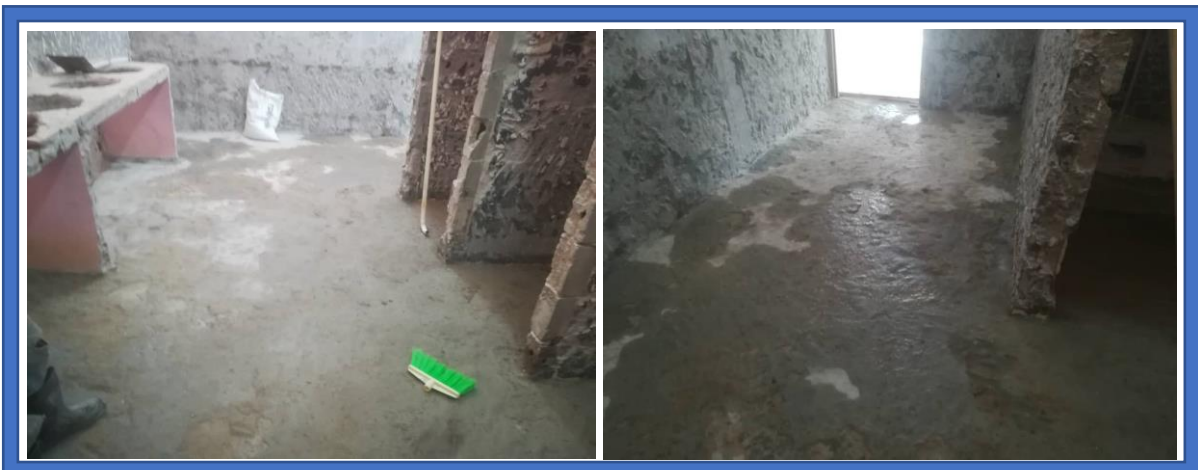
Figures 3.3.2.3: After the Site Preparation.

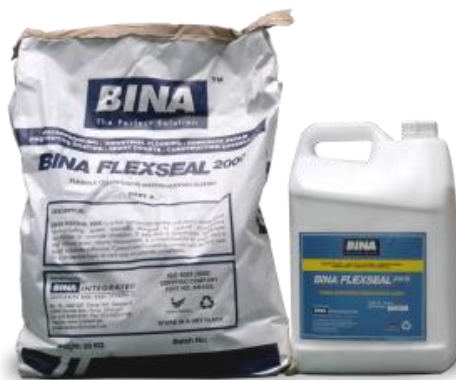
Figures 3.3.3.1: The Cementitious Waterproof that are used in this project.

However, there are numerous types of cementitious waterproofing. Two-component polymer modified cementitious coating, cementitious waterproofing slurry, rapid-setting hydraulic cement, and cementitious waterproof plugging compound are only a few examples. Cementitious waterproofing slurry is used in this project. It is a two-part polymer-modified cementitious waterproofing slurry for concrete and masonry. It is made up of a liquid polymer and a cement base mix with unique additives. The benefits of cementitious waterproofing slurry include its ease of application and availability at any hardware store or masonry supply shop. Aside from that, the coatings are applied in the same way that cement is mix it with water until it reaches the desired consistency and then apply it using a stiff-bristled brush. It is also nontoxic, making it safe for contact with drinking water, and it is not corrosive to steel or iron.

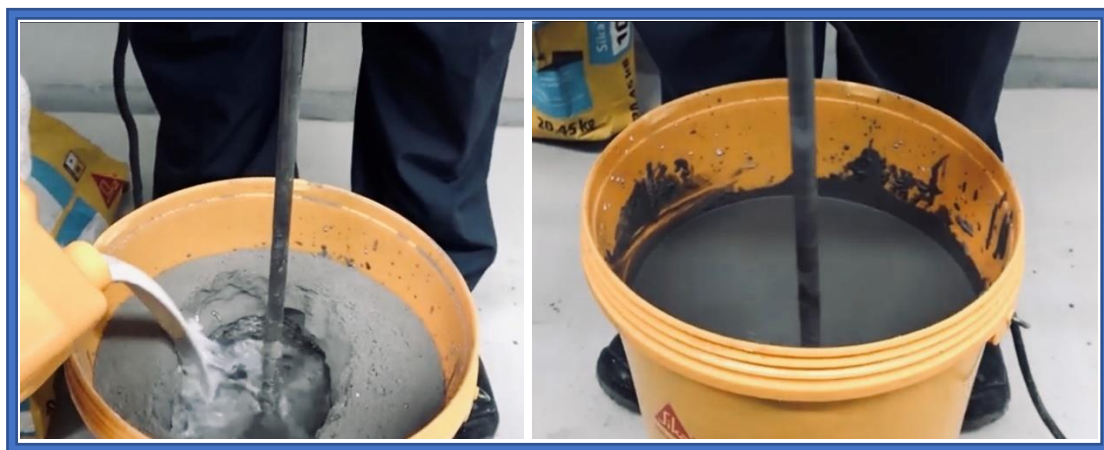
Figures 3.3.3.2: The mixing Process of the Cementitious Waterproofing Slurry.

To begin the waterproofing process, clean the surface to eliminate all dust, loose particles, and contaminants. The surface should be scrapped to make it smooth, and the walls should be brushed to remove undulations. Next, mark the height of the waterproofing place on the wall with tape at 4 feet and presoak the surface with water. Then, before applying the actual coating to the surface of the floor and wall, apply a primer layer. After that, begin mixing the two cementitious waterproofing slurry components, part A being cement and part B being

slurry or liquid, until a homogenous and lump-free slurry is achieved. After that, apply the waterproofing to the wall as high as 4 feet and as thick as 1.5 mm, and then to the floor as thick as 1.5 mm. After the first coating has dried for eight hours, repeat the process for a second coat of 1.5 mm thickness. The layers should be applied in a cross-directional manner and near one another. Run a water ponding test once the waterproof coating has dried. Begin by ponding the surface for 48 hours with water to a depth of 50mm. This determines the floor's watertightness. The test is considered good if there is no leakage and no damp patches on the floor's surface as measured by the depth of the water. The water-ponding test was passed with flying colors in this project.

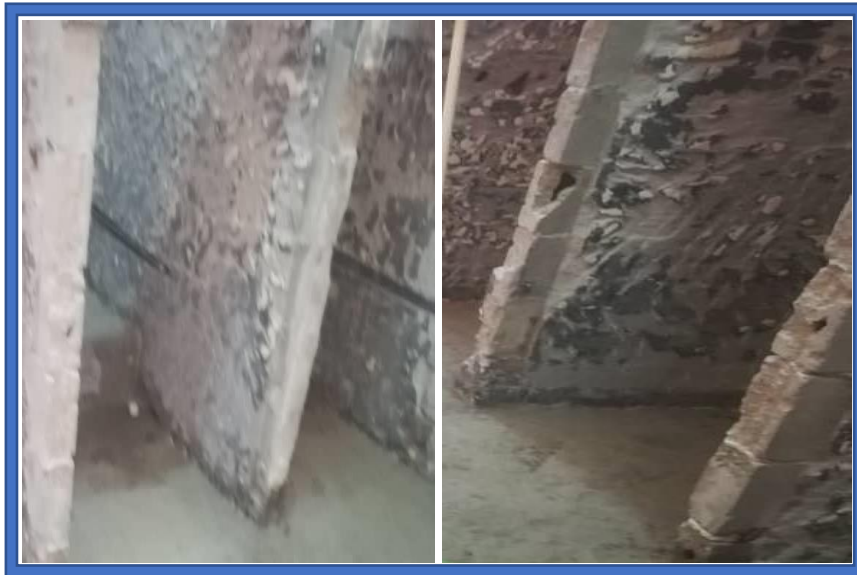
Figures 3.3.3.4: Before the Cementitious Waterproofing Slurry are applied on the wall.

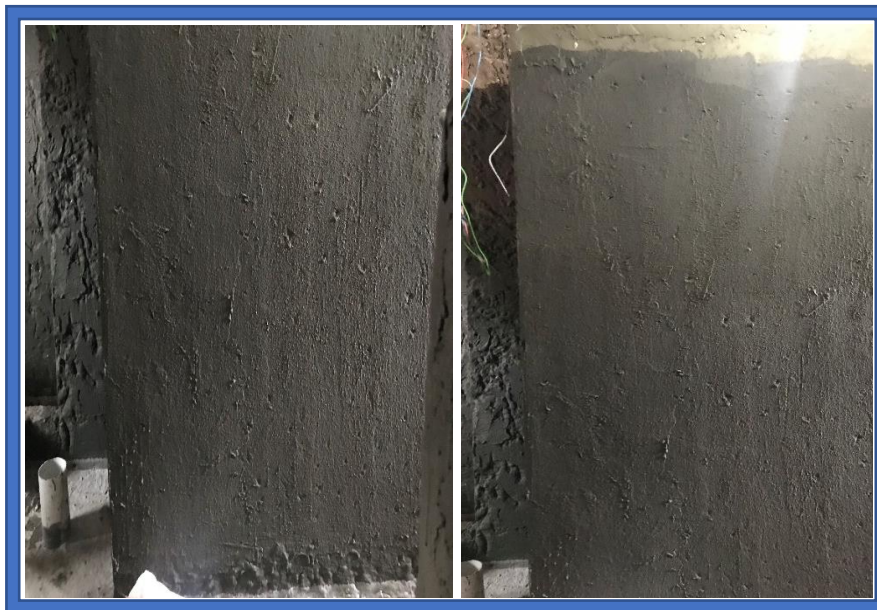
Figures 3.3.3.4: After the Cementitious Waterproofing Slurry are applied on the wall.

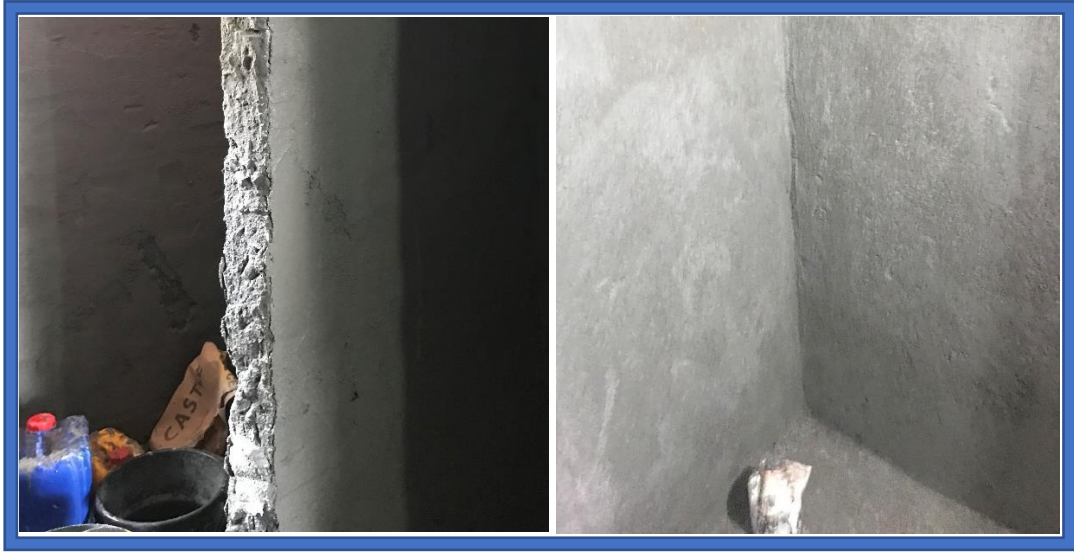
Figures 3.3.4.1: The rendering before and after it dried.

The first thing to do after the cementitious waterproof has dried, is render the wall with 25mm thickness of sand and cement mixtures to attain a smooth or textured surface. It is similar in technique to plastering. After it dried, start by mixing the tiles adhesive by Mix the adhesive into the water, then add additional adhesive or water as needed to achieve a thick consistency like the richness of thick peanut butter. Swirls at the bucket's top to let it to stand upright without slumping or disappearing and apply it onto the walls. Once the thinset is ready, begin by applying it with the notched trowel to the substrate or underlayment. Grooves will be left on the substrate and tile by the notched trowel. To produce a consistent mortar bed beneath the tile, ensure that all of these are going in the same direction. Hold the trowel at a 45-degree angle while the thinset spreads to create a thick enough layer. Next, apply strong, uniform pressure when setting a tile in thinset. Wiggle the tile back and forth a few times to allow the thinset ridges to break down and fill in the valleys. This results in a thick layer of thinset beneath the tile. Use spacers between tiles to maintain a consistent gap and grout lines throughout the installation. After the thinset cures, the spacers should be able to be removed. Lastly, clean any extra thinset squeezed out and in grout joints to prepare the space for grouting. Using a grout float, begin applying the grout. A grout float is a spatula-like flat rubber or silicone instrument with a flexible edge. Hold it at a 45-degree angle and approach the grout line diagonally. Make sure to properly fill in the joint from top to bottom. Repeat the same process onto the floor.

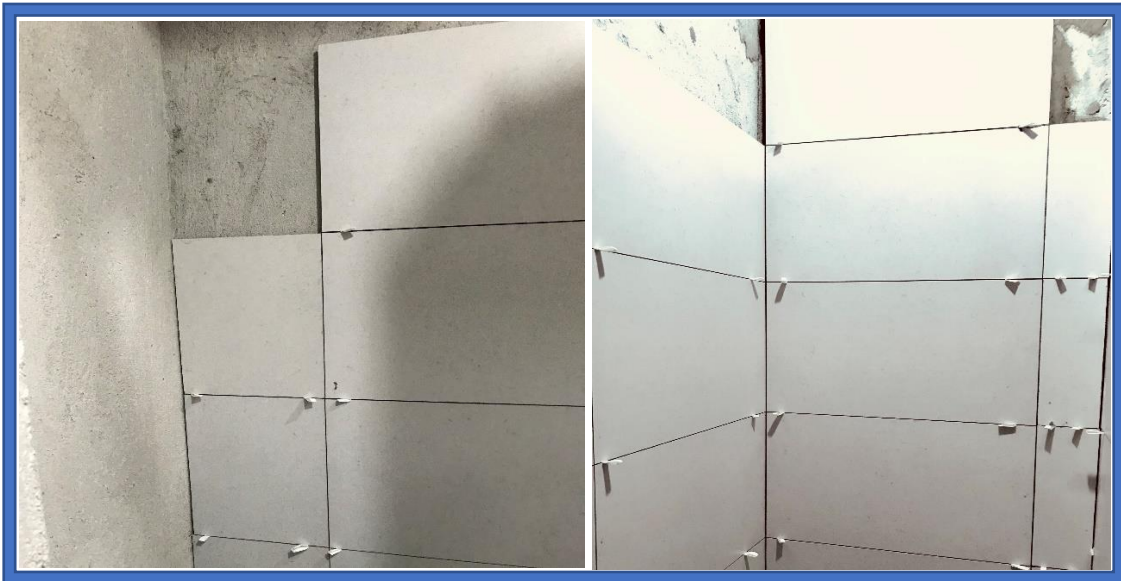
Figures 3.3.4.2: During the tile's installation.

For the tile's installation, the type of tiles that are used in this project is 300mm x 600mm x 8mm anti-slip homogenous tiles. It is a type of ceramic tile made of fine porcelain clays that is burned at substantially greater temperatures than ceramic tile. This method produces homogenous tiles denser, tougher, and less absorbent than ceramic tiles, making them less responsive to moisture and stain absorption. It is used to enhance residential and commercial spaces, such as the kitchen backdrop, toilet, or the building's exterior walls. Besides including waterproof properties to keep them from getting wet and deteriorating and has rough surfaces that prevent slipping to safeguard the students, this characteristic ensures that the products persist a long time. The quality of these anti-slip homogeneous tile will ensure that the school toilet remains modern for a very long time.

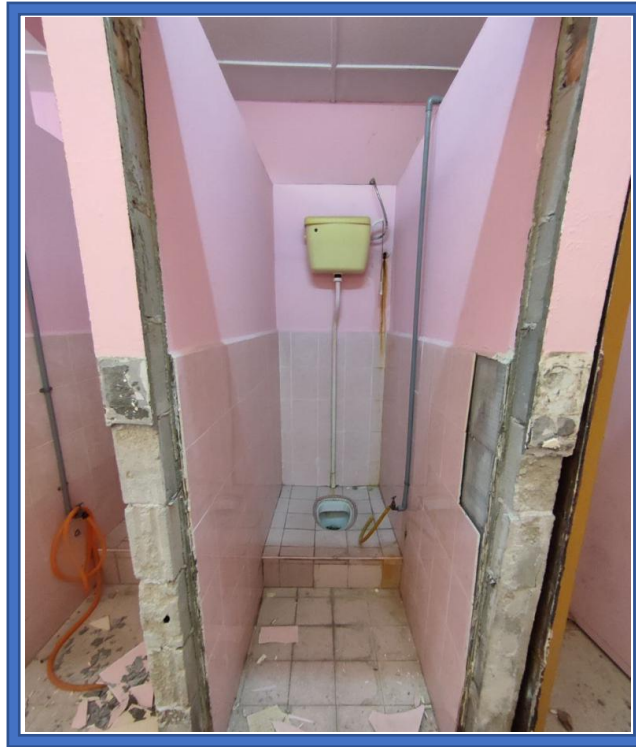
Figures 3.3.5.1: Before the fixtures are installed.

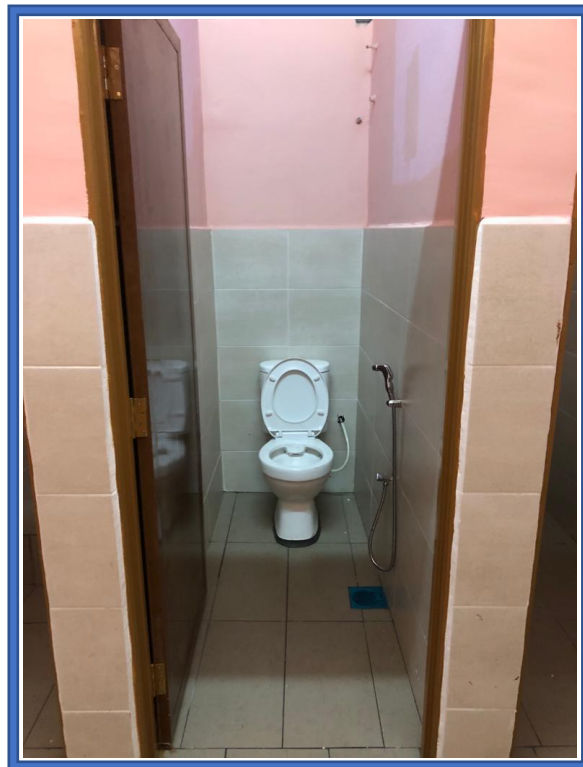
Figures 3.3.5.2: After the fixtures are installed.

For the next method is fixtures installation. In this project, there are 3 fixtures that need to be installed. Started with ceramic two-piece toilets, Aluminum door frames, and door leaf. For the installation of ceramic two-piece toilet, the first thing to do is install the toilet flange to the drainpipe in the finished floor and drill the bolt hole aligned for the new toilet. Next, apply the new toilet seal by place the new toilet bowl on its side on a padded area to protect the floor and the toilet from breaking or cracking, and then attach the replacement seal to the bowl's bottom. The advantage of this method is that it can be certain that the ring is in the appropriate position when placing the toilet over the flange. After that, place the toilet bowl on the flange, matching the bolt holes in the bowl's base with the flange's bolts and place a washer and nut on each toilet bowl bolt and equally tighten the nuts onto the bolts and carefully not to over-tighten the nuts and crack the bowl. The next step is attaching the tank to the toilet bowl. Install the "cistern to bowl" gasket to the flush valve's base by insert the tank bolts and washers from the inside of the tank. Next, connect the shank of the bolts with the holes in the bowl and fasten the tank to the bowl by alternately tightening each tank bolt until the tank pulls down and meets the bowl. Finally, reconnect the supply line to the exposed section of the fill valve that extending out of the tank's bottom with the supply valve coming out of the wall, and install the toilet seat and lid. For the finishing, plaster around the toilet bowl to the finished floor.

For the installation of aluminum door frame and the door leaf, start by insert the door frame into the rough opening of the door and place the frame in the center of the opening. Next, hold on a bubble level against one of the vertical sides of the door frame and adjust the vertical side until it is plumb, using the bubble level as a guide. Insert shims between the plumb side of the door frame and the rough opening in the cubicles. Tack the plumb side of the Aluminum doors' frame to the rough opening in the cubicles. with 3-inch screws, tighten the screws with a drill. Install a screw 8 inches from the top and bottom of each side of the frame. Then, use 3-inch screws, secure the aluminum door frame to the rough opening in the cubicles. Install a screw 8 inches from each side of the frame as well as in the center. After that, lay the bubble level on the top of the door frame. Adjust the top of the door frame until it is level in the rough opening, using screws to raise or lower the frame as necessary. Tightening the screws lifts the frame, while loosening them lowers it. Insert shims between the side of the door frame and the rough opening. Then, use 3-inch screws to hold the remaining side of the frame in place, placing a screw 8 inches from the top and bottom of the frame and in the middle. And

lastly, Install the 38 mm PVC doors to the door frame. Close the doors and inspect the gaps on both sides.

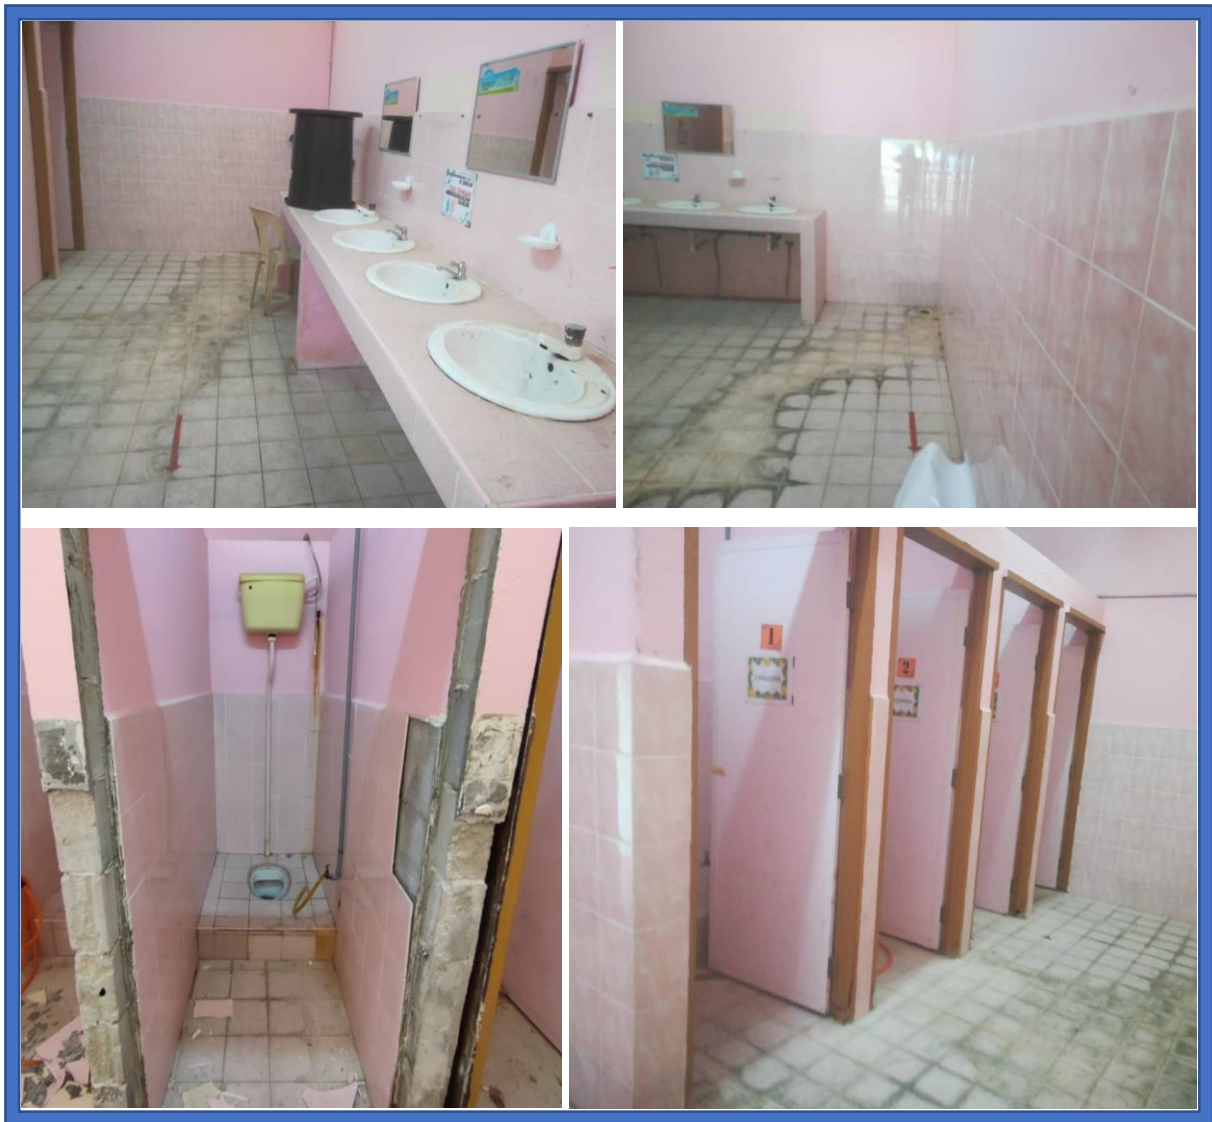
Figures 3.3.6.1: The toilet exterior during the project.

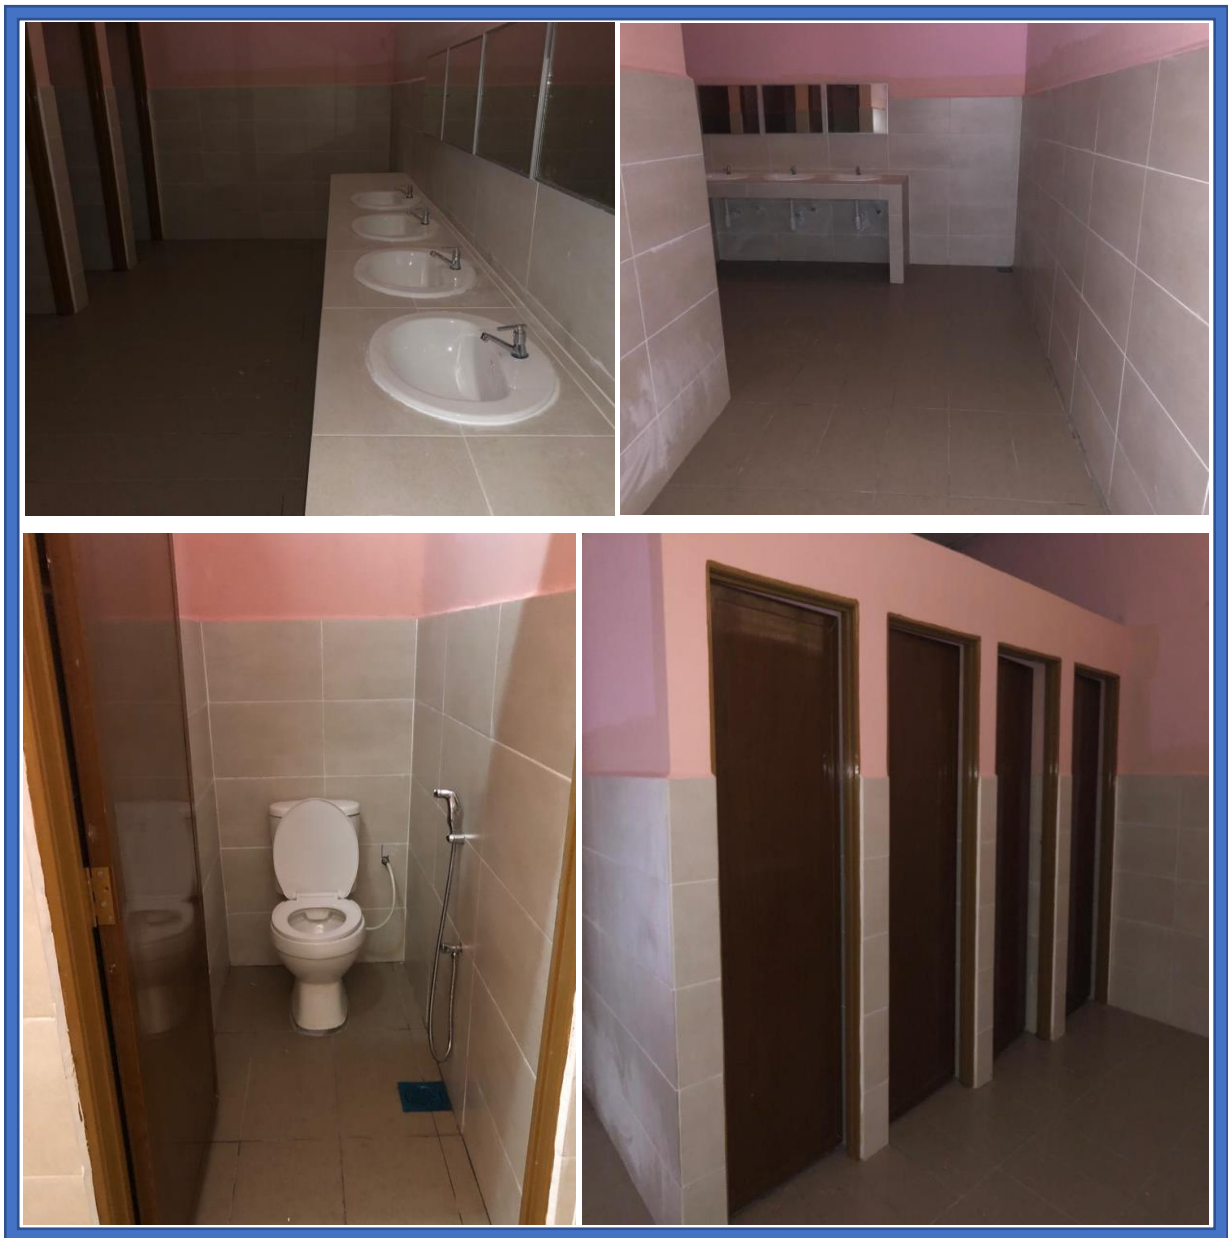
Figures 3.3.6.2: The toilet exterior after the project.

The last method of renovating school toilet is finishing. What it mean by ‘finishing’ is preparing the toilet to be used by the citizens of the school. To be specific, the toilet are tidy-up, or beautify, improve, and inspect. In the first process of the finishing, the toilet are tidied-up or beautified. Firstly, remove the rust stain on the walls using paint with the same color of the toilets wall. Besides that, cleaning the features that was dismantled and set it back to the original places. For example, the sinks, and the mirrors. After that, cleaning the debris of all the fixtures. For instance, clean the new tiles by using muriatic acid. Since muriatic acid is a harsh chemical, mix it outside with five parts waters. Follow the warning and instructions on the bottle and be sure to wear rubber gloves. Repeat the same process to the other fixtures like the two-piece toilet and sinks.

After the beautify process is improving. The toilet can be improved by changing the old and cheap parts with the new one. For instance, the floor drains, faucet, and the hand bidets are replaced with the new and fresh version. This is to give the toilet the complete look and attain the excellent customer services just to prove the quality of the company’s work. Later on, throw all the garbage away from the school properties. Last but not least, the last thing to do is inspecting. Inspection is the most important part of the project. It is to make sure all the fixtures did not have any faults and error. For examples, toilet clogging, and fixtures did not work. To inspect it, turn the toilet water system on and let the water fill the toilet cistern. While wait for the water to fill it, turn the hand bidets, and sinks water on to make sure the water run smoothly, and the sinks did not have any leaks underneath. After that, flushes the two-piece toilets to make sure the toilets works. Check the toilet to see if there’s any leakage. After the inspection going smoothly, inform the client that the project has been done and let the client inspect the toilet. Finally, turn over the site’s key to the responsible party.
