**CONSTRUCTION ENGINEERING IN BUILDING
RENOVATION**

**PREPARED BY:
MUHAMMAD FARHAT BIN EZRAL MIZARE
2019220564**

DEPARTMENT OF BUILDING
FACULTY OF ARCHITECTURE, PLANNING AND SURVEYING
UNIVERSITI TEKNOLOGI MARA
(PERAK)

FEBRUARY 2022

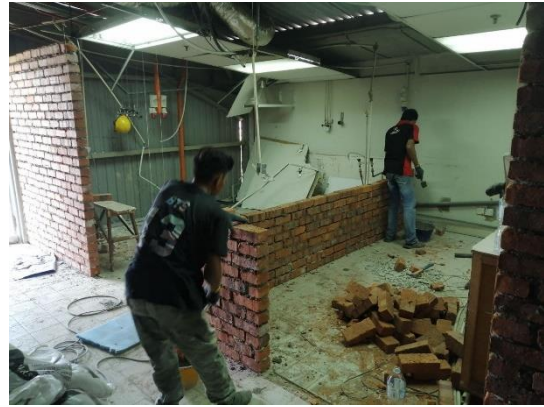
Before the construction of the wall started, the ratio between sand, water, and cement is determined. The ratio of sand, water, and cement used is 1:1:3, and the thickness of the wall is 115mm. The construction began with the measurement of the wall. After measuring, points are marked to know where the clay bricks will be laid on. This will avoid the clay bricks from not being aligned and straight. The cement mortar was spread onto the floor before laying the clay bricks. Exmet wires were used to absorb stress and vibration in building and were embedded at every fourth joint of the cement mortar. The clay bricks were layered until it reached the height of 3m, and the opening gap will then be covered by the ceiling which will be installed later. The wall was left to dry for a week before reaching its full strength. After the clay brick wall was completely dry, plastering work was commenced by layering a mixture of cement, water, and sand. Plastering was done to protect the wall. After the plaster was set, skim coating was done to smooth out the surface of the wall and to ready the wall for the application of undercoat and final coat of paint.

Figure 4: The construction of clay brick walls at Autoclave Lab and Centrifuge Lab

Based on the bill of quantities (BQ) of the project, two rooms will have clay brick partition walls constructed. Before the construction of the clay brick wall, these two rooms used to have a polyurethane partition wall (PU) which was taken down by the previous contractor that oversaw the project.

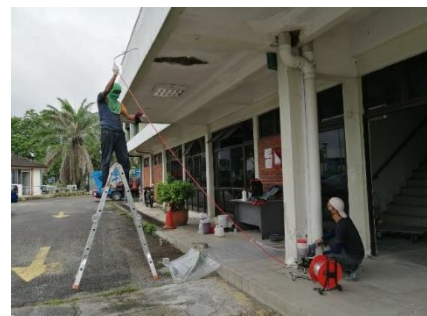
Specialists investigated the cause and location of water leakage on concrete ceiling before drilling. The floor was covered by plastic sheets to protect it from dusts and spillage since grouting work is usually messy. After identifying the cause and location of water leakage, holes were drilled on

the ceiling where there are cracks. A metal injection port was then inserted into the holes. The PU grout was injected via the injection ports using a high-pressure grouting machine. Injection was done twice to ensure that the grout material covers every crack in the concrete. The mixture will react and expand and toughen. After the grout has dried, the injection ports were removed, and the holes were sealed with waterproof cement compound.

Figure 5: PU grouting work on concrete ceiling

Polyurethane grouting is a technique of waterproofing which is done on concrete ceiling or concrete wall that suffers from water leakage. Waterproofing is an important step in renovation work to stop water from entering cracks or flowing down which will then cause mold to grow and will risk the health of the occupants in the building.

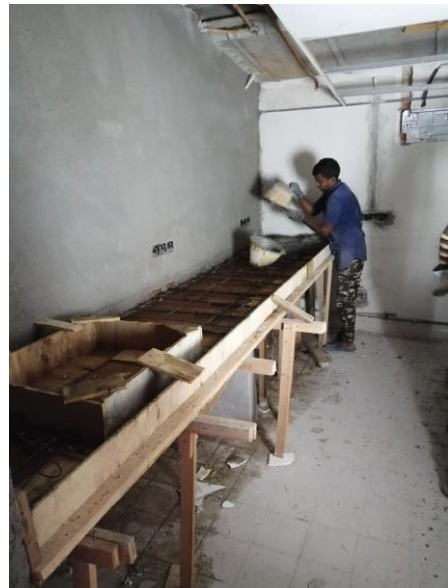
The construction of concrete bench began with the setting out of concrete bench to determine the measurements of the bench as specified in the bill of quantities (BQ). The length of concrete bench varies in each room, but the height is the same. The height of the concrete bench is 0.90m or 900mm with a thickness of 100mm. After setting out was done, formwork was constructed as a support to hold the concrete mixture. Clay bricks were used as a foundation to hold the load. Reinforcement bars were drilled into the wall to strengthen the slab and to avoid the slab to break apart in half if too much load is applied. Then, cement, aggregate, and water were mixed to form a concrete mixture with the ratio 1:1:2. The concrete used is grade 25 which has a compressive strength of 25MPa or 3625psi. The concrete mixture was poured evenly onto the formwork until it reached the thickness of 100mm. The concrete mixture was then left to dry for 2 days. After the concrete was set, the formworks were taken off and plastering work was done on the clay brick foundations to even the surface and to protect the clay bricks. Skim coat was applied onto the plastered clay bricks to smoothen the surface. Epoxy resin was applied on the concrete slab as the finishing and epoxy resin is used because it is resistant to acid and any chemicals.

Figure 6: Construction of concrete bench

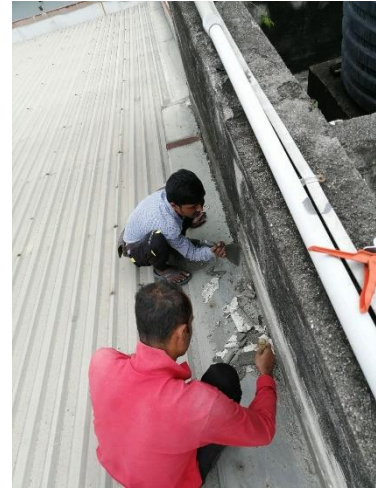
Waterproofing work was done on the roof by removing the existing flashing which functions to direct rainwater away from reaching into any openings that will cause leakage on walls and ceilings. Protected and concealed by the flashing, the existing silicone that sealed the opening on the roof was removed by using a scraper

and collected into a gunny sack for disposal. After removing the existing silicone, new silicone was applied on the opening. Silicone was used to seal openings as it is a water-resistant material and can block water from passing through any openings. The brand of silicone used is V-Tech, type VT-210, and has a volume of 300ml. The silicone tube was placed into the caulking gun which functions to hold the silicone tube and make the application of silicone easy. The caulking gun was held at an angle of 45 degrees and the trigger was squeezed to release the silicone. The silicone was applied along the opening and smoothed by using fingers. After 24 hours, the newly applied silicone was completely cured and ready to be exposed to water. Paint sealer was applied on the wall and silicone as extra protection. When the paint was dry, the silicone was concealed with new flashing. After the new flashing was installed, silicone was applied in the openings between the flashing and the wall.

Figure 7: Removal of existing silicone

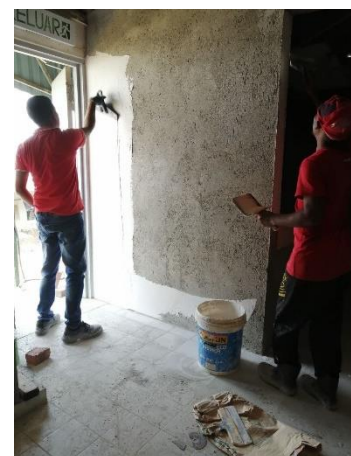
The skim coat powder was mixed with water with the ratio of 2:1 in a bucket. The mixture was mixed until it had a paste-like consistency. After it reached a paste-like consistency, the first layer was applied on the wall. 12-inch taping knife were used to apply the skim coat mixture on the wall. Scraping was done downwards in columns at 10-degree angle to the wall with slightly more pressure applied to the left side of the knife than the right. This was done to ease out imperfections on the left side but leaves a low ridge on the right side. A second pass adjacent was made to the first column. Pressure was kept on the left side of the knife, thus eliminating ridges on the left. After the application of skim coat, the skim coated walls were left to dry for 3 hours before the final coating of skim coat. After the walls were completely dry, they were sand by using fine 180-grit sandpapers to remove noticeable lines on walls due to overlapping strokes of skim coat. Second application of skim coat was done on the

Figure 8: Application of skim coat on wall

walls after the walls were sand. The process is the same as the application of the first layer of skim coat.

Skim coat is a technique used to smoothen a wall and is a great way of making old walls look new again by hiding defects such as imperfect taping job or small cracks on walls. Skim coat is typically made of white cement, limestone, and water. Skim coat is usually done after the plastering of walls and is crucial for the application of paint and final coating on a wall.

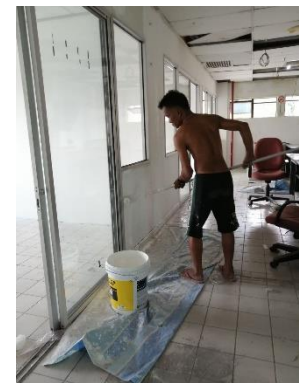
Figure 11: Application of undecoat paint on wall

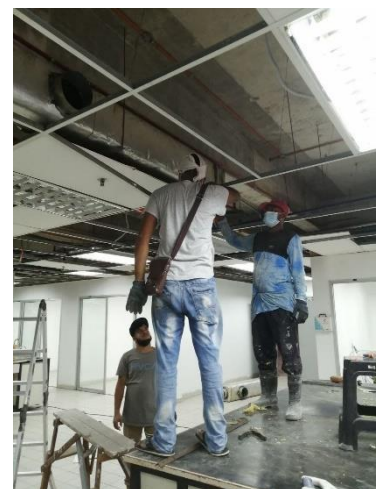
Figure 12: Labourers removing existing a/c ducts
