**DEPARTMENT OF BUILDING
UNIVERSITI TEKNOLOGI MARA
(PERAK)**

**STRUCTURAL WORKS OF COLUMN AND STAIRCASE FOR
WATER TANK**

Structural Works of Column and Staircase of Water Tank

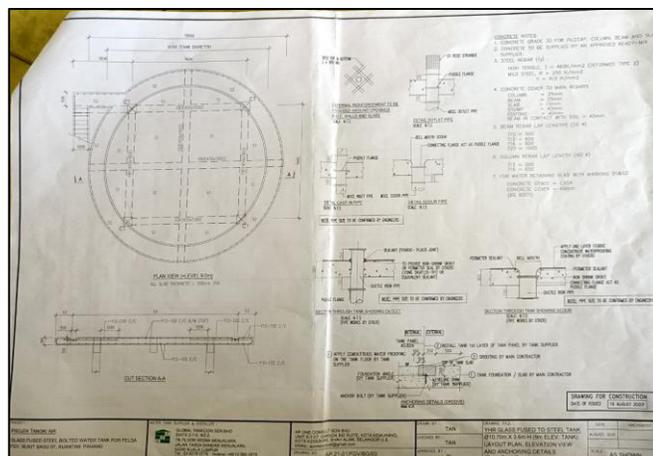
Figure 1.2: Construction drawing

The document that has been reviewed to get more details about this case study is construction drawing. This drawing is the most detail source to get more information because there are the specifications provided for each of the structure, for example, the length and the width of ground beam that should be constructed. Other than that, there is also daily site report that must be filled about the works that has been done every day. From there, the information can be collected by reviewing the site daily report to know the process step by step to build the structure. The two figures below show the construction drawing and site daily report that are used to collect the informations.

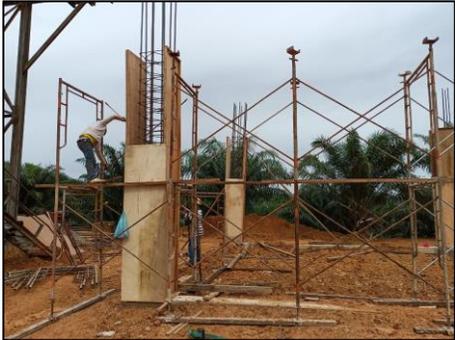
| MATERIAL/ EQUIPMENT | PICTURES | FUNCTIONS |
|---|---|---|
| Scaffolding | | <ul style="list-style-type: none"> ▪ Scaffolding on a construction site allows workers to work in separate locations at the same time, for instance, a worker doing the column formwork installation work while the other one doing steel installation work for staircase. ▪ Transports a certain amount of construction materials to various levels of a structure, for example, the workers transferring plywood from the ground to the first level of the structure. |

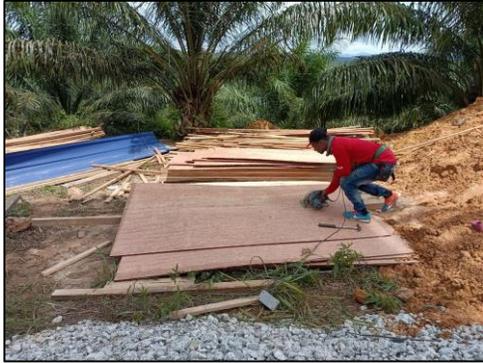
| <p>Woods and plywood</p> | | <ul style="list-style-type: none"> Also use in both columns and staircases structures, the primary function of these materials for this project is to build formwork which is the temporary mould that support the structure when the concrete is poured and formed. |

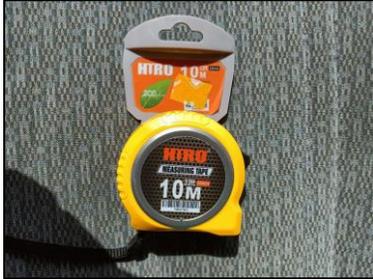
| <p>Measuring tape</p> | | <ul style="list-style-type: none"> A portable device that is used to determine the measurement of height, length and width of the columns to make a correct size of columns according to the construction drawing provided. |

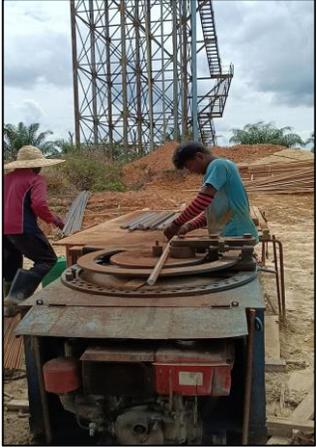
| <p>Bar bender machine</p> | | <ul style="list-style-type: none"> ▪ Steel round bar and steel rebar can be bent using a bar bender machine. Steel bending equipment can bend bars in various arcs between 0° and 180° within a specified range of diameters. ▪ Metal bars bent into 90° are the most common bends for columns. |

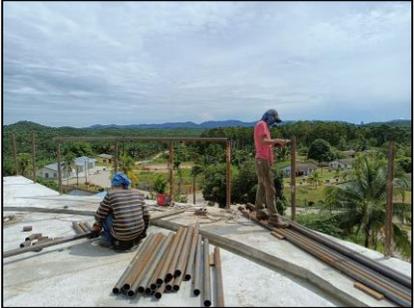
| <p>Black iron pipe</p> | | <ul style="list-style-type: none"> ▪ This material is use to build hand railing that is used while ascending and descending the staircase and around the platform level of water tank. ▪ This is to provide stability and support to avoid any injurious falls. |

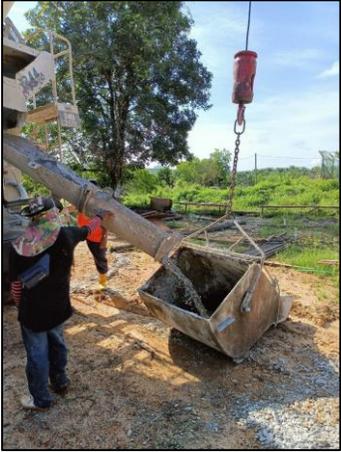
| <p>Concrete</p> | | <ul style="list-style-type: none"> Concrete grade 35 normal are used to build columns and staircases structure for this project. |

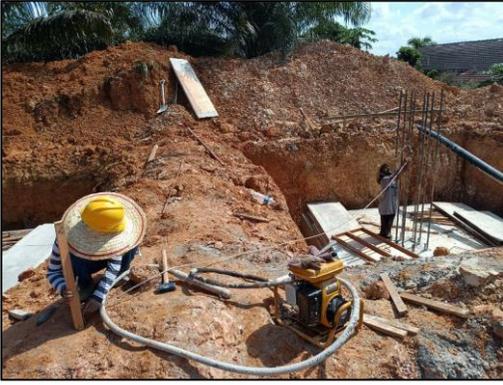
| <p>Vibrator</p> | | <ul style="list-style-type: none"> Concrete vibrators are used to remove air pockets that can form during the concrete pouring process that can damage the structural strength of the column and staircase. Bad weather and earthquakes can cause the structure to easily break apart without the use of vibrator. |

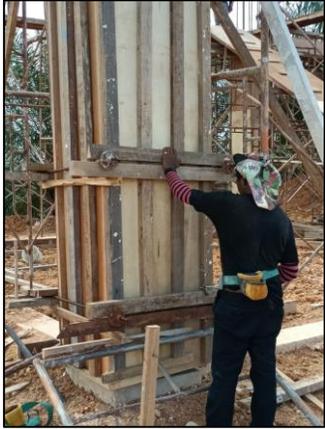
| <p>Taper tie lock system</p> | | <ul style="list-style-type: none"> ▪ Taper tie lock system is a formwork attachment that is used to keep concrete wall forms firmly in place against the pressure of concrete pouring. ▪ It retain the same amount of space between the shapes, resulting in walls of consistent thickness and avoid concrete leaking. |

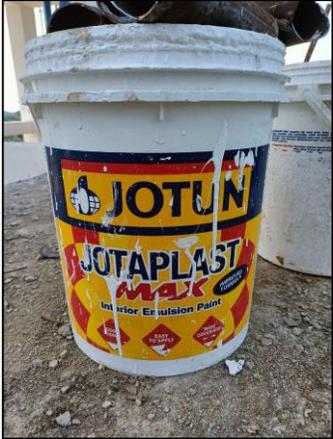
| <p>Paint</p> | | <ul style="list-style-type: none"> ▪ Paint is a coating of liquid material which is used over the surface of concrete that provides a smooth and attractive surface also It protects the surface from the impacts of the atmosphere's weathering as well as other liquids, fumes, and vapours. ▪ The colour that is used to paint the column and staircase is white colour. |

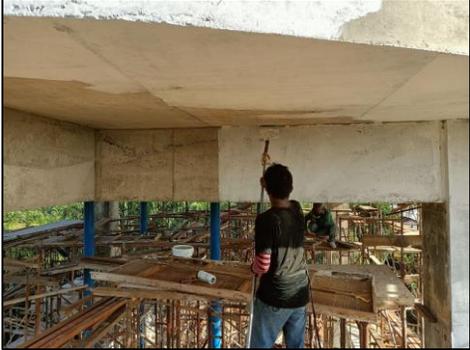
| <p>Roller paint</p> | | <ul style="list-style-type: none"> ▪ A paint application tool that is used to paint large surfaces rapidly and efficiently. |

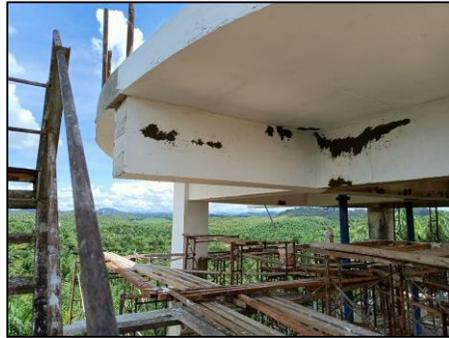
- Cement plaster is a mixture of water, fine aggregate and cement that is used to plaster the honeycomb that exist on the column and staircase surfaces to ensure that the surfaces are even and smooth.

- The defect that happened at the columns are plastered using cement to create an even and smooth surface.

7. The defects on the staircase surfaces are plastered using cement plastering and painted the staircases' side surfaces using interior emulsion paint.

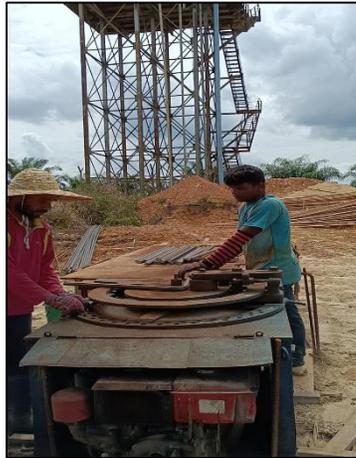
Figure 3.2: Bar bender machine

1. Reinforcement bars are bent using bar bender machine. The sizes of reinforcement bars that are used are Y32, Y25 and Y10.

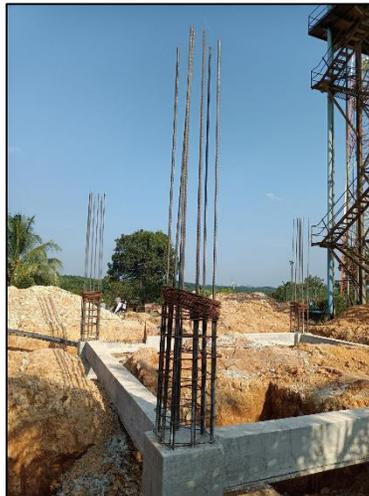
Figure 3.3: Column rebars

2. The primary reinforcement bars with length of 4.5 meters are placed vertically at the four places of column stumps. Each column required eight numbers of reinforcement bars and tied using binding wire.

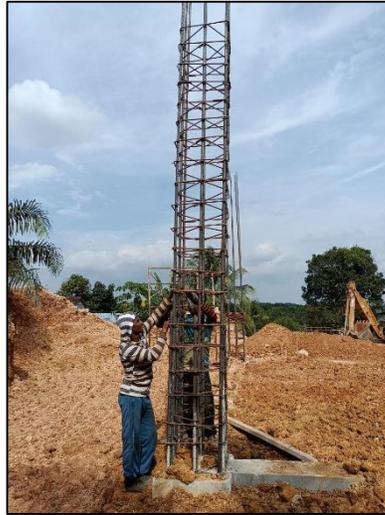
Figure 3.4: Column stirrups

3. The stirrup bars were installed to the columns with the spacing between each stirrup is 200 mm. The function of stirrups installation is to hold the primary reinforcement bars properly.

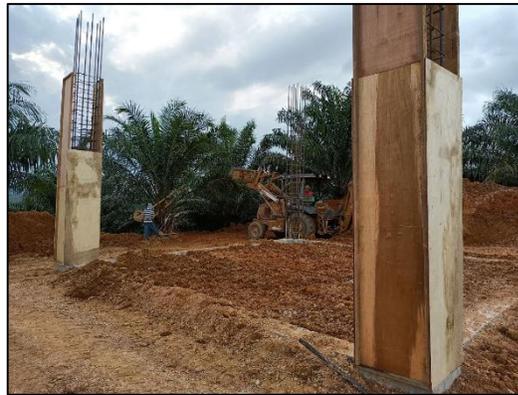
Figure 3.5: Column formworks

4. The formworks with the height of 4.5 meters are installed properly using hammer and nails by the workers.

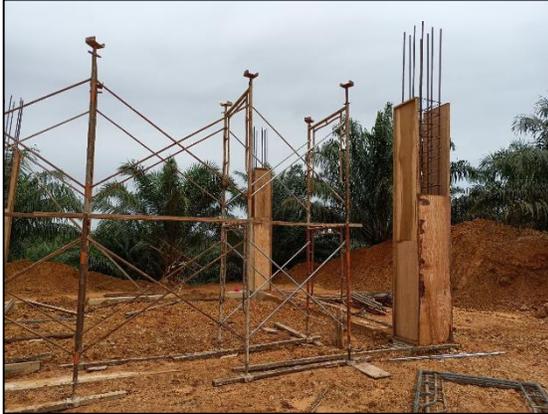
Figure 3.6: Scaffoldings installation

5. To continue the works at the next 4.5 meters' height, the workers installed the scaffoldings to allow workers to do works at the high place sufficiently.

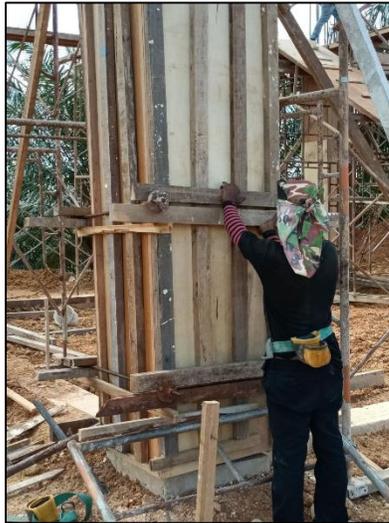
Figure 3.7: Column shutters installation

6. After the scaffoldings already being installed, step 2, 3 and 4 are repeated to build the column with the total height of nine meters from the ground.
7. Column shutters are installed absolutely straight and plumb, with enough supports to keep the structure in place before and after concreting.

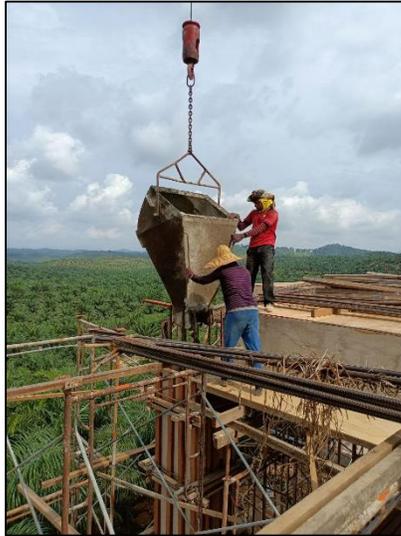
Figure 3.8: Column concrete pouring

- The concrete was poured into the structure using crane and vibrated them using vibrator to avoid honeycomb to happen to the structure. The grade of concrete used for this structure is grade 35 normal ready-mix.

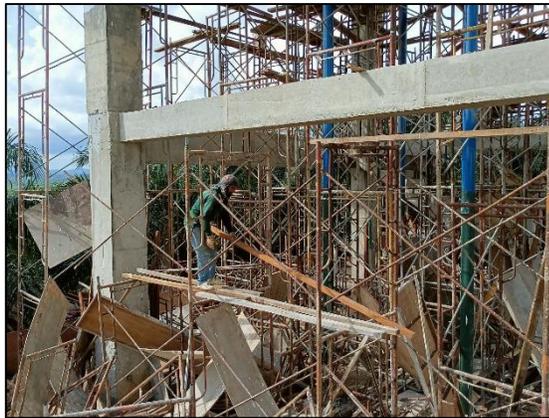
Figure 3.9: Column formwork dismantling process

- The structure was left for several days for the concrete to harden fully and after that, formworks are dismantled from the structure carefully.

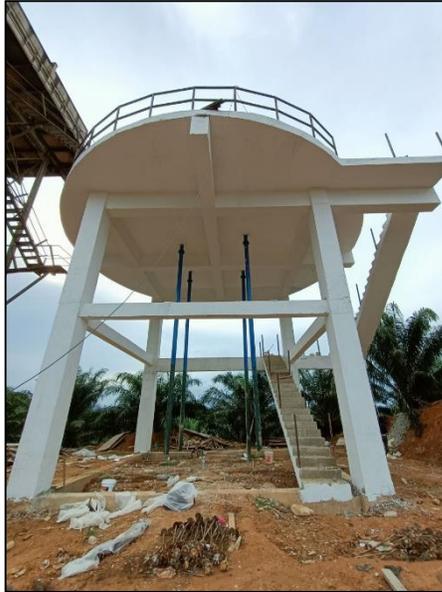
Figure 3.10: Column painting work

11. The columns were painted using interior emulsion paint to make them look nice and long-lasting by giving the protection from the environmental factors.

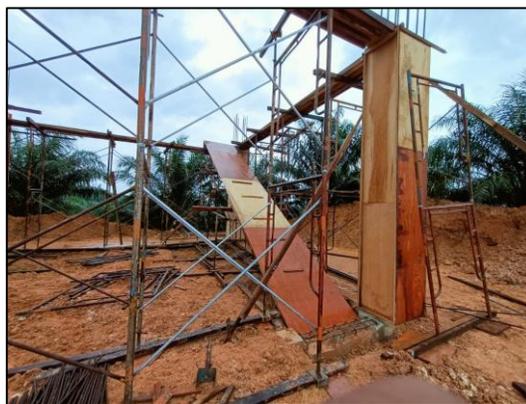
Figure 3.11: Formwork installation for soffit

1. The sawn formworks are formed to the slopping soffit of staircase for the first and second flight together with the timber strut to support the formwork.

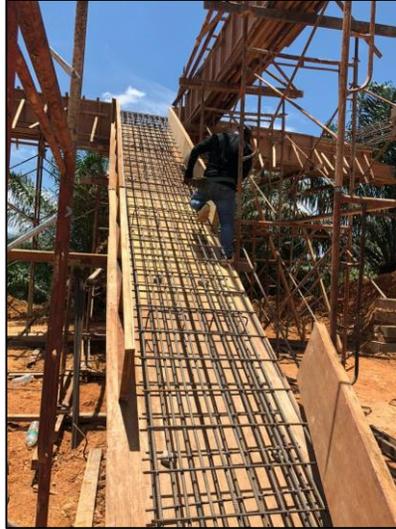
Figure 3.12: Rebar installation to staircase

2. Mild steel and high tensile reinforcement bars are installed to flight and landing slab of staircase using binding wires together with spacer block.

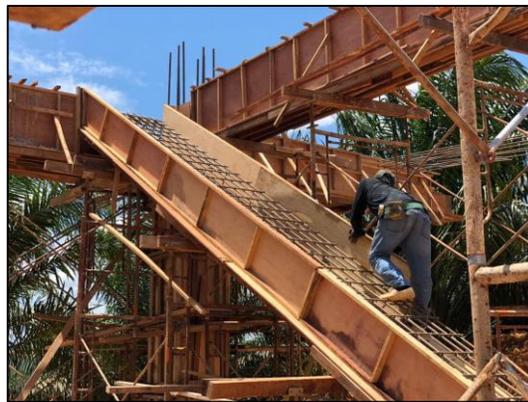
Figure 3.13: Sides formwork installation

3. The sawn formworks are installed to sides and soffit of staircase landing slabs together with timber struts to give sufficient support to the formwork.

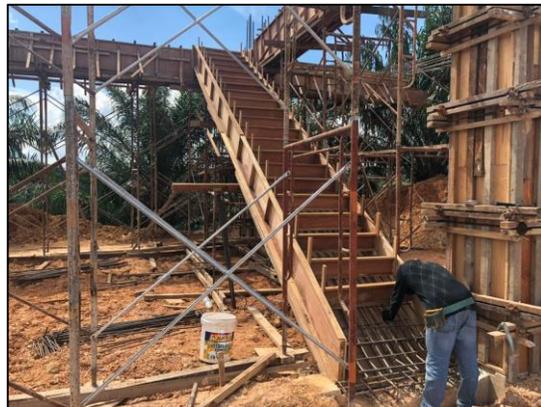
Figure 3.14: Riser formwork installation

4. Sawn formworks are formed to receding riser of staircase with 180 mm high.

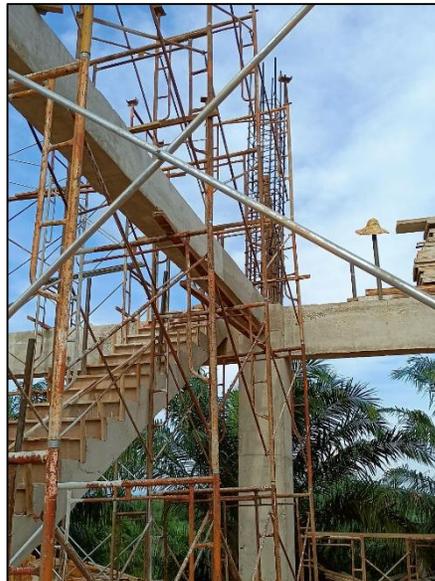
Figure 3.16: Staircase formworks dismantling process

6. After the concrete already harden for several days, the formworks are dismantled carefully by the labours.

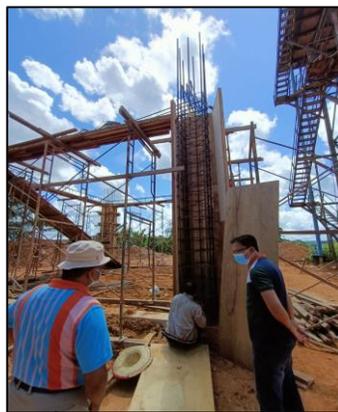
Figure 3.17: Steel checking progress

The overcome this problem, it is a must to recheck the work progress several times before site visit by the engineer is done. The skilled and unskilled labours checked the progress two times to make sure that there were no unfinished works such as untied reinforcement bars and the formworks were not installed properly that avoid any problems to the structure in the future. The figure shows that the site visit by the engineer before the labours were asked to redo the works.

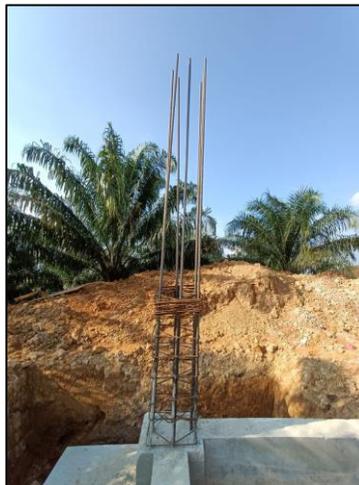
Figure 3.18: Incorrect column rebars

To avoid this problem to happen again, before the labours started their works in the morning, the skilled labours will have a little discussion among them to explained what type of works and the types of equipment and materials that will be used on that day. These are to ensure that there will be no more miscommunication among them. Fortunately, the works were run smoothly onwards. The figure below shows that the incorrect reinforcement bars that were installed by the labours.
