**DEPARTMENT OF BUILDING  
UNIVERSITI TEKNOLOGI MARA  
(PERAK)**

**INDUSTRIALISED BUILDING SYSTEM :  
PRECAST CONCRETE WALL**

**Prepared by :  
MUHAMMAD IDLAN HARITH BIN HAIDIR  
2019281626**

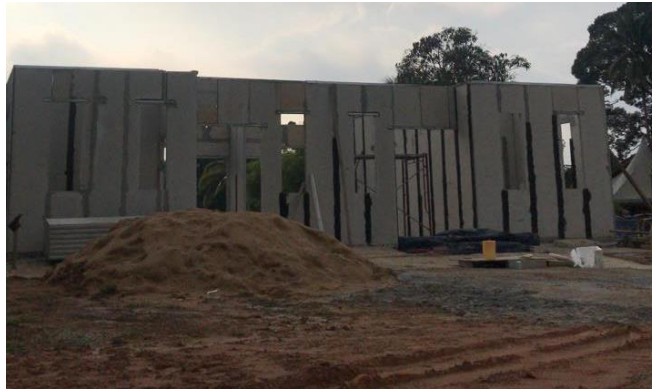
**Figure 3.2: Project Bukit Tembakau at 40%**

Throughout my duration of internship in this company, I was involved in the project of bungalow house located at Jalan Bukit Tasek, Bukit Tembakau, Umbai, Merlimau, Melaka. The duration of this project is 2 years and the overall cost of the project is around RM 90,000. The size of the site is 28' X 38' feet as the house has 4 rooms and 2 toilets. Figure 3.1 shows Architecture Plan of bungalow house at Bukit Tembakau. The location of the site was surrounded by bushes and houses. The accommodation near the site is accessible because there is a mini market nearby where supplies can be purchased. . There is also a mosque nearby the site. The activities that been carried out on the site were installations of Precast Concrete Walls. Figure 3.2 shows the bungalow house project was 40% completed.

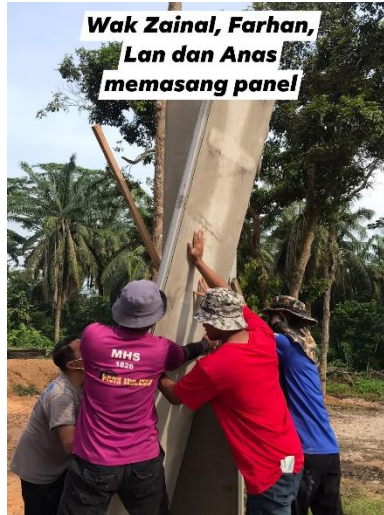
**Figure 3.4: Installing Precast Concrete Wall required manpower**

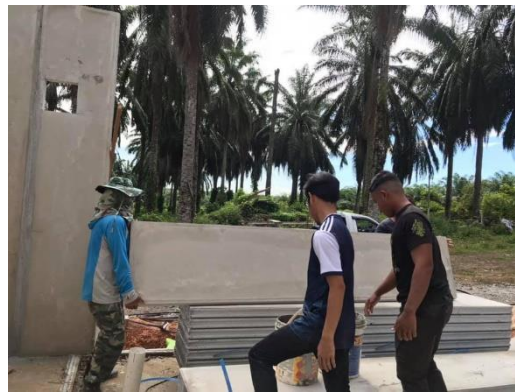
**Figure 3.5: Precast Concrete Wall came in bundle.**

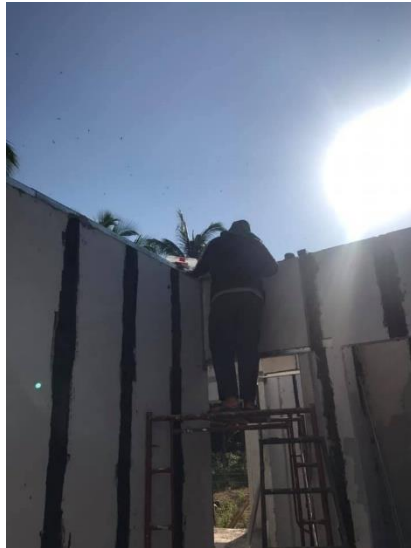
**Figure 3.7: Applying top track to the wall**

planks that been used to support the wall too. The wall was checked by using water level to avoid error on installation. Next step that been carried out was nailed the wall to the foundation by using Dowel bar that been shaped into number 7. The foundation was drill through bottom track by using power drill. Then, the 7-shaped dowel bar was nailed into the foundation and the side of wall. The next wall was applied with cement mixture as to stick the walls to each other. There was another type dowel bar that been cut into 7 inches and joint bar which were a R6 that shaped into stapler bullets were nailed into both of the wall as it will reinforce the joints between the walls. After jointing the walls together, fiber mesh was applied on the gap between the walls. There were also UCO jointing compound that was applied after fiber mesh net was applied as their purpose were strengthen the joints between walls. Both of the step can be seen in Figure 3.5 As for the last step, the accessories called top track were applied on the top of each walls as the top track will became the base for truss as it is shown in Figure 3.6.

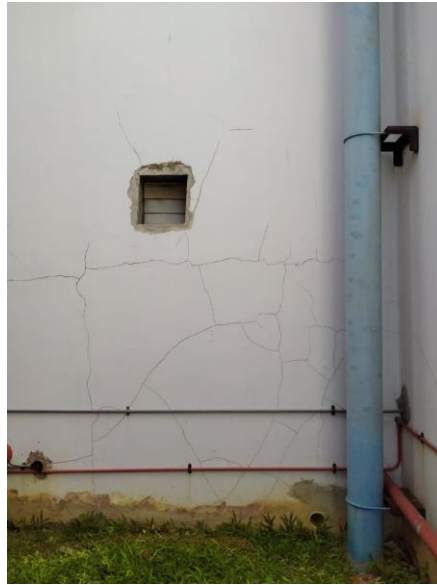
**Figure 3.8: Defects behind Chiller Plant building in UiTM Jasin**

As for maintenance and repairs of IBS Precast Concrete Walls, the problems were identified that were located at UiTM Jasin. There were some defects on the walls of Chiller Plant Building and Library which were located inside UiTM Jasin that shown in Figure 3.7. There were also defects that were identified behind 'Blok Kuliah' and behind Administer Building as shown in Figure 3.8 and Figure 3.9 The solutions for defects were carried out by using fiber mesh tape, silicone, and adhesive cement mixture. The purpose of using fiber mesh tape was to seal the crack of the wall while adhesive cement mixture sticks them together. The silicone was used for seal small cracks that can be seen with eyes. There was previous maintenance that been made but it was done properly as the cracks on the wall were sealed by using only cement mixture and doesn't use any binding material such as fiber mesh tape, or silicone. As the results, the defects were happened again.

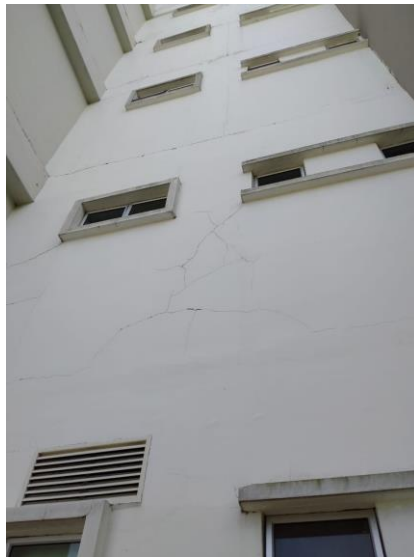
**Figure 3.9: Defects behind 'Blok Kuliah' in UiTM Jasin**

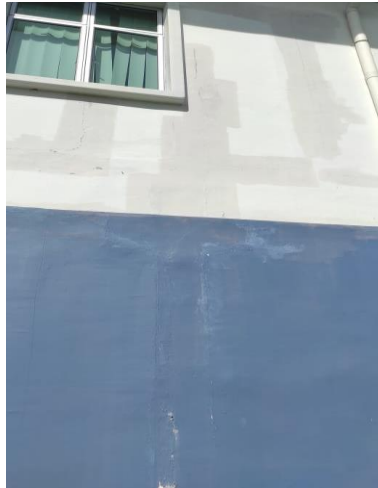
**Figure 3.10: Defects detected behind Administer Building**

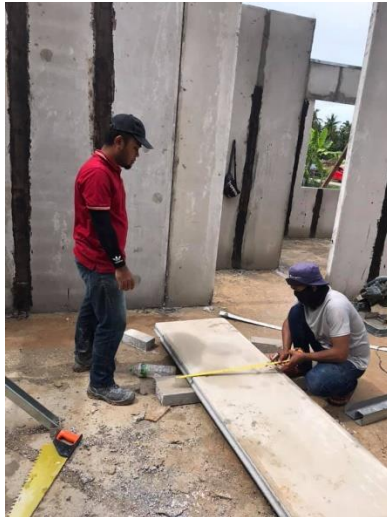
**Figure 3.11: Worker measured the part to cut it**

Any problems always have solutions. As on site, there were problems that commonly occurs as such the walls wasn't balanced based on water level, and others. Luckily, the workers were experienced as these problems can be solved by using stepping stone and supporting beam that been made out from wood planks. As by the action that been done, the walls will be strong and doesn't fall. There were also problems as the walls doesn't have any space to install windows and doors on the wall. As we know, there were many types of doors and windows such as sliding door, casement window, and others. The only solution that been used were cut the walls using machinery which was called Circular Saw by using figure 3.11 as reference. First, the wall was measured as to position the window or door using given measurement as shown in figure 3.10. But even with the machinery, it can't cut through the walls. The solution was by using Brick Cutting Hand Saw as it efficiently cut through the wall. This process was done before the walls were installed.

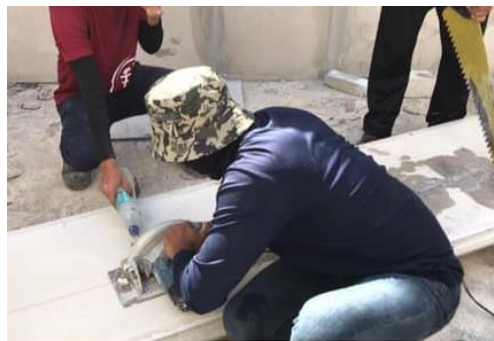
**Figure 3.12: Worker cut the wall using Circular Saw**

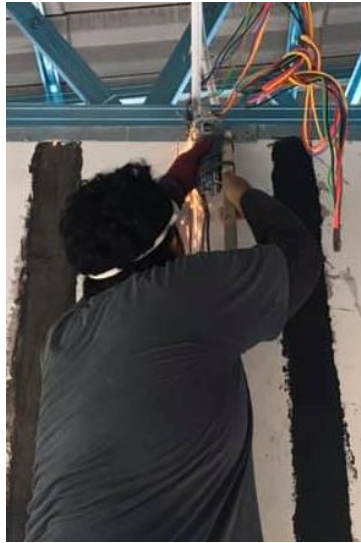
**Figure 3.13: The walls were cut using Grinder**

As for the next problem that always occurs on site were the walls doesn't have electrical holes as electricity is an important need in a house. The solution that been done were drawing the lines of electrical holes on the wall. The next step can be seen in figure 3.12 where the holes were shaped by using machinery called Grinder. As using the machinery, it cut the wall but it doesn't go through as the disk of machinery doesn't have wide diameter. Next was to make the holes as the electrical pipes went into the holes as it was shown in figure 3.13. It was done by using machinery called Hammer Drill as the machinery hacked through the walls. This step was done cautiously as not to overdone the hacking as avoiding to hack through the walls. The wires were protected by PVC pipes as the wires were made by fragile material and dangerous if it was exposed. After the holes been hacked, the wires with pipes were planted inside the holes and covered by cement as it can be seen in figure 3.14.

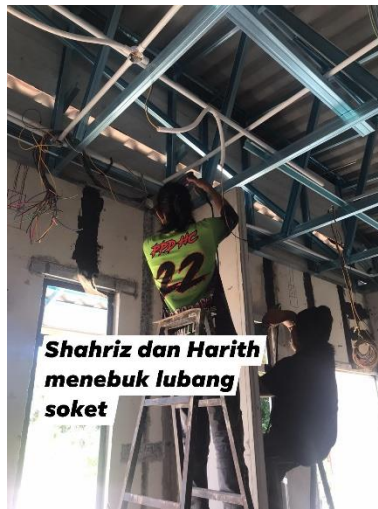
**Figure 3.14: The holes were made using Hammer Drill**

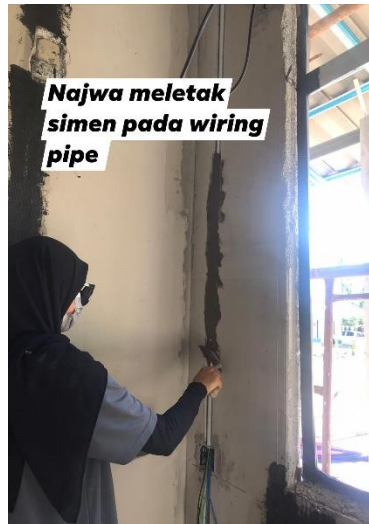
**Figure 3.15: Closing the holes using cement**

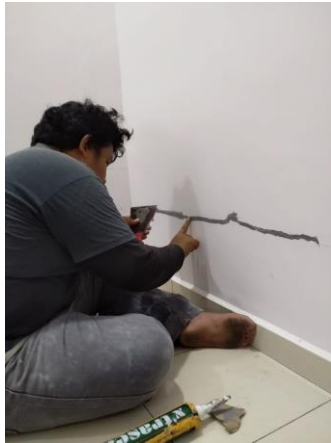
**Figure 3.16: The cracks on the wall was closed using silicone**

Last but not least, the problem was the walls were needed maintenance frequently as there might have problems on the installation that caused the defects of walls, or others. The maintenance sometimes took high maintenance depends on what type of maintenance have been done such as leaks from rooftops, wall cracks, damp ceilings, and others. Based on the practical learning, I learned the solution from workers. As for the leaks on rooftops, the problems were identified as the source came from either the gap between roof tiles, or there were holes on the roof tiles. The solution that been carried out were to replace the roof tiles as to prevent leaking again. As for wall cracks, the problem was being solved by spread silicone through the cracks and closed the cracks using fiber mesh tape as shown in figure 3.15. The silicones were act as glue between the cracks, and the fiber mesh tape was kept them together and as closing tape. Last step was to paint the wall back as it was shown in figure 3.16. The step was done as a finishing step. As for the damp ceiling, the problem came from the rainwater that been flowing the gap between the rooftiles as making it flowed to the top of ceiling. The solution for this problem was to replace it with new ceiling board. As the first step was to cut out the damp part of the ceiling, then make sure there doesn't other ceiling that been affected. Next step was to cut the new ceiling board as to fit in the damp part or took out the entire ceiling board and replaced it as it was shown in figure 3.17. After the ceiling was installed, the edges of ceiling board were sealed using fiber mesh tape as it strengthens them. After that step, it was shown in figure 3.18 as the sealed part of the ceiling was closed using Cornice Compound mixture as it acted as a binder on the fiber mesh tape. Last but not least, the ceiling was painted back as finishing touch.

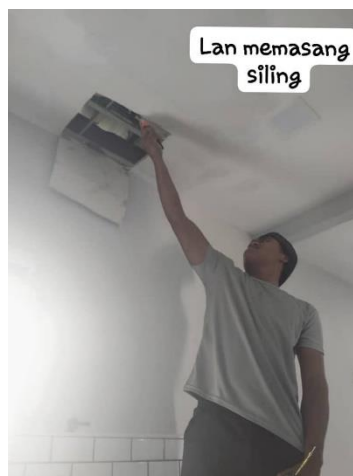
**Figure 3.18: Worker replaced the damp ceiling with new ceiling board**

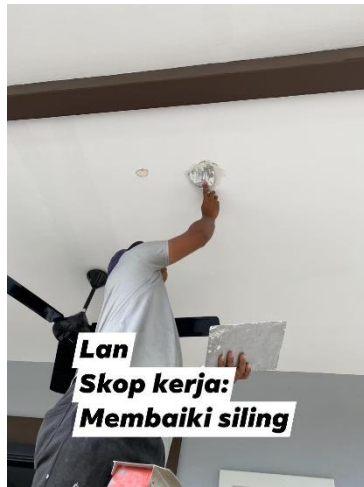
**Figure 3.19: Worker covered the holes using Cornish Compound mixture**
