**DEPARTMENT OF BUILDING
UNIVERSITI TEKNOLOGI MARA
(PERAK)**

TOILET RENOVATION

**Prepared by:
NUR HANIS BINTI KAMARUDIN
2019237582**

FEB 2022

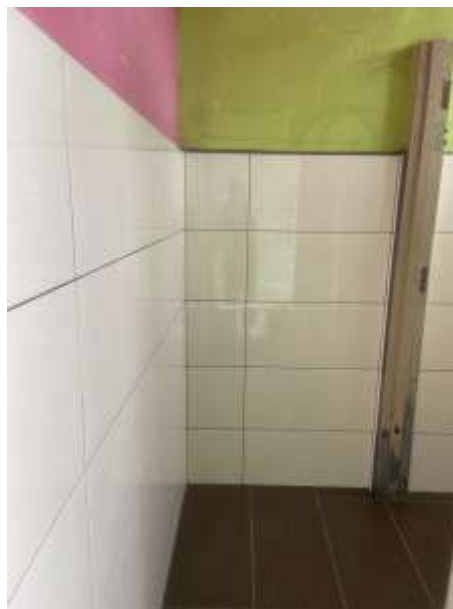
Figure 3.3: Homogeneous Tiles has been selected

- ii. Next, for the wall, it used 20mm cement and sand (1:6) cement mortar ratio. The renovation same as the floor. They hacking the floor and tiles and touch up with new cement mortar and install new tiles. The tiles that has been used is homogenous tiles (600mm x 300mm x 8mm) in white colour. Homogeneous tiles are nonporous and resistant to water. A homogeneous tile has a substantially lower absorption rate than other porcelain tiles. Homogeneous tiles are the ideal choice for bathroom tiling because of their impermeable qualities.

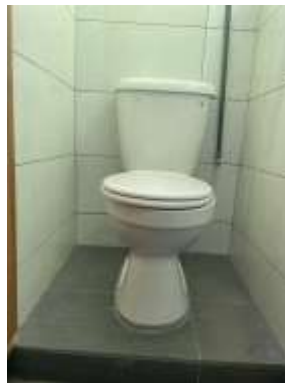
Figure 3.4: Close Coupled Toilet Bowl

- iii. In addition, for this toilet renovation project, 2 types of toilet bowls have been installed by the contractor. Close coupled toilet bowl is one of the toilet bowls types. Close coupled toilets have the cistern linked to the toilet bowl, resulting in a single streamlined device that integrates both necessary pieces. These toilet bowl are quick and simple to install, making them an excellent choice for any toilet. Close toilets get its name from the close connection of the pan and cistern, which results in a single toilet unit rather than a separate bowl and cistern. Close-coupled toilets are simple to install, clean, and maintain, and they come in a variety of designs.

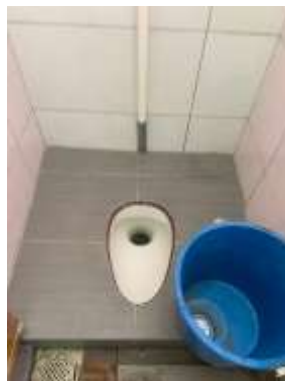
Figure 3.5: Squatting Toilet Bowl

- iv. Besides, squatting toilet bowls is the another one toilet bowl has been selected to install. Squat toilets, often known as Indian toilets, are toilets that are used by squatting rather than sitting. This indicates that the defecation posture is to kneel over the toilet drain or hole with one foot on each side. A toilet pan of this type is sometimes known as a "squatting pan."

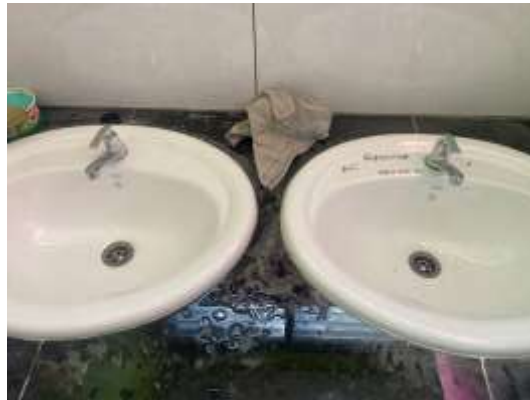
Figure 3.6: Sink that has been selected

- v. In addition, there was 2 sinks has been installed for this project. 2 sinks have been installed with size 585mm x 430mm. It was installed to make easy for the staff to wash their hand.

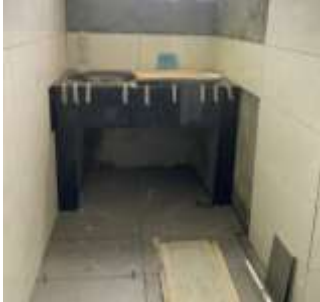
<p><i>Figure 4.9: Tiles installation for table top</i></p>		2 skilled worker	<ul style="list-style-type: none"> • Hand trowel • Concrete trowel • Scrapper • Tiles cutter 	3 days	Homogenous tiles have been applied. It is because suitable for toilet users.
10.	Sink Installation

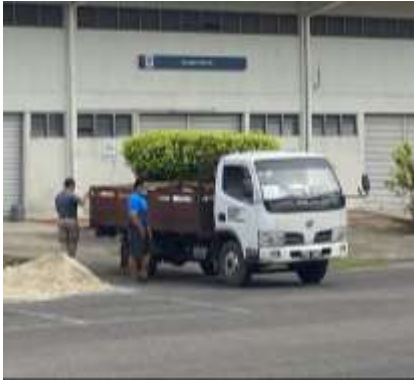
<p data-bbox="475 786 815 824"><i>Figure 4.15:Lorry 1 tonne</i></p>	As a transport for material and site clearance.
2.

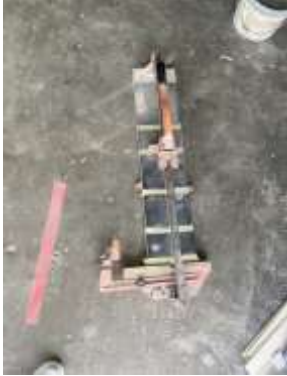
<p data-bbox="491 1473 801 1512"><i>Figure 4.20: Tiles cutter</i></p>	Used to cut the tiles based on shape and size that they need.
4.

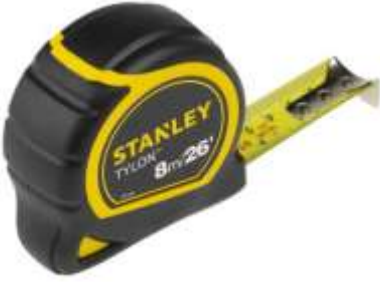
<p data-bbox="453 600 868 636"><i>Figure 4.26: Measurement Tape</i></p>	<p data-bbox="940 344 1370 546">Used to measure size. It is like a much longer flexible ruler consisting of a case, thumb lock, blade/tape, hook and etc.</p>
10.
