**DEPARTMENT OF BUILDING
UNIVERSITI TEKNOLOGI MARA
(PERAK)**

INSTALLATION OF RC COLUMN

DEPARTMENT OF BUILDING
FACULTY OF ARCHITECTURE, PLANNING AND SURVEYING
UNIVERSITI TEKNOLOGI MARA
(PERAK)

Installation Of RC Column

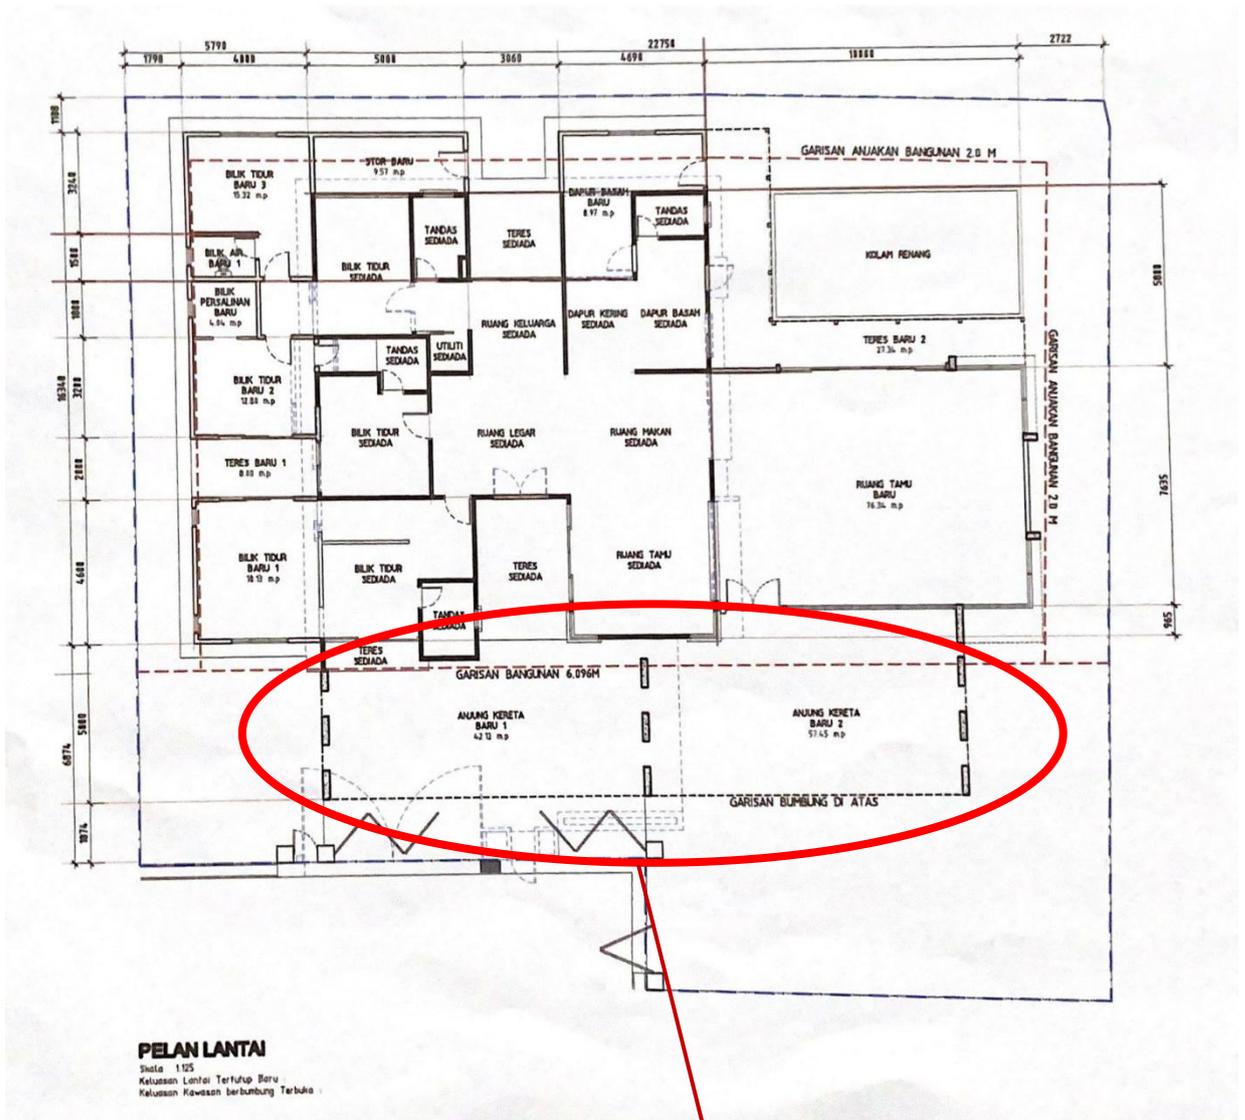
RC COLUMN

Figure 3.1.1 : Floor Plan

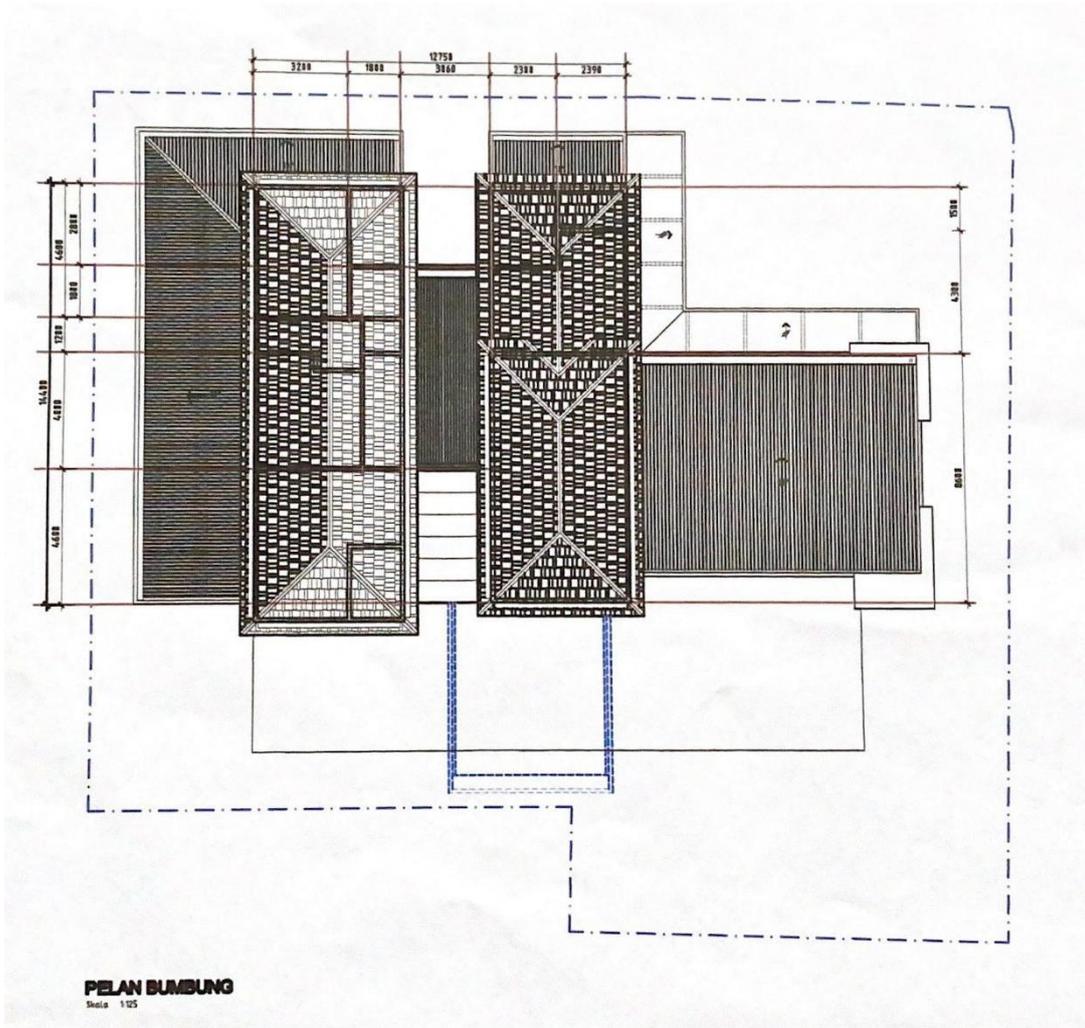
Figure 3.1.2 : Roof Plan

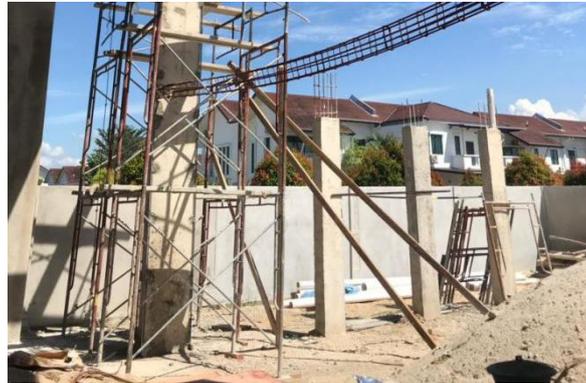
Figure 3.2 : Building Site Construction.

Firstly, The location of columns is determined practically in the field at this stage of the project. It is accomplished by laying rope in accordance with the grids shown in the drawing, and then marking the location of rope-related columns. Column locations are shown in relation to a grid-line with dimension in the drawing. Ropes serve as our grid-line in the field. As a result, we place rope-line-related columns by measuring the dimensions shown in the drawing.. Based on the drawing plan, there are 9 columns required with each distance of 0.4 m for each 3 columns. Meanwhile, there are two concrete roofs built, each of which is 9.8 m long and 4 m wide. Following that, the contractor calculates the amount of material required such as steel bars, stirrup, formwork, cement, nails and other materials required. The contractor then goes to the construction material store and purchases the correct type of material.

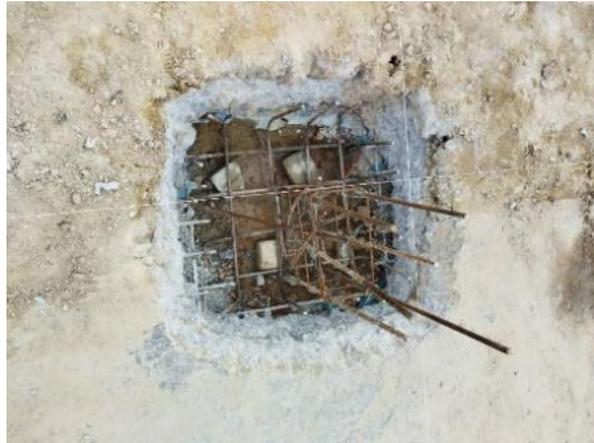
Figure 3.2.1 : Footing Pad that have been prepared.

Small excavation are done as deep as 24 inches with a width and length of 48 inches to make a pad footing. After that, Lay a layer of lean concrete to make sure firm base for the footing were prepared and clean. Next, install reinforcement, the rebars were bent and tied before the whole thing was lowered and placed inside. The steel is place properly on spacer blocks, avoid touching the lean concrete below. The process continue by installing stump reinforcement and finally pour the cement that has been mixed into the mold.

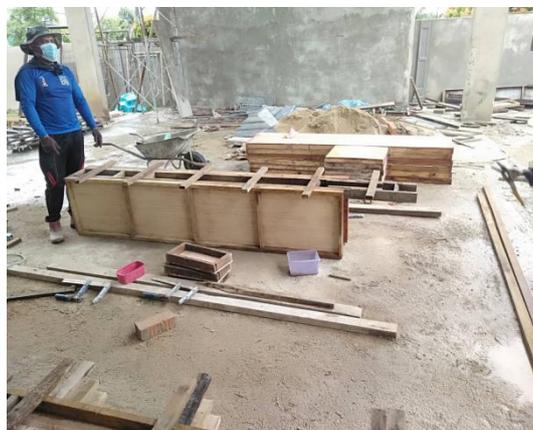
Figure 3.2.2: Install Column Formwork by the workers

Workers install wood formwork according to the prescribed column size before erecting the column. Workers then used rebar tying hooks to secure the stirrups to the steel bars as reinforcement. Stirrup is a closed loop of reinforcement bars that serves to keep the main reinforcement bars in a reinforced concrete element together.

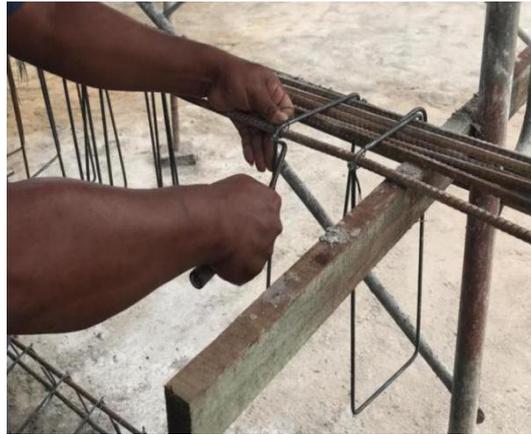
Figure 3.2.3 : Workers used rebar tying hooks to secure the stirrups.

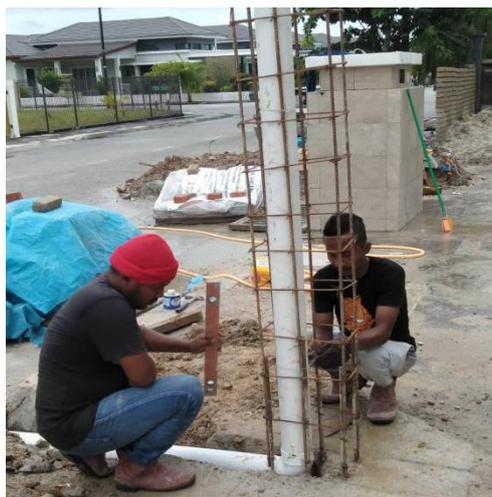
Figure 3.2.4 : Column Reinforcement Work.

The stump reinforcement footing will be visible after the footing reinforcement has been installed, and the correct location of column can be determined. At the most basic level, the accuracy of column positioning is determined by the accuracy of the setting out work. This is why, during the foundation stage, proper setting is important. The footing reinforcement and column reinforcement are then installed by using a rebar tying hook to connect the two reinforcements. After installing column reinforcement, rain water down pipe is installed inside the column according to the height of the column. The pipe is then installed horizontally at the bottom as well as connected to the drain, to allow rainwater to flow down the pipe and into the drain.

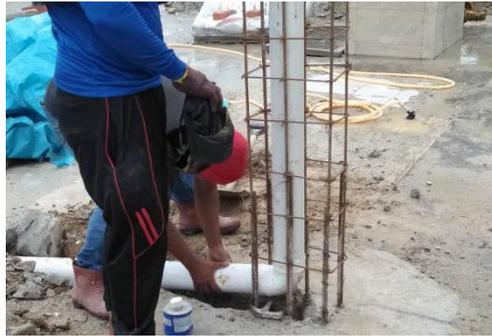
Figure 3.2.5 : Rain Water Down Pipe installed

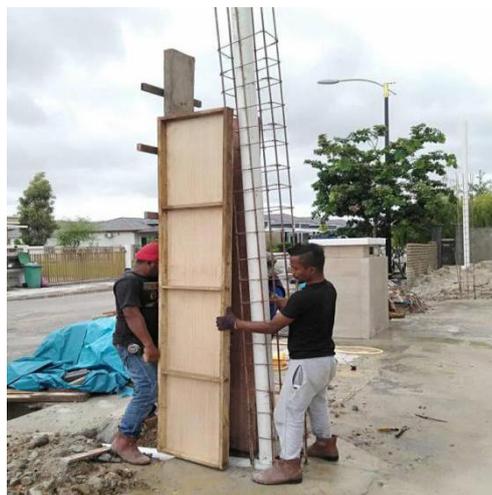
Figure 3.2.6 : Column Formwork Work.

To begin, three pieces of formwork are connected with nails. Then formwork is installed around the reinforcement. At the bottom of the formwork is nailed so that the formwork stands upright and strong. After that, the final piece is spliced together to cover the formwork. The formwork must be installed neatly and securely to prevent leakage during the concrete pouring process. The top of the formwork is left open for the purpose of pouring concrete.

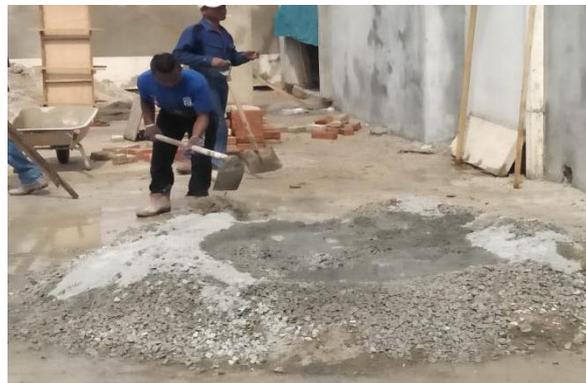
Figure 3.2.7 : Concrete are Mixed using manual process.

When it comes to mixing concrete, the worker uses a hand mixing process which is the process of mixing the ingredients of the concrete manually without a mixer machine. The worker has to mix the concrete according to the required ratio based on the drawing plan. Concrete is mixed by hand on a hard and flat place. On the platform, a measured amount of sand is spread, and then the cement is poured over the sand. In a dry state, the sand and cement are thoroughly mixed with shovels several times until the mixture reaches an even colour throughout and is streak-free. The coarse aggregates are then spread out in a uniform layer on top of the above mixture and thoroughly mixed. After that, the entire mixture is properly blended by twisting it from centre to side, back to centre, and then to the sides several times. After that, a depression is made in the mixed materials' centre. 75 percent of the required amount of water is then poured into the depression and mixed with shovels. Finally, the

remaining water is added, and the mixing process is repeated until the concrete has a uniform colour and consistency.

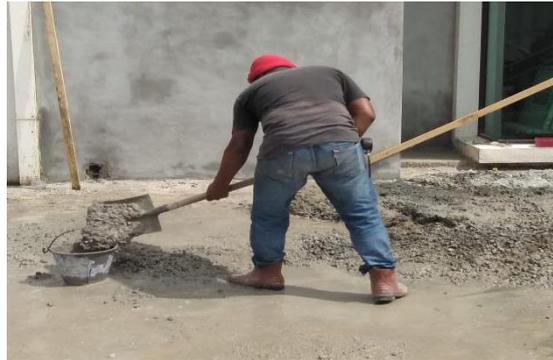
Figure 3.2.8 : Concrete is moved using buckets.

Concreting of column is done by manually. Worker pour the concrete that has been mixed using a bucket repeatedly until it fills the space in the column. Concrete is poured little by little then compaction is done using rods. In rodding, generally, the workers tamp a steel rod for the compaction of concrete. During concreting pouring , the temperature should be below 30 °. Lastly , check verticality and horizontally of the column after pouring and vibrating the concrete.

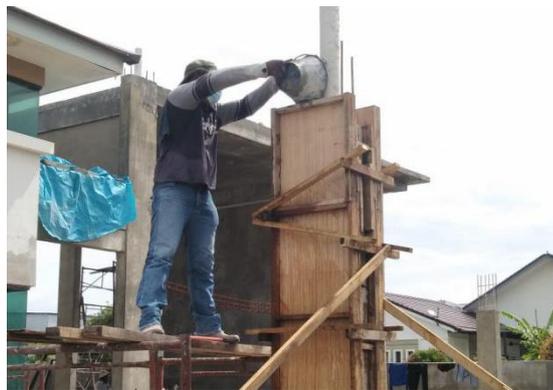
Figure 3.2.9 :Pouring Concrete work.

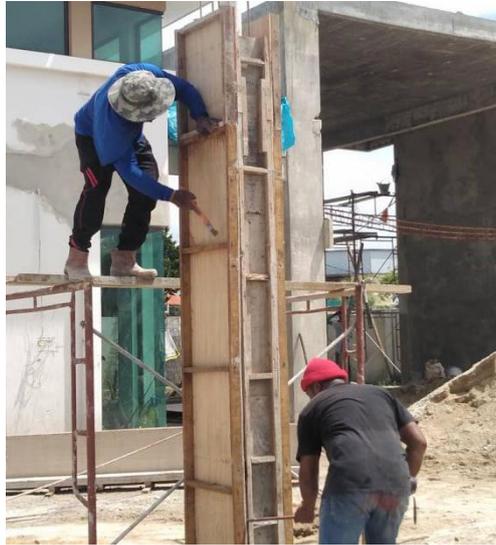
Figure 3.2.10 :The Formwork is remove by using the hammer .

After the concrete has turned and gained sufficient strength, it is time to remove the formwork. Workers open the formwork using a hammer by removing nails. The formwork should be opened carefully so as not to damage it as it can be reused.

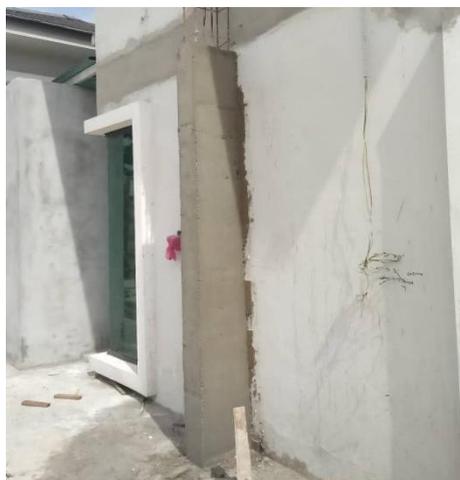
Figure 3.2.11 :Column that is ready for finishing with plastering work.

Finishing works is a job in the construction process that adds to a building's visual beauty and typically requires a skilled worker. Sand, cement, and water are mixed together to make cement plaster. To begin, skilled workers use a trowel to apply cement plaster to a dust-free column, then flatten the cement layer by layer until it is neat. After that, dap the surface of the column with a sponge scrub trowel to smooth it out. It was then repeated on the other side of the wall until the plaster was completely covered.
