**THE IBS CONSTRUCTION FOR PERUMAHAN RAKYAT
TERMISKIN (PPRT) SINGLE STOREY HOUSES IN CHEMOR,
PERAK DARUL RIDZUAN.**

**Prepared by:
SHARIFAH NURIN AFIQAH BINTI SYED RAZALI
2019233992**

FEBRUARY 2022

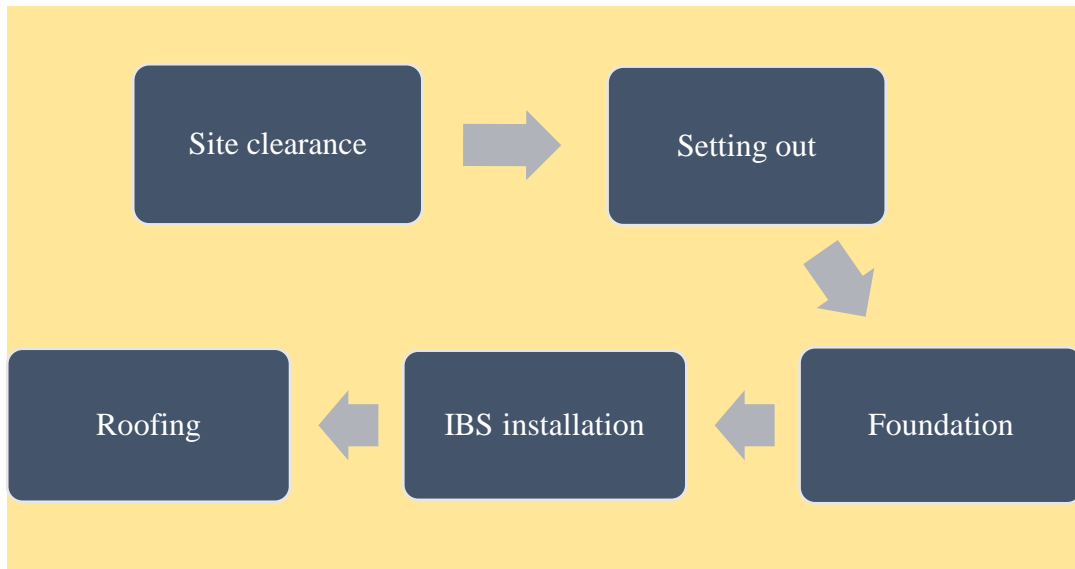
Figure 4: The stages of construction single storey house

Figure 4 shows the whole process of the construction for single storey houses starting from site clearance, setting out, foundation, IBS setting out, IBS installation, and lastly roofing. The main focus of this study is the IBS installation.

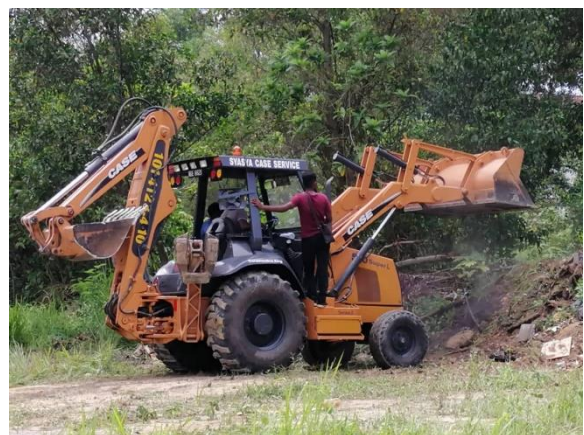
Figure 5: Site clearance using backhoe
(Source: Courtesy of Site Supervisor)

The first method to do before any construction and structural work is site clearance. In this case study building, the site clearance was done by using the backhoe as shown in Figure 5. Backhoe is a common machinery that is used for site clearance. Site clearance is the process to clear all the vegetation, and remove the surface of the topsoil layer. Therefore, backhoe was used for cutting brush, moving debris, digging out rocks and removing the surface of topsoil layer.

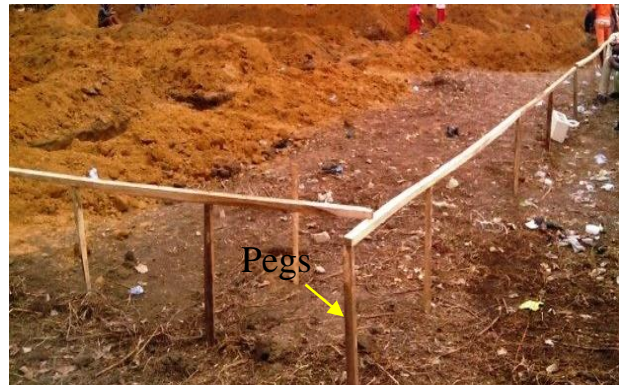
Figure 6: Setting out

The centre line method of setting out was generally preferred and adopted. Setting out was done by marking the outline by using pegs that was made by the wood size 1" x 2" as shown in Figure 6.

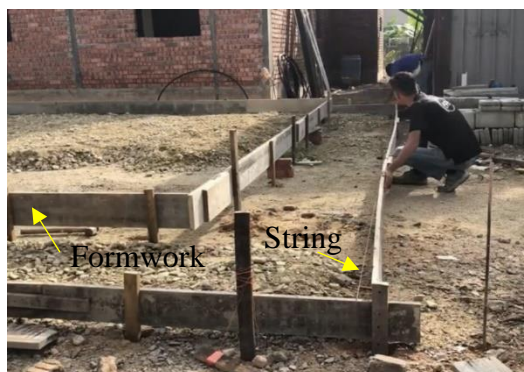
Figure 8: Formwork installation

This case study building was used raft foundation. Firstly, formwork has been installed according to the drawing plan. A string was pulled between two marked pegs so that the formwork can be installed in a straight line. The formwork was made from the plywood and timber as shown in Figure 7. The second step, the crusher run was poured using a wheelbarrow in the formwork area and the crusher run was levelled using a hoe as shown in the Figure 8.

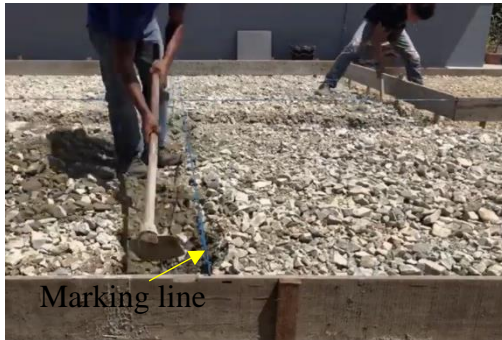
Figure 9: Crusher run was excavated

The third step, the crusher run was excavated one feet width from the marking line to make a gap between each section as shown in Figure 9. The crusher run was excavated using hoe. The fourth step, the crusher run was compacted using compactor machine as shown in Figure 10. The function of compaction was to make the crusher run level be in uniform.

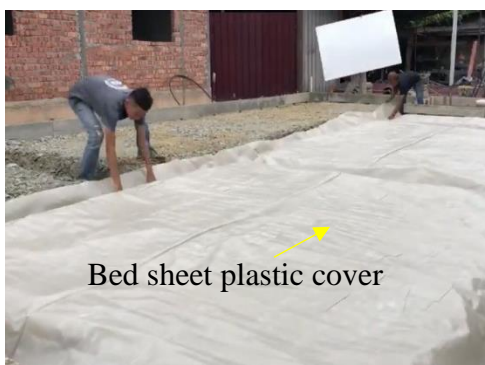
Figure 11: Bed sheet installation

The fifth step, the surface of the crusher run was covered with the bed sheet plastic cover as shown in Figure 11. The purpose of the bed sheet plastic cover was to avoid water moisture from the soil absorbing the concrete. Bed sheet plastic cover was important as a layer to prevent water moisture so that termites from the soil will not come to attack the building structure. The sixth step, the rebar was placed at the spacing area and the BRC were placed on the rebar as shown in Figure 12. The brick is placed on the bed sheet plastic cover as the spacing component to provide a gap between the bed sheet plastic cover and the BRC. The rebar is made from steel reinforcement grade Y10 while the BRC used grade A10.

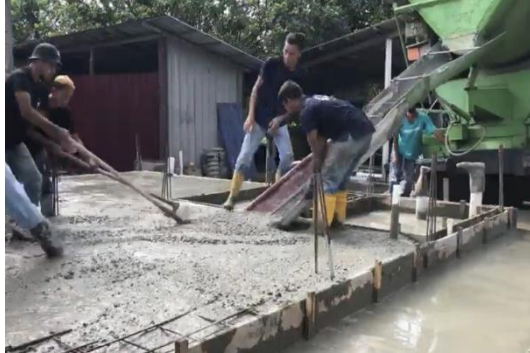
Figure 14: Concreting work

The last step of raft foundation was concrete and curing. The formwork area was poured with the concrete from the concrete mixer truck as shown in Figure 13. Then, the surface of the concrete was curing to smooth the surface as shown in Figure 14.

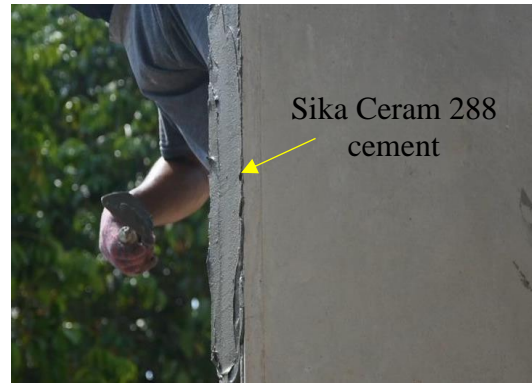
Figure 17: The placement of Sika Ceram 288 cement

The third step, Sika Ceram 288 cement was placed on the side of the panel as shown in Figure 17. In this process, the whisk was used to achieve a perfect combination between Sika Ceram 288 and a water mixture. Only one side of the panel is plastered with Sika Ceram 288 cement. A moist sponge was used to flatten excess Sika Ceram 288.

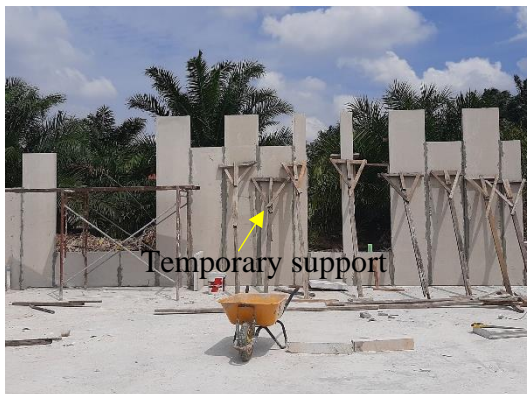
Figure 19: IBS panel support by temporary support

The fourth step, the panel on which Sika Ceram 288 had been placed, was lifted and placed vertically on the bottom track. The 1" x 2" wood was used to support the panels that had been placed on the bottom track as shown in Figure 18. The fifth step, water levels were used vertically and horizontally to check and ensure each panel placed on the bottom track is in the proper position as shown in Figure 19. This process seems simple but it was very important to keep the panels in balance.

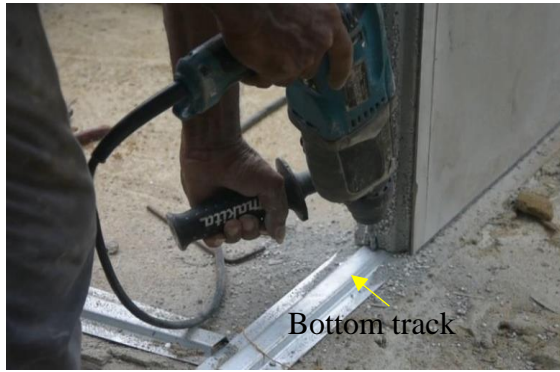
Figure 20: Bottom track is drilled

The sixth step, connecting devices were mounted on each bottom of the panel for the purpose of panel rigidity. In this step, the bottom track was drilled and fitted with a Y10 grade “7-shape” dowel bar as shown in Figure 20. A hammer was used to install the Y10 “7-shape” dowel bar on each side of the bottom corner of the panel as shown in Figure 21.

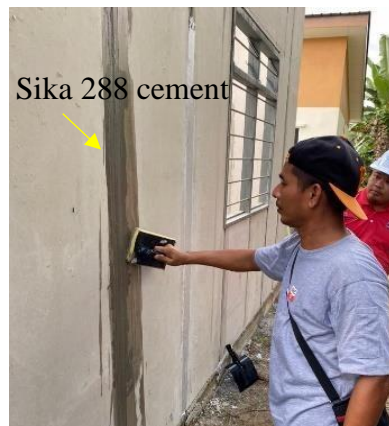
Figure 25: Sika 288 cement is applied

The last step is known as the final touch up process of the connection. In this process, Sika 288 cement was applied entirely at a width of 50mm between two panel connection surfaces. In Figure 25, a wet sponge was used to smooth and level the Sika 288 cement. Then, Figure 26 shows the skim coat was also used on the connection part between the panels to prevent cracking and cover the effect of the connection.

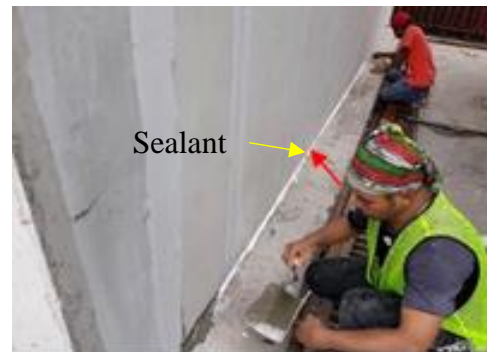
Figure 28: The sealant was applied

In Figure 28, the sealant was applied between the panel connector surface and the floor on the outer wall to seal the gap between the panel and floor. Sealants are used to keep air, water, and other environmental elements from entering or exiting a structure while allowing limited movement of the substrates.

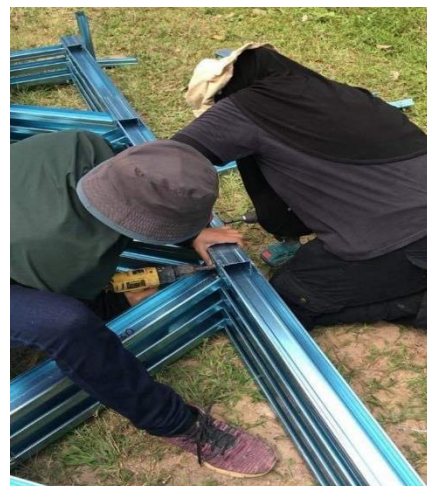
Figure 29: Installation of roof truss component

This case study building was used gable roof design and lightweight steel truss system. There were a few steps in roof trusses process. Firstly, roof trusses consisting of struts and rafters were constructed according to the drawing plan. In Figure 29, all strut and rafter installation work were done on the floor before the roof trusses were lifted and placed on top of the building structure.

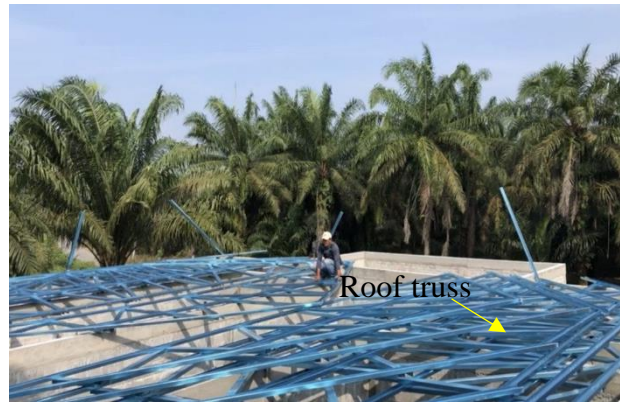
Figure 30: Roof trusses are placed on the building structure

The second step, roof trusses that had been installed with struts and rafters were lifted and placed on top of the building structure as shown in Figure 30. The components of the roof trusses were all built of C channel steel. Nowadays, most of the contractor used a lightweight steel truss system due to the fact that it was lightweight and durable. So, the workers were easy to lift and place the roof truss. Furthermore, C channel steel had the advantages of being termite-proof, rust-resistant, and non-combustible.

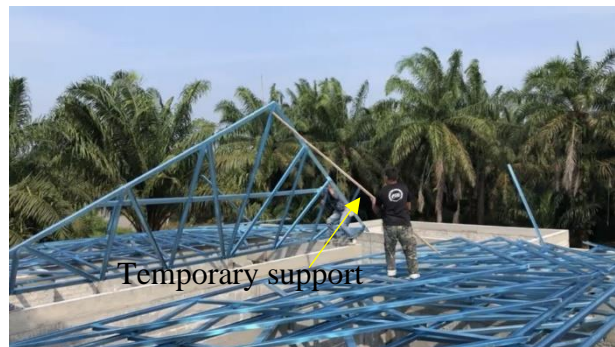
Figure 31: Roof truss support by temporary support

The third step, Figure 31 shows temporary supports were used to erect roof trusses according to the drawing plan.

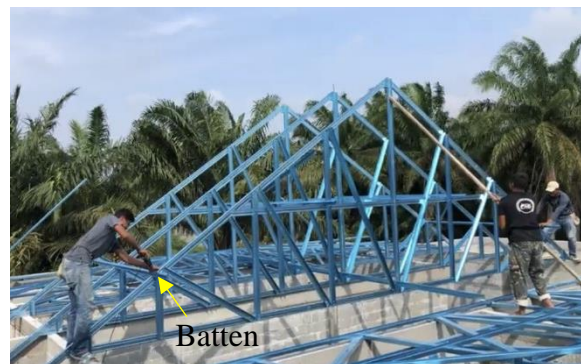
Figure 32: Installation of batten

The fourth step, in Figure 32 the batten was mounted on the roof truss horizontally using fasteners to lock the position of the roof truss from falling.

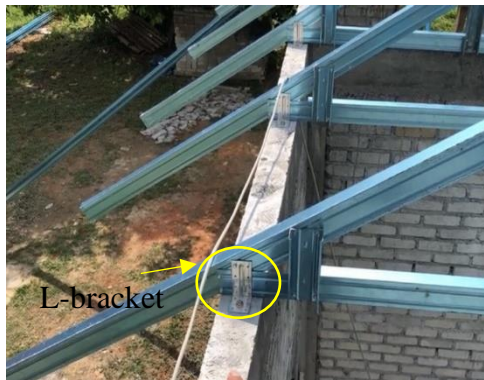
Figure 34: The L-bracket is mounted with roof truss and beam

The fifth step, L-brackets were used to fasten the roof truss to the beam so that the roof truss remains in position as shown in Figure 33. The L-bracket was mounted on the roof truss using fasteners while the sleeve anchor was used to mount the L-bracket to the beam. The next step, 14 pieces of metal deck with the size of 2.5 feet wide and 14 feet length was placed on top of the roof truss and screwed on the batten using fasteners as shown in Figure 34. A metal deck with a 25° slope was mounted on the roof truss.

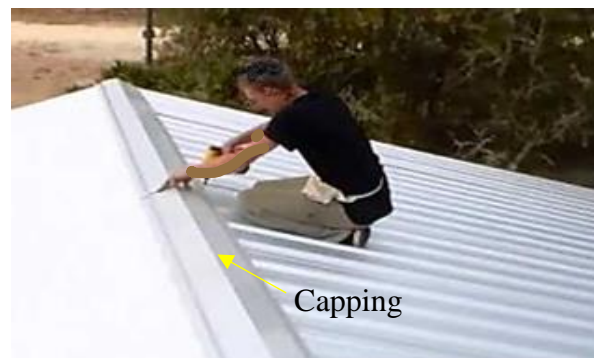
Figure 35: Installation of capping

Lastly, in Figure 35, a flashing cover was installed on top of the roof to cover up the connection, or space, where the two sides of the roof meet. By installing this flashing cover, it can prevent the roof connection from leaking especially during rain.

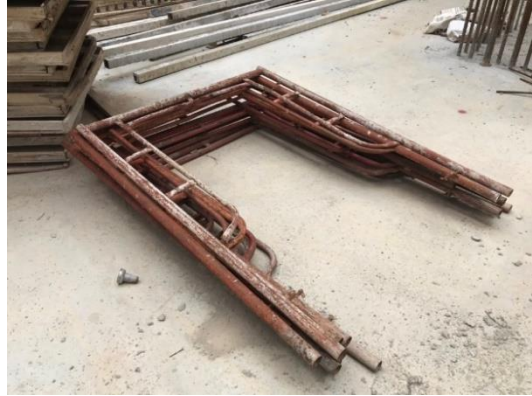
Figure 36: Scaffolding

Figure 36 shows the scaffolding. Scaffolding was a temporary structure that was commonly used at construction sites. Scaffolds were widely used on site to get access to heights and areas that would be otherwise hard to get to because its function seems like a ladder. In this case study, scaffolding was used to transport the roof trusses to the top of the building.

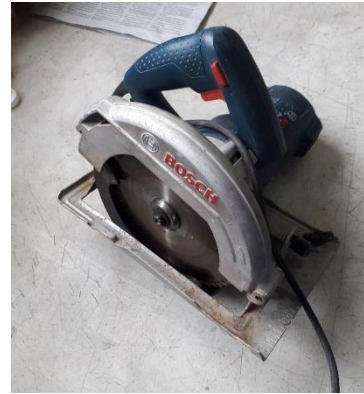
Figure 38: Circular saw machine

A circular saw was a type of power-saw that used a toothed or abrasive disc or blade to cut various materials in a rotational motion that revolved around an arbour. A circular saw was a tool for cutting a variety of materials such as wood, stone, plastic, or metal. It can be hand-held, as shown in Figure 38, or machine-mounted. The most common circle saw was a hand-held circular saw. In this case study, a hand-held circular saw was used to cut the IBS precast panel for the purpose of door and window opening.

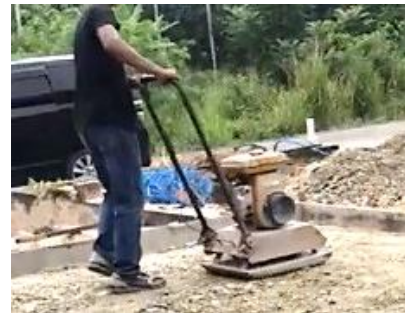
Figure 39: Compactor machine

A compactor was a type of construction machine that applies pressure on soil, reducing air trapped and allowing the soil to support higher weights on flat surfaces. Roller compactors and flat plate compactors were the two main types of compactors. One of the most obvious advantages was their ability to boost a surface's load-bearing capability. In this case study, a flat plate compactor was used during construction of raft foundation as shown in Figure 39.

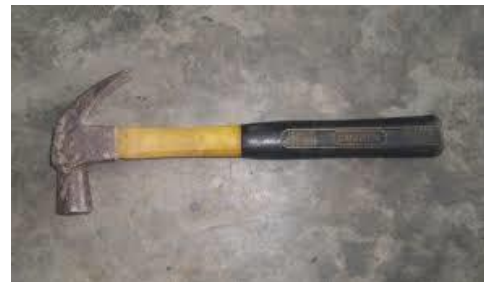
Figure 40: Hammer

Figure 40 shows a hammer. A hammer is a hand tool that consists of a weighted "head" attached to a long handle and swung to produce an impact to a limited area of an item. In this case study, a hammer was used to install a dowel bar and joint bar into IBS precast panel.

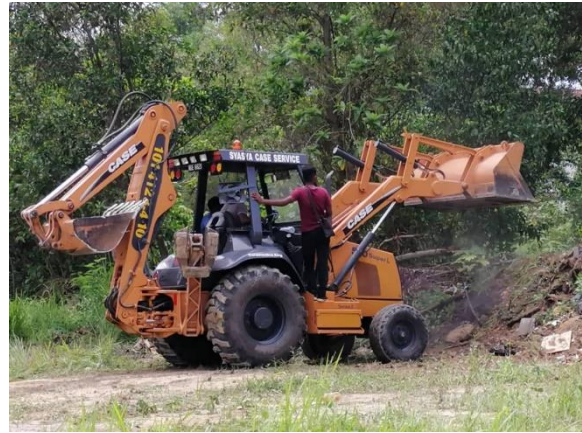
Figure 41: Backhoe

In this case study, a backhoe was used for site clearance activity as shown in Figure 41. A backhoe was an excavating equipment that had a digging bucket attached to the end of a two-part articulated arm. Backhoe loaders were normally loader or tractor units with a loader-style bucket on the front and a backhoe digging bucket on the end of a two-part articulated arm on the back.

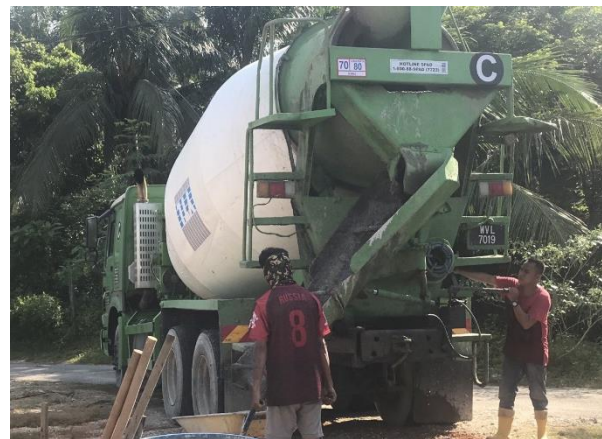
Figure 42: Concrete Mixer Truck

Concrete mixer was a machine that combines cement, aggregate such as sand or gravel, and water to form concrete. A typical concrete mixer used a revolving drum to mix the components. Usually, a mixer concrete truck can hold 9m³ of concrete. The concrete in the truck usually can hold for 2 hours after the batching concrete time. In this case study, a concrete mixer truck was used for concreting raft foundation as shown in Figure 42.

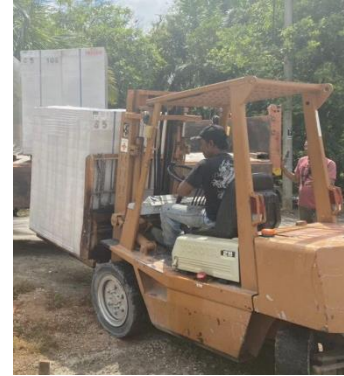
Figure 43: Forklift

A forklift was a compact industrial vehicle with a power-operated forked platform connected at the front that can be raised and lowered for insertion beneath a load to lift or transport it. They were used for short-distance lifting and moving of various materials. In this case study, a forklift was used to unload the IBS precast panel as shown in Figure 43.

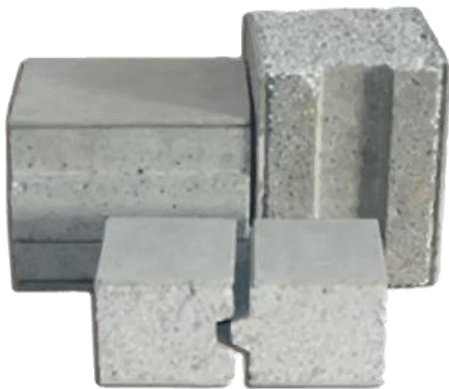
Figure 45: Interlocking of panel

The IBS precast panel system consisted of interlocking in every side of the panel as shown in Figure 44. In this case study building, jointing for panel to panel were used Sika Ceram 288. Sika Ceram 288 were laying on one side of the interlocking surfaces as shown in Figure 45. Sika Ceram 288 was a specialist cement that used to join each panel. Due to its high performance, thin layer, and flexible cementitious adhesive, Sika Ceram 288 was the best adhesive for the jointing of IBS precast panel wall.

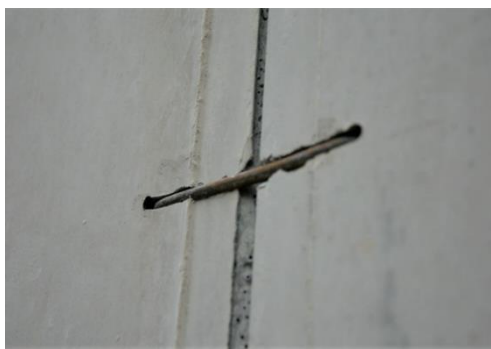
Figure 46: Stapler-shape jointing bar

In addition, a jointing bar called a stapler-shape, was also used as a jointing element. After the Sika Ceram 288 cement had hardened, a stapler-shaped jointing bar was installed in the centre of the interlocking line as shown in Figure 46. This stapler-shape jointing bar was made from steel reinforcing link grade R6 with the size of 4 inches length and 1.5 inches wide as described in Figure 47. This stapler-shape jointing bar was installed in three areas namely the top, middle and bottom of the interlocking line. The function of the stapler-shape jointing bar was to provide more support and strengthening of the jointing element. Moreover, the function of this stapler-shape jointing bar was also used as a fastener of each panel simultaneously.

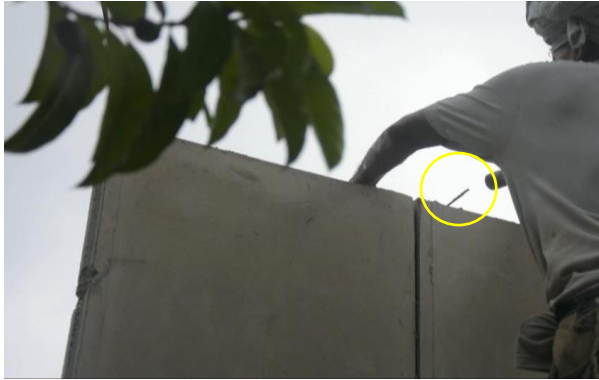
Figure 48: Dowel bar

Furthermore, in this case study building, a dowel bar was also used as a jointing element. A dowel bar was only installed in the top side of the panel as shown in Figure 48. This dowel bar was made from steel reinforcement bar grade Y10 with the size of 1 feet length. These dowel bars were placed diagonally between the two panels as shown in Figure 49. The purpose of the dowel bar was to offer additional support and strength to the jointing elements, especially at the top of the panel.

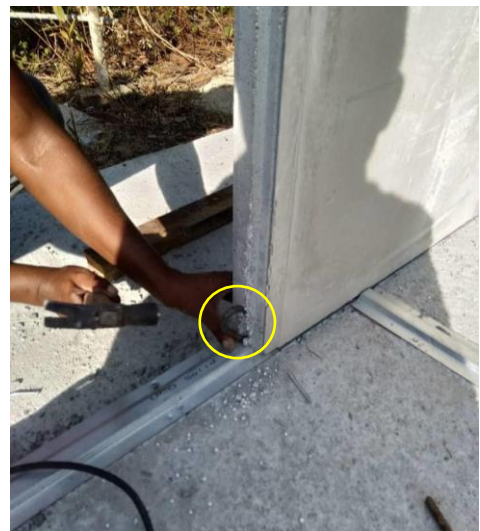
Figure 50: Y10 J-shape dowel bar is installed diagonally

Jointing elements for the panel to slab section used a dowel bar that was called J-shape. A J-shape dowel bar was installed in the bottom edge of the panel as shown in Figure 50. These J-shape dowel bars were made from steel reinforcement bar grade Y10 with the size of 4 inches length. These J-shaped dowel bars were diagonally placed between the panels and the slab. The J-shape dowel bar's purpose was to tighten the panel to the slab, and thus providing further support and strength to the jointing parts.

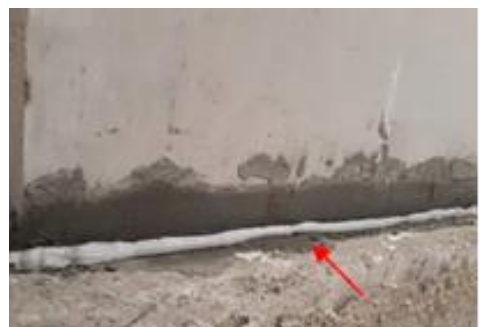
Figure 51: Sealant is applied to the surface of the connection gap

Furthermore, sealant was also used as a jointing element in this case study building. Sealants were used to seal joints and openings or gaps between the panel and the beam. For this case study building, sealant was only applied on the surface between panel and beam as shown in Figure 51. The main purpose of sealants was to prevent water, air, and other environmental elements from entering or exiting the house while permitting limited movement of the structure.

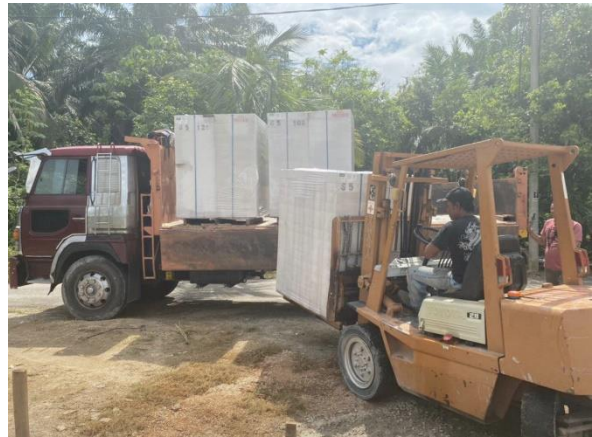
Figure 52: Forklift transfers the IBS precast panel

The case study building is located in a rural area, and the distance from the main road to the construction site is around 4 kilometres. Furthermore, the road width in this location is insufficient for heavy vehicles such as trailers and lorries. As a result, due to small road factors, the IBS precast panel cannot be delivered directly to the construction site. During the delivery of IBS precast panel, the contractor had to rent two forklifts and a one-tonne lorry since only these vehicles were allowed to access the construction site area. The first forklift transfers the IBS precast panel from a trailer to a one-tonne lorry as shown in Figure 52, while the second forklift unloads the IBS precast panel at the construction site. This delivery period takes a long time since the one-tonne lorry cannot carry a large quantity of IBS precast panel due to the size of the one-tonne lorry being too small to transport large quantities of IBS precast panel.
