**DEPARTMENT OF BUILDING
UNIVERSITI TEKNOLOGI MARA
(PERAK)**

**MAINTENANCE & SERVICES WORK
(ROOF RENOVATION)**

AUGUST 2021

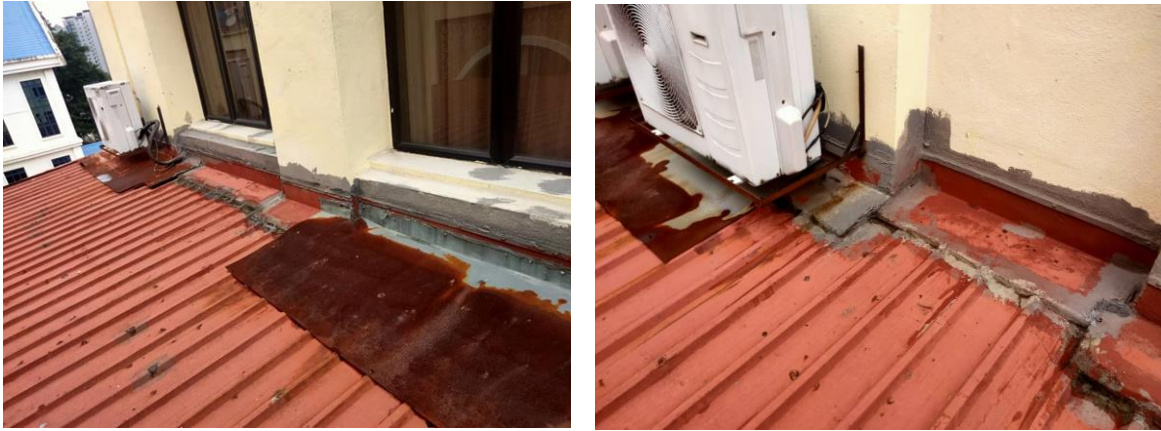
Figure 5: Flushing roof that already rusted

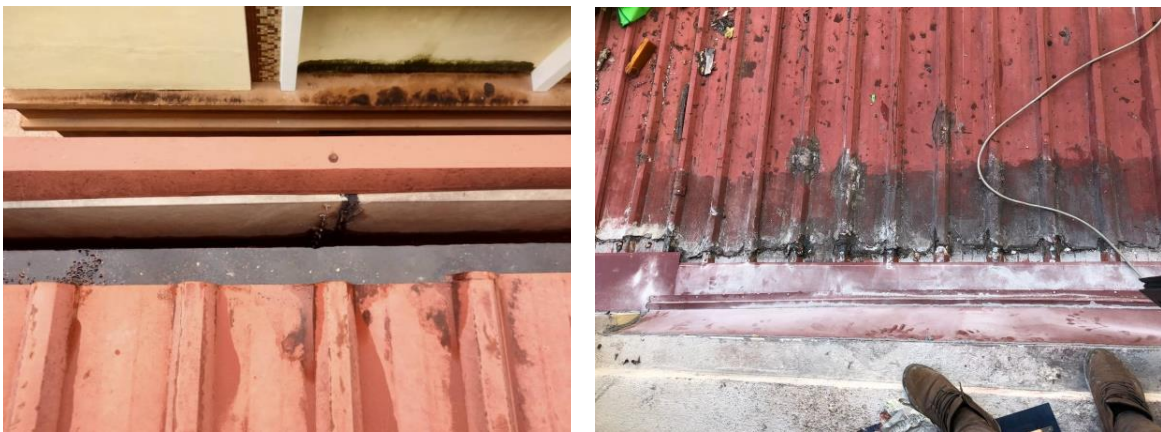
Figure 6: The gutter that full of garbage and the roof that has damaged

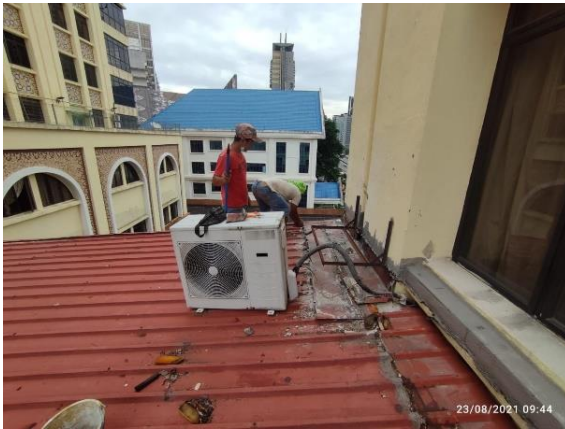
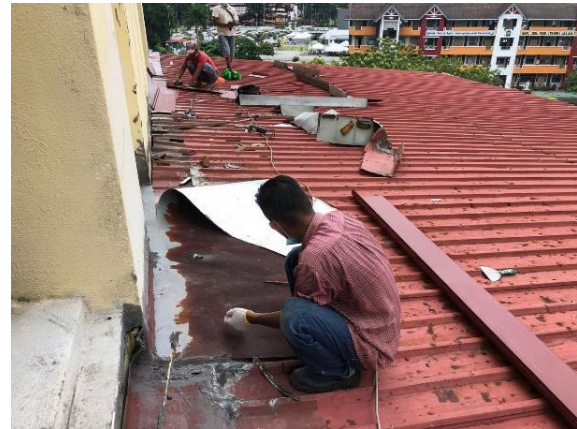
Figure 7: The workers are removing the air conditioner outdoor unit and flushing roof

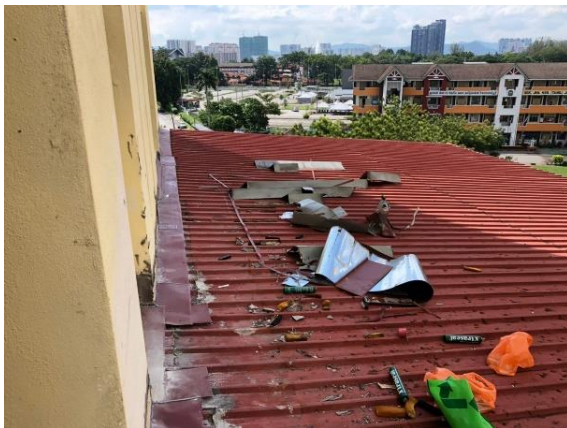
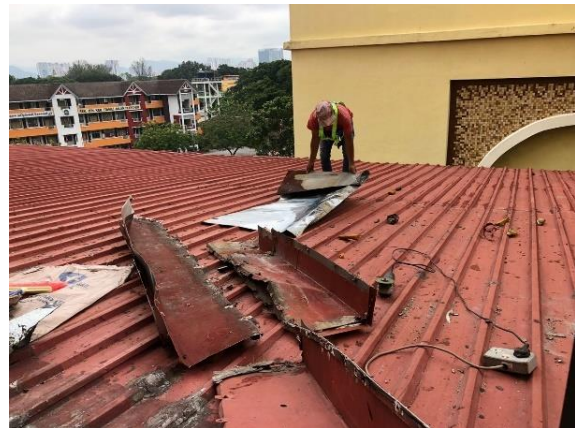
Figure 8: The flushing roof that had been removed

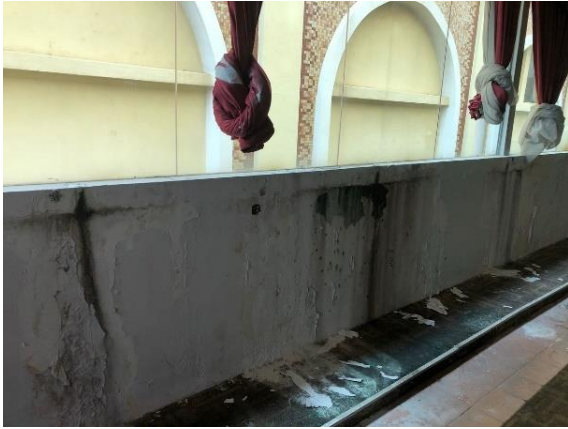
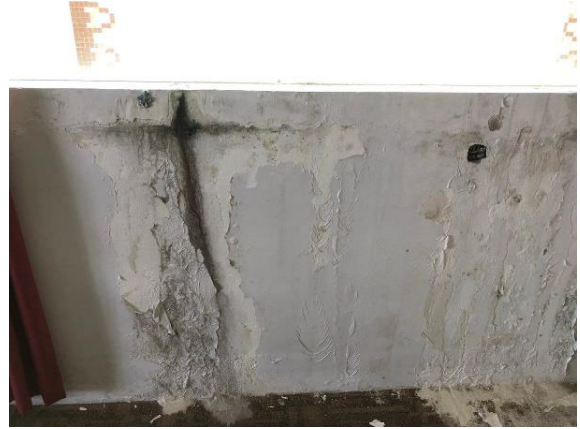
Figure 9: The wall that have damaged due to leakage

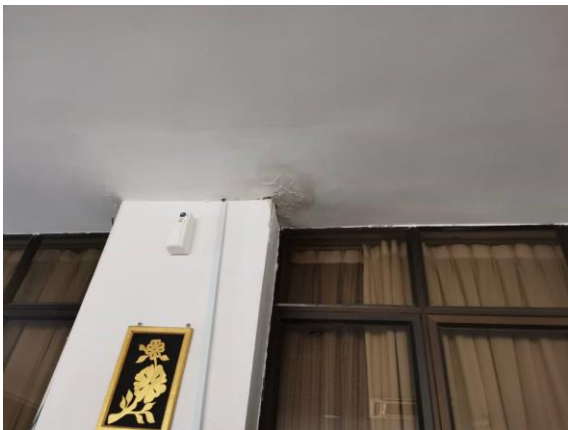
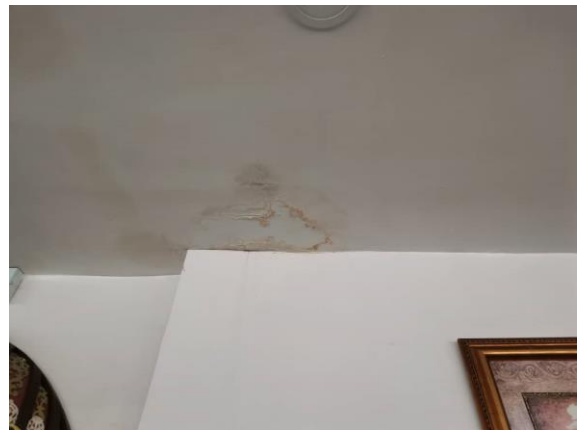
Figure 10: The damaged ceiling due to leakage

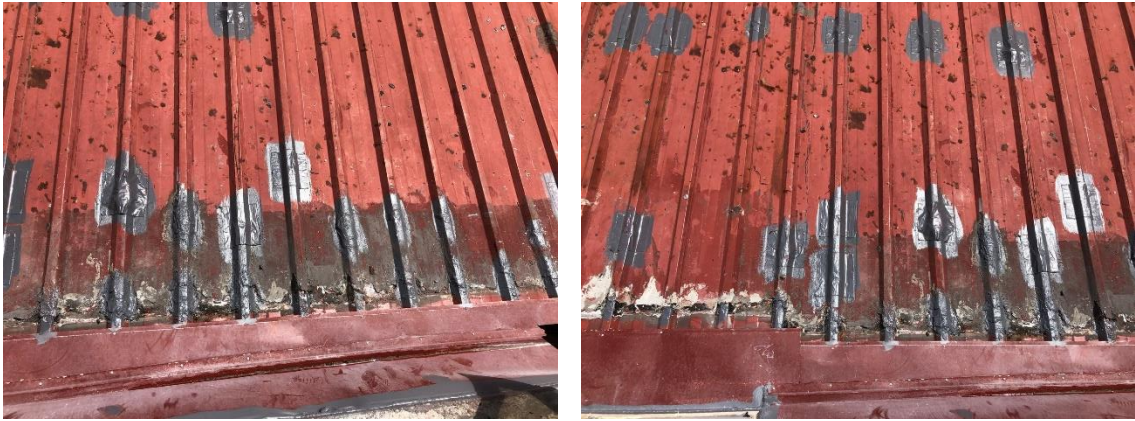
Figure 11: Damaged roof that was attached with waterproofing tape and silicone

After the site preparation is done, the process of roof maintenance is proceeded with installation work. The term "installation" refers to placing or installing equipment or materials in a permanent position, as well as making them ready to use or operate. While in general, installation is the process of placing something in a permanent, semi-permanent, or temporary location. It can also refer to a perfectly functioning system that has been installed. Next, subsequent work was continued by pasting waterproofing tape on the damaged and leaking parts of the roof. The waterproofing tape is applied to each part of the roof that are badly damaged, holed, leaking and even crack. Mostly on large crack parts. After attaching the waterproofing tape, the roofing silicone will be applied on the top surface of the waterproofing tape. Silicone is commonly used in the roofing sector since it is a dependable substance that has been proved to withstand the weather for a long time. Next, for gutters that have been cleaned, the workers will paste waterproofing tape on the inside of the gutter after placing the aluminum sheets as there are parts that have cracked and caused a leakage. Then, roofing silicone will be placed around the waterproofing tape that has been pasted on the roof for the double secured. This process is to prevent further leaks on the roof and to avoid the ceiling from being damaged. For the roof flushing part, its condition has damaged and rusted due to unexpected weather in the country such as heavy rain and sun as well as its longevity. Therefore, the flushing roof section will be replaced with a new one. The workers will install roof flushing using drills and roof screws, silicone is also been placed on the surrounding part of the roof flushing to ensure that no more leaks occur.

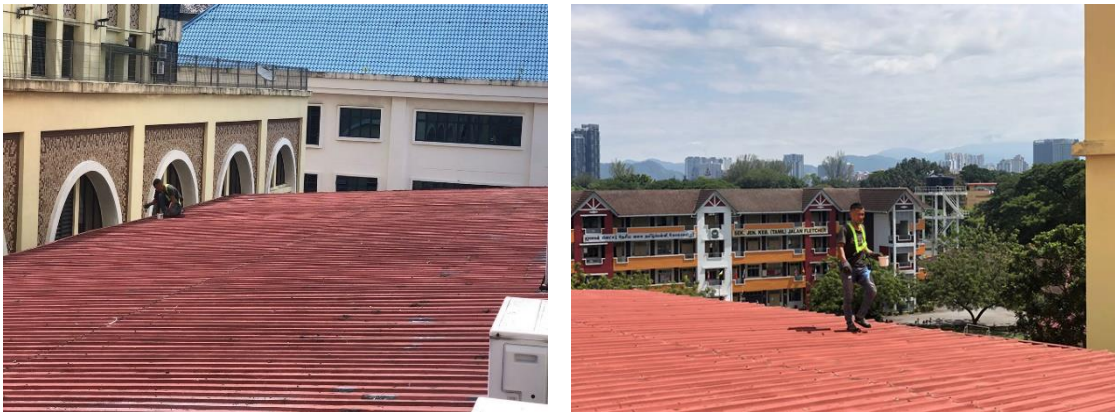
Figure 12: The workers are attaching waterproofing tape and silicone to the damaged roof

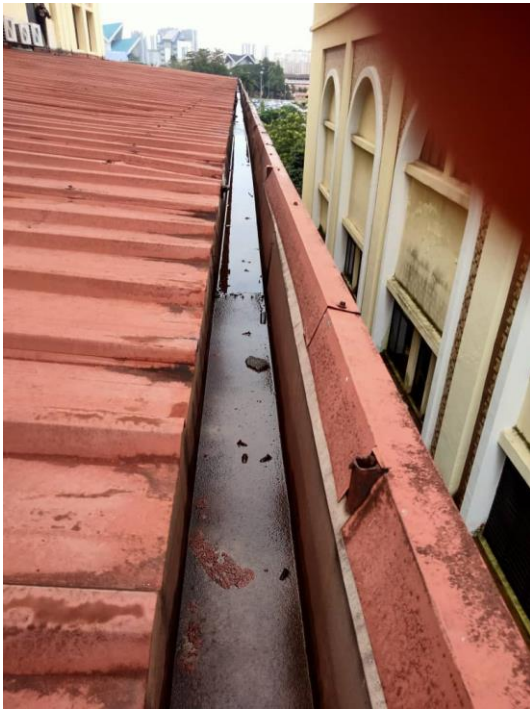
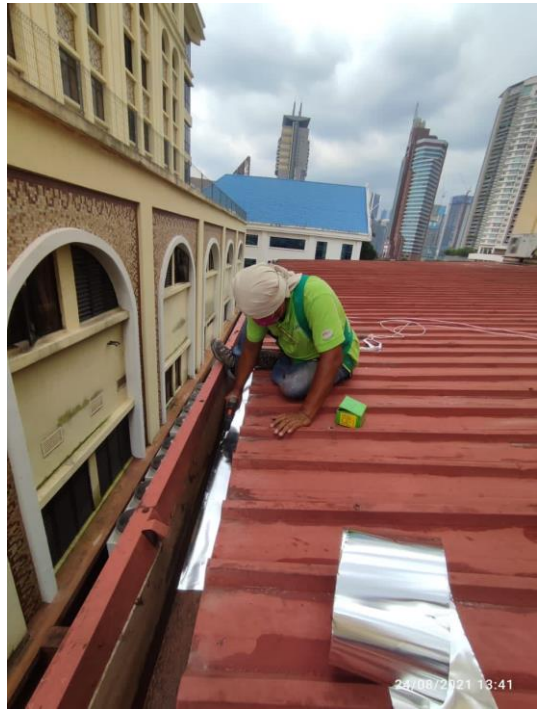
Figure 13: The gutter that has been cleaned and workers attached the waterproofing tape and silicone

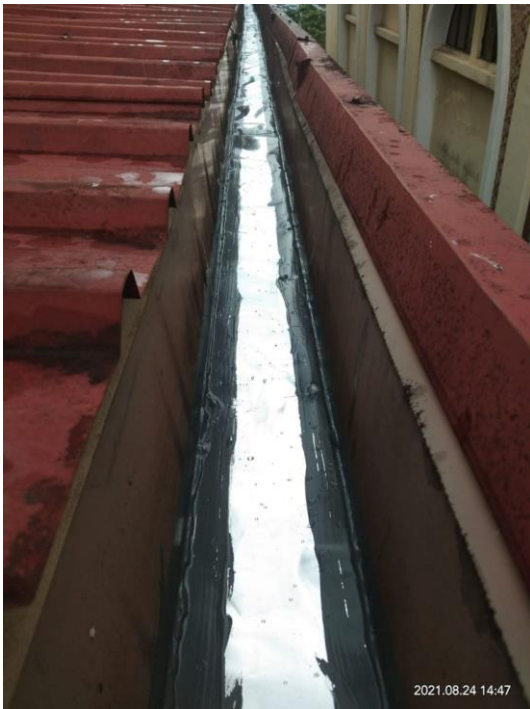
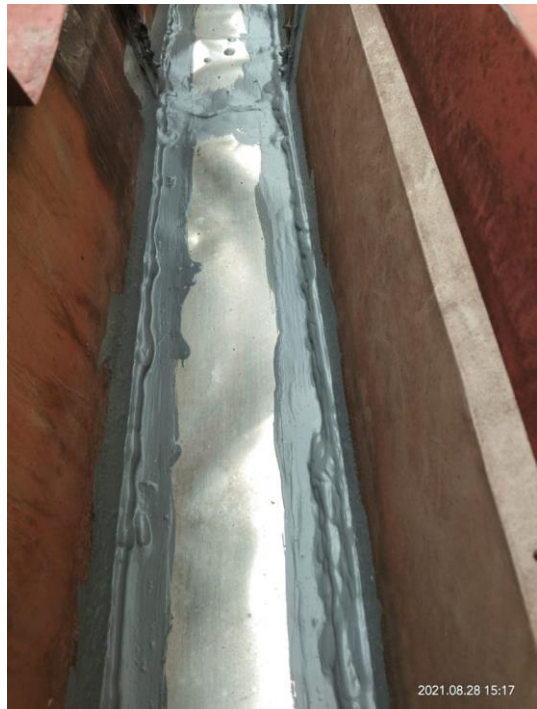
Figure 14: The gutter that has been attached with waterproofing tape and silicone

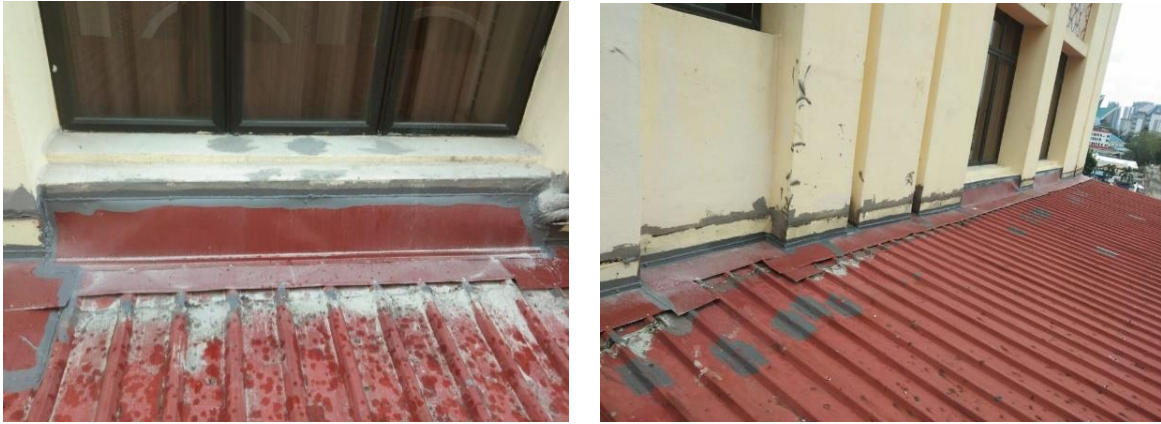
Figure 15: Flushing roof that has been installed

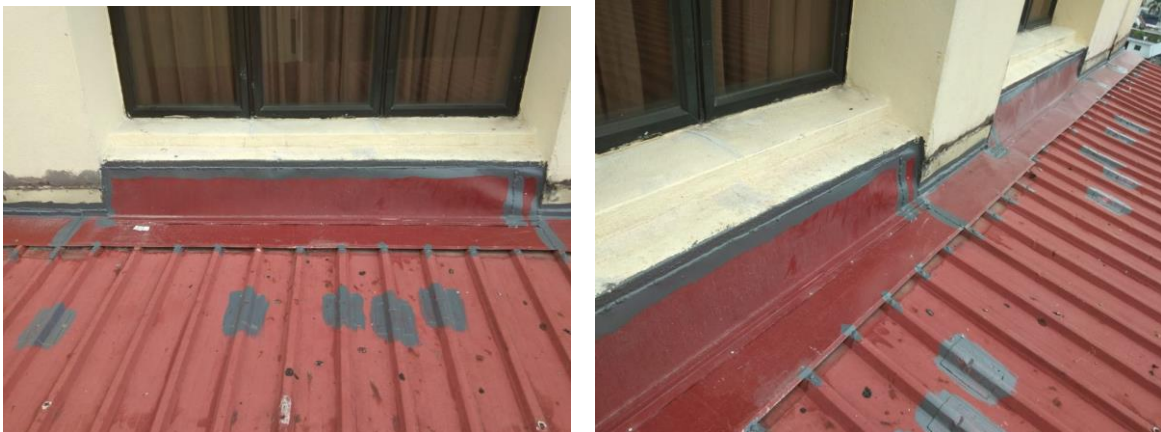
Figure 16: The flushing roof that has been installed and putted silicone to prevent leakage

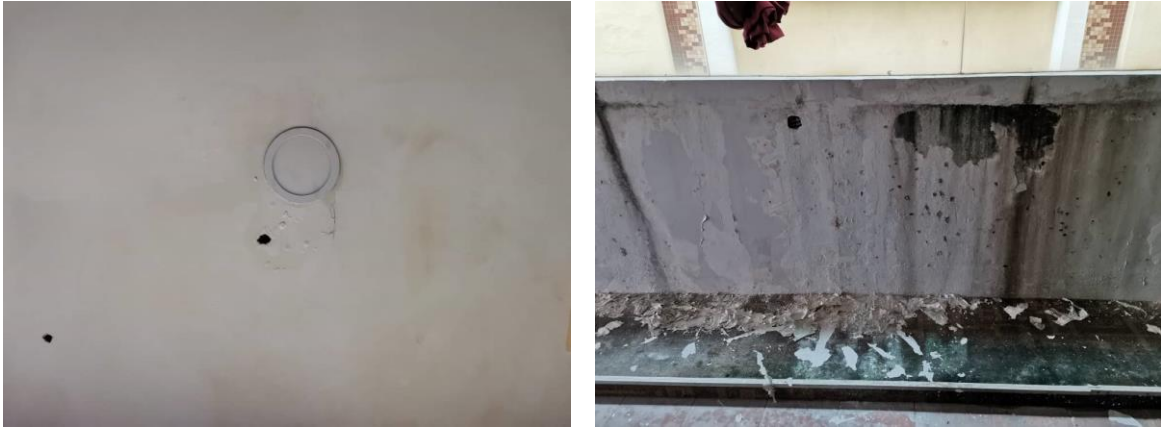
Figure 17: Damaged ceilings and walls

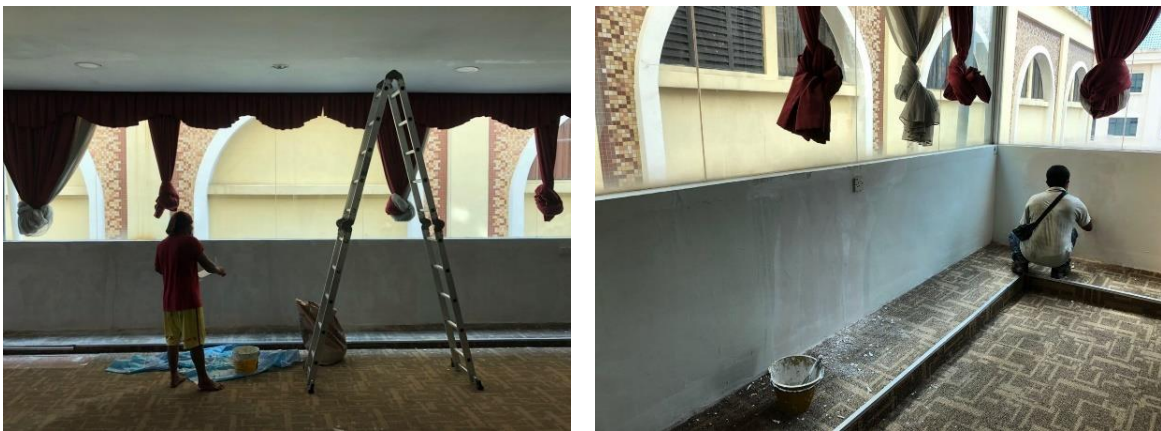
Figure 18: The work of putting sealers on the ceiling and the work of painting the walls

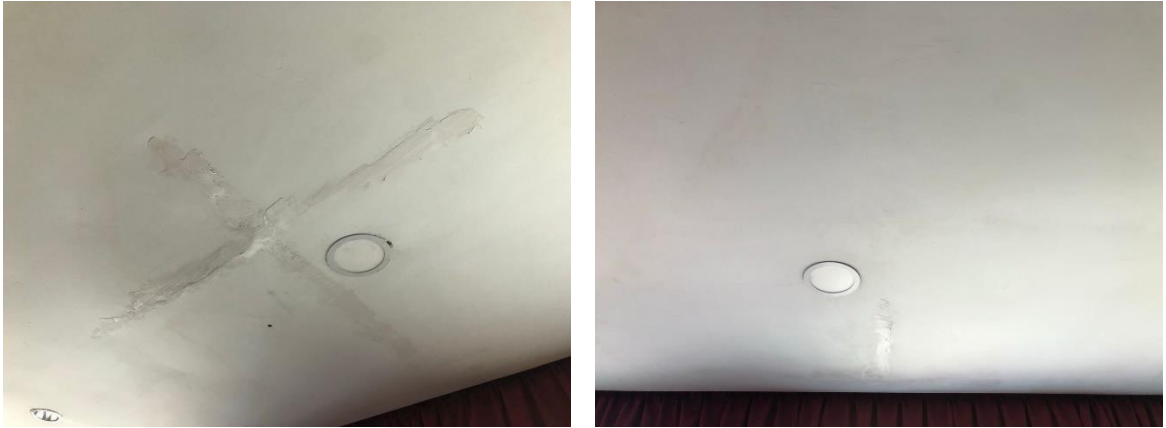
Figure 19: The ceilings that has been sealed and repainted

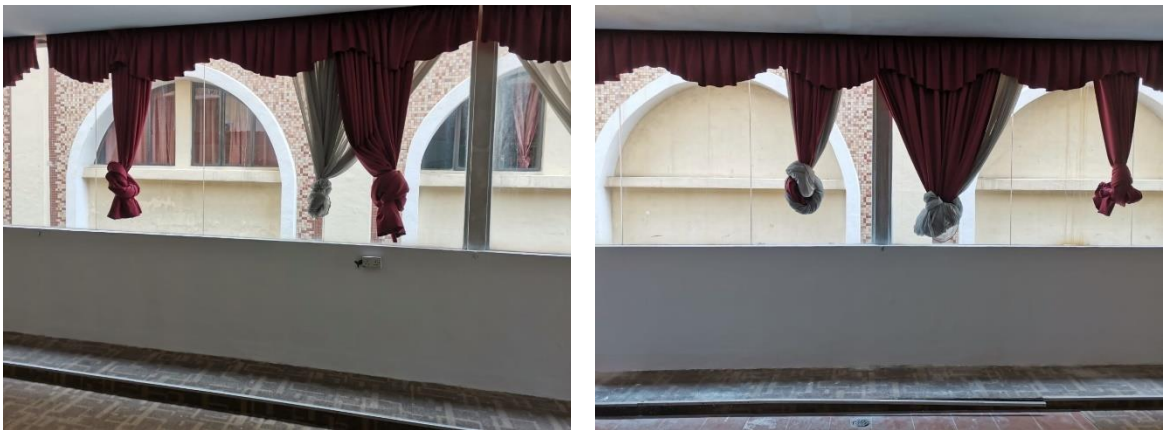
Figure 20: The walls that has been repainted

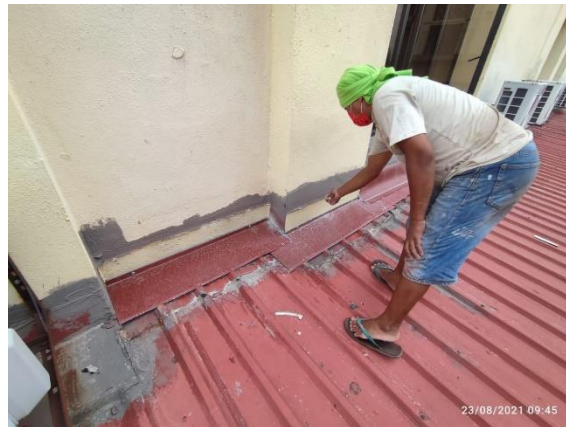
Lastly, problem that can be witness is the incorrect roof flashing installation issues. Roof flashing is important for preventing leaks in the most vulnerable areas of the roof. Flashing is commonly made of aluminum or steel, and it's positioned at the weak spots on the roof where it expands and compresses to keep water out. Roof flashing is one of the most time-consuming and labor-intensive elements of roof installation, which is unpleasant to say, but it is also one of the most rushed and disregarded. Temperature changes cause roof flashings to expand and contract even more, emphasizing the need of properly fitted flashings. Roof flashing can rust or get damaged, or the sealant can dry out and shatter, even in good installations. Regular inspections are necessary, as are quick repairs or replacements, to maintain your roof in good working order and your building safe. To fix this, site supervisor needs to hire a professional roofing contractor who is informed, skilled, licensed, and insured for roof flashing installation work. A professional can appropriately diagnose the issue of the flashing roof and work to resolve it fast. This can help the site supervisor to prepare for this work more quickly.

Figure 25: A roofing professional has completed the flashing roof installation work
