**DEPARTMENT OF BUILDING  
UNIVERSITI TEKNOLOGI MARA  
(PERAK)**

**CONSTRUCTION OF CAR PORCH STEEL STRUCTURE**

**Construction of Car Porch Steel Structure**

To investigate the construction of car porch steel structure at Surau An-Nur, Taman Daya, Johor.

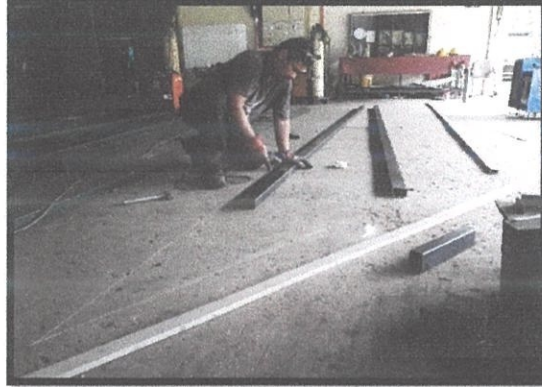
Figure 3. 2: Labor was drawing an outline on floor.

The first step before constructing the truss is to draw an outline of truss on the floor by using a chalk, tape measure and any straight light steel as a ruler. All the dimension of truss was drawn according to the dimension that was stated in Appendix A.

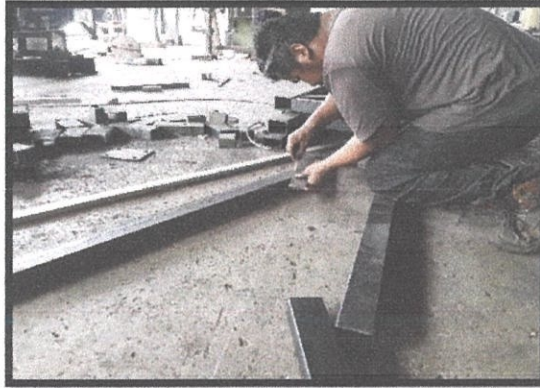
Figure 3. 3: Labor marking the excess steel.

According to appendix A, there was two size of rectangle hollow steel were used for the frame of the truss. Truss A used 100mm x 75mm x 4.5mm thick rectangle hollow steel. Both Truss B and C used 75mm x 50mm x 3.2mm thick rectangle hollow steel. The steel was lifted by using an overhead crane and lay down the steel at the layout that have been drawn. In the figure 3.3 one labor was measuring and marking the excess steel that exceeded the layout and later to be cut. The labor used a steel square and chalk to measure and mark the steel.

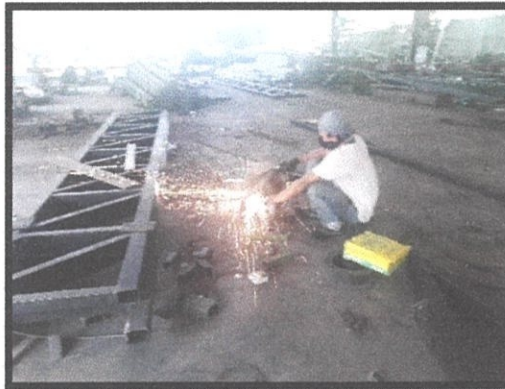
Figure 3. 4: Labor was cutting steel for frame.

In figure 3.4 one labor was cutting all the end joints that marked previously with an abrasive saw.

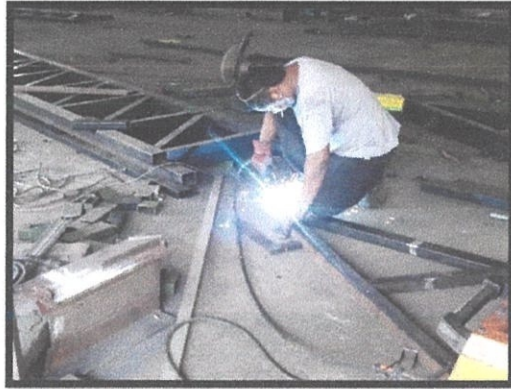
Figure 3. 5: Labor was fabricating the steel frame.

Afterwards, one semi-skilled labor fabricated the jointing of the truss by using a MIG welding machine as in figure 3.5 and can proceeding to start working on the strut and diagonal members of truss.

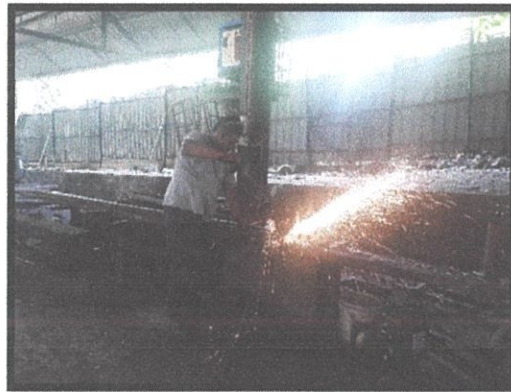
Figure 3. 6: Labor was cutting steel for strut and diagonal members.

Referring to appendix A, the size for strut and diagonal for Truss A is 65mm x 65mm x 4.5mm thick square hollow steel. Both truss B and C used the same size of 50mm x 50mm x 2.3mm thick square hollow steel. The labor has measured the length for every strut at the layout and mark the measurement on the steel. Later, one semi-skilled labor cut the steel at the mark using the abrasive cutting saw as in figure 3.6.

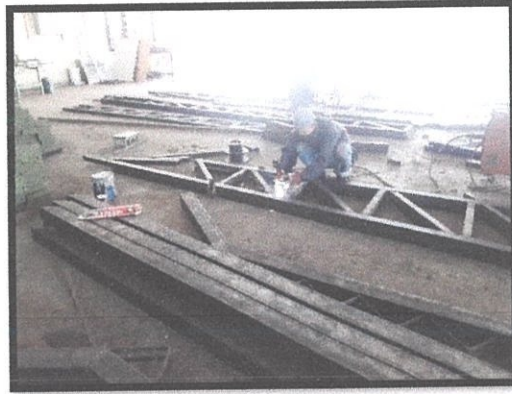
Figure 3. 7: Labor fabricating struts and diagonal to the frame of truss.

Strut and diagonal of the truss was fabricated to the frame of the truss by one semi-skilled labor with using the MIG welding machine as in figure 3.7.

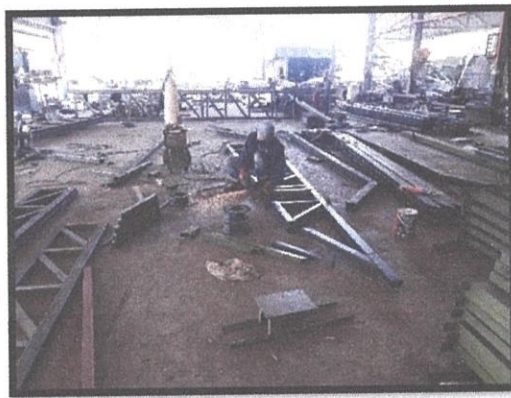
Figure 3. 8: Labor was grinding the excess material of welding.

Moreover, the joint that have been fabricated then grinded by one semi-skilled labor as in figure 3.8 to smoothen the surface of the steel like in figure 3.9.

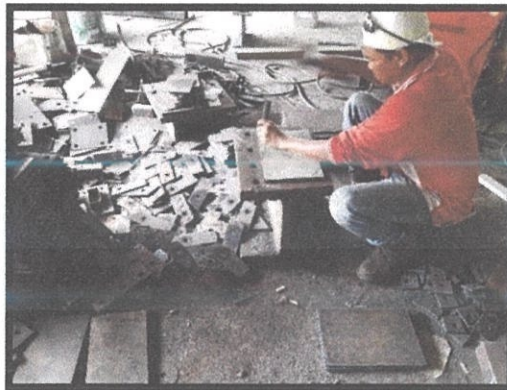
Figure 3. 10: Labor was marking the plate using a sledgehammer and a center punch.

Later another labor starts to mark the plates using a sledgehammer and a center punch as in figure 3.10 for later to punch holes on the plate.

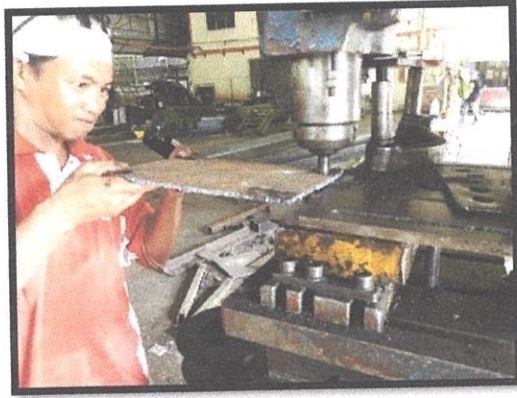
Figure 3. 11: Labor was punching a hole on the plate.

The plate later was brought to the hydraulic steel bender machine that was operated by one semi-skilled labor as figure 3.11 to pierce various size hole on the plate.

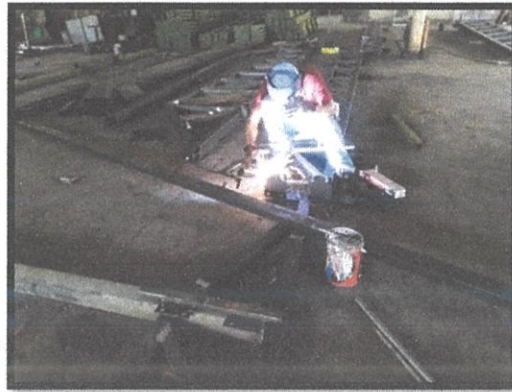
Figure 3. 13: Labor fabricating with 6mm thick fillet weld.

The plates were fabricated to the truss with 6mm thick fillet weld as in figure 3.13 by one semi-skilled labor by using the MIG welding machine.

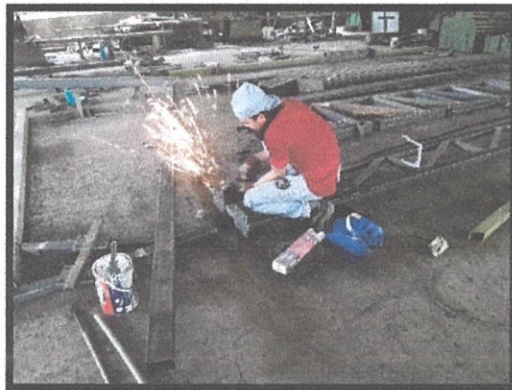
Figure 3. 14: Labor was grinding the excess material.

The area that were fabricated were later grinded and brushed off to smoothen the surface of the jointing between the plate and the truss by one semi-skilled labor.

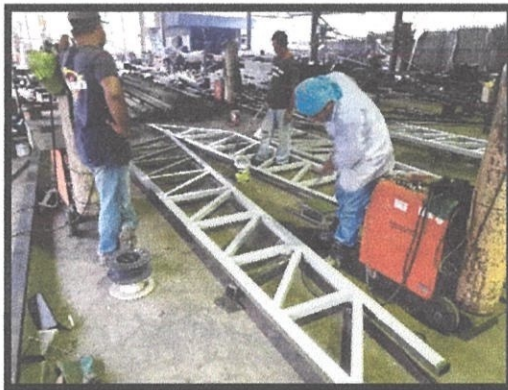
Figure 3. 16: Labors were painting undercoat and finishing paint.

After all truss have finished fabricated. The truss was painted with undercoat and one coat of enamel gloss paint by 3 unskilled labor as in figure 3.16.

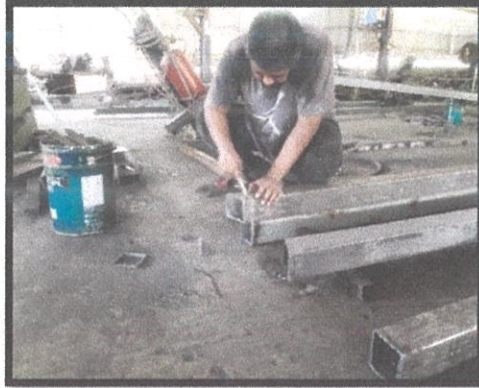
Figure 3. 18: Labor was measuring and marking the steel column.

The size for column C1 was 150mm x 150mm x 5mm thick square hollow steel and Column C2 using 100mm x 100mm x 4.5mm thick square hollow steel as referred to APPENDIX B in pad footing type F1&F2 detail. Both of the steel column was measured 2400mm length by one semi-skilled labor and mark using a chalk and steel square as in figure 3.18.

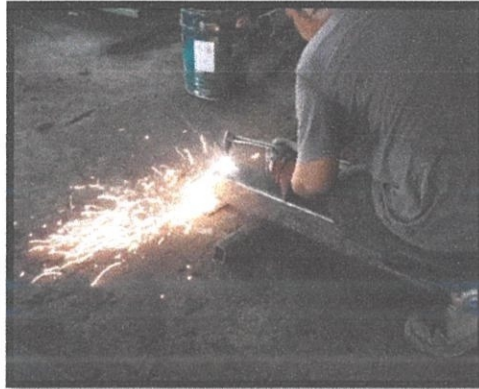
Figure 3. 19: Labor was cutting the steel column using oxy-acetylene cutting torch.

The mark then was cut using oxy-acetylene cutting torch by one semi-skilled labor like the figure 3.19.

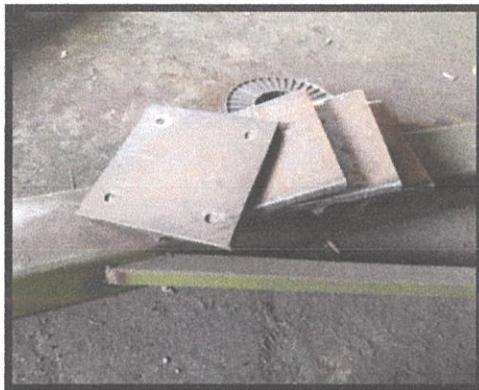
Figure 3. 20: Plates for column steel.

The 15mm thick plate were cut using oxy-acetylene cutting torch to 350mm x 350mm and 300mm x 300mm with 15mm thickness. The hole of the plate was also cut using oxy-acetylene cutting torch at the chalk mark which is 50mm cover distance.

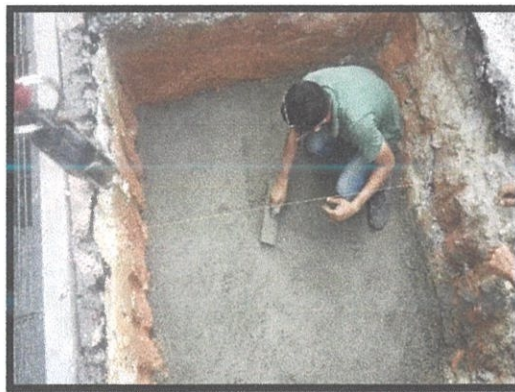
Figure 3. 22: Labor was rendering lean concrete smooth and evenly spread.

According to APPENDIX B the soil and premix were excavated 900mm x 900mm x 1000mm for pad footing type F1 and 600mm x 600mm x 1000mm for pad footing type F2 of soil and premix were excavated using a backhoe which was operated by one skilled labor. afterwards, 1:3 ratio lean concrete with 50mm thick was added and spreaded evenly using a trowel by one unskilled labor as in figure 3.22.

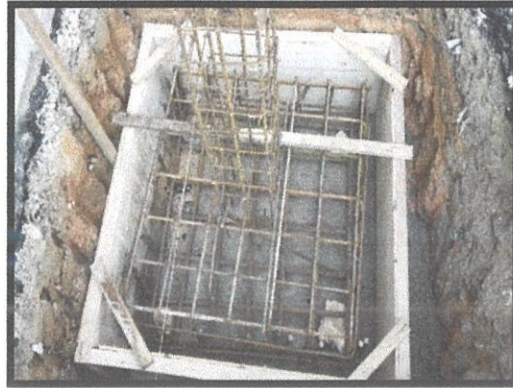
Figure 3. 23: Formwork and reinforcement bar.

Reinforcement bar consist of Y12 and Y16 for main bar and R10 for links were ready and installed in the 900mm x 900mm x 300mm size of formwork for pad foundation according to APPENDIX B pad footing F1&F2.

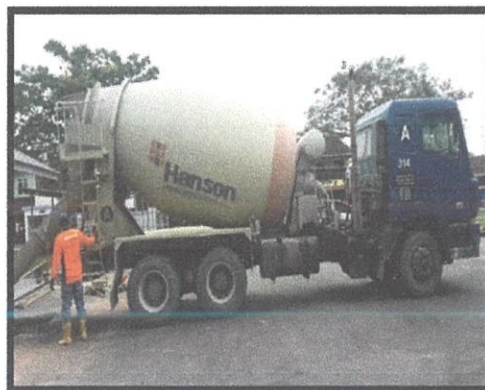
Figure 3. 24: Cement mixer truck was arrived at site.

After reinforcement bar has ready installed to six formwork of pad foundation. A total of 1m<sup>3</sup> G25 concrete were ordered to fill the formwork for pad. Cement mixer truck arrived at the site like in figure 3.24 and ready to pour in the formwork as in figure 3.25

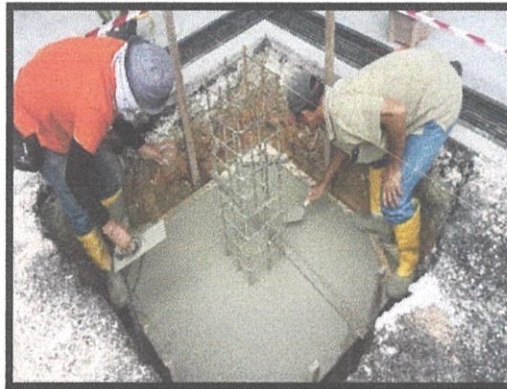
Figure 3. 26: Labors were rendering the concrete smooth.

The surface of the concrete was rendered by 2 unskilled labor with using trowels like in figure 3.26.

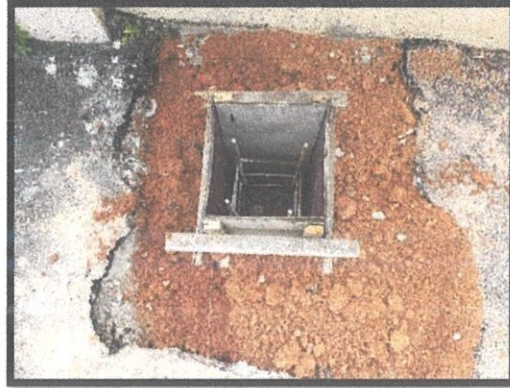
Figure 3. 27: Formwork of column stump

Formwork for column stump was installed after 3 days of concrete pad footing has cured. Then every six column stump were filled with concrete G25 with a total of 0.5m<sup>3</sup> of concrete.

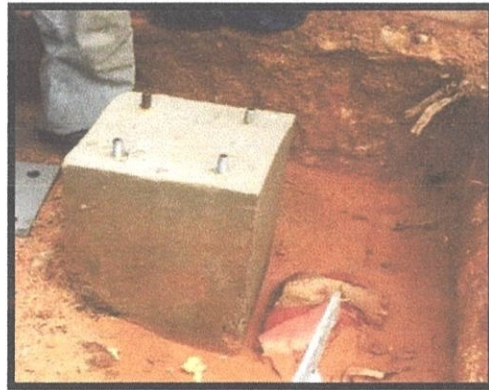
Figure 3. 28: Column stump after cured 3 days.

Formwork were removed and cured for 3 days. After 3 days, the formwork were removed by using claw hammer.

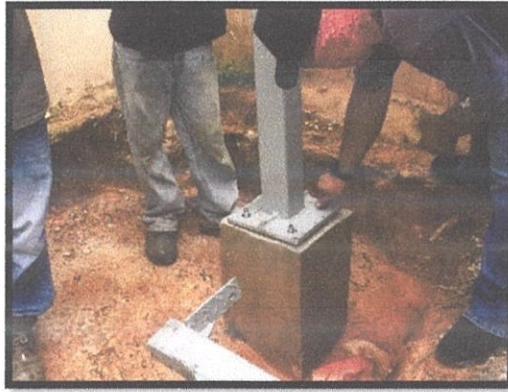
Figure 3. 29: Labors are lifting the steel column.

The steel column than lifted by 4 labor and put on the column stump like in figure 3.29. Then the labors screw the bolt and nut to the plate and tightening the screws using spanner.

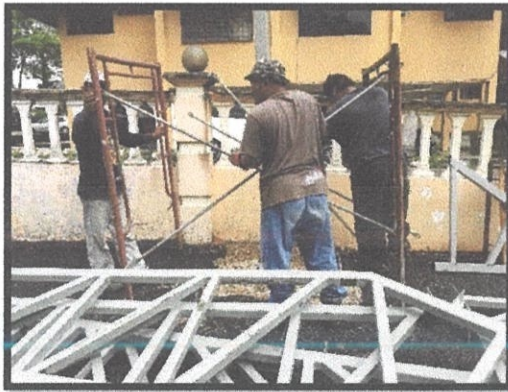
Figure 3. 30: Labor were erecting scaffolding.

2 unskilled labor were erecting scaffolding at two points of the steel column as in figure 3.30.

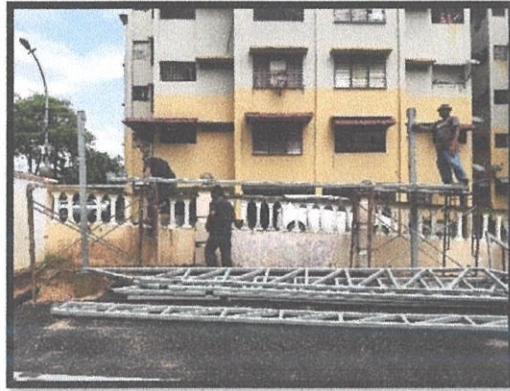
Figure 3. 31: Labors lifting truss on scaffolding.

Truss C was lifted by 4 labors onto the scaffolding as in figure 3.31.

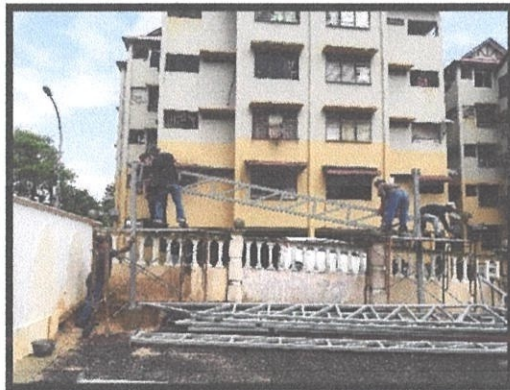
Figure 3. 32: Labor lifting truss on one side.

2 labors on one side lift the truss and the other 2 labors holding the truss to prevent from falling as in figure 3.32.

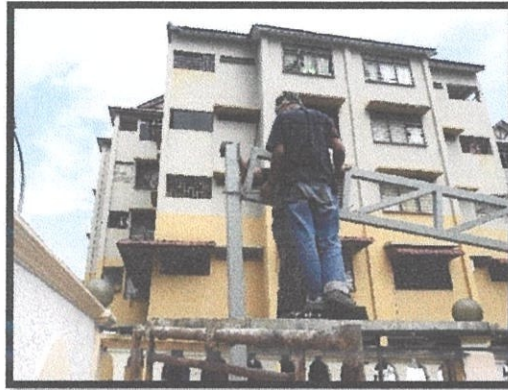
Figure 3. 33: Labor puts a round bar for temporary structure.

Slide a round bar in one of the hole in the plate for temporary support as in figure 3.32

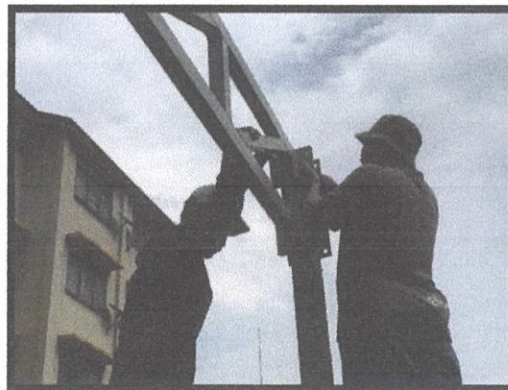
Figure 3. 34: Labors screwing bolt and nut at the plate.

Afterwards 4 M16 bolt and nut were inserted to the plates by 2 unskilled labor as in figure 3.34 and later screwed with a nut by tightening it with using a spanner.

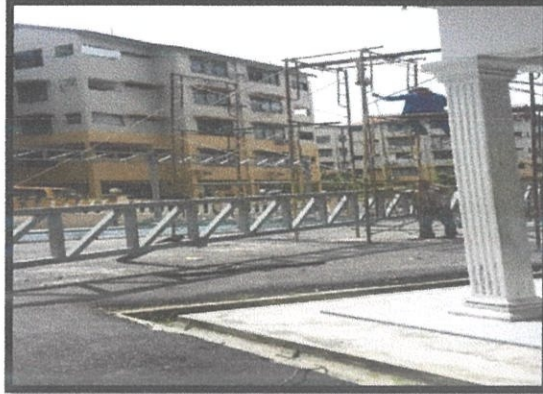
Figure 3. 35: Labor were lifting truss A using chain block.

Truss A was then hooked to 3 chain block. One at the left corner, middle and right corner. Then the truss was lifted slowly upwards and installed 10 numbers of M20 bolt and nut in the hole at the plate and screwed the nut onto the plate at the column.

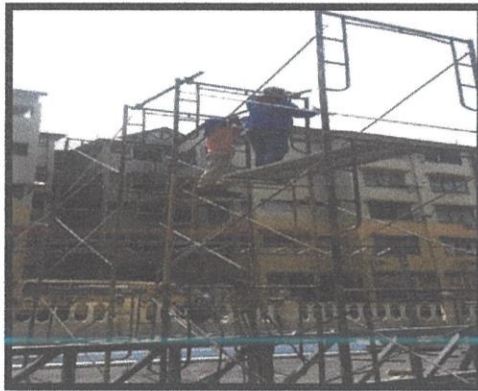
Figure 3. 36: Labor was lifting truss B using chain block.

Truss B was also lifted using chain block and repeating the same process as Truss A. then the truss B were connected to the plate using M16 bolt and nut to the plate that was welded to the truss A and C.

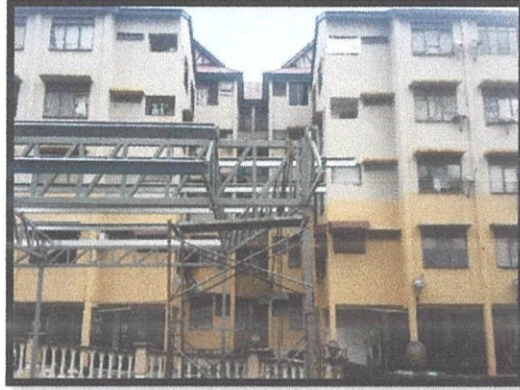
Figure 3. 37: Purlin were installed.

After truss A, B, and C were successfully installed to the column. The labors proceed to install 150mm x 6.5mm x 1.6mm thick high tensile galvanised C purlin onto the truss with 750mm centres by piercing the purlin with a drill and connected using M12 bolt and nut to the angle bar that was welded during the production of truss.

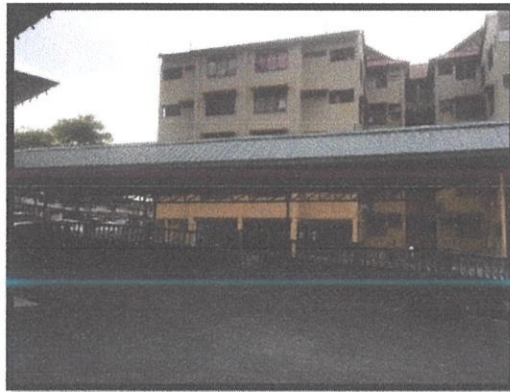
Figure 3. 38: Metal deck and gutter were installed.

0.4mm thick metal deck were installed by screwing it to the purlin. 150mm diameter PVC gutter and rain water down pipe then installed to the truss.

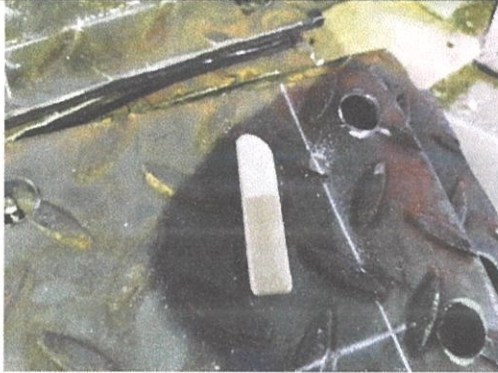
No	Name of Equipment	Diagram	Functions
1	Chalk

<ul style="list-style-type: none"><li>• To mark points that have been measured.</li></ul>
2.	Measuring Tape

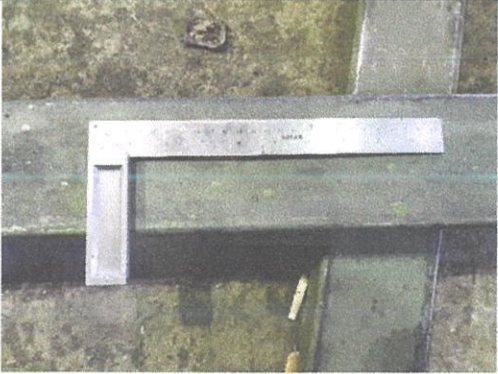
<ul style="list-style-type: none"><li>• To measure angle</li></ul>

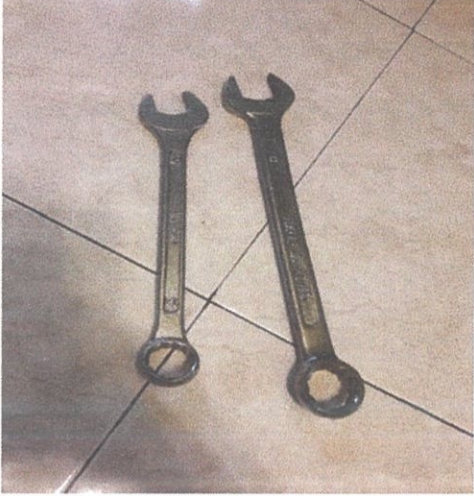
4.	Spanner size 24 and 30

<ul style="list-style-type: none"> <li>To provide grip to the nut and tightening screws.</li> </ul>
5.	Drill

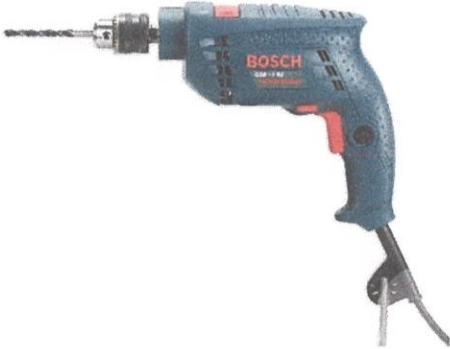
<ul style="list-style-type: none"> <li>Used to pierce holes, and screwing.</li> </ul>
5.	Abrasive Cutting Saw

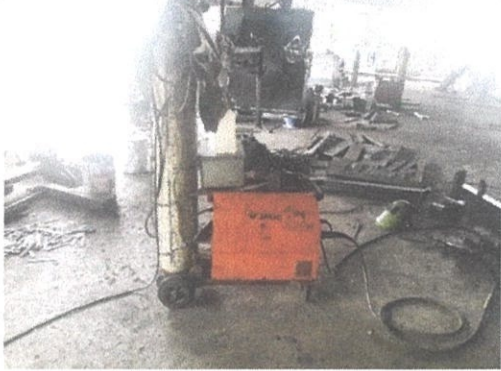
6.	MIG Welding Machine

<ul style="list-style-type: none"> <li>• To join two base materials together</li> </ul>
7.	Welding Mask

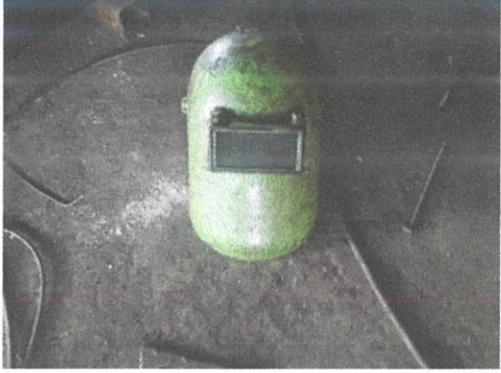
<ul style="list-style-type: none"> <li>• To protect the eye while welding.</li> </ul>
8.	Angle Grinder

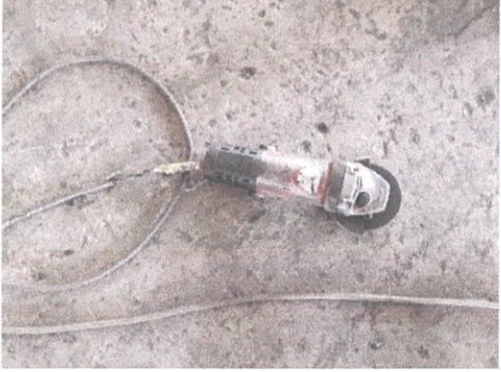
<ul style="list-style-type: none"> <li>• To remove excess welding material.</li> </ul>
9.	Wire Brush

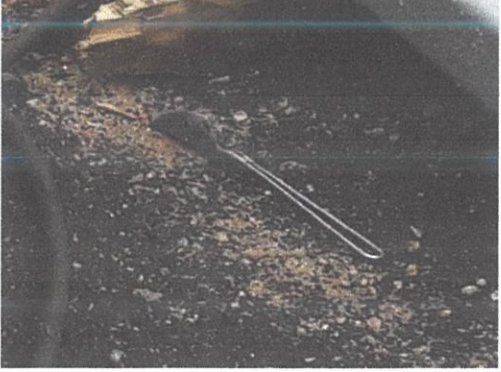
<ul style="list-style-type: none"> <li>• To clean the surface of place of welding.</li> </ul>

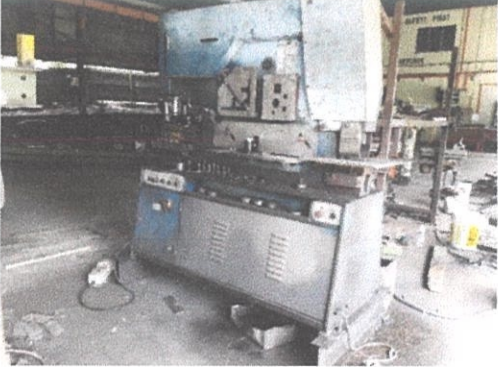
<ul style="list-style-type: none"> <li>• To punch holes on steel plates.</li> </ul>
12.	Roller Brush

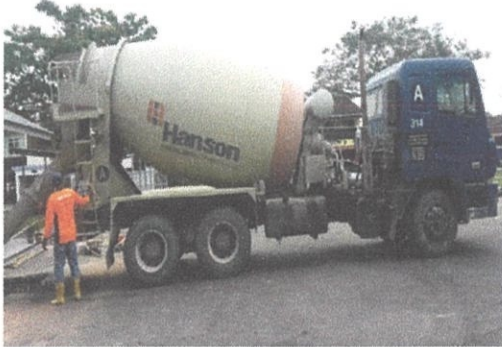
<ul style="list-style-type: none"> <li>• To mix the cement, sand and aggregates to produce concrete and to deliver to site.</li> </ul>
15.	Claw Hammer

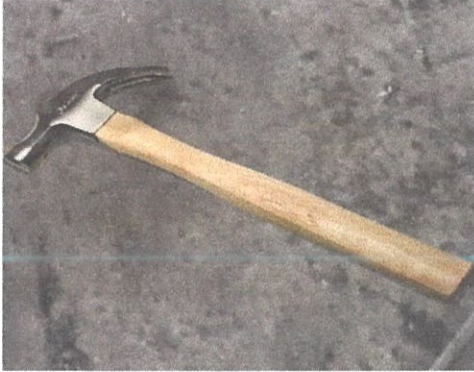
<ul style="list-style-type: none"> <li>• Used to remove the formwork at site.</li> </ul>

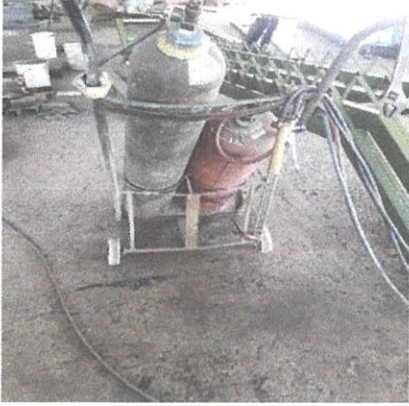
16.	Oxy-Acetylene Cutting Torch

<ul style="list-style-type: none"> <li>• Used to cut the steel hollow and plates</li> </ul>
17.	Scaffolding

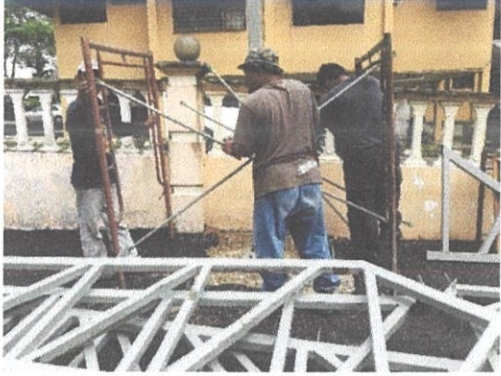
<ul style="list-style-type: none"> <li>• Used as a temporary structure to support the workers and materials on it.</li> </ul>
18.	Chain Block
