**BUILDING MAINTENANCE
PROJECT AT MENARA TABUNG HAJI, JB**

**Prepared by:
ZHIMIYA BINTI MUHAMMAD
2016458624**

CASE STUDY OF TH JOHOR BAHRU

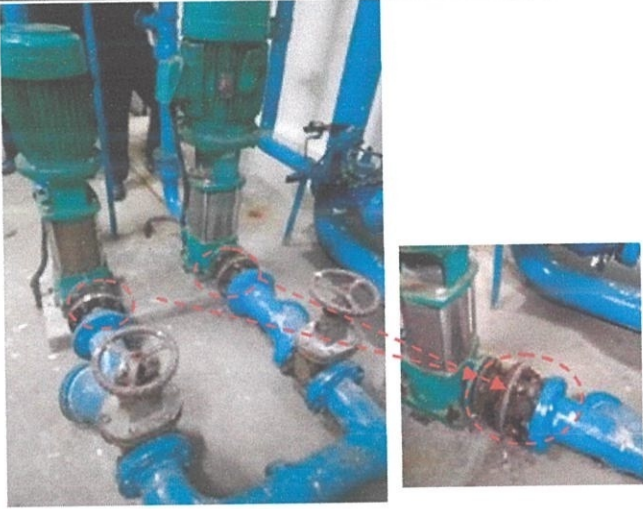
<p data-bbox="331 1102 858 1137">Photo 3. 1 Joint Pipe No.1 & No.2 rusty.</p> <p data-bbox="242 1169 896 1326">Rust happens when there is presence of oxygen and moisture, pipes are subjected causes the metal to oxidize. Rust creates friction inside the metal joints and makes it impossible to turn.</p>	Level B, ST2 Pump Booster Room

A defect is a building flaw or design mistake that reduces the value of the building, and causes an unsafe condition. Most of the common problems associated with the frequency of maintenance and wrong installation. Firstly, pipe is rusty when metals containing iron, exposed to air and water will rust. Rust affects the metals in many ways. It affects the magnetic properties of a metal. There are many rust proofing methods that can prevent the formation of rust. Example, galvanizing is the method of applying a protective layer of zinc over iron or steel to prevent rusting. The zinc forms a barrier between the atmosphere and the metal underneath it. Though galvanized metal can get corroded eventually, it can still take decades. The corrosion resistance offered by the zinc depends on the thickness of the coating and the seriousness of the environment. Accurately predicting the life time of a coating is important for planning the budget and maintenance issues.

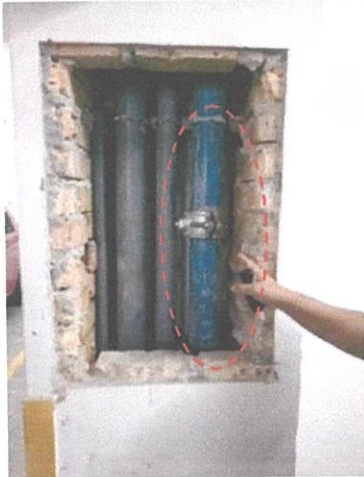
Photo 3.3. Leaking (blue) pipe

This may indicate there is a problem with the float valve in the leaking pipe. The float valve is usually a plastic ball at the end of a metal arm in the tank that's usually found in the loft. It controls the water level of the tank and will cause your overflow pipe to leak if it's faulty.

Level 1B,
Parking lot

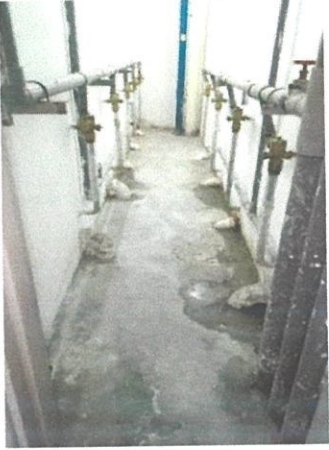
<p>4</p>	<p>Photo 3.4. Leakage on floor</p>

<p>The problem is sewer backups can be caused by individual service lines being plugged by grease, waste, tree roots, and breaks in pipes or saturated ground.</p>	<p>Level 12, Riser water pipe flow and sewage</p>
<p>5</p>	<p>Photo 3.5. Whole tile popped up</p>

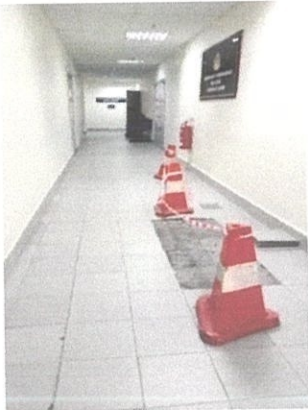
<p>Tile is a permeable material, so after some time, it can swell with high moisture absorption. Due to expansion, the pressure will cause the tile to pop up and therefore the tiles may get tent. Uneven sub floor also causes the tile to buckle.</p>	<p>Level 10, Corridor hallway</p>

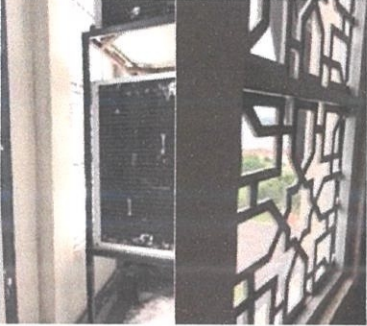
No	Damage Explanation	Location
1	<p>Photo 3.6. Room condition is hot, it caused by heat hindered by 'signage'</p>

<p>Outside unit's job is to release that heat to the air outside. Poor insulation can have a big negative impact. System is longer than it should be necessary to heat and cool them, which can be expensive in the long run.</p>	Level 17, Condenser room
2	<p>Photo 3.7. Outdoor unit is broken (AHU-M-01-CU-01 & AHU-M-01-CU-02)</p>

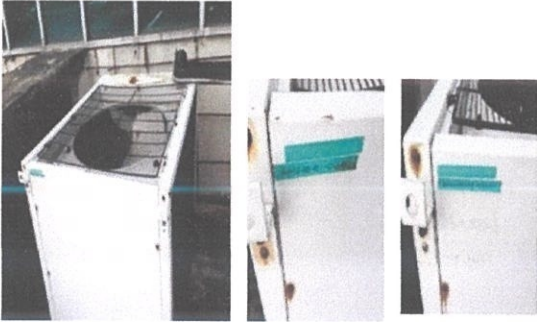
<p>Air conditioner suddenly stops working, it can be something as simple as a blown fuse or tripped circuit breaker. It is important to note that many common problems with air conditioners can be caused by inadequate maintenance.</p>	Level 18, outdoor spaces

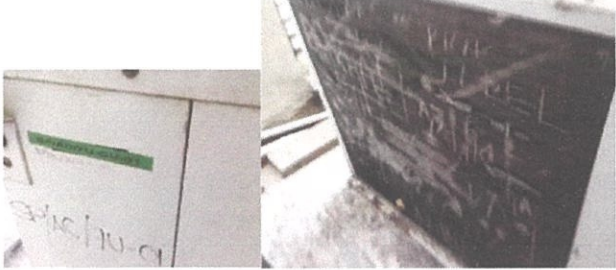
3	<p>Photo 3.8. Net damaged (SP/AC/7U-01& SP/AC/7U-02)</p>

<p>When the condenser overheats, all of the components of the AC system will begin to overheat until they eventually get hot enough to burn and emit an odor.</p>	Level 7-U, Condenser room.

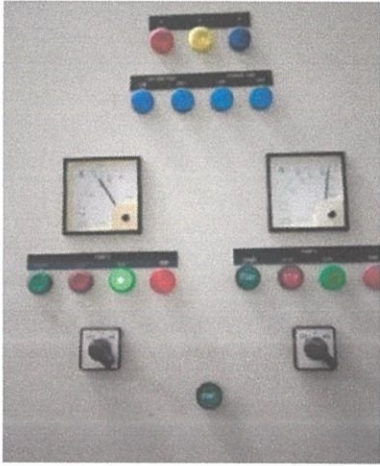
No	Damage explanation	Location
1	<p data-bbox="197 304 644 338">Photo 3.9. Ammeter display faulty</p>

<p data-bbox="201 869 919 1059">An ammeter is an instrument used for measuring electric current in units of amperes. An ammeter must be connected in series with the path of the current being measured. Faulty ammeter can be detected when the needle stops working.</p>	<p data-bbox="963 304 1123 338">Level B, St2</p> <p data-bbox="963 371 1150 450">Pump Booster Room</p>

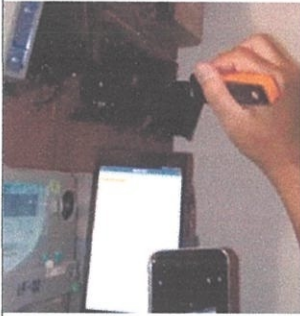
Photo Cut off fuse (Red) faulty

Level 17,
Electric Riser

Temp. reading for Cut off fuse :

Red :	134.2 °c
Yellow :	46.5 °c
Blue :	36.5 °c

Temp. reading for red phase
cable :

- Top : 74.9 °c
- Bottom : 44.1 °c

The bottom and top of cable must be at the same temperature and if it exceeds, the wire will become loose, soon it will cause faulty wire.

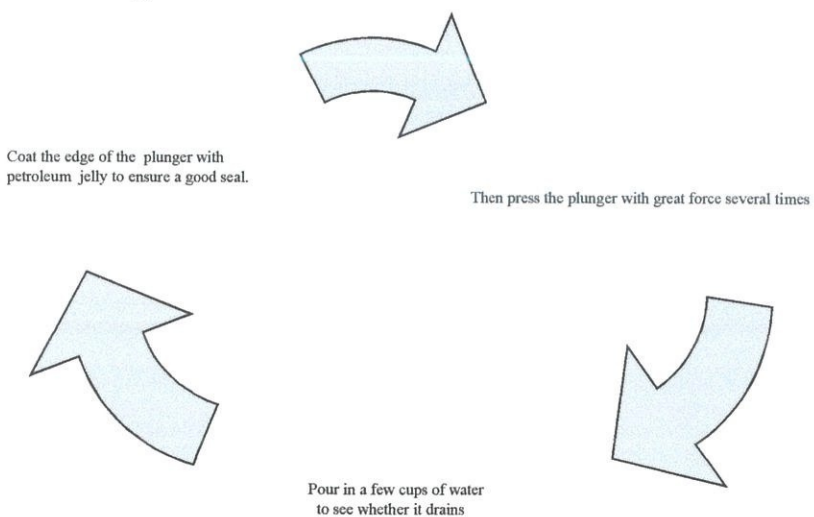
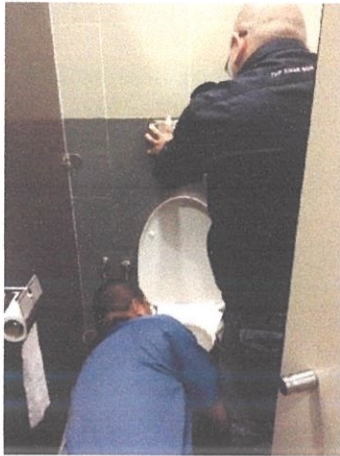
Photo 3. 2 The drainage is checked in the ladies' toilet no 2.

Moreover, a clogged drain can be a serious problem. The most obvious effect of a clogged drain is poor drainage. When drain is clogged, water will have a difficult time passing through the time, causing drainage to be slower than usual. Often times, more severe clogs will even cause water to travel back up your drain and bubble. Figure 3.2 shows the checking done after maintenance. However, a plunger is a tool that nearly every building has in advance. Photo 3.1 shows the authorities checking the drainage.

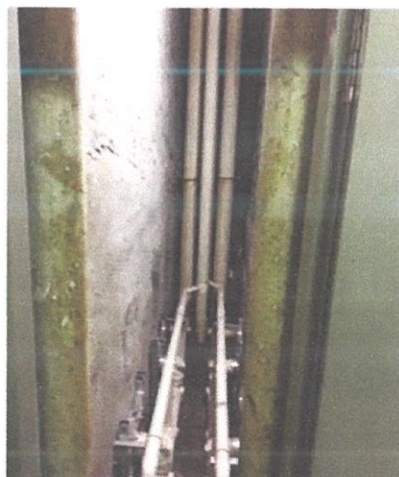
Photo 3. 3 Pipe leaking at level 3

Next, leaking pipes will cause hard times if left unnoticed. If it being kept ignored, it will keep causing more damage to building. Photo 3.2 shows the metal pipe. Leaking pipes can cause water damage to many areas. Therefore, stop the leaking by shutting off the water valve to the pipe. Then, turn on the faucets to drain the water that is left in the pipes. Continue with wiping the pipe dry with a towel or cloth and allow it to air dry completely. Then, use a putty knife to put some epoxy on the leaking area. Epoxy is created by a mixture of two, the resin and the hardener. It is various in colour. Cover the leak with rubber after. Make sure it is completely covered before tighten a clamp down on the rubber and allow it to set for an hour. Furthermore, use water resistant tape to cover the rubber after it has dried. This will serve as double protection. Lastly, turn the water valve back on and make sure there is no leak.
