**DEPARTMENT OF BUILDING  
UNIVERSITI TEKNOLOGI MARA  
(PERAK)**

**SUPERSTRUCTURES WORK OF HOUSING**

**DECEMBER 2019**

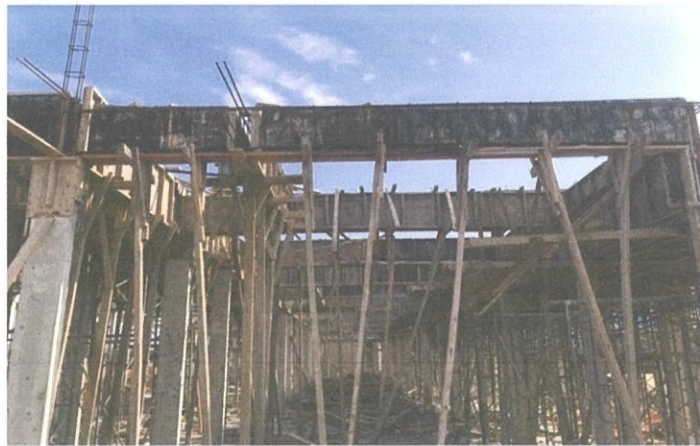
*Figure 3.2 Design of formwork*

Based on the case study at Mukim Parit Buntar, the developer has chosen a different type of design, material and sizing of each superstructure works construction since they were building a different type of building based on its need and functions. For addition information, before construction work begins, the workers are required to refer all construction drawings to ensure that all of the works comply strictly with the following acts in the contract. Figure 3.2 and Figure 3.3 below, show the design and installation of the superstructure formwork that was built by the contractor.

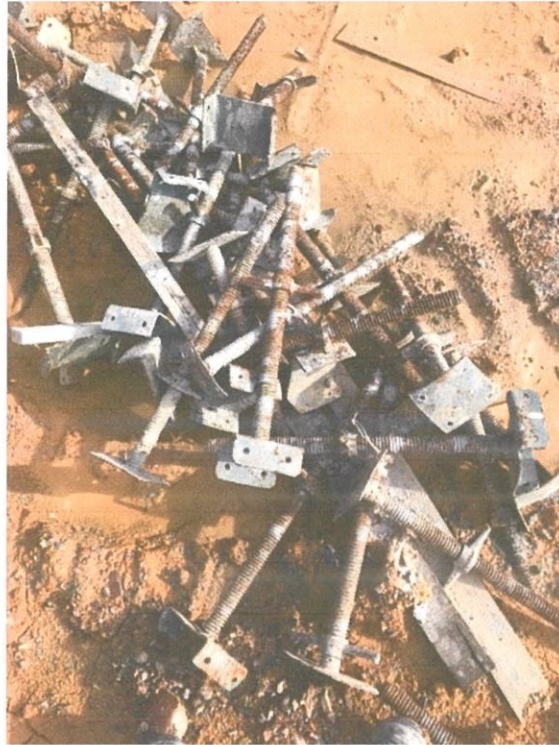
*Figure 3.4 Braced for formwork*

In this stage, the workers will ensure that the formwork are fixed in perfect lines, grades and dimensions, with no crevices at joints. Figure 3.4 above show the braced that used in the formwork installation which were to securely braced the formwork, supported and wedged so as to retain its position without displacement or deflection during the placing and compaction of concrete.

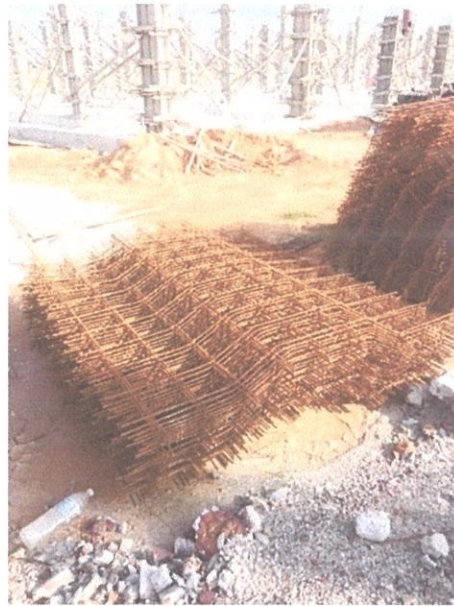
*Figure 3.5 BRC for ground slab*

Next, the reinforcement bar of each of the superstructure elements as shown in the Figure 3.5 and Figure 3.6 has been prepared by the workers according to the size and specification given in the architect requirement.

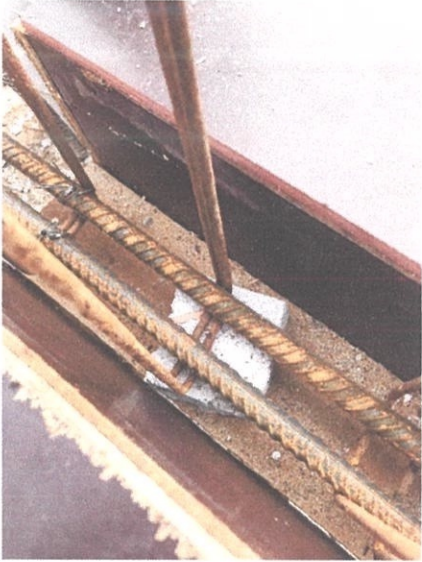
*Figure 3.7 Installation of concrete spacing blocks*

Figure 3.7 below show that the reinforcement bar was fixed accurately and securely in position. This is to ensure that the reinforcement was in the correct position in relation to the formwork to give the specified concrete cover and will not be displaced due to trafficking around site or during the placing and compaction of the concrete or any related operations. At the same time, a concrete spacing block was installed in between the reinforcement bar and formwork.

The correct cover shall be maintained by the use of plastic spacers or other approved means. Concrete spacing blocks is approved for use. Concrete spacers should be comparable with strength, durability and form to the surrounding concrete. Spacers fixed are to parallel the reinforcement bars that cannot be located in a line across a section. Timber, stone or metal spacers are not permitted. Starter bars to columns and walls must be securely fixed to the reinforcement in the parent concrete and accurately located to maintain the specified cover. Reinforcement embedded in hardened concrete shall not be bent.

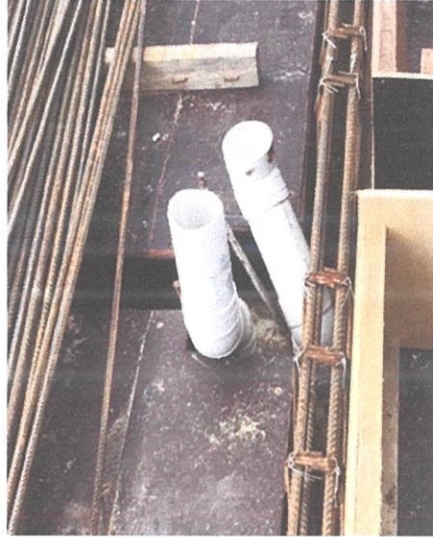
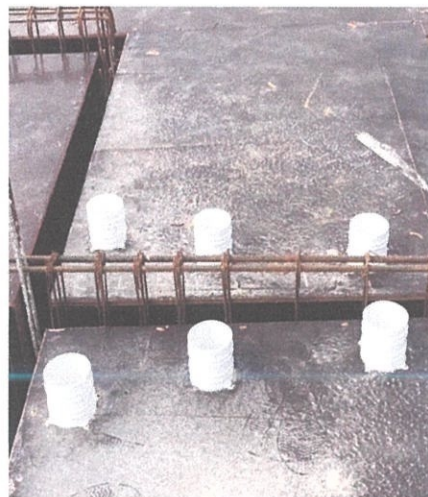
*Figure 3.9 Installation of pipework*

*Figure 3.10 Installation of pipework*

Mechanical and electrical piping was installed in this stage as shown in Figure 3.9 and Figure 3.10 which consist of electrical and alarm conduit, sanitary pipe, aircond drain pipe, rain water down pipe, and also the ventilation pipe. The position of each item was located in the correct position according to the drawing given by the architect. All pipe fittings shall be of the correct size. Changes in diameter shall be by means of reducers. Bushing down will not permitted.

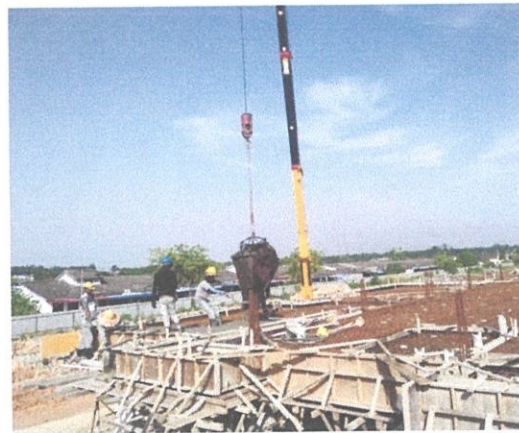
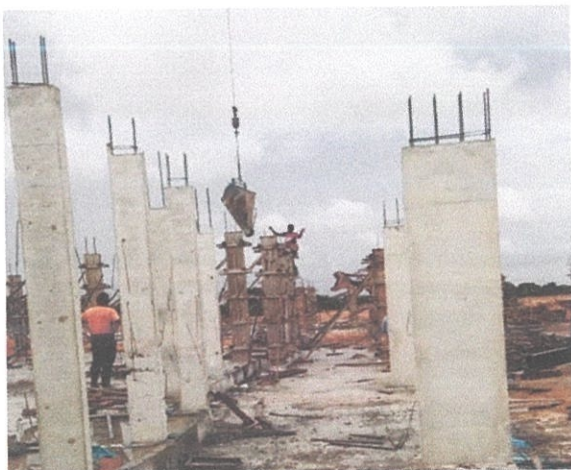
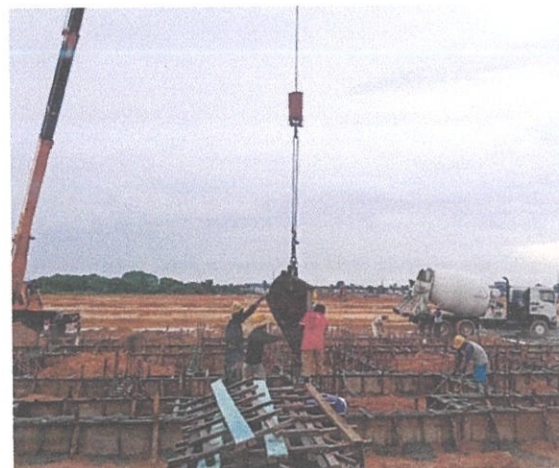
Next, the process of transported, placed, and spread of concrete to form a superstructure element are proceed as show in the Figure 3.11, Figure 3.12 and Figure 3.13 below. The process of pouring the concrete mixture are done by using a bucket that was attached with a mobile crane.

*Figure 3.11 Pouring concrete for slab*

*Figure 3.12 Pouring concrete for column*

*Figure 3.13 Pouring concrete for ground beam*

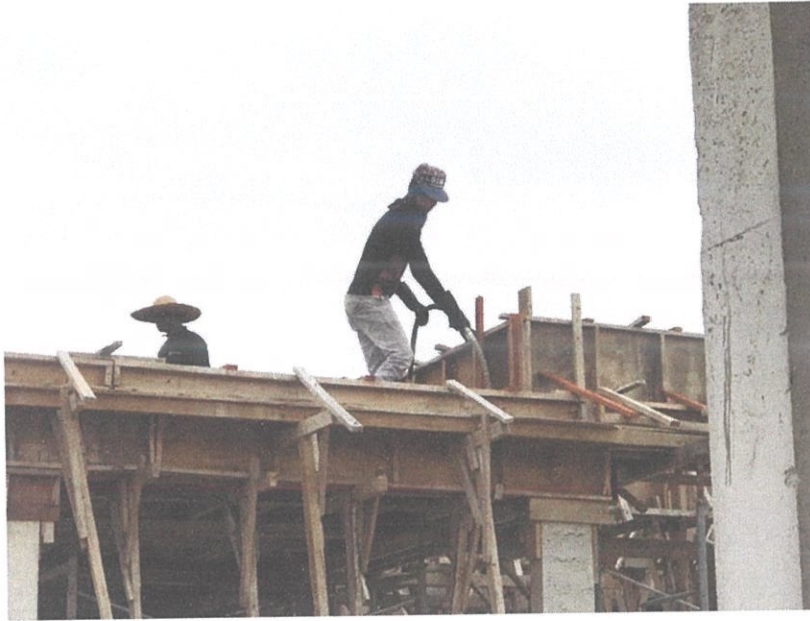
*Figure 3.14 Concreter is compacting the concrete*

should compact using the vibrators to ensure none of the problem such as honey-comb will appear in the final product. Figure 3.14 below show the concreter compacting the concrete mixer which was poured into the formwork by using a concrete vibrator.

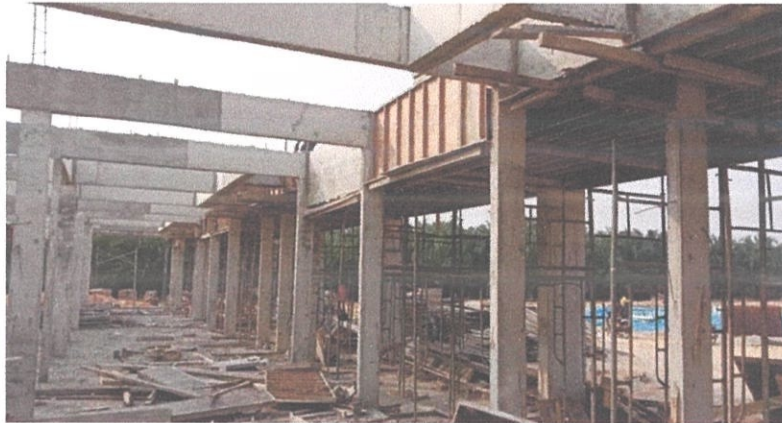
*Figure 3.15 Stripping of formwork*

Figure 3.15 above show the stripping of formwork activities. Formwork should be removed without cause any damage to or overstress in the concrete. Formwork should not be removed before the concrete has sufficiently set and hardened after 24 hours to 48 hours (as per engineer's decision)

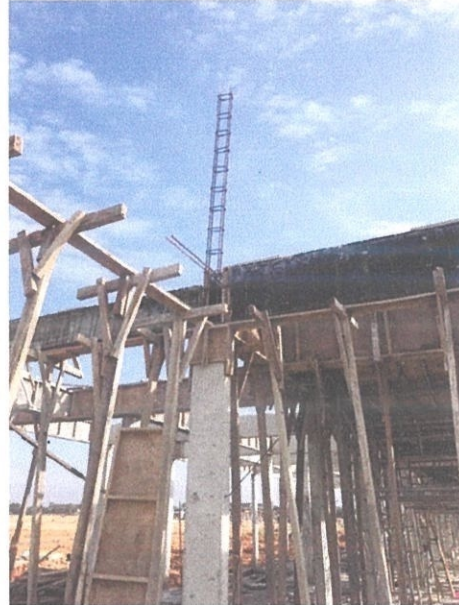
*Figure 3.18 Formwork of beam*

A beam is a structural member which spans horizontally between supports and carries loads which act at right angles to the length of the beam. The width and depth of a typical beam are “small” compared to their span. Generally, the width and depth of are less than 10 cm.

4. Make sure the reinforcement and the link are as shown in C&S Engineering drawing.
5. The formwork should be strut properly and free from gap to avoid concrete leakage during concreting work.

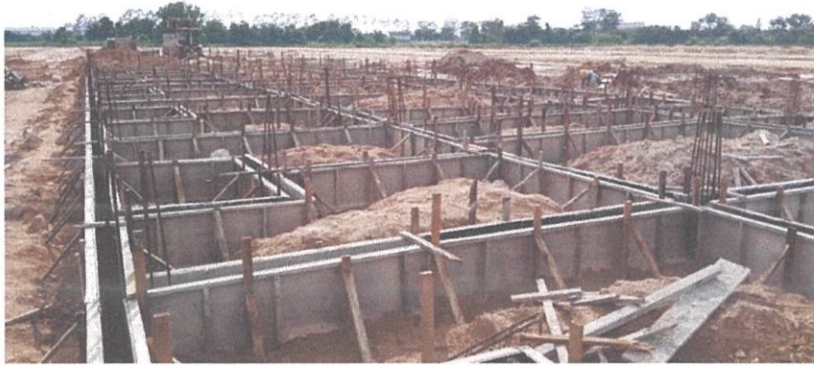
*Figure 3.19 Installation formwork of ground beam*

1. Determine the location of ground beam.
2. All formwork needs to apply with a layer of used oil plus diesel before using
3. Lean con is to be laid before installing reinforcement. Make sure column stump is free of lean con and dirt. Do sloping down where necessary.

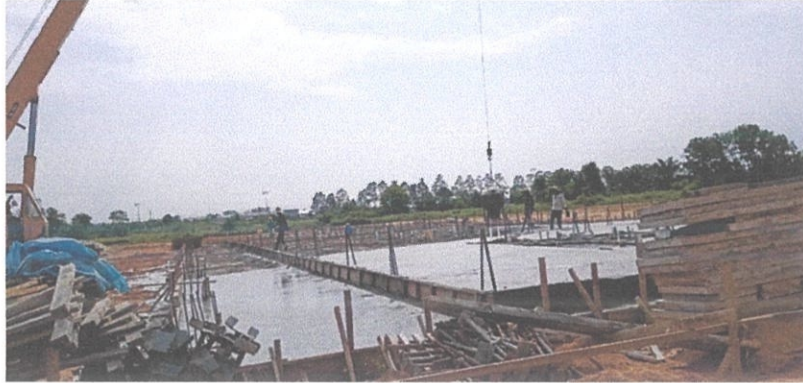
*Figure 3.21 Pouring concrete for slab*

Concrete slabs are form for roof and floors of reinforced concrete buildings. Usually, slabs will be designed to act as diaphragms to transfer horizontal loads to the structural frame. Slabs are often reinforced with welded wire fabric, but can also bond directly to a steel deck. The deck is supported by joists, which may be open web steel joists or concrete.

5. Toilet and gutter area NOT ALLOW using spaces Block. Must use steel bar chair to prevent leakage.
6. The formwork for slab should be strong enough and can support the concrete load. Check all prop and scaffolding bracing properly install.
7. Never miss out all coping for architectural design to avoid TO. Determine location of stiffeners (if additional is required).
8. Formwork for toilet and drops area, size must be slightly bigger from architectural dimension.

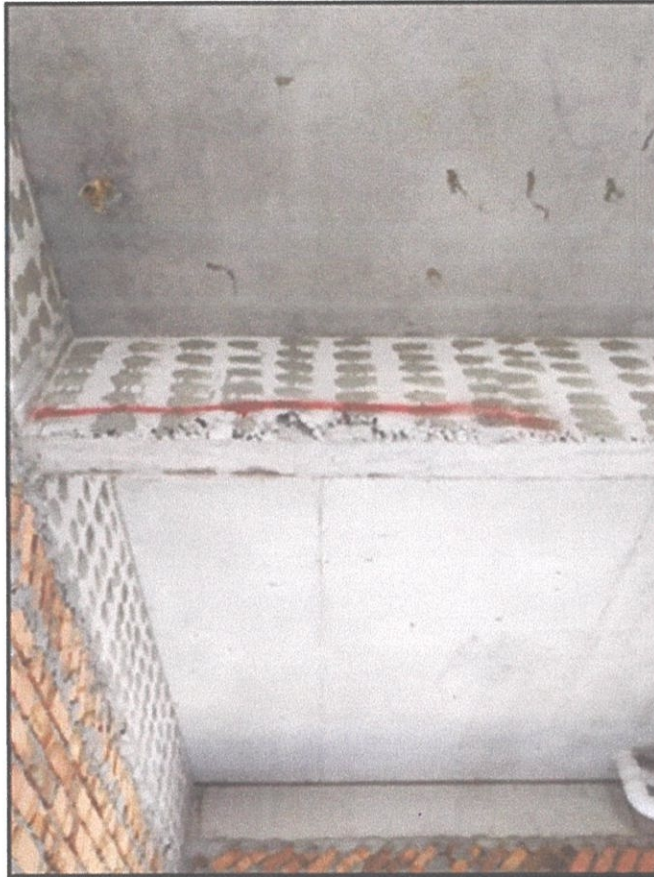
*Figure 3.22 Honeycomb defect*

Honeycombing is usually found in vertical rather than in horizontal surfaces and can occasionally extend completely through. Honeycomb happened because of bleed water carrying fine aggregates to the surface or the concrete not compacted properly while casting.

- Using mortar paste to fill in honeycomb.
- Make sure the concrete compact the concrete using vibrator sufficiently.

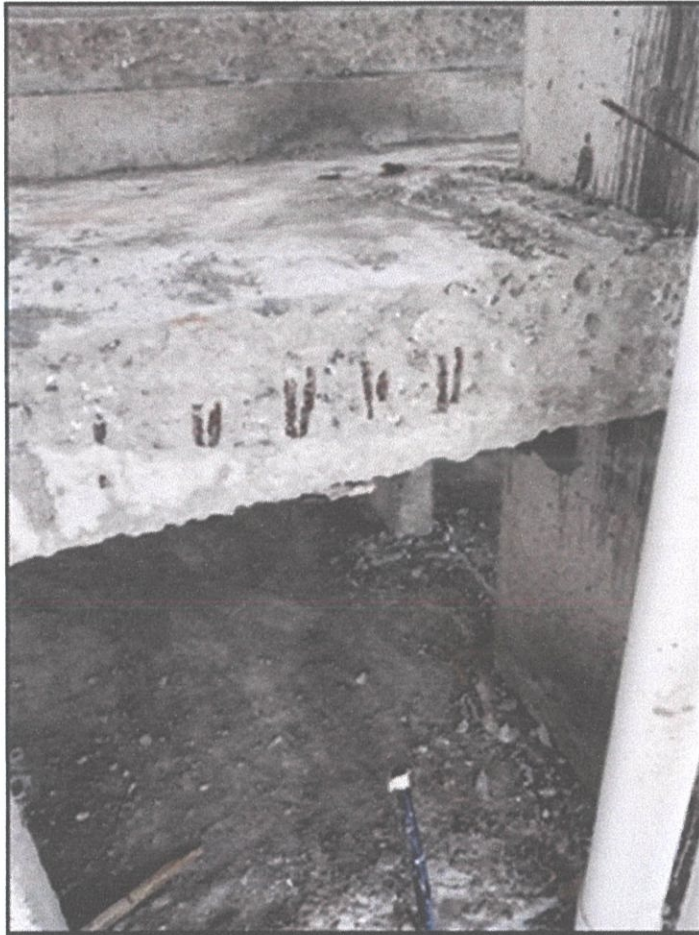
*Figure 3.23 Steel bar visible out from structure*

Steel bars coming out from structure may affect the strength of structure. This defect happened because the bar bender not using the spacing.

- Paste the cement to cover the steel
- Make sure the barbender use the spacing block to make a gap between formwork.
