THE DEFECTS IN HOUSING PROJECT

The study was carried out at Taman Salman Al Farisi which is located at Kampung Batu Mengkebang, Kuala Krai, Kelantan. In Figure 3.1 below shows the area of the defect studies being conducted. The total unit's houses there are 78 units consist 69 single and 9 double storey terrace houses. The size of the project is a large scale. This site commencement at the end of 2017 and the site certificate of completion and compliance (CCC) had just been release on October 10, 2019.

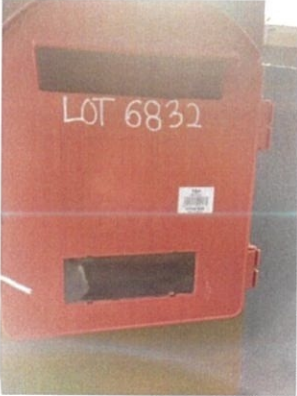
Procedure	Picture
1) Firstly, the house number lot was jotted down on the housing defects complain form before undergoing an inspection. This is to make sure that the house are correctly in order to be checked and also not to be blend by others house defects.

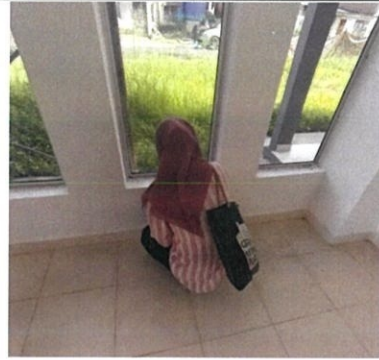
2) Then, a meticulous tour around the house was been taken to spot the damaged area. Once, the defects being found, a masking tape was taped beside it with a marked sign

about the problem such as leaking, cracking and others. This to make sure that the workers who had being doing rectification work can easily spot the problematic areas.

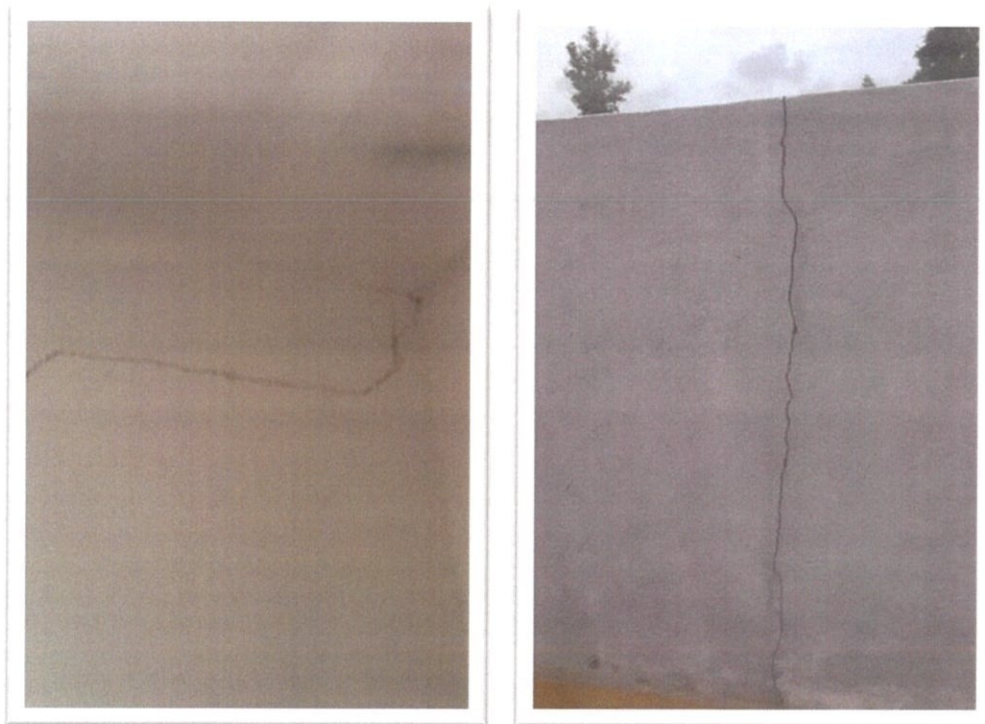
Figure 3.2 The example of cracking that can be found at Taman Salman

One of the cracking problems occur at the wall is cracking of compound wall shown in figure 3.2. This happened because of the upward thrust on portion of the building where the new lumber contains a high level of moisture and it tends to move slightly as it dries out, so small wall cracks are common in newly built homes. It is a good idea to wait a year after the house was completed before repairing any cracks. This gives the wood time to dry completely.

3.4.1 CRACKING ON THE WALL

When the temperature gets warmer, the homes structural materials expand, and when the temperature drops, they shrink. Because of this movement, cracks may begin to form on the walls.

Settlement occurs when unstable soil causes the home above it to sink, or settle. This downward movement can cause cracks to form in walls, especially near the ceiling and above door frames.

During installation, the seams between drywall sheets must be properly taped, smoothed, and sealed. If not, cracks in the drywall will likely form.

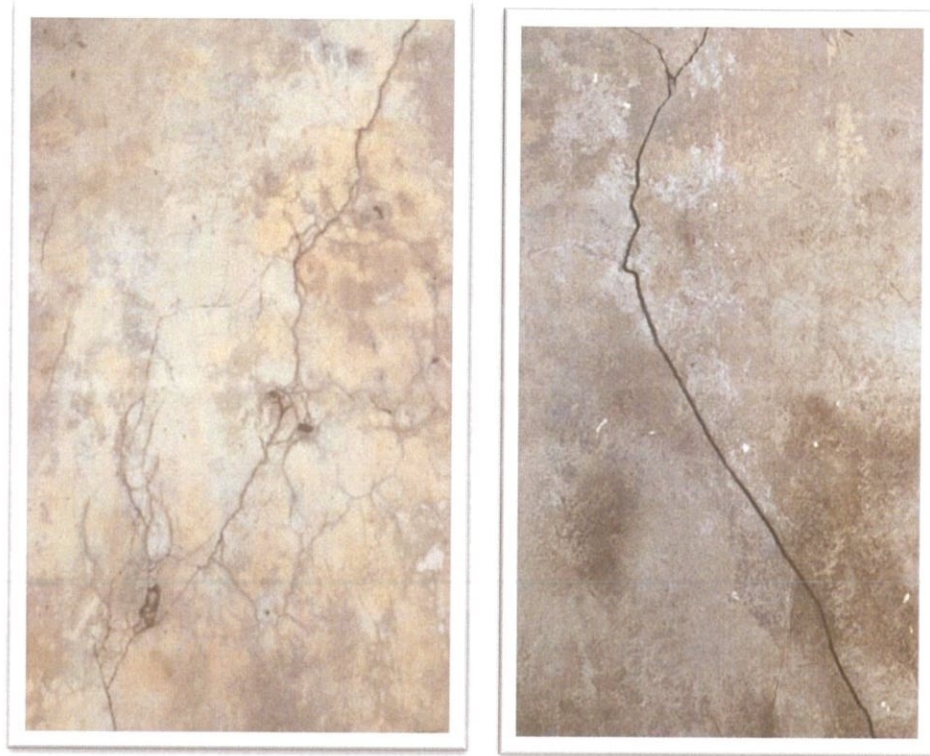
Figure 3.3 The form of cracking on the floor at the house porch

Besides, other cracking problem is settlement cracks in a slab are as shown in figure 3.3, which indicate inadequate site preparation where the compact fill on the poured concrete slab was failed. This also involves tensile stresses being loaded onto the concrete make the cracks occur when the force exceeds its maximum tensile strength. If steel reinforcing bars are close to the surface and insufficiently covered with concrete, the concrete bends back around the restraint and cracks at the apex. Deeper sections of concrete lead to greater separation between the sediment and the water, so it is important to ensure that it cover all superficial restraints adequately to reduce the amount of cracking.

In the terms of cutting the cost and saving times, the developers just used the cement, water and sand mix and spur it at the porch slab without any installation of BRC first. RM's (BRC) wire mesh is machine-made, with joints at the intersections of the main and cross wires made by special electrical resistance welding processes. This is to provide shear resistance at the joints complying with the MS 145:2006 standard. So, this had been the results of the existed cracking in the slab.

Concrete for residential floors tend to own excess water as a result of this makes the concrete easier to install. The problem is that it greatly reduces the concrete's strength, creating it at risk of cracking. With an awfully wet combine, the concrete can shrink because the excess water evaporates the wetter or soupier the mix the greater the shrinkage are going to be inflicting cracking. A concrete slab will shrink by the maximum amount as 1/2 inch per each 100 feet. This shrinkage impact causes forces within the concrete that may virtually pull the slab apart. Cracks are simply the tip result of these forces. So it needs to be concerned for.

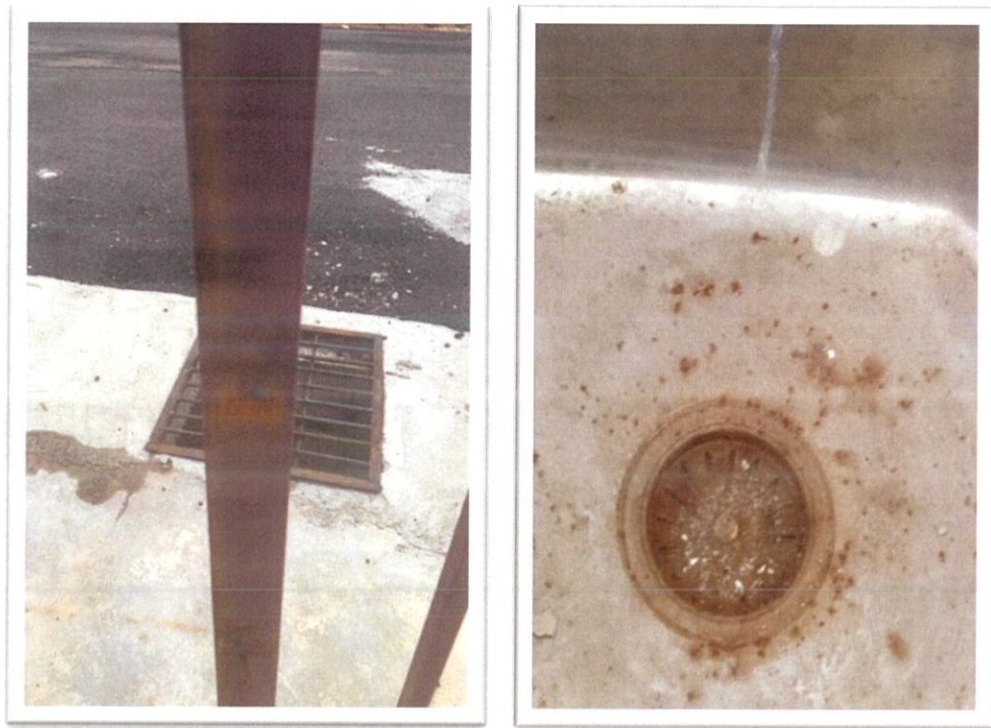
Figure 3.5 The affected gate and gasket by corrosion defect

A corrosion defects also occurs in the proposed building which is at the lock gate and the sink gasket as shown in figure 3.5. Corrosion of structural steel is an electrochemical process that requires the simultaneous presence of moisture and oxygen. Essentially, the iron in the steel is oxidised to produce rust, which occupies approximately six times the volume of the original material. The picture above shows the lock gate already corroded and weakened because it had been exposed to harsh weather. The corrosion can be defined as its degrading from a reaction with its environment. This degradation can cause weakening of the metal by reducing its cross section, changing its crystalline structure or by a gradual chemical reaction converting the metal to a compound with less strength. So this lock gate needs to be fixed as soon as possible before it fully weakened by corrosion that makes it no longer function.

Crevice corrosion is one of the types of localized corrosion. This corrosion attacks only portions of a metal structure. It only occurs in stagnant locations such as those found under gaskets. Crevices can be formed by design detailing, welding, surface debris, etc. Available oxygen in the crevice is quickly used by the corrosion process and, because of limited access, cannot be replaced. The entrance to the crevice becomes cathode, since it can satisfy the oxygen-demanding cathode reaction. The tip of the crevice becomes a localised anode and high corrosion rates occur at this point.

This is the proportion of total time during which the surface is wet, due to rainfall, condensation and others. Therefore, for unprotected steel in dry environments such as inside heated buildings, corrosion will be minimal due to the low availability of water. The requirement for the application of paints or coatings becomes unnecessary other than for appearance or fire protection purposes. The corrosion of iron is limited to the availability of water in the environment. So, the exposure to rains is the most common reason for rusting.

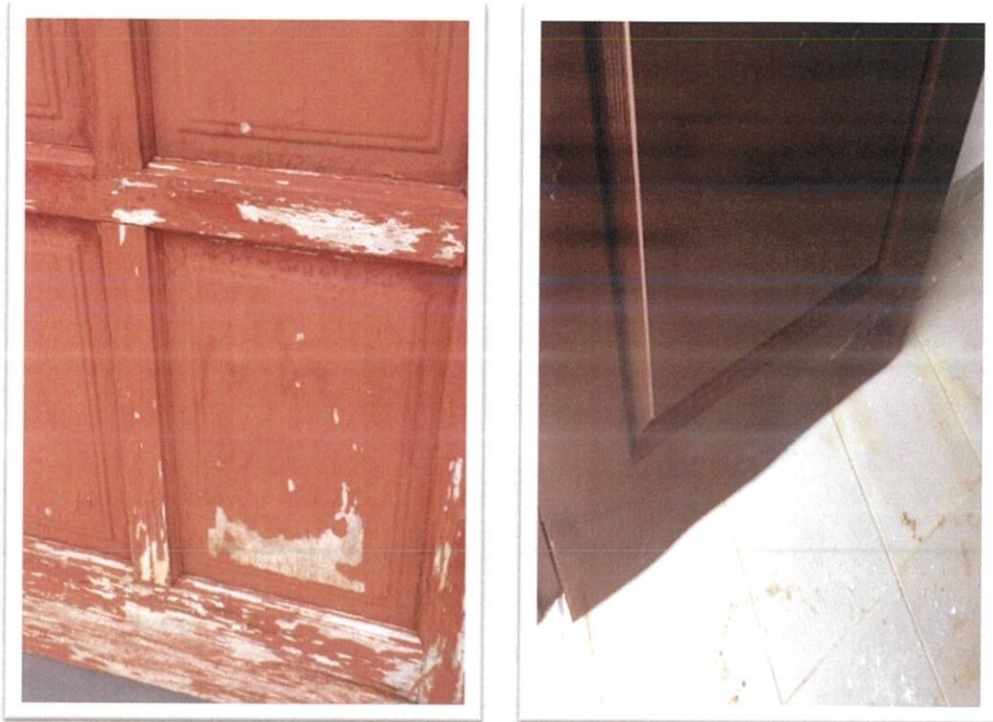
Figure 3.6 The front and back door condition due to deterioration

Other than that, the figure above shown about the defects that occur at timber located at the door as shown in figure 3.6. There are two type of detrition which at the first picture was weathering and the second is wood wrapping. All of these phenomena just cause an eye sore to the buyers if they went for an inspection to their houses and this should immediately being fixed by the developer to prevent problems in the future. In the inspection, the defects only affected the bottom of the door which being called as panel. It is a framework that responsible for holding the whole door. Composed of stiles (sides) and rails (top and bottom). The wooden doors swell up during 'rainy season' because of a process known as imbibition. 'Imbibition' is a type of modified diffusion where water molecules are absorbed by solid particles known as colloids without forming as solution. This results in increase in volume of the solid substance. During rainy season the humidity or the 'moisture content' of the atmosphere increases. This water is taken up by the hydrophilic wood and as a result, the volume of the 'wood increases'.

Over time, the door would begin to warp or bow slightly, allowing air, and heat to escape or enter the house. This is all can be blamed to the moisture content especially that came from rainfall. This had been one of the most challenging things to combat against entirely. In areas that are particularly wet or humid like our country, Malaysia it will obviously have more issues than in dry and or tepid areas. As with warping or bowing, another possible result of moisture getting into the wooden doors could be door expansion or swelling, which are less aesthetically damaging than warping, but arguably more structurally damaging. Wood is porous, especially if it is not protected properly, and that means that it will generally contract in dry air and expand in humidity. This can be the possibilities of why the front door and bathroom door have

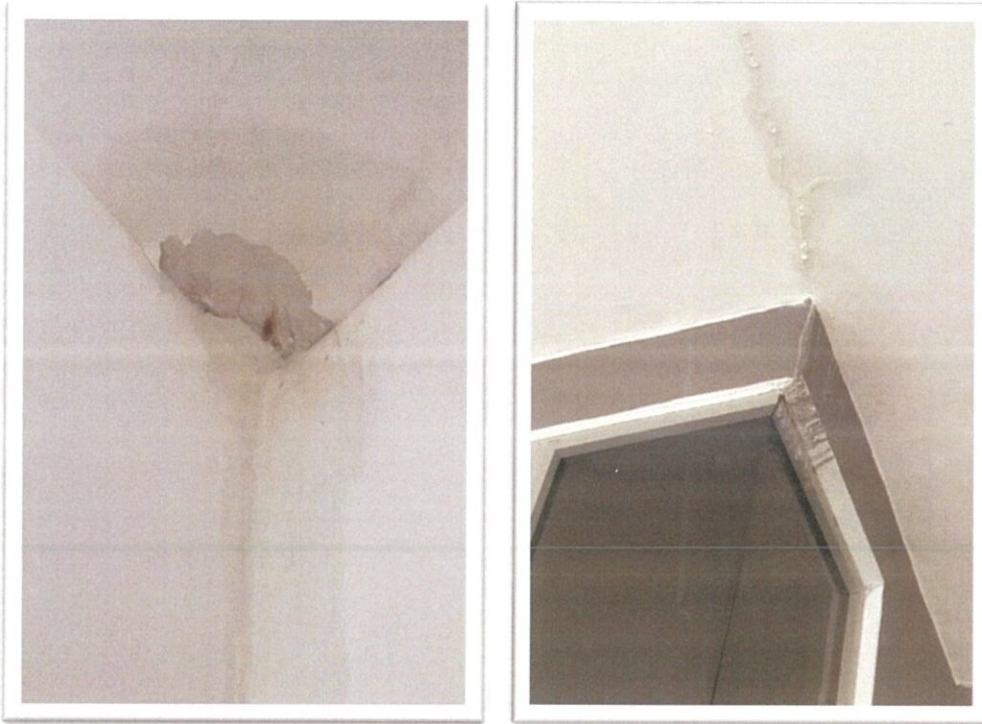
Figure 3.7 Water leakage condition

The leakage from the ceiling can be spot on as it can be seen on the floor of the dripping water fallen from the ceiling as shown in figure 3.7. This had been the common defects that can struck any of the housing projects. It would not just affect the view but also harm the safety of the clients if it is not fixed as soon as possible. The ceiling can crumble due to the water seepage from the rainfall. Besides, it can also cause the floor to be slippery and if it had been ignored for a long period of time it can be infected by a mold.

If there are signs and symptoms of water harm or dripping water coming from the ceiling that locate exactly below an attic space or directly underneath the roof surface itself, there may be almost absolute confidence that the proper cause is a hollow or another kind of harm in the shingles and other roofing cloth that make up the roof machine. There are not often any plumbing pipes or furnishings jogging via an attic, so signs and symptoms of water harm in a ceiling underneath an attic or roof are constantly because of a roof problem.

Another major source of leaks coming from the ceiling is a problem with plumbing pipes or plumbing fixtures in the property. If the leaking ceiling or available water damage appears underneath a rest room, kitchen, or internal ceiling spaces where plumbing pipes are placed, there's a superb risk that the supply of the hassle lays both with water supply pipes or drain pipes which have developed leaks. Water leaking from the ceiling is regularly clean water, rather than brown and dirty, if a faulty plumbing pipe is the culprit.

- ✚ Even though the cracks cannot clearly be seen but the stained with peeled paint start to appear under this concrete slab hence creating problem. It is worsen when the leak water start to penetrate the electrical lighting as well as the wiring. This is the typical interior scene when the top slab failed and leads to unwanted hazards involving electric shocks.
