DEPARTMENT OF BUILDING
UNIVERSITI TEKNOLOGI MARA
(PERAK)

DEFECT LIST AT SEMI-D HOUSING PROJECT

Defect List at Semi-D Housing Project

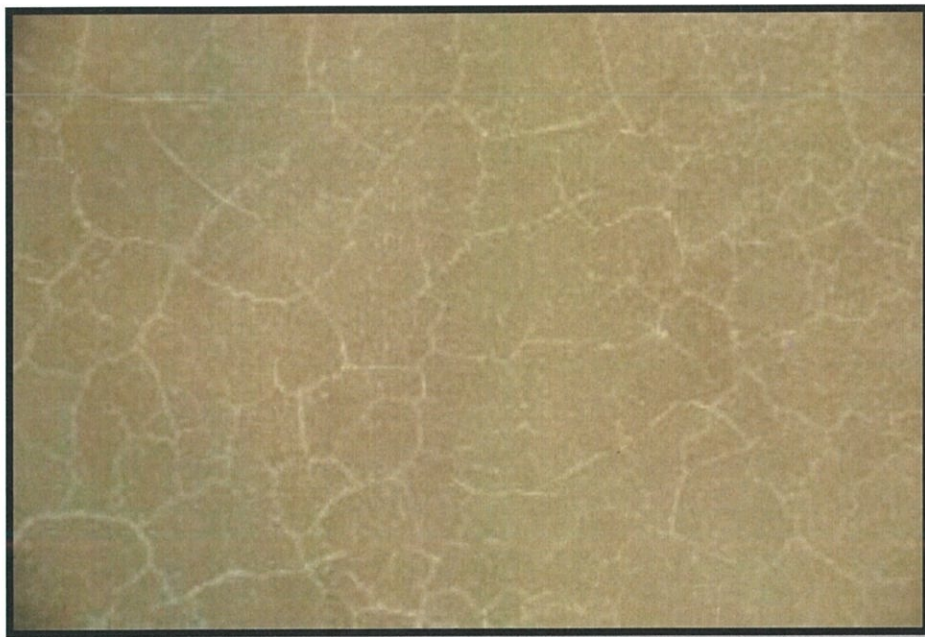
Crazing was induced by drying out of the concrete surface, so it is particularly common when the surface is subjected to low humidity, high air and concrete temperature, hot sun or any mixture during installation. Concrete contractors can mitigate or avoid insane cracks by beginning to cure after final finishing as soon as possible, particularly on a hard-trodden base. Moist curing is best, although a spray-on monomolecular curing compound also can be effective. Using a drier, stiffer mix can reduce crazing as well. For exterior slabs, minimize the amount of working or trowelling of the surface and use a broomed finish, which tends to mask minor cracks and surface blemishes.

Figure 3: Crazeing Crack. (Source: Hijauan Damai Sdn. Bhd.)

Typically, craze cracking is not repaired because it does not deteriorate over time. Sealers and surface hardeners actually can make crazing more obvious. The only choice is by a thin overlay across the crack.

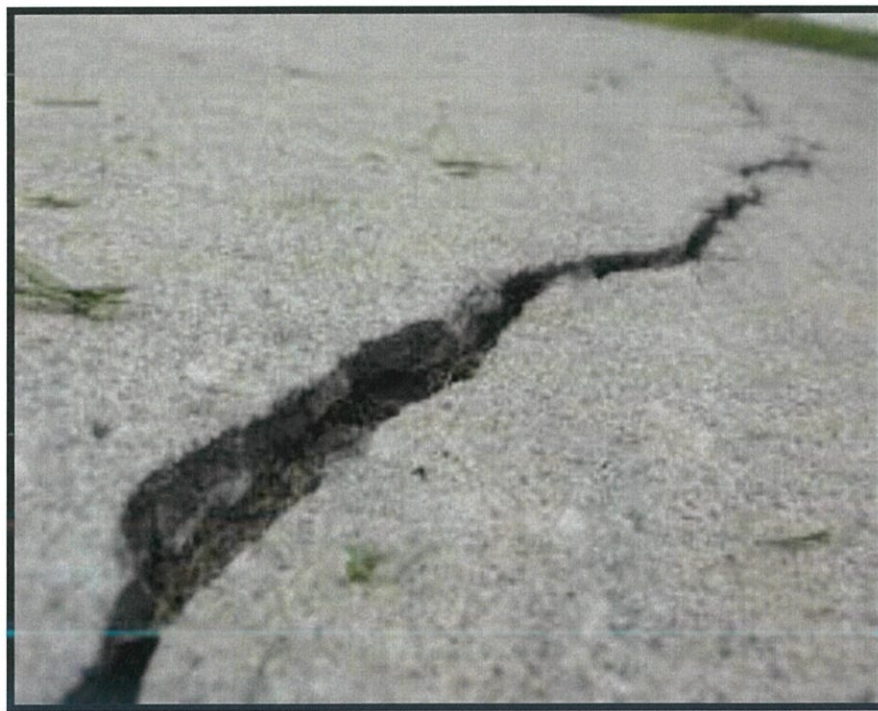
Settling concrete crack occur when there's a void or loose soil underneath a concrete slab causing it to have unstable base resulting occur of crack. For example, if a tree is removed from the ground with closed proximity of a concrete slab, the root that have decomposed. The resultant vacuum can cause sinking of the floor and fracturing of the concrete. Settling is also referred to as subsidence. In trenches where water lines and drainage pipes are concealed, subsidence is very normal. Many occasions when it is refilled, the utility trench is not compacted. When concrete is placed on top of a poorly compacted trench, the void produced by the subsidence can trigger a crack in the unsupported concrete slab.

Figure 4: Settling Crack. (Source: Hijauan Damai Sdn. Bhd.)

Prevention step must be taken before pouring wet concrete on the ground surface. The ground must be compacted thoroughly or repeatedly to ensure the ground surface is completely solid without any void or loose soil. One of the methods is by using a Plate Compactor to compact the soil by doing it will reduce or eliminate any existing void or loose soil in the ground.

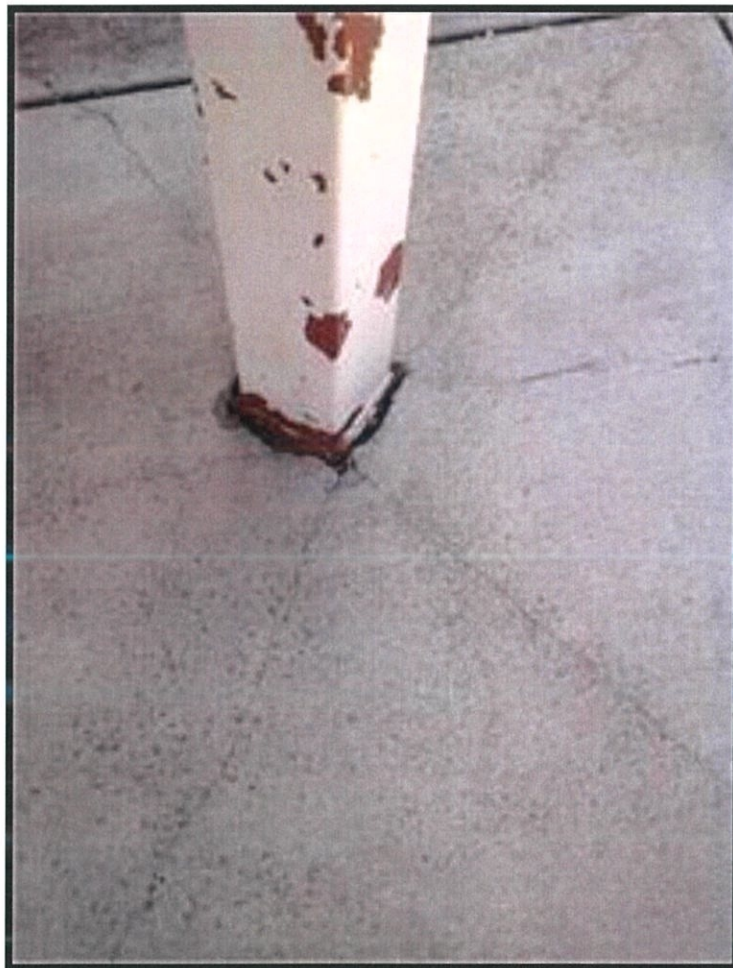
Plastic shrinkage is probably the single most common reason for early concrete cracks. It is full of water when the cement is still in its liquid condition (before it is hardened). This fluid takes up space and makes a certain width for the base. It gets a little smaller as the slab loses moisture while curing. This shrinking creates stress on the concrete slab because concrete is a very rigid material. This drags through its granular subbase as the asphalt shrinks. This impediment to their free movement creates stress which can actually break the concrete. The mortar can break in order to relieve pressure when the strain becomes too high for the now hardened cement. Shrinkage cracks may appear as early as a couple of hours after the slab has been poured and completed, particularly in hot weather.

Figure 5: Plastic Shrinkage Crack. (Source: Gramho.com)

Mixing the asphalt so moist is one factor that contributes greatly to the shrinkage. When excess water is poured into the mix, the slab may shrink more than if the right amount of mixing fluid has been used. This is because the extra water takes up more space, pushing apart from each other the solid ingredients in the mix. By doing so, it creates a weaker solution. The solid particles have greater voids between them when the excess water leaves the slab. These empty spaces make the concrete weaker and more susceptible to crack. Unfortunately, it is easier to place and finish weathered concrete, especially in hot weather. This is one factor why many concrete finishers are adding water to concrete mixer trucks: making their work easier. A few liters per cubic meter will not have a significant impact on the combination. However, if an undue amount of water is applied, the strength of the concrete can inadvertently be diminished.

There are several rule or step that is need to be follow in prevention from the plastic shrinkage concrete crack to occur. The rule and step are as follow;

1. Dampen the subgrade and form if there is an increase of evaporation rate.
2. Excessive surface moisture evaporation can easily be avoided just by providing fog sprays and erecting windbreaks.
3. As the weather can also contribute to the existence of the crack it is advise to used colour concrete in a hot weather meanwhile avoid excessively high concrete temperature in the cold weather.
4. Curing can also prevent the crack to occur, it is advised to immediately start curing the concrete as it has been completed.
5. By covering the concrete between operation using a wet burlap or polyethylene sheet plastic shrinkage concrete crack can be prevented.

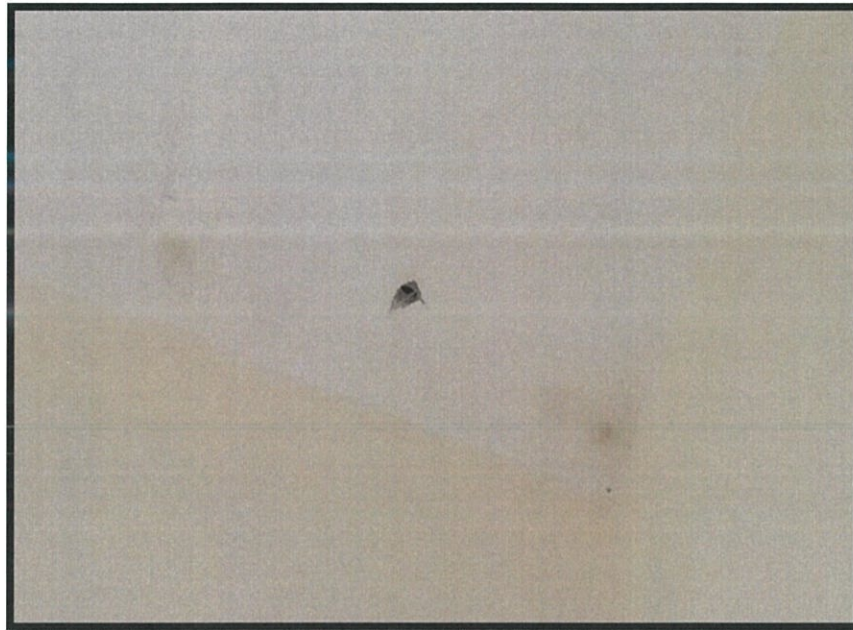
roof. Flat roof structure is mostly popular in the United Kingdom, ranging from residential housing to car garage. Being a cheaper option doesn't necessarily mean it is prone to defect. The figure below shows if a roof leakage is left untreated for a period of time,

Figure 6: Roof Leakage. (Source: Hijauan Damai Sdn. Bhd.)

The first thing to do is to locate the origin of the leakage came from such as which room or what part of the ceiling is affected. By determining the point of origin, it will give a better understanding to why it has a leakage in the first place. For Example, the 6 Semi-detach housing all have the same leakage and located in the exact room of each houses. After undergoing investigation, it is concluded that the airduct above the room is not properly as water can seep through it.

Secondly, the initial step is by scrub the area of the hole or point of origin with a wire brush. Then fill the area with plastic roofing cement to seal or join the crack. As the time passed, conduct a water test to see if the problem has been solved.

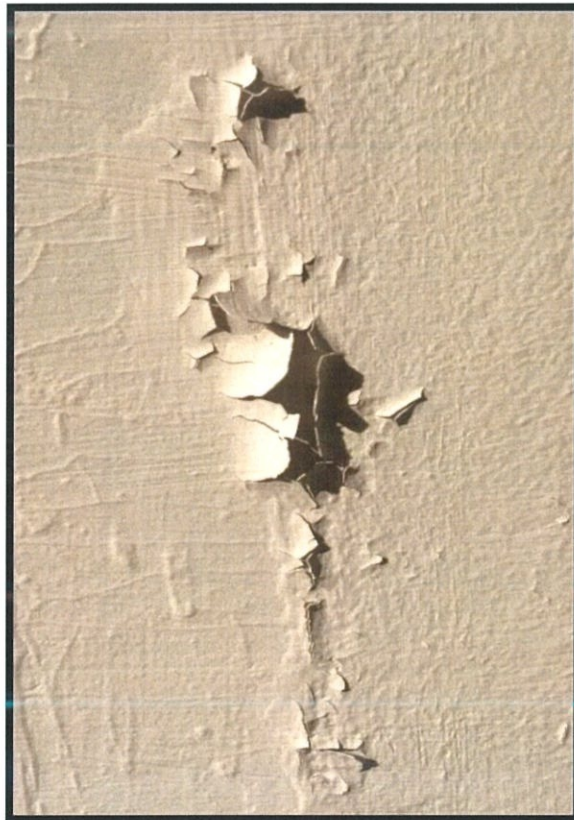
Peeling paint is as its name implied is a situation whereby a layer of paint is peel away from a surface mainly on a wall that is already plastered. Building columns or other parts of a building structure that has been exposed to excessive amount of sunlight or rainwater will cause the peeling paint to occur. For example, if a building is located near the seashore where a high amount of sunlight and humidity can be found will most definitely increase the chances of the paint of the building to deteriorated thus peeling the layer of paint. As shown below,

Figure 7: Peeling Paint in House Unit No. 20. (Source: Hijauan Damai Sdn. Bhd.)

On that note, there another reason why the peeling of paint occurs and that is because the layer of the paint applied is not uniformly distributed. According to Miles (1976), a layer of paint is approximately 0.01 cm if the layer of paint does not have a uniform paint layer there will be an area where it will dry faster than the other area making it easier for the paint to peel. As well as, the thickness of the coating will affect the components of the building which the paint covers.

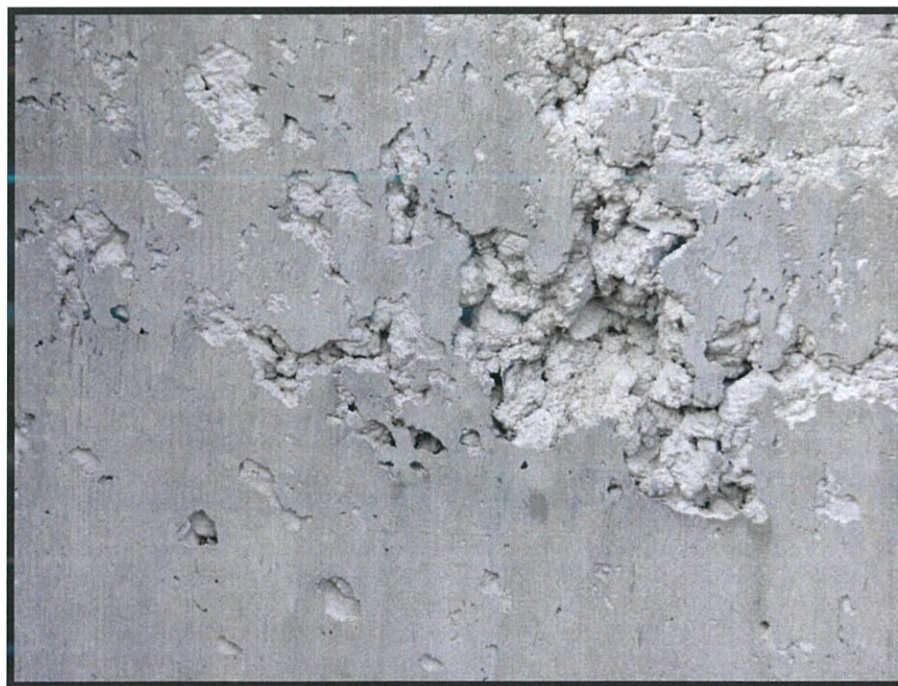
Honeycomb is a situation whereby when a concrete is set. there exist cavities or hollow point that the mortar didn't fill in properly (Charles, 2012)., thus weakening the overall strength of the concrete. The name "Honeycomb" originates from its appearance resemble a bee nest. In fact, the appearance of the honeycomb can clearly be seen after the formwork has been withdrawn, exposing a rough and ' stony concrete layer with air voids in the coarse aggregate. In comparison, honeycomb will appear more inside the concrete and honeycomb is usually an aesthetic issue for the contractor and depending on the size and magnitude of the honeycomb it may decrease the member's quality and strength. The existence of air bubbles can lead to the formation of the honeycomb on the concrete surface, resulting in the isolation of aggregate and cement mixture. This will result in damage to the foundation. As Figure show below:

Figure 8: Honeycomb in Concrete. (Source: Civilengineernotes.com)

The incidence of Honeycomb is attributed to several factors. For example, lack of vibration when concreting works are on-going, poor sampling, incorrect placement of the reinforcement bars, inaccurate of water cement ratio will cause honeycomb to occur (Schultz, 2014). Other than that, using a good mix design uniformly vibrating or compacting the cement, utilizing watertight good formwork and preventing separation by correctly pouring the concrete will eliminate the honeycomb from happening.

The solution for fixing the honeycomb that occur in concrete is rather influence by how deep does the honeycomb reach within the concrete. The repair can be easily managed or it will need several hours to days just to fix it. Below are the steps to fix honeycomb;

2. Simply trowel it into the void is a common way of placing the repair material. Yet according to Glenn Smoak, contractor (author of the book Guide to Concrete Repair) can achieve better results by using a compact pneumatic mortar device to add a grout equivalent to a hand-applied dry kit.

3. Using a 1:4 of Portland cement and sand ratio including a water cement ratio of about 0.35. If the repair is deeper than 1 inch (or 25 mm), apply the mortar in layers no thicker than 3/4 inches to prevent bond shrinkage and loss.

5. To finish the patch, marginally overfill the gap. After the surface has been partially hardened or set but can still be shaved off with the tip of a steel trowel, chip off the excess material and operate from the middle to the sides. On completion of the patch, take special care to prevent bond damage.
