DEPARTMENT OF BUILDING
UNIVERSITI TEKNOLOGI MARA
(PERAK)

RC COLUMN AND BEAM CONSTRUCTION

RC Column And Beam Construction

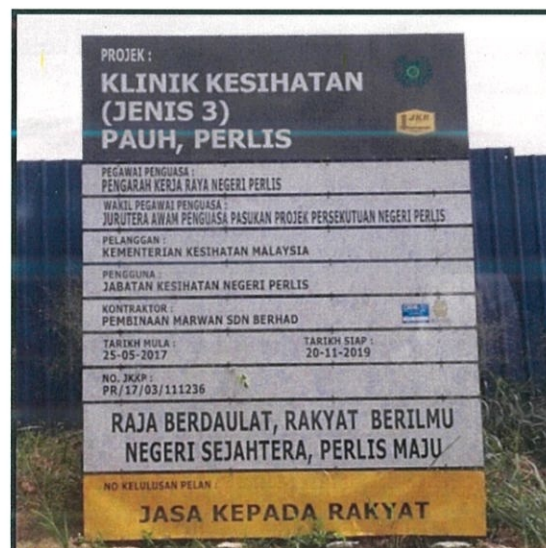
Photo 3.1 : Signboard of the contract informations of the Klinik Kesihatan (Jenis 3), Pauh Perlis project

The parties involved in this construction project include the Health Department Malaysia as the client of this project, Public Works Department as the executor of this project and Pembinaan Marwan Sdn. Bhd. as the main contractor. Photo 3.1 below shows the signboard containing project information which placed at the outside of the construction site:

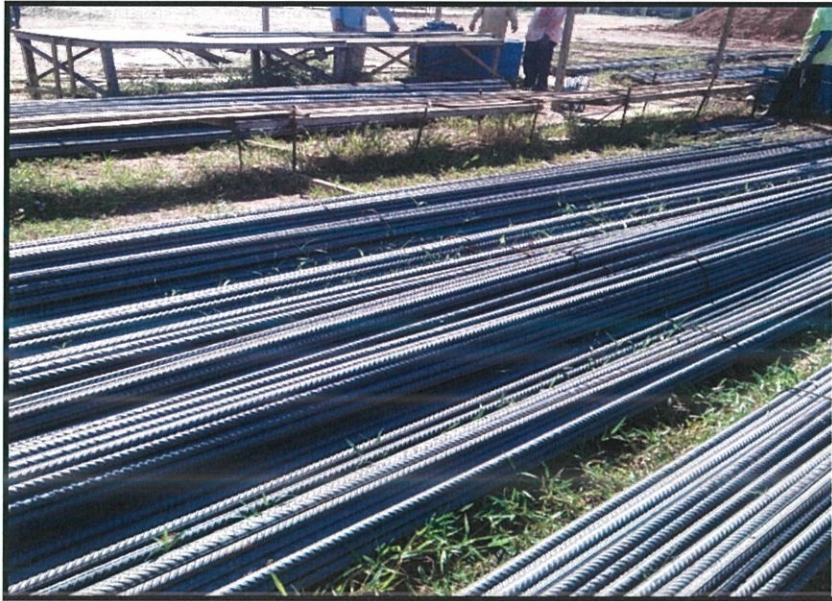
Photo 3.2 : Shows the steel bar prepared to be cut

The reinforcement bars for both column and beam were made of steel bars which being cut according to the size as shown in Photo 3.2 below:

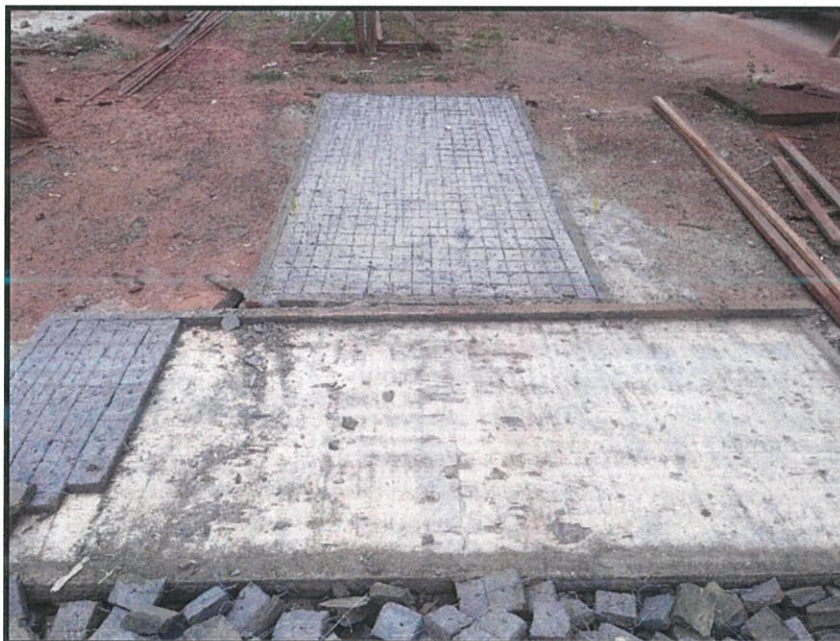
Photo 3.3 : Shows the concrete blocks prepared for reinforcement bar

Photo 3.3 shows the concrete blocks being prepared :

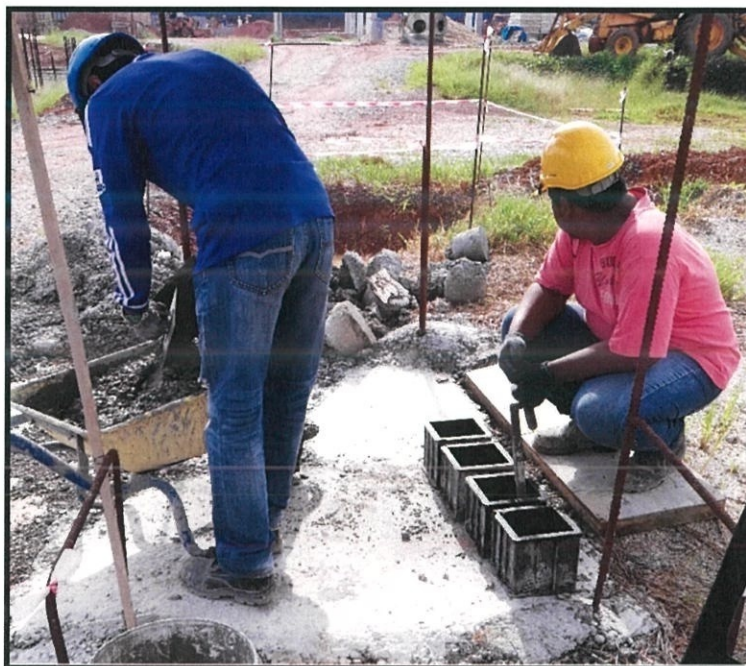
Photo 3.4 : Shows the making of concrete cube for concrete Grade 35

The strength of the concrete used is determined by undergoing a cube test. For this pupose, every batch of concrete delivered test cube shall be made. The cubes should be tested at 7 days and at 28 days.

The cube being prepared before going through the test as shown in photo below :

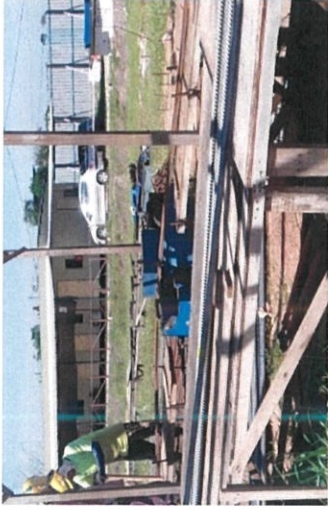
NO	OPERATION	SEQUENTIAL DIAGRAM	LABOUR	MACHINERY AND PLANT	EQUIPMENT	DURATION
1.	Workers prepare steel bars for the columns.

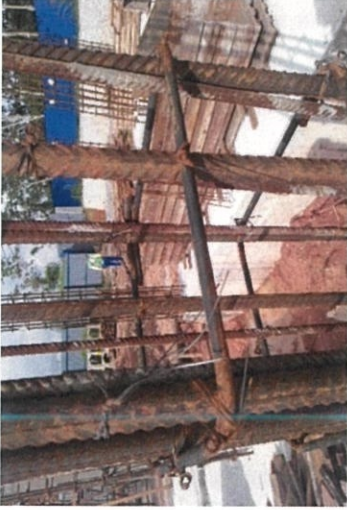
-1skilled worker -2 unskilled workers	- Steel cutter machine - Steel bar bending machine	- Measuring tape - Marker pen - Steel bar	- 2 days (10 Columns)
2.	Main bars for column were connected to the column stump by tying the link to the reinforcement bars using wire ties.

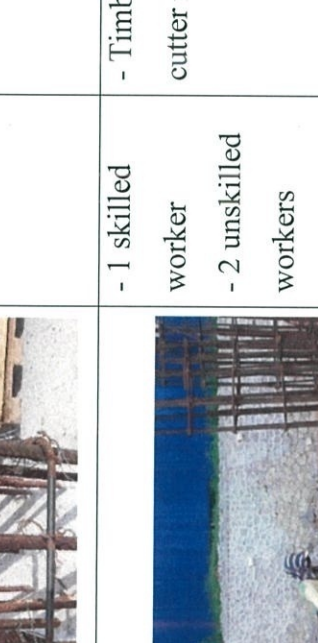
<p>- 2 unskilled workers</p>	<ul style="list-style-type: none"> - Wire mesh tying bar - Concrete blocks - Wire mesh 	<p>- 2 days (10 Columns)</p>
<p>4.</p> <p>Timbers were prepared for the columns' formwork while the ground beam and slab were being concreted.</p>

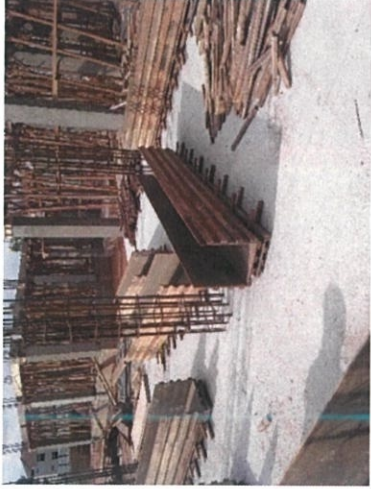
5.	Workers install the formwork for column.

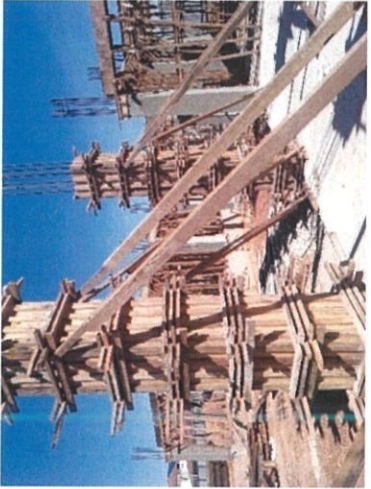
- 4 unskilled workers	<ul style="list-style-type: none"> - Hammer - Nails - Column's formwork 	- 4 days (10 Columns)
6.	Temporary support for columns were installed to avoid the formwork from falling down during concreting process.

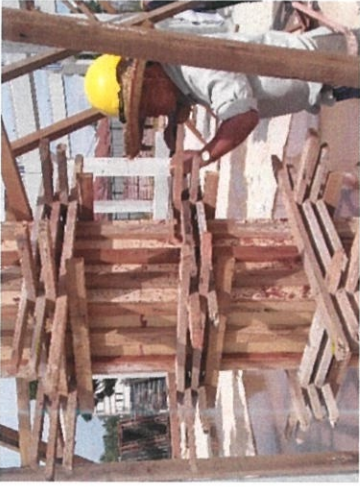
7.	<p>Holes were made at some part of the columns' formwork for grouting purpose.</p>

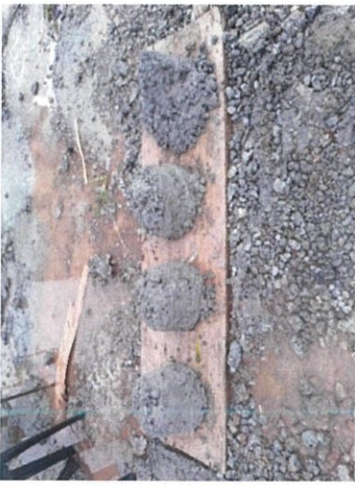
<p>- 2 unskilled workers</p>		<p>- Handsaw - Measuring tape</p>	<p>- 1 day (10 Columns)</p>
8.	<p>Cement go through slump test before approved to be used in construction.</p>

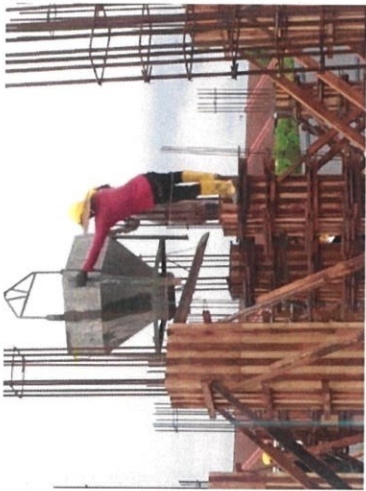
9.	Concrete was poured into the column's formwork.

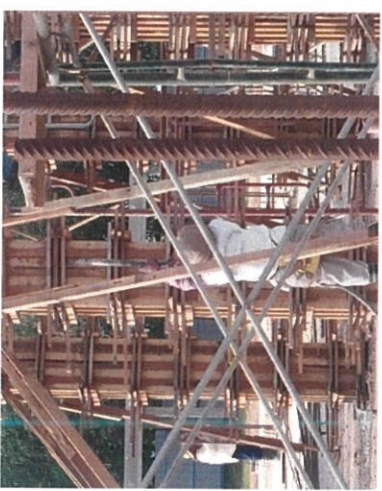
- 4 unskilled worker	<ul style="list-style-type: none"> - Crane - Concrete mixer truck 		- 2 days (10 Columns)
10.	Vibrating process been done after the concrete was poured.

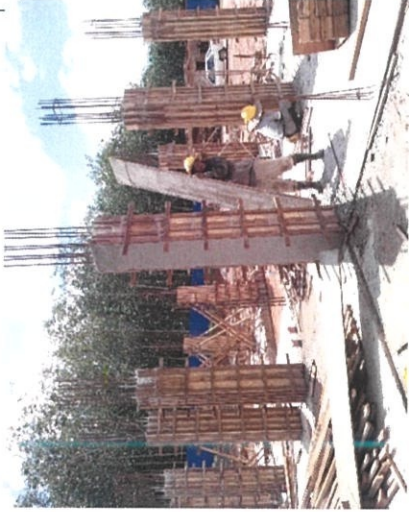
11.	<p>After the concrete had hardened, the formwork was dismantled from the column after 3 days.</p>

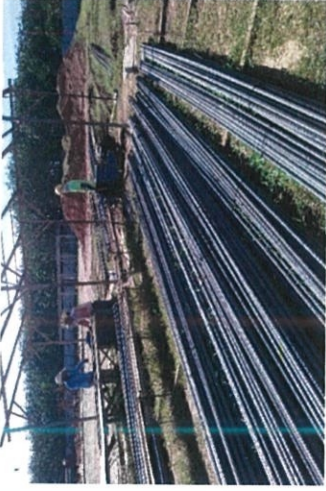
NO.	OPERATION	SEQUENTIAL DIAGRAM	LABOUR	MACHINERY AND PLANT	EQUIPMENT	DURATION
1.	Workers were cutting and bending the steel bars for beams.

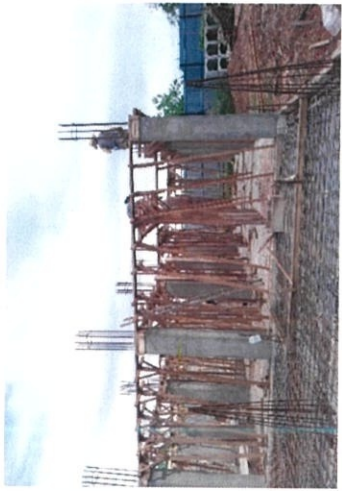
<ul style="list-style-type: none"> - 1 skilled worker - 2 unskilled workers 	<ul style="list-style-type: none"> - Steel cutter machine - Steel bar bending machine 	<ul style="list-style-type: none"> - Measuring tape - Marker pen - Steel bar 	<ul style="list-style-type: none"> - 2 days (10 Beams)
2.	Supporting timber props was installed before starting with the formwork of beam.

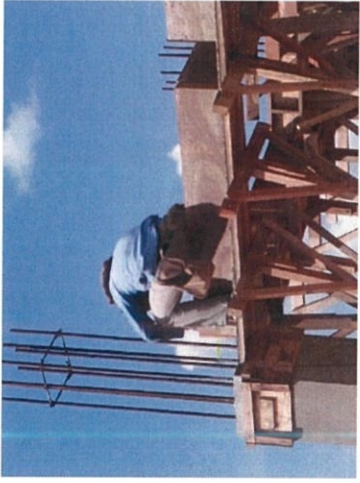
<p>3. Formwork of the base of the beams were installed.</p>

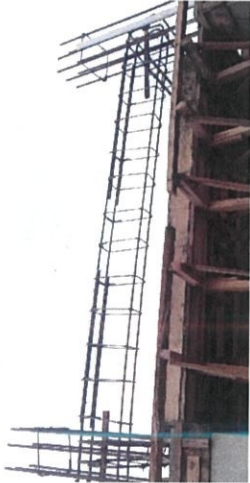
<p>- 2 unskilled workers</p>	<ul style="list-style-type: none"> - Hammer - Nails - Timber wood - Measuring tape 	<p>- 2 days (10 Beams)</p>
<p>4. The reinforcement bar were installed onto the base of the beam formwork.</p>

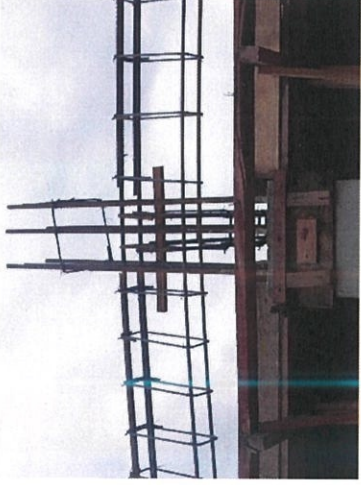
<p>5. Reinforcement bar of beam were connected to the reinforcement bar of column.</p>

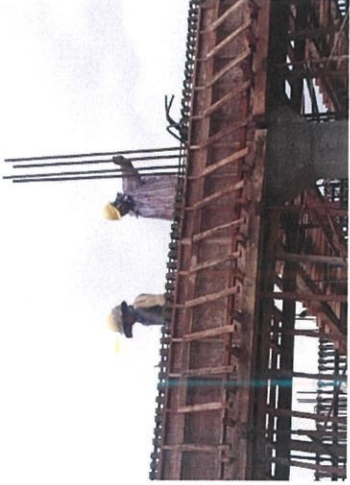
<ul style="list-style-type: none"> - 1 skilled worker - 2 unskilled workers 	<ul style="list-style-type: none"> - Wire mesh - Wire mesh tying bar 	<ul style="list-style-type: none"> - 2 days (10 Beams)
<p>6. The formwork of beam were being installed.</p>

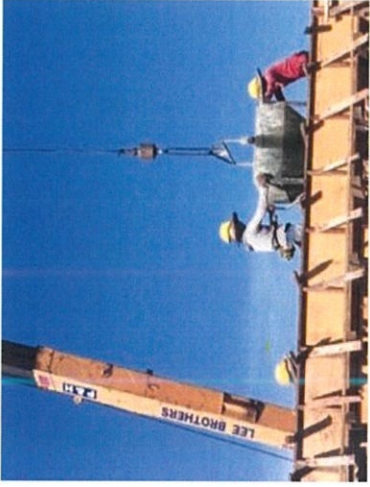
<p>7. The concrete was poured into the formwork mould and worker continue the vibrating process.</p>

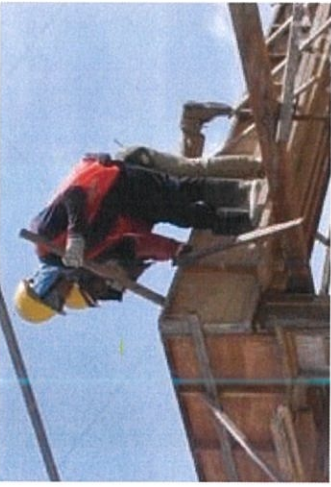
<p>- 4 unskilled worker</p>	<p>- Crane - Concrete mixer truck</p>	<p>- Cement vibrating machine</p>	<p>- 2 days (10 Beams)</p>
<p>8. After the concrete had been fully set, the formwork was dismantled from the beam after 3 days.</p>

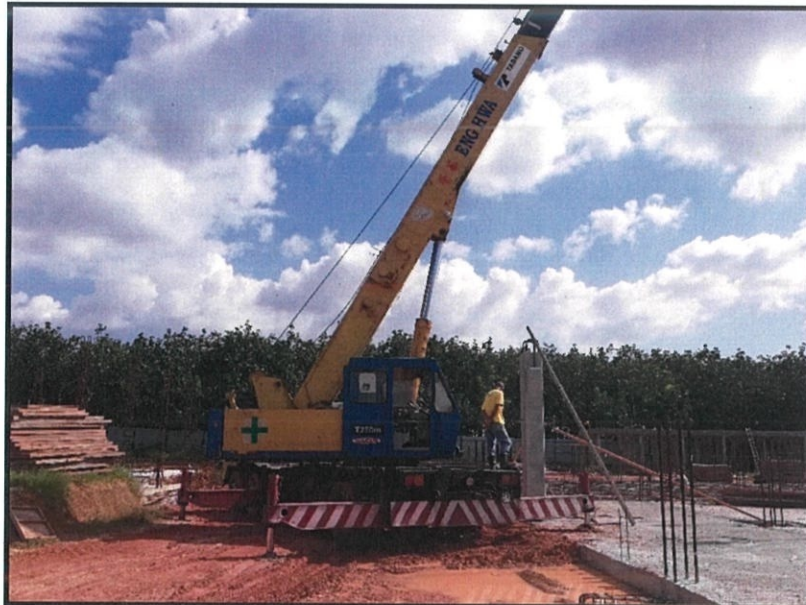
Photo 3.11 : Shows the crane used at the construction site

There are many types of cranes used in construction project and the cranes has different function for each works. Cranes are normally used in process of lifting, lowering and moving the heavy materials with the use of its components. Cranes are very valuable because it simplify the works at construction site especially works at high level.

At this construction site, cranes are used to move the soil from the soil heap to the construction area for backfilling purpose . The crane fasten the works of backfilling to avoid from delay of other works. Other than that, the crane is also used during concreting process which it move and lift the concrete from cement lorry to the construction area by using a bucket with the help of the workers.

Since some parts of this project used Industrialised Building System (IBS) columns and beams, the crane was used to lift the structural elements and help the workers with the installation process.

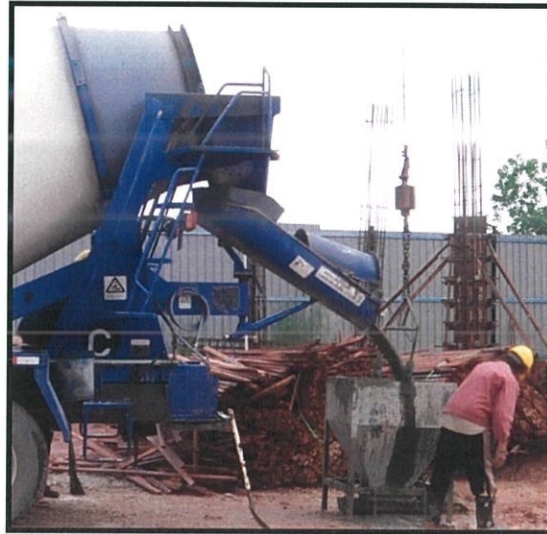
Photo 3.12 : Shows the concrete mixer truck pouring concrete into the bucket

Usually, the company will buy and order the concrete from the cement factory itself. The supplier will send the concrete straight from factory by using a concrete mixer truck. This truck will mix the cement and aggregates in the part of its body called the mixer equipment. This truck will keep on running during the concreting process. It will transport the concrete to the construction area by using the crane.

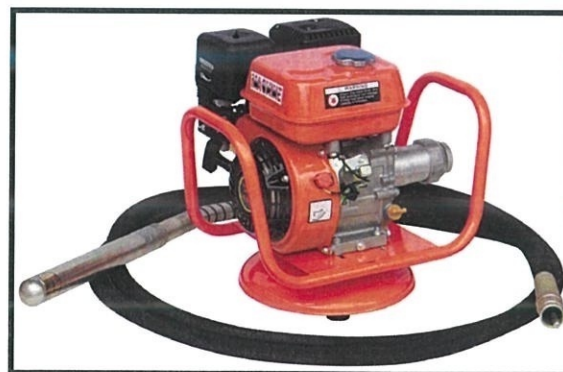
Photo 3.13 : Shows the concrete vibrating machine

The concrete mixture will produce honeycomb and trapped air which may cause the building become weak and not durable. This concrete vibrating machine will help the workers to released the trapped air inside the concrete mixture to consolidate the freshly poured concrete. Inappropriate consolidation will produce defects in future.

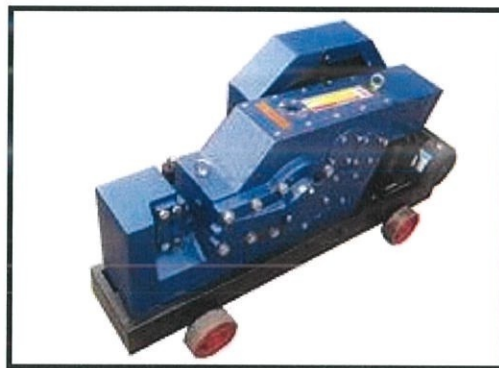
Photo 3.14 : Shows the steel bar cutter machine

Steel bars are the most important things that will be on site to produce the reinforcement bars of each structure of the element. Steel bars need to be cut according to the size stated in the structural drawing but it cannot be done manually. So, with the help of this steel bar cutter machine, workers can quicken their works. This machine will also cut the steel bars flawlessly without damaging the steel bars and cause loss of money.

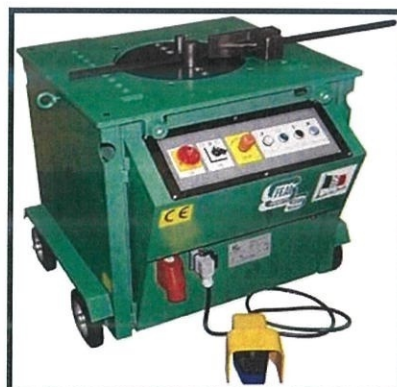
Photo 3.15 : Shows the steel bar bending machine

Reinforcement bars need to be bend at some points in order to combine with the other reinforcement bars. This steel bar bending machine will bend the steel bars accurately after being marked by the workers. Bending works cannot be done manually since its diameter is big and difficult to be bend.

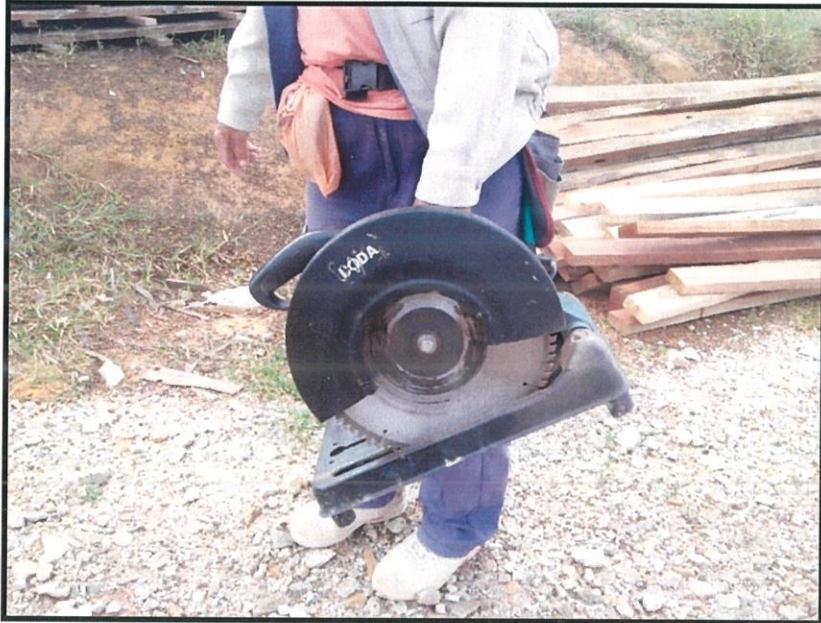
Photo 3.16 : Shows the timber wood cutter machine

This machinery is used to cut the timber wood for the formwork structure which can shorten the time compared to use manual equipment such as handsaw.
