**PRACTICAL REPORT TITLE
TYPE OF TILES AND THEIR APPLICATION IN BUILDING**

TILE FINISHES AT RESIDENSI KEPONGMAS, KEPONG

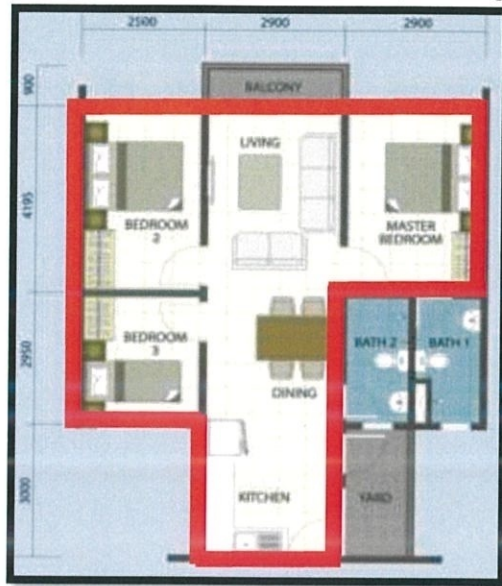
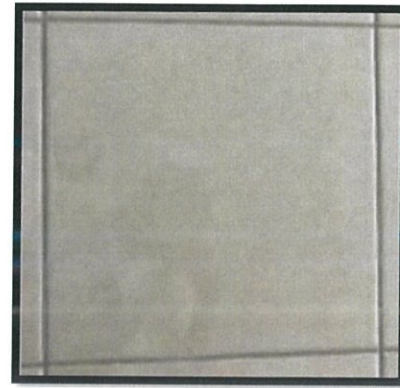
Figure 7 kitchen, living, dining and bedrooms floor plan

The type of tiles used in the highlighted area are glazed ceramic tiles with glossy finish and bright colour for the main purpose of reflecting natural light to brighten up the space. With light coloured tiles it can also perceive the eyes and mind to make the space looks and feels bigger. The shading of the tile also adds aesthetic values. Glossy finish is used mostly throughout the unit is because it will give less footprints marks on floor in comparison to matte finish. Therefore, unit can look clean for longer period of time.

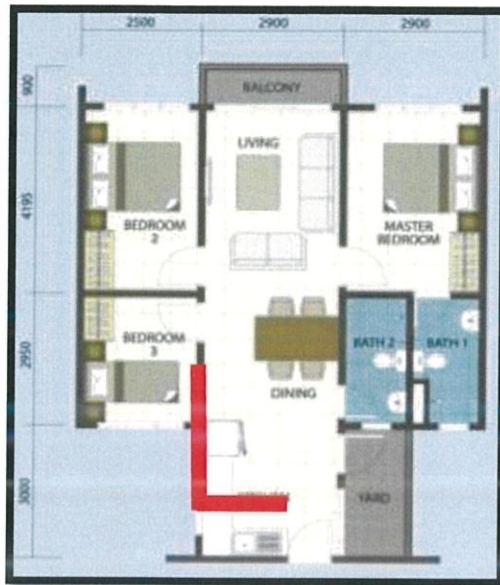
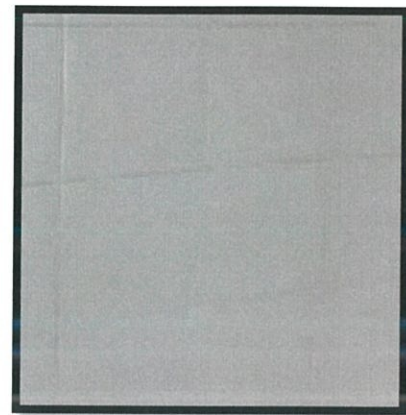
Figure 8 Floor plan for kitchen area wall tiles

The type of tiles used in the highlighted area are glazed ceramic tiles with matte finish and bright colour. This is also for purpose of reflecting light in that area to make the space looks bigger. By using matte white coloured shading it gives the unit a modern and clean look and also adds aesthetic values. The main purpose of wall tile at kitchen area is to act as a backsplash when preparing a meal so that paint on walls are not stained in comparison to tiles that can easily be cleaned. It is also used to separate kitchen area from dining area.

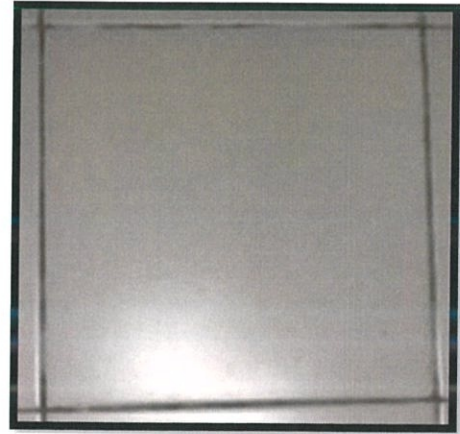
Figure 10 Bath 1 and 2 floor plan

The type of tiles used in the highlighted area are glazed ceramic tiles with matte finish and darker colour. It is necessary to use glazed ceramic tiles in bathrooms because of its characteristics that does not absorb water in comparison to unglazed ceramic tiles. With this humidity in that area can be avoided as it is exposed to high volume of water in an enclosed area.

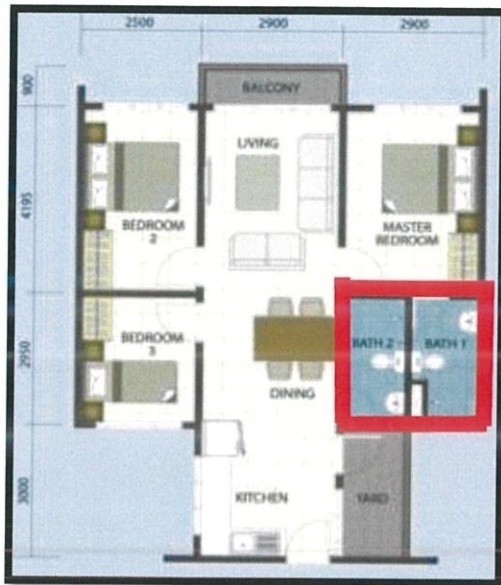
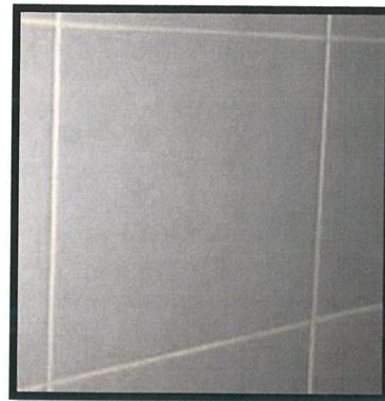
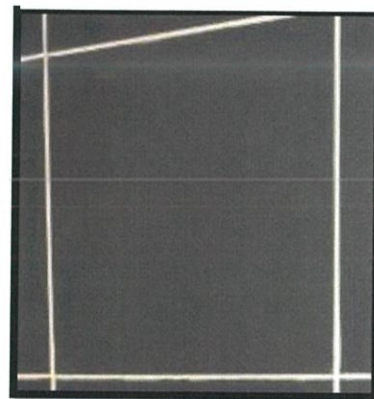
Figure 13 Bath 1 and 2 floor plan

The type of tiles used is same as the floor tiles for bathrooms the only difference is the shading which has two colours. One is a bright colour and the other is a dark colour. The difference in colour is used to separate the toilet area and shower area. The difference in colour adds aesthetic value and a modern look

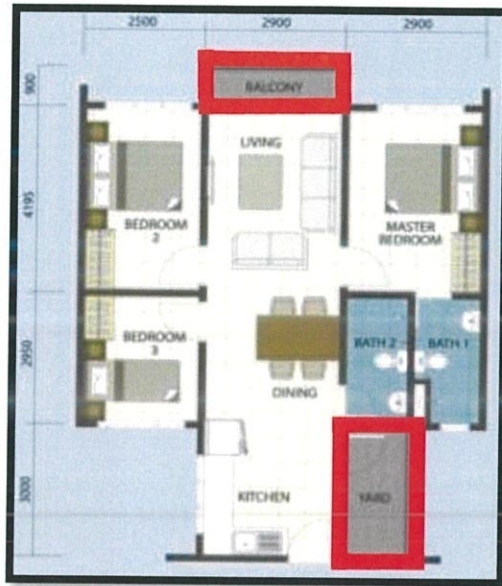
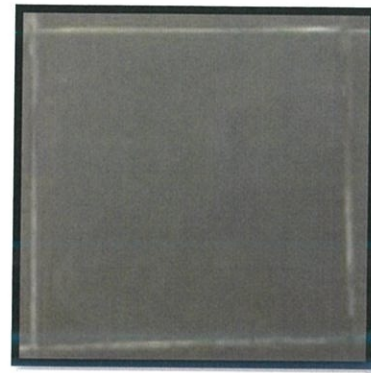
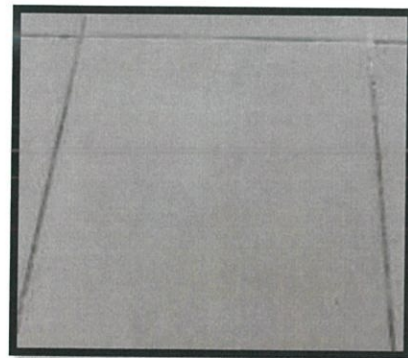
Figure 16 Yard and balcony floor plan

Both yard area and balcony area used unglazed ceramic tile which has a rough finish. The only difference is balcony area has a brighter colour than yard area. Unglazed ceramic is used for exterior is because it is denser and more durable than glazed ceramic tile. It also to avoid slipping as it can be exposed to water, different with bathrooms as it is in an enclosed area compare to yard and balcony which open.

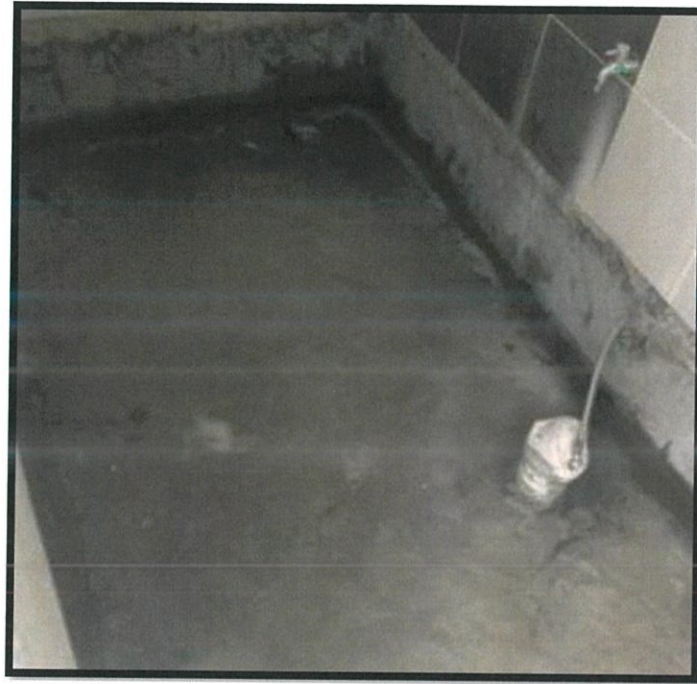
Figure 18 Apply water proofing membrane

This is the most important part before constructing tiles on a high-rise building. Water proofing membrane is evenly coated throughout tiles area, this is to ensure that no excess water can seep through the concrete and affect units below with water leakage from ceiling. After water proofing is applied a water proof test is conducted by filling the area with water for at least 2 days. Improper waterproofing could lead to financial harm to company as all tiles and floor needed to be hacked in that area to re-do the water proofing. It can also harm the unit below it as plaster ceiling that has absorbed plenty of water for a long time can collapse and harm the owner living in the unit

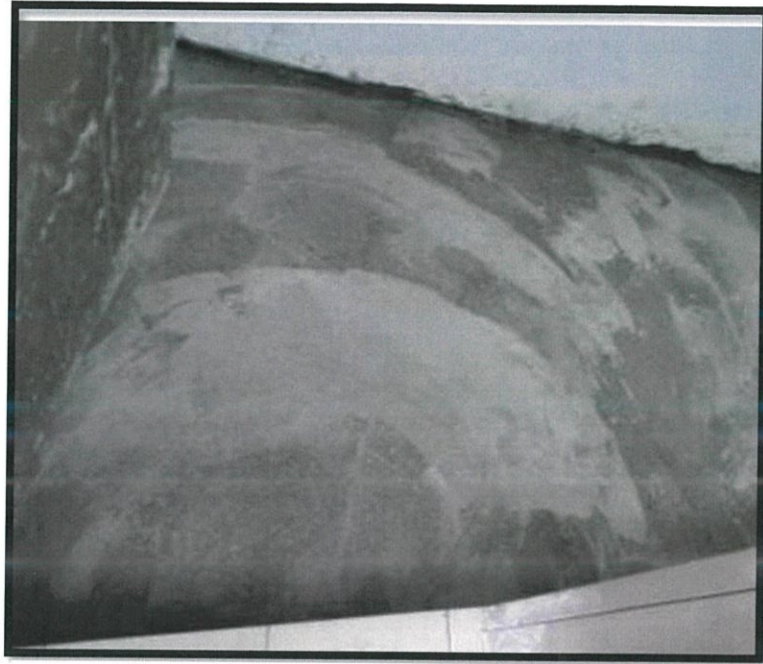
Figure 19 Construct floor on concrete bed

After water proofing process is complete, Floor screed made from 1:3 ratio of cement to sharp sand is applied on the concrete ground floor slab to provide a level leveled surface to applying tiles. Improper materials used and applying method can lead to hollow of floor which is a major defect as new floor needed to be constructed again and wait for it to dry which is time consuming. Unleveled floor can also cause defect to tiles such as “lip”.

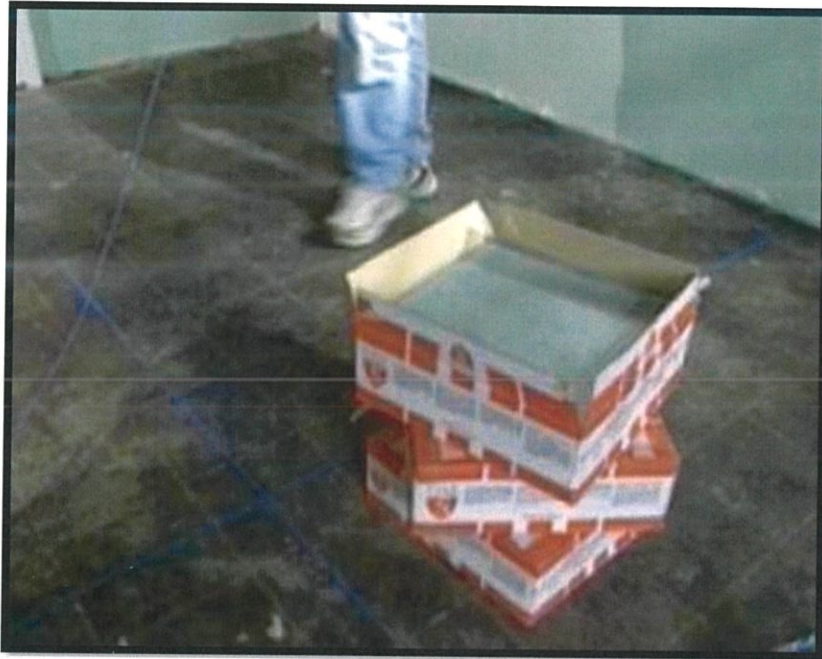
Figure 20 Using snap chalk line method

Snap chalk line method is used as a guideline on where tiles are going to be placed. Measure to find the center of the room, and snap two chalk lines that intersect exactly in the center of the floor. With this total of tiles and odd piece tiles can be identified by observing the guidelines.

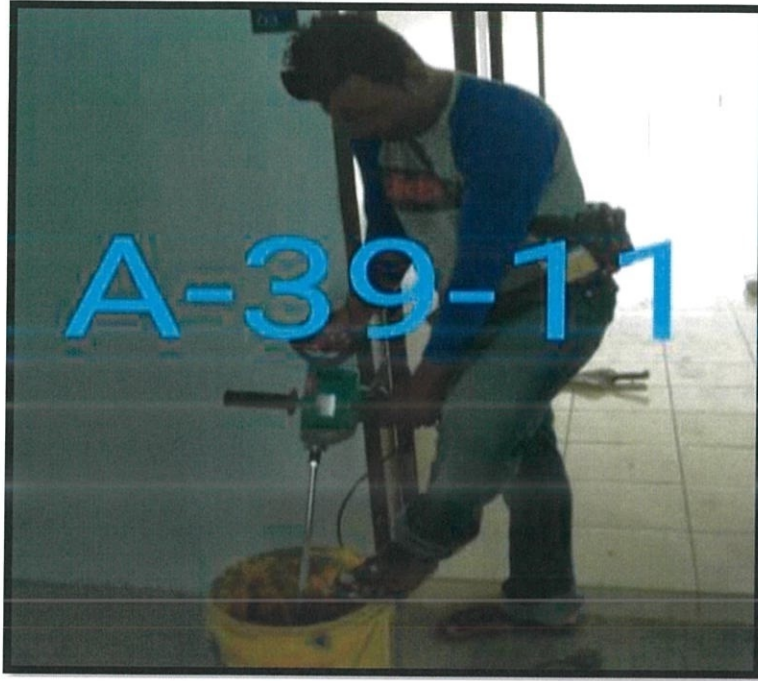
Figure 21 Mixing thin-set mortar

Thin-set mortars are great for installing tile tiles and wall tiles, because they can handle a great deal of weight and are very durable. They can be used in wet areas or high-heat areas. Thin-set mortar are in powdered form and is mixed with water until it reaches a peanut butter like state for easy application.

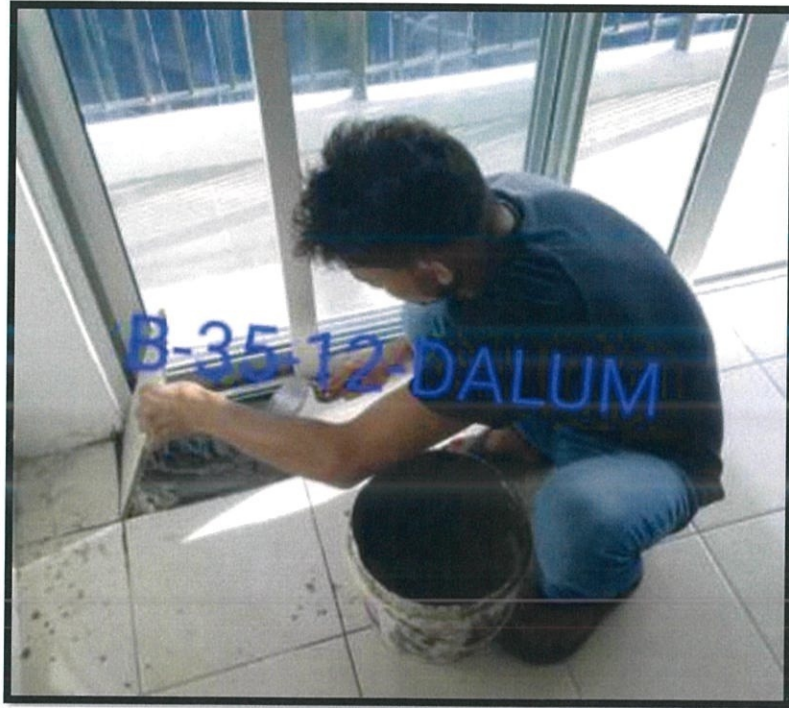
Figure 22 Applying mortar on floor and tile

After successfully mixing the thin-set mortar, it is then applied on the base of floor and on the back of floor tiles. Mortar should be used as soon as possible as it can hardened at a fast rate. It should also be mixed in small quantities to avoid waste of mortar. When applying mortar, it should sufficient and cover the whole back of the tiles to avoid hollowness of tile. Insufficient mortar used are the main reason for hollow tiles and needed to be replaced in the near future.

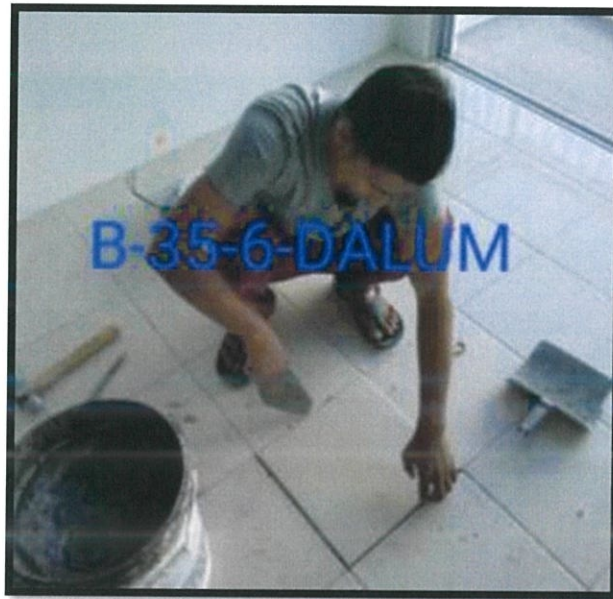
Figure 23 Placing tiles

After successfully apply mortar on floor and tiles, tiles are then placed on floor according to the guidelines. Tiles needed to be placed starting from the middle as in the guidelines and move in one direction.

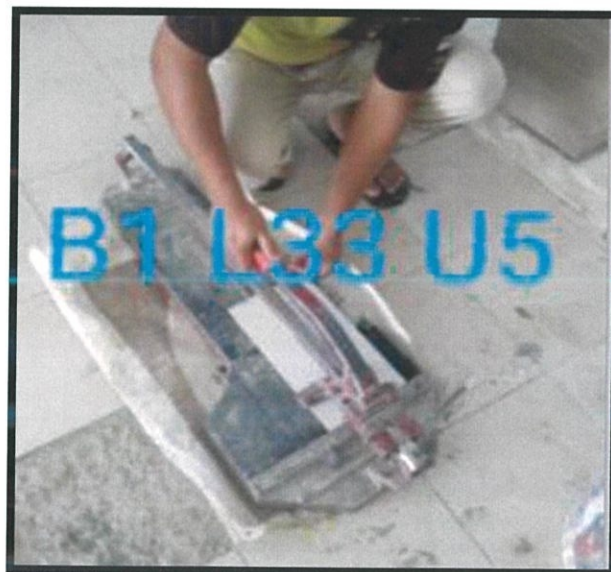
Figure 24 Cut odd tiles

When you get to a wall where a standard tile will not fit, mark and make cuts with a standard tile cutter. This type of tile is called a short piece. It is necessary as to fill the whole area with tiles and to avoid unfinished look in houses and units. Odd tiles are normally used at the side of wall, drop and at base of door frame.

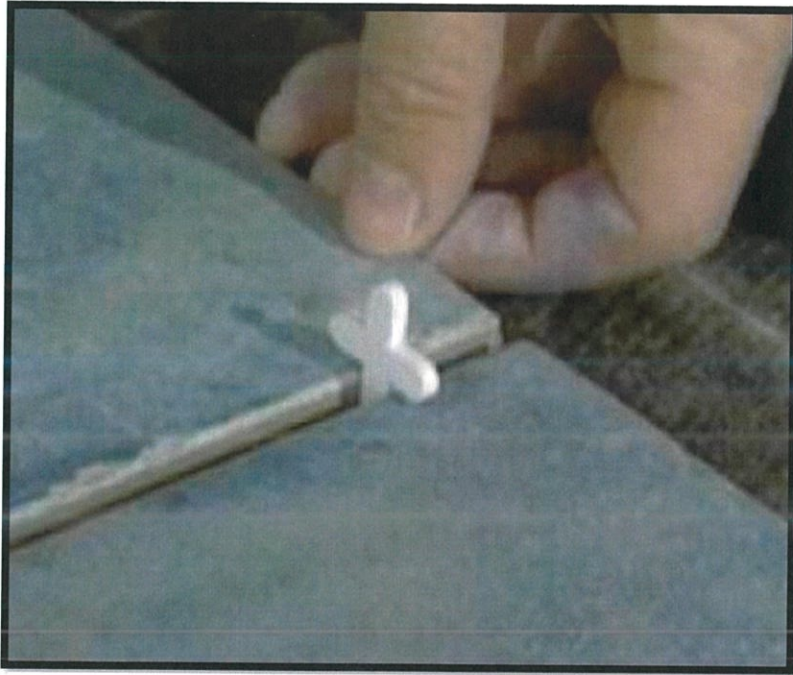
Figure 25 Place spacers

Continue the process, using the chalk line as a guide and placing spacers between each tile to ensure uniform distance between the tiles. When all the tile work is complete, allow the tiles to dry in place for at least a whole day. Spacers create voids in between tiles which is then covered with grout. By using spacers, it creates a uniform and neat look when finish as all the tiles have a uniform distance between each tile.

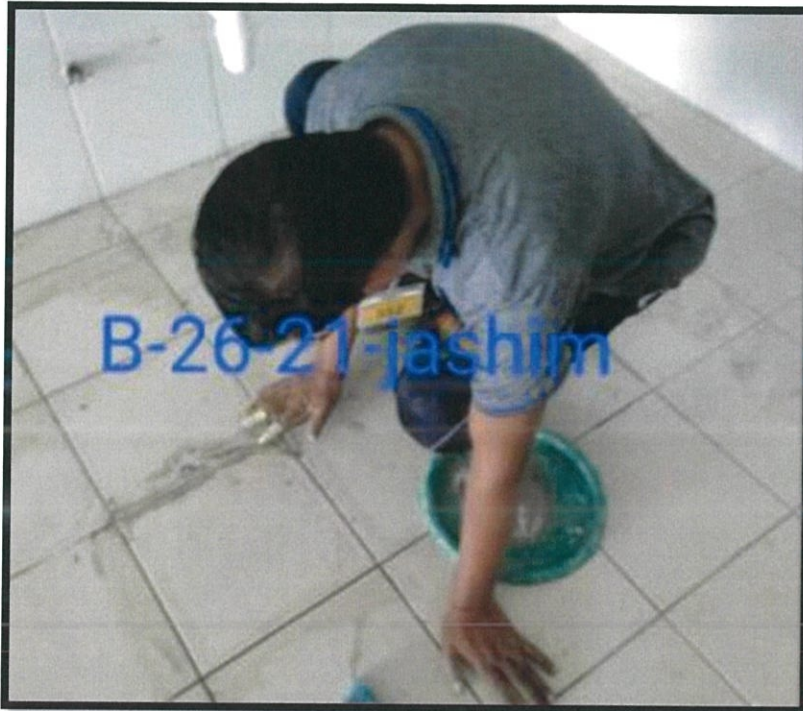
Figure 26 Apply grout on tiles

After tile is completely fixed to the surface, spacers are then pulled out in between tiles to proceed to the next step which is grouting. Grout is spread in between tiles to fill voids that is visible in between tiles to create the finish look. grout is available in a variety of textures and colours. Pick a colour that matches the colour of the tile. The types colour used in this project are cement colour for overall floor tiles, yellowish coloured grout for bathroom walls tiles and white coloured grout for kitchen wall tiles. Use a rubber trowel or float to spread the grout across the tiles at an angle to be certain to get it between each tile.

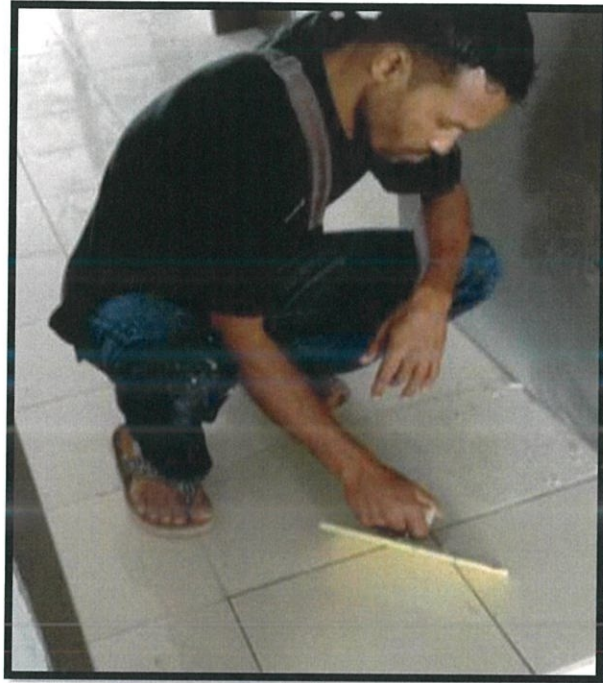
Figure 27 Removing excess grout

When the grout is in place, wipe away all the excess grout with a damp sponge or cloth for easy removal. Repeat this process several times to completely remove the excess grout and being careful not to remove the grout lines around the tiles. After all the excess has been removed, wait for at least 3 hours for grout to harden completely. With this construction of tiles is done and finish look is achieved.

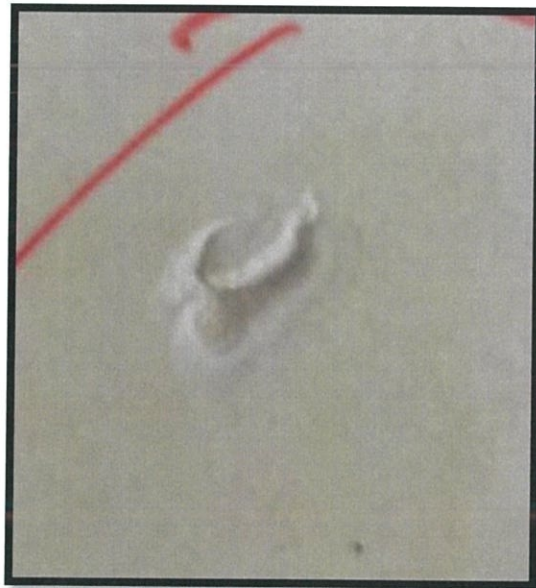
Figure 28 Chipped tiles

Chipped and Scratched on tiles are one the defect that occasionally occurs. This happened solely because of poor workmanship and carelessness of workers while doing their line of work. Carelessness of worker such as accidently dropping pointy objects or hard object from height causing chipped and scratched tiles. This can be avoided if workers are more concerned with their surrounding when handling objects. Chipped and scratched tiles also threaten company's financial status as tiles needed to be replace and this could lead to other unit defects.

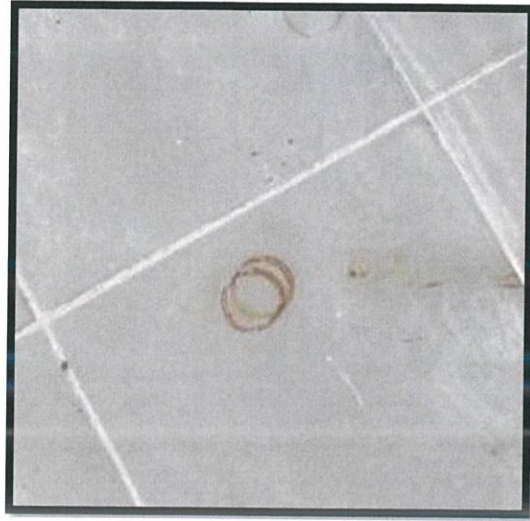
Figure 29 Stain on tiles

Stain on tiles are also defects that needed to be taken into action immediately as it could affect purchaser's satisfaction on cleanliness after handing over unit. Stains on tiles can arise from many aspects when finishing a unit such as paint stains, cement stains, rust stains, and etc. Stains on tiles can be seen on unit that has been hand over to purchaser are the caused of negligence of workers when cleaning. This can be avoided by double checking unit cleanliness by site supervisor to ensure unit is in good condition before handing over.

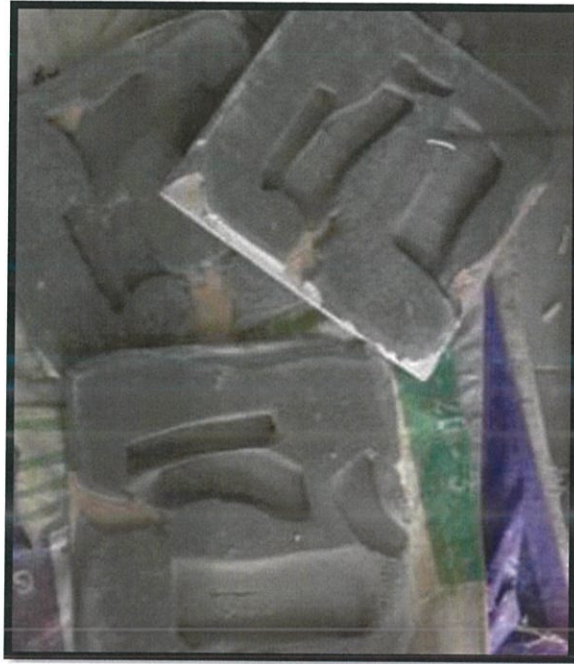
Figure 30 Hollow tiles

Hollow tiles are one of the major tile defects that needed to be handled with care and supervision. Hollow tiles can happen because of lack of cement applied when installing tiles, wall plaster hollow resulting in tiles to appear hollow and floor is hollow resulting in floor tiles to appear hollow as well. This is the cause of poor workmanship by workers and negligence of supervisor during inspection. Hollow tiles are a major financial problem for a company as more materials are needed to replace the tiles. This is because new wall plaster and floor needed to be replaced in addition to new tiles in that area. This could also add other defect while repairing tiles which is a big problem for the company.

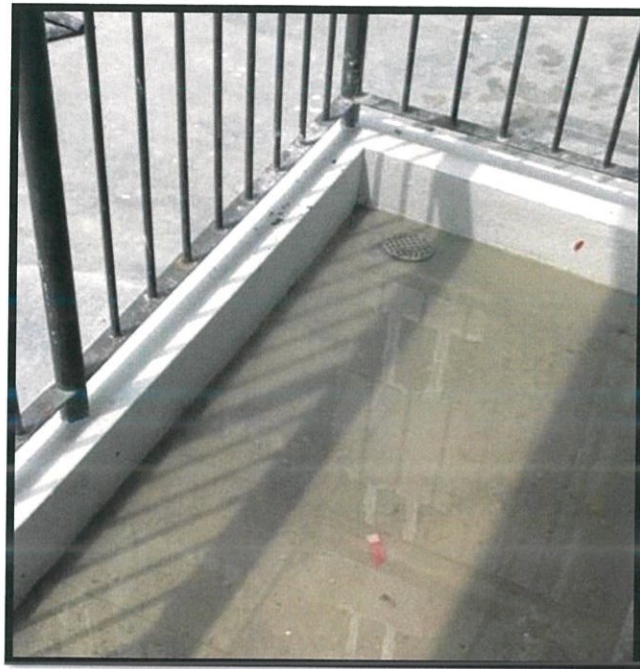
Figure 31 Water ponding

Water ponding is also one of the major tiles defect that occurs in Residensi Kepongmas unit. Water ponding is a common problem occurring in many condominiums and apartments on balcony area and bathroom area. Simply defined, water ponding is areas where large amount of water are exposed such as ponding on balcony area after heavy rainstorm and on bathroom when water tap or shower in open. Water ponding can occur when there is inadequate drainage in that certain area or wrong placement of drainage that causes small areas of water ponding. Water ponding is caused tiles are not properly placed resulting in lack of water runoff towards drains.

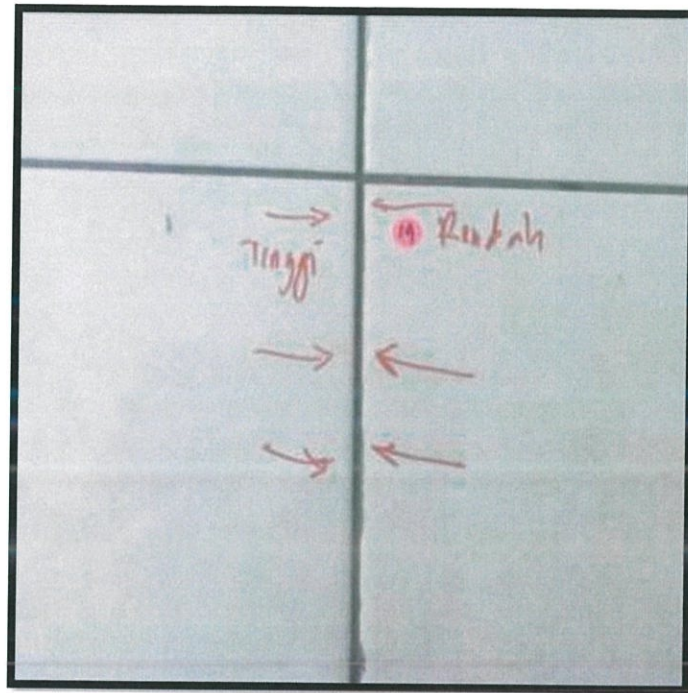
Figure 32 Uneven surface of tiles

An uneven floor or wall surface can lead to several problems in a tile job. Tiles may crack, pop loose or "lip" a condition that occurs when the corners or edges of some tiles stick up higher than those around them. This can harm owners as sharp and pointy edges of tiles are exposed. This is the result of poor workmanship when installing tiles. This can be avoided by using spirit level to identify which part of the surface is uneven prior to installing tiles
