**DEPARTMENT OF BUILDING  
UNIVERSITI TEKNOLOGI MARA  
(PERAK)**

**DEFECTS IN CONSTRUCTION**

The study is carried out on the construction project of Existing R&D Building at Lot H.S (D) 9147, P. T NO.4444, Lot 6343, Seksyen 20, Bandar Serendah, Daerah Hulu Selangor, Selangor Darul Ehsan for Perodua Manufacturing Sdn Bhd.

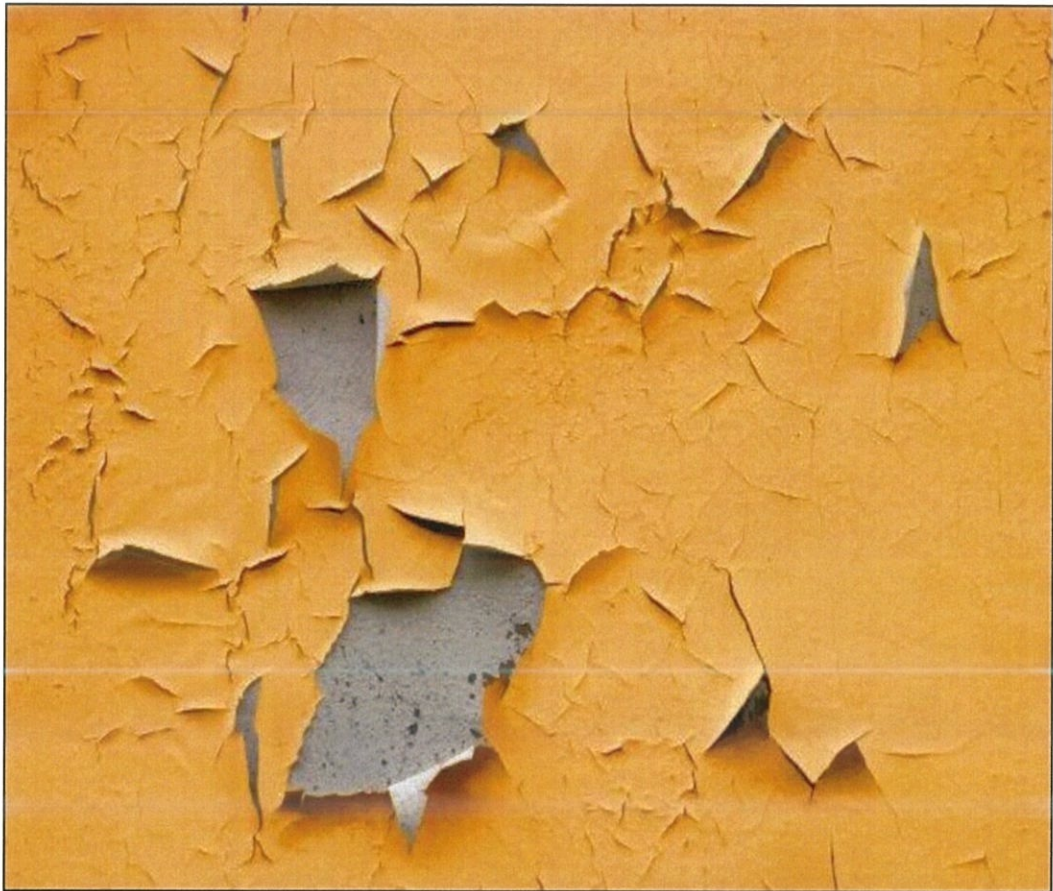
Figure 3.5: Peeling of Paint

The majority of peeling paint problems occur on surfaces exposed to the rain, sun, and the variation degree of temperature. If paint peels from an interior wall as in figure 3.5, the reason for the peeling paint is most often due to improper preparation of the surface before painting. Thus, to repair and restore, repainting the wall that had peeling paint on it can be made to make it attractive again.

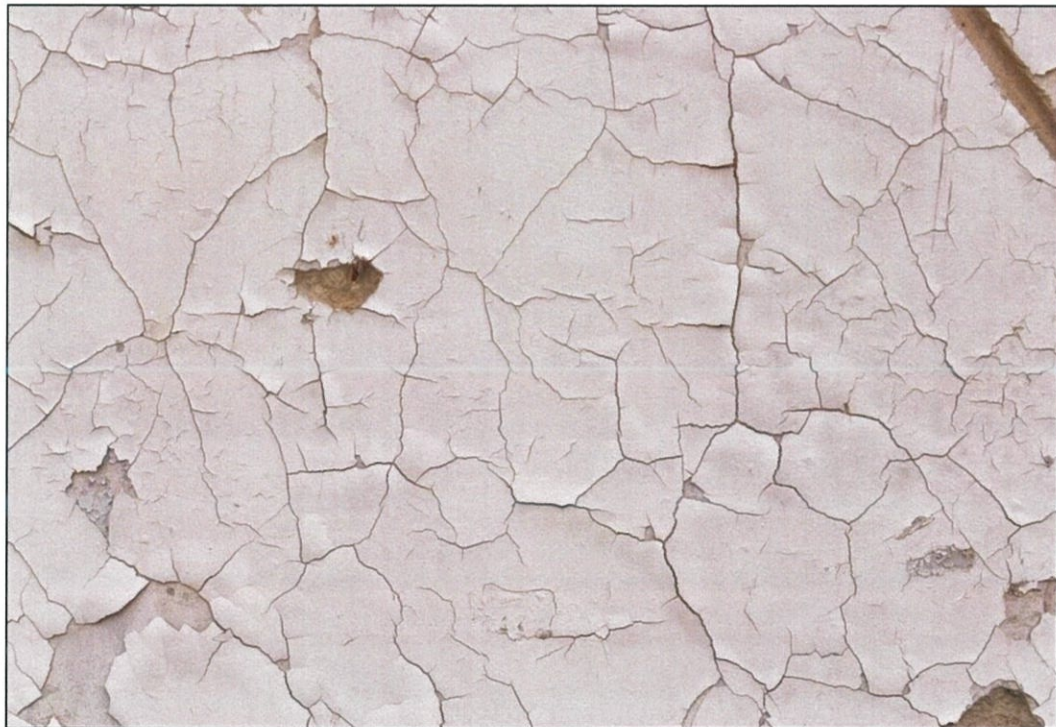
Figure 3.6: Defective Plaster Rendering

Mostly the defective plaster rendering occurs on the external walls, column, and ceiling as figure 3.6. Normally caused by biological attacks arising from penetrating rain, evaporation, condensation, air pollution, dehydration, and thermal stress. The mold or harmful growth, insect, animals, and traffic vibration also will contribution causes of defective plaster rendering. Before being decomposed and broken apart, rendering may crack due to either shrinkage or movement in the substrate. (A Ghafar Ahmad).

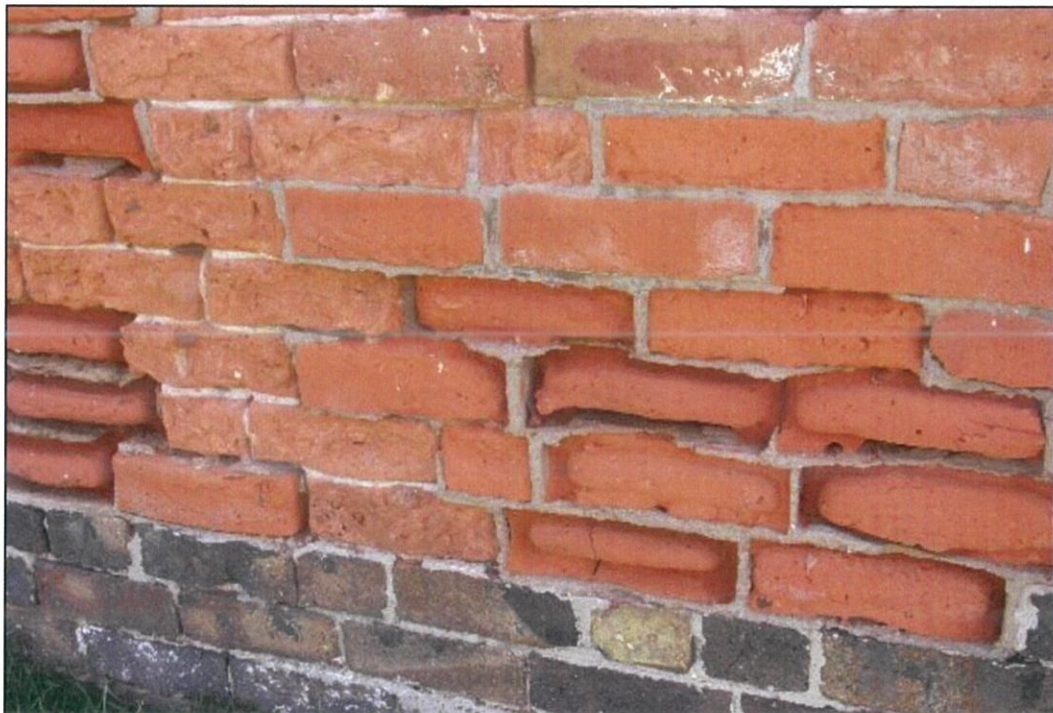
Figure 3.7: Erosion of Mortar

- i. Cracks are visible within the mortar
- ii. The bond between brick and mortar is broken or the mortar is soft or crumbling
- iii. Any portion of a mortar joint is missing

Mortar joints are not intended to be a permanent part of a masonry wall, but rather, an expendable component that does have to be replaced at intervals. Removing deterioration of the mortar joint is having through the repointing process and replacing it with new mortar. (Nadia, Bakri & Mydin, 2019)

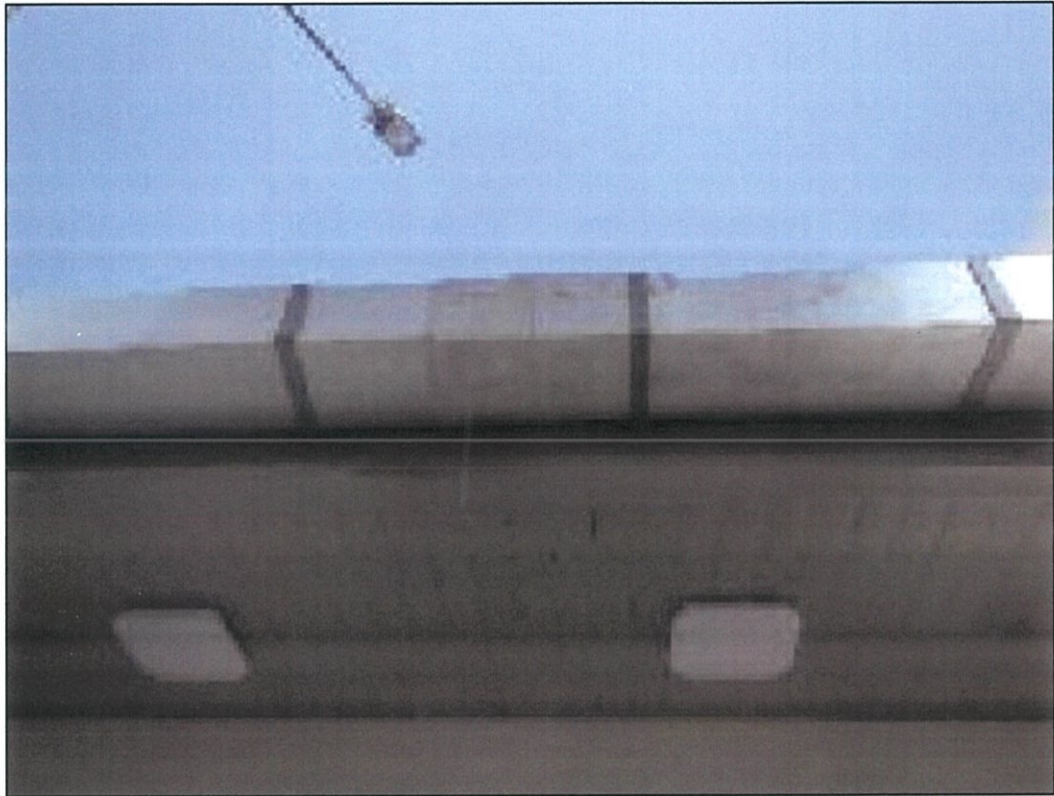
Figure 3.9: Gutter Brackets Rusty

The problem occurs due to exposure to direct sunlight and rain which makes the gutter rusty with the presence of water and oxygen into contact with iron as figure 3.9. With using metal guttering, rust comes with the territory. Once it develops on any surface, the corrosion can eat through the gutters. Gutter rust can even form large holes, coupled with the action of leaf acids which also weakens the structure and leaking rusty gutters stains paths.

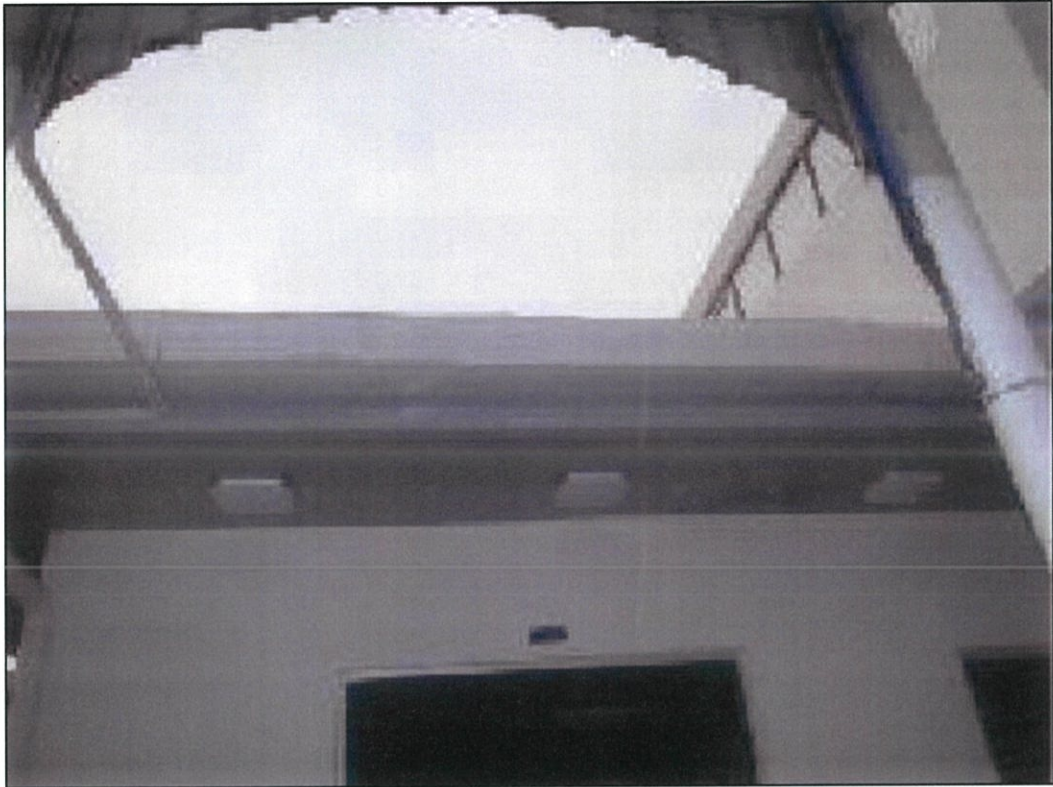
Figure 3.10: Re-Painted Gutter Brackets

The solution is the rusty gutter brackets are to be re-painted shown in figure 3.10. The gutter should be painted on a generous coat of rust-neutralizing primer and allow it to dry completely.

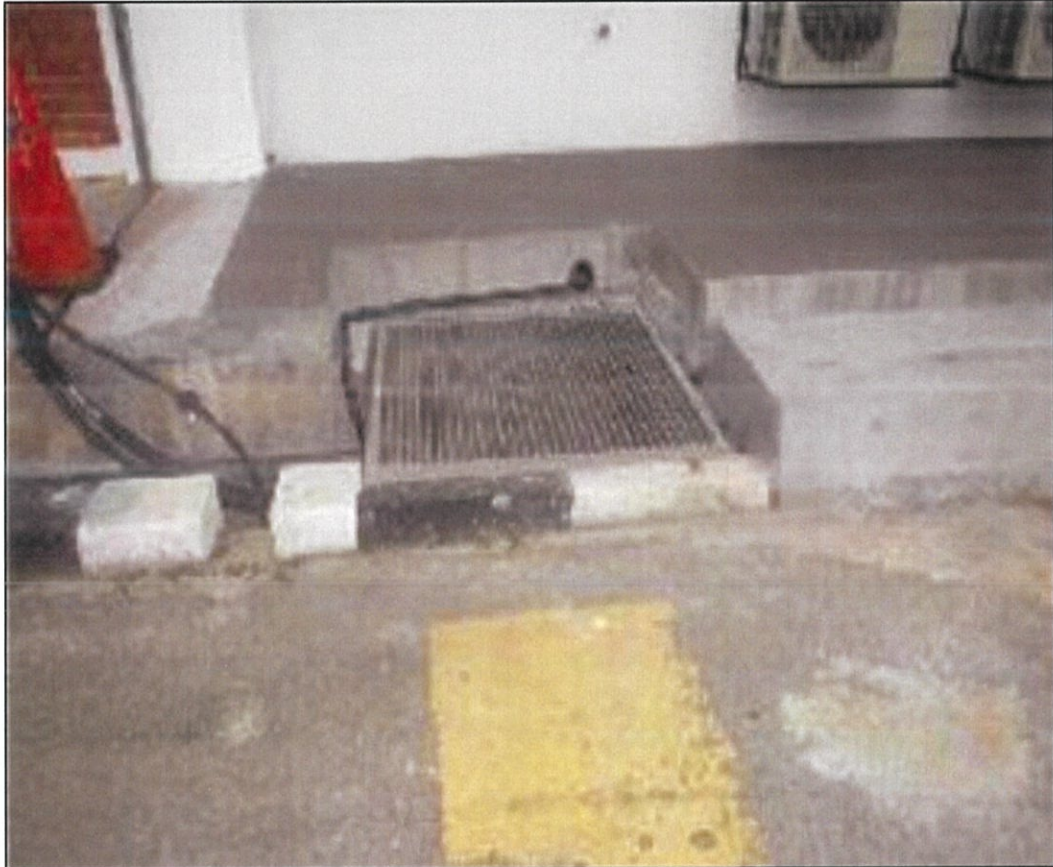
Figure 3.11: Exposed Electrical Cables

The problem occurs due to improper installation by the sub-contractor. The cable can cause passer-by saddled. Electrical cabling becomes unsafe if the bare wires are exposed as shown in figure 3.11 and they rub or strain against structural steel framing or other rough edges. Nails, screws, and pests can also damage cabling, which can lead to electrical faults, shocks or fires. It is very important to make sure that electrical installations and fittings are isolated from people.

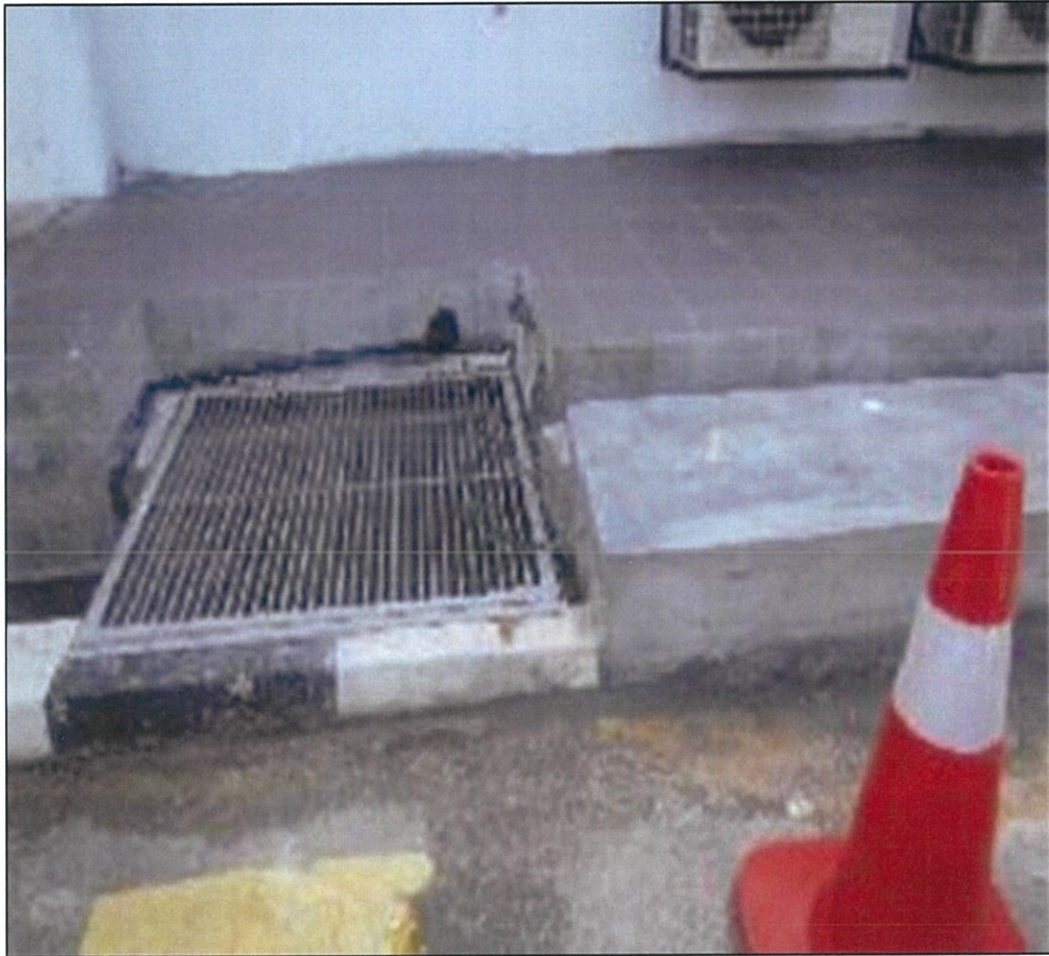
Figure 3.12: Cables to be Removed

The solution is the exposed electric cables are wrap up neatly with electrical tape until the wires are safely covered. Other than that, the cables either to be terminated or removed from the drain as shown in Figure 3.12.
