**DEPARTMENT OF BUILDING
UNIVERSITI TEKNOLOGI MARA
(PERAK)**

**INSTALLATION OF FLOOR AND WALL FINISHES FOR
BATHROOM AT APPLE 99 HOTEL**

**Prepared by:
SITI NOOR AIDA BINTI SAMSURI
2016458618**

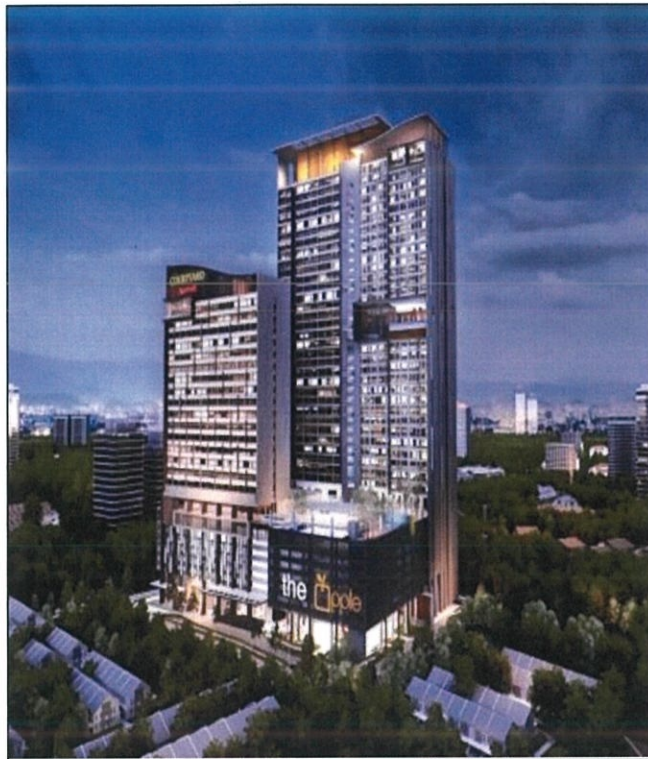
Figure 1.1: The prototype of project Apple 99, Melaka.

Title for the project that handle by construction company, Kerjaya Prospek (M) Sdn.Bhd is “Cadangan Pembangunan Hotel dan “Service Suite” 41 Tingkat dan 1 Tingkat Aras Bawah Tanah at Lot 2005 (PT 79), KB XXI, Daerah Melaka Tengah, Melaka Bandaraya Warisan Dunia”. The developer for this project is Apple 99 Development Sdn.Bhd. Cost for this project is RM412 million and the expectation of complete date is April 2019. This report were conducted the installation of floor and wall finishes for bathroom at Apple 99 Hotel.

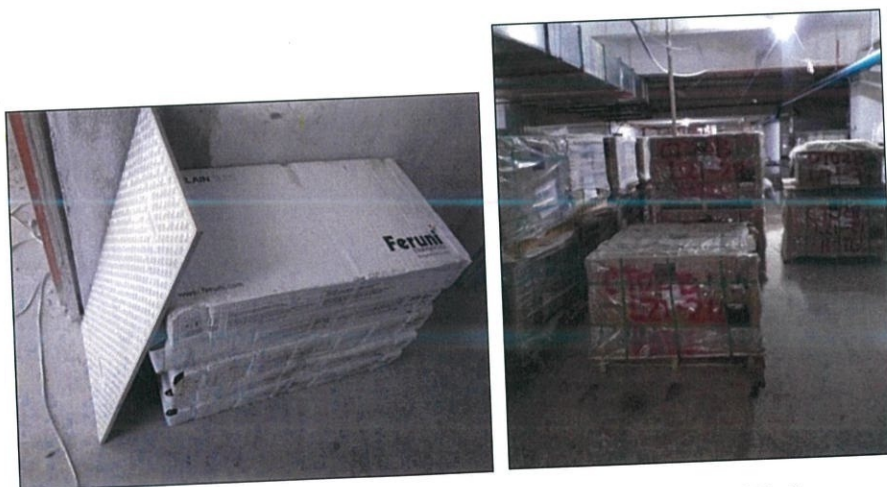
Porcelain tiles are ceramic tiles commonly used to cover floor and wall with a water absorption rate less than 0.5 percent. Plus, it is extremely tough and the tiles are difficult to crack. If the single tile does crack due to a severe impact, the process of replacing a tile is relatively simple. This is the main reason why tile is preferred for wet areas like bathrooms. Porcelain tiles that using for hotel bathroom Apple 99, Melaka is from Feruni Ceramic Sdn Bhd.

Figure 1.2: Packing tiles from Feruni Ceramic Sdn. Bhd

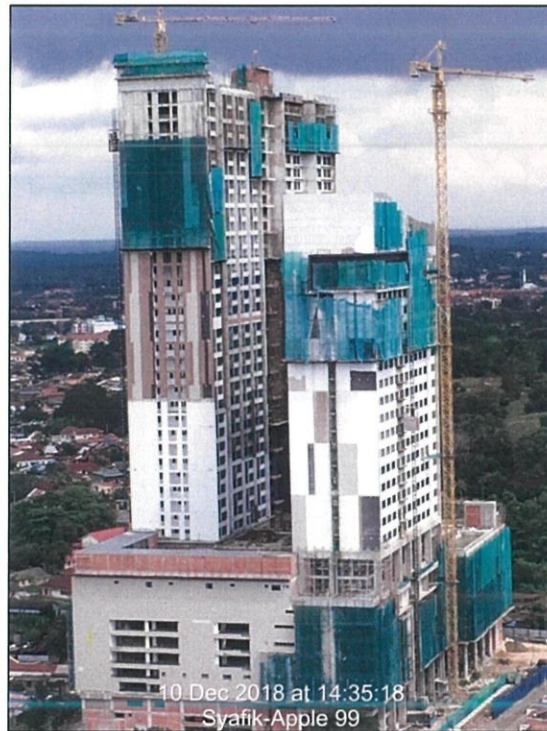
- Type of buildings : Hotel and Residential Units
- Number of Lots and Blocks : Hotel (24 Storeys,284 Units)
Service suite (41 Storeys,361 Units)
- Building Height : 41 Storeys

Figure 3.2: Condition of site on December 2018.

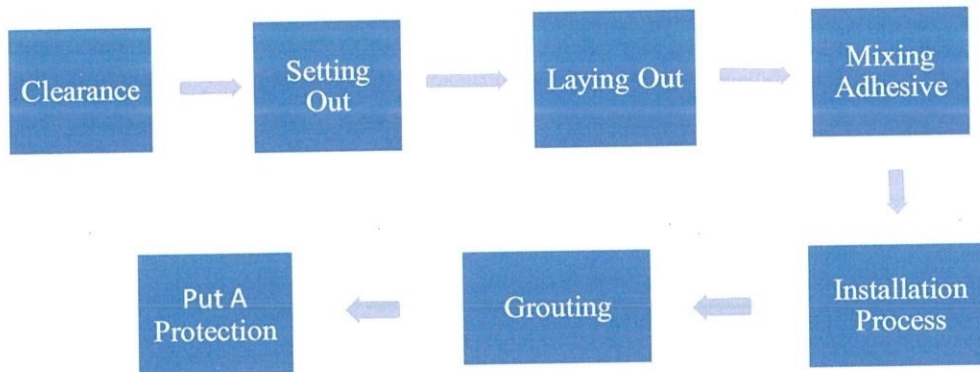
There are seven stages that should be considered for floor tiling for bathroom hotel Apple 99, Melaka project.

Figure 3.5: Flow chart of floor installation method.

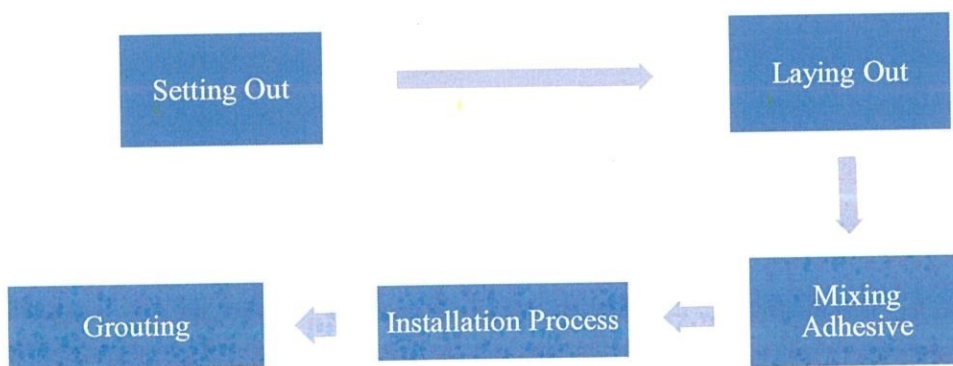
Figure 3.6: Flow chart of wall installation method.

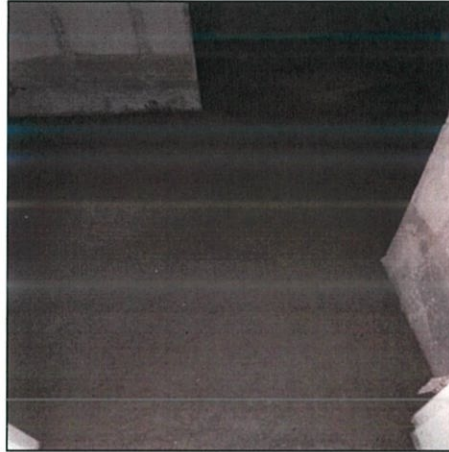
1. Clean the floor from dust and debris. This is to ensure that the tiled surface will be level.

Figure 3.7: The condition of bathroom floor that clean from dust and debris.

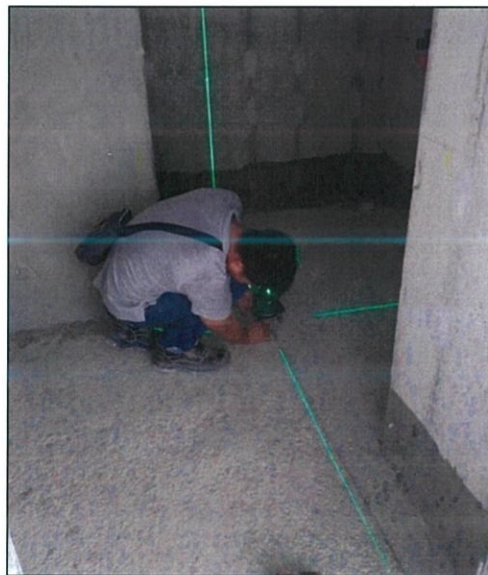
2. Measure to find the center of the bathroom using laser, and marking with oily thread that intersect exactly at the center of the floor.

Figure 3.8: The tile layer making using laser.

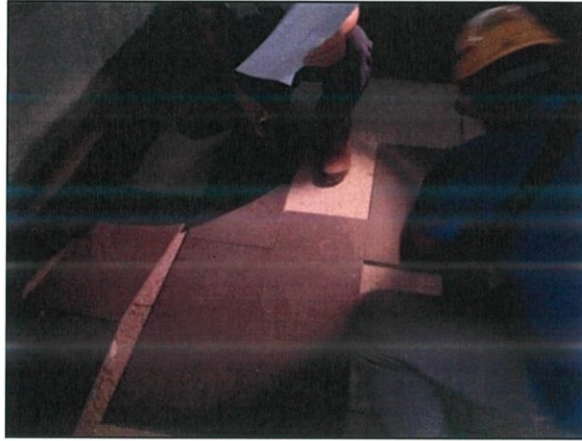
3. Before starting the installation, start with a dry run which is laying out the tiles and spacers. This is to determine where to start the process and determine the width of the grout lines.

Figure 3.9: The tile layer laying out the tiles before start the installation process.

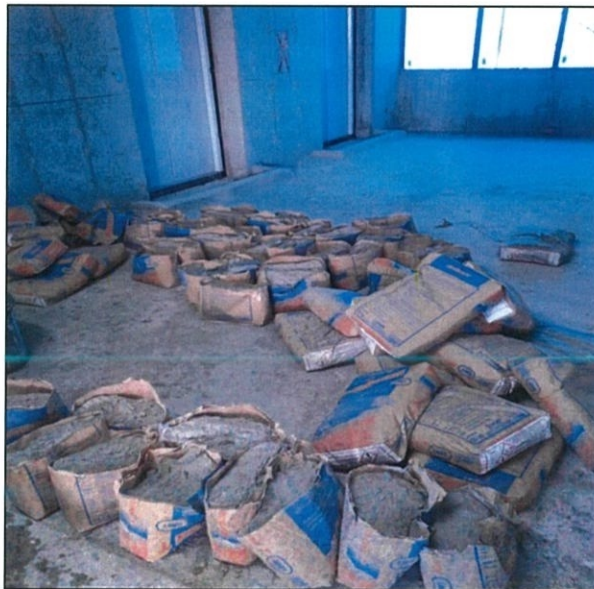
4. Pour just about an entire bag of Kerabond T cement into a container. Add an enough water to get the dry mixture wet, and start mixing using the mixer.

Figure 3.10: Preparation for mixing Kerabond T cement that use as adhesive for floor tiles.

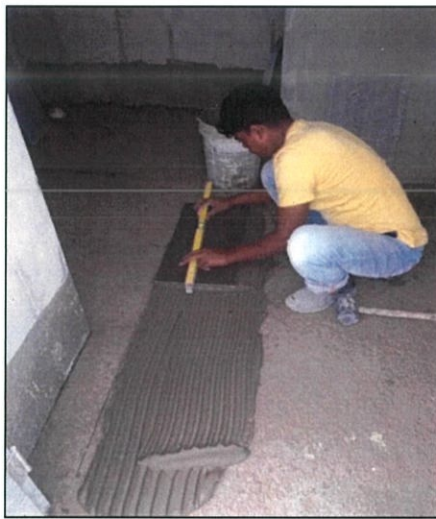
5. When the mortar is ready, begin working on one section of the floor. Spread the mixture and use a notched trowel to obtain an even layer of mortar. Work in small sections to keep the mortar from drying before the tile is in position.
6. Put the tiles at their place. Once the tiles have been laid, put a spirit level on top of the tiles. This is to make sure the verticality of the tiles. Floor tiles cannot be an equal verticality because in bathroom, we need to make sure the water is flowing not the floor trap directly.

Figure 3.11: The tile layer use spirit level to make sure the verticality of the tiles.

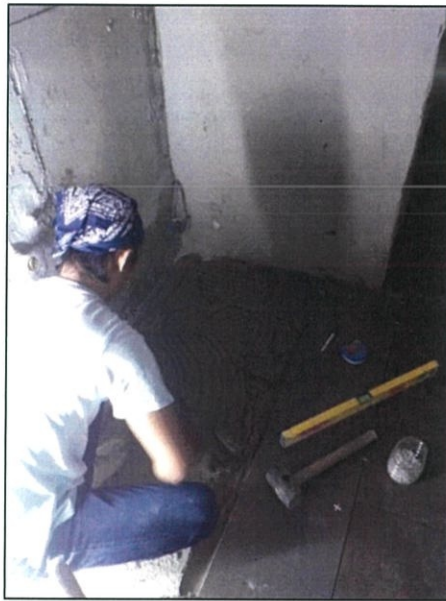
7. When getting to a wall where a standard tile will not fit, mark and make cuts with a standard tile cutter. If do not use the tile cutter, mark and have a tile supplier to cut them prior to installation.
8. Continue the process with using the oily line as a guide and placing spacers between each tile to ensure uniform distance between the tiles. The spacer is about 2mm or 3mm. When all the tiling work is complete, allow the tiles to dry in the place for several days before grouting process.

Figure 3.12: The tile layer continues install the floor tiles and put the 2mm spacer between it.

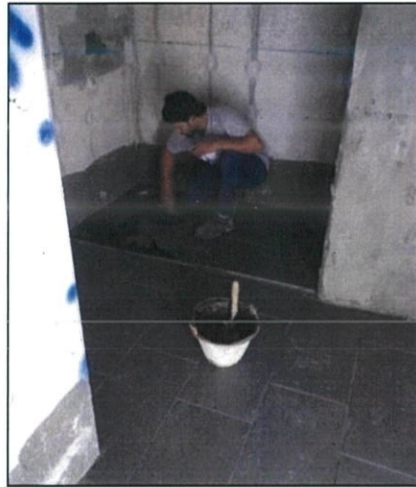
9. For the grouting process, Kerjaya Prospek (M) Sdn Bhd using Grouting 140 cement. Grout is available in a variety of textures and colors. Pick a color that matching with the tiles. Use a sponge trowel to spread the grout across the tiles at an angle to be certain to get it between each tile. Before that, remove all the spacers before the grouting process start.

Figure 3.13: The tile layer grouting the floor tiles.

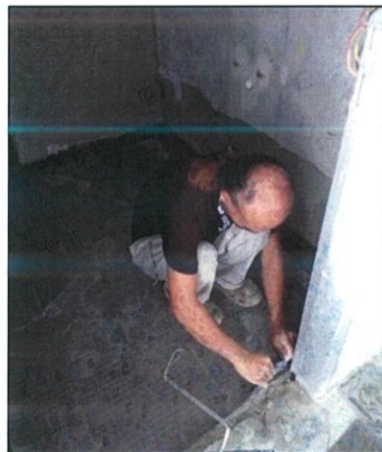
10. When the grout is in the place, wipe away the excess with a damp sponge. After a few hours, do a water flow inspection and then put the protection carpet to cover the floor during installation of wall.

Figure 3.14: The tile layer covers the floor tiles for protection during tiling wall.

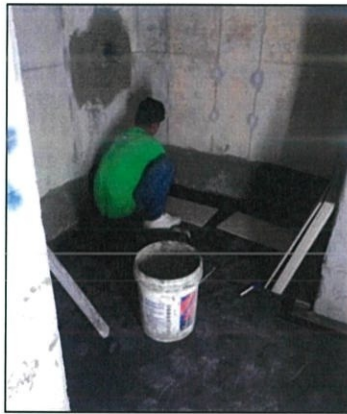
1. Measuring to find the center of the bathroom using leaser, and marking with oily thread that intersect exactly at the center of the wall.
2. Before starting the installation, start with a dry run which is laying out the tiles and spacers. This is to determine where to start the process and determine the width of the grout lines.

Figure 3.15: The tile layer prepares for install the wall tiles.

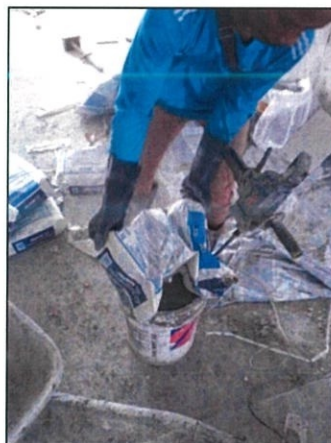
3. Pour just about an entire bag of Adesillex P9 cement into a container. Add an enough water to get the dry mixture wet, and start mixing using the mixer.

Figure 3.16: The tile layer preparing the Adesillex P9 cement for the adhesive of the wall

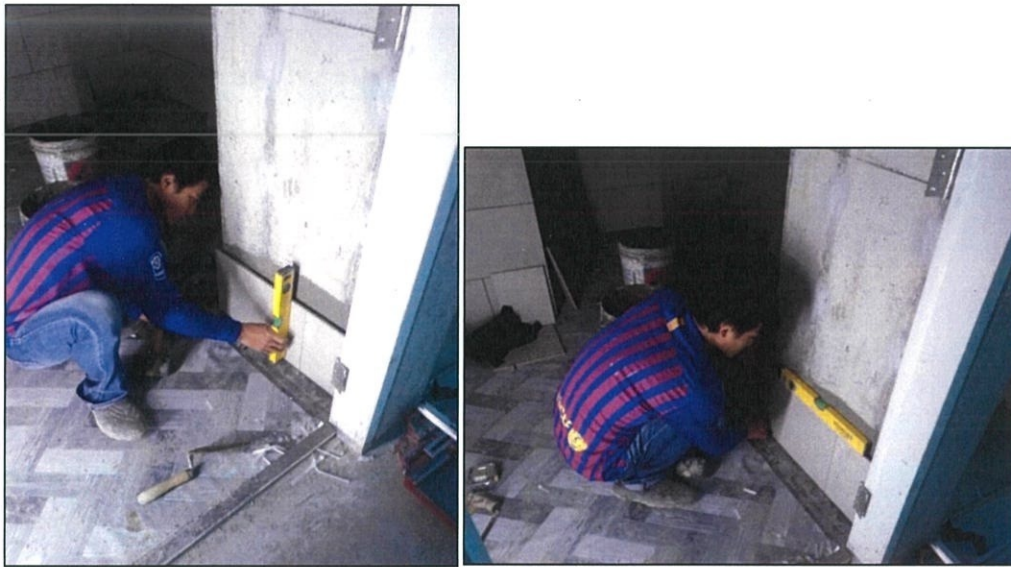
4. When the mortar is ready, begin working on one section of the floor. Spread the mixture and use a notched trowel to obtain an even layer of mortar. Work in small sections to keep the mortar from drying before the tile is in position.
5. Put the tiles at their place. Once the first row of tiles has been laid, put a spirit level on top to check that they are horizontal. This is where the wedges are helpful. If any of the tiles need adjusting, simply shift the position of the wedges to lift or drop the tiles so they line up correctly.

Figure 3.17 : The tile layer use spirit level to check the tiles are horizontal correctly.

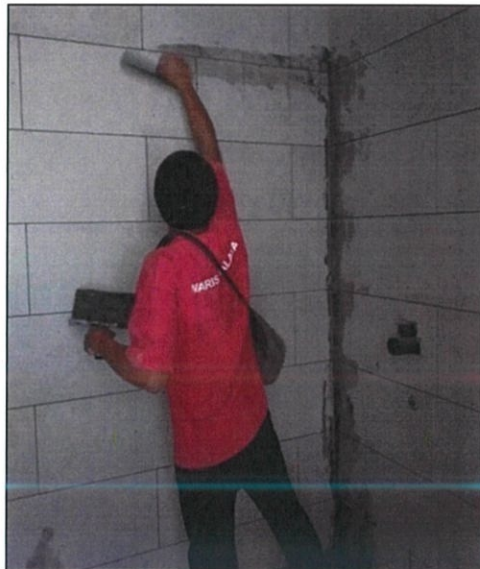
6. When getting to a part where a standard tile will not fit, mark and make cuts with a standard tile cutter. If do not use the tile cutter, mark and have a tile supplier to cut them prior to installation.
7. Continue the process with using the oily line as a guide and placing spacers between each tile to ensure uniform distance between the tiles. The spacer is about 2mm or 3mm. When all the tiling work is complete, allow the tiles to dry in the place for several days before grouting process.
8. For the grouting process, Kerjaya Prospek (M) Sdn Bhd using Grouting 132 cement. Grout is available in a variety of textures and colors. Pick a color that matching with the tiles. Use a sponge trowel to spread the grout across the tiles at an angle to be certain to get it between each tile. Before that, remove all the spacers before the grouting process start.

Figure 3.18: The tile layer grouts the wall tiles.

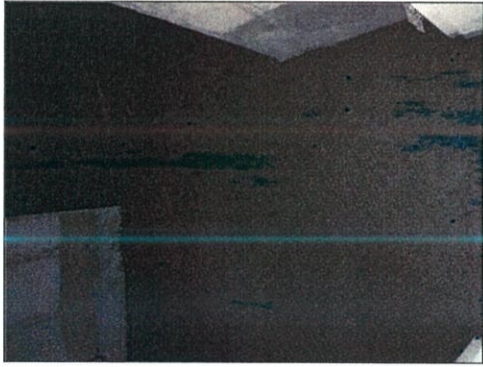
NO	OPERATION	SEQUENTIAL DIAGRAM	MACHINERY AND PLANT	LABOUR	EQUIPMENT	DURATION
1.	<p>Clearance</p> <ul style="list-style-type: none"> - Clear all the debris and rubbish that disturb the installation work of floor tiles.

<p>Figure 3.19 : Ready for installation floor tiles.</p>		<ul style="list-style-type: none"> • Worker 	<ul style="list-style-type: none"> • Broom • Wheelbarrow • Chisel • Hammer 	30 minutes

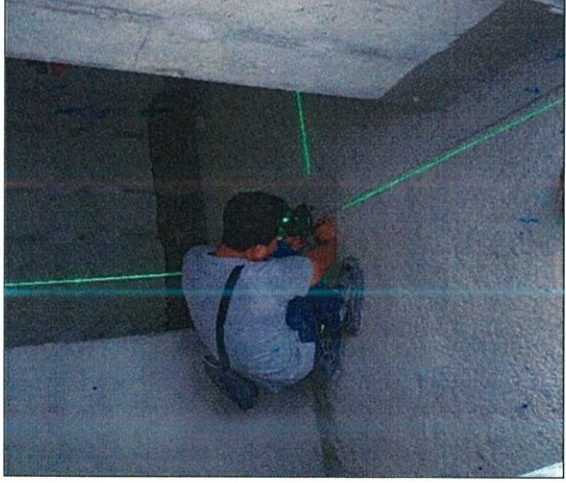
NO	OPERATION	SEQUENTIAL DIAGRAM	MACHINERY AND PLANT	LABOUR	EQUIPMENT	DURATION
2.	Setting Out - Marking to find the center of floor.

<p>Figure 3.20 : Marking center of floor using setting out laser.</p>		<ul style="list-style-type: none"> • Supervisor • Skilled labor 	<ul style="list-style-type: none"> • Setting out laser • Oily thread • Measuring tape • Permanent marker 	10 minutes

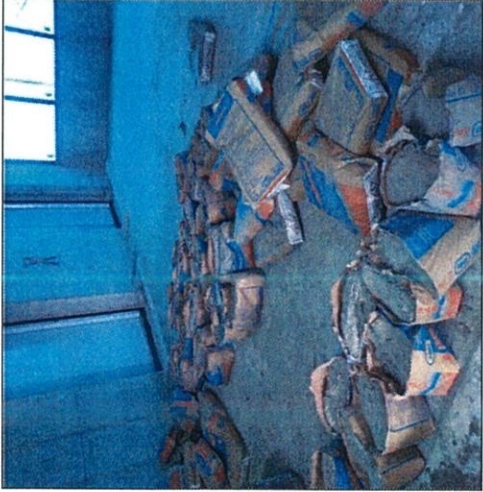
NO	OPERATION	SEQUENTIAL DIAGRAM	MACHINERY AND PLANT	LABOUR	EQUIPMENT	DURATION
3.	Mixing Adhesive - Mixing the Kerabond T cement as an adhesive.

<p>Figure 3.21: Kerabond T cement</p>	<ul style="list-style-type: none"> • Hand held mixer 	<ul style="list-style-type: none"> • Worker 	<ul style="list-style-type: none"> • Container bucket 	15 minutes

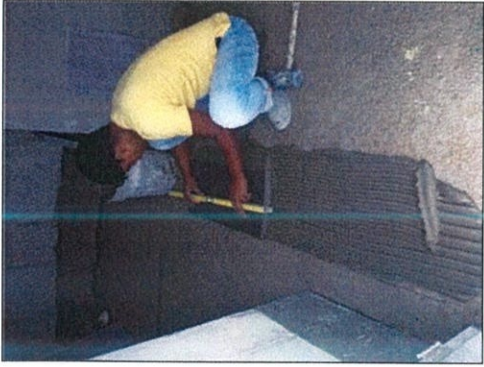
NO	OPERATION	SEQUENTIAL DIAGRAM	MACHINERY AND PLANT	LABOUR	EQUIPMENT	DURATION
4.	Install the floor tiles - Installation of floor tiles based on the architecture drawing.

<p>Figure 3.22: Measuring the verticality using spirit level.</p>		<ul style="list-style-type: none"> • 1 Skilled worker 	<ul style="list-style-type: none"> • Rubber hammer • Notched trowel • Spirit level • Spacer 	1 day

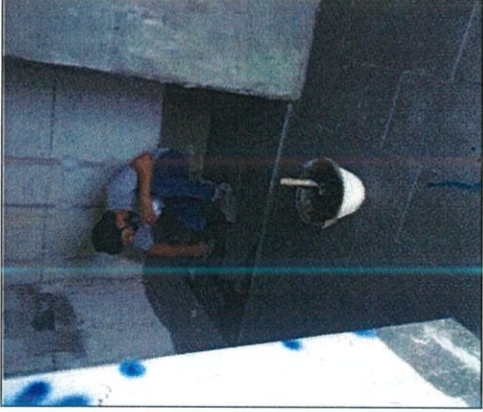
NO	OPERATION	SEQUENTIAL DIAGRAM	MACHINERY AND PLANT	LABOUR	EQUIPMENT	DURATION
5.	<p>Grouting</p> <ul style="list-style-type: none"> - Grouting process is filling the space among the tiles with the grouting cement. In this project, Kerjaya Prospek (M) Sdn Bhd using cement grout with code 141.

<p>Figure 3.23: Grouting process.</p>		<ul style="list-style-type: none"> • Skilled Worker 	<ul style="list-style-type: none"> • Sponge trowel • Small container bucket • Large sponge 	30 minutes

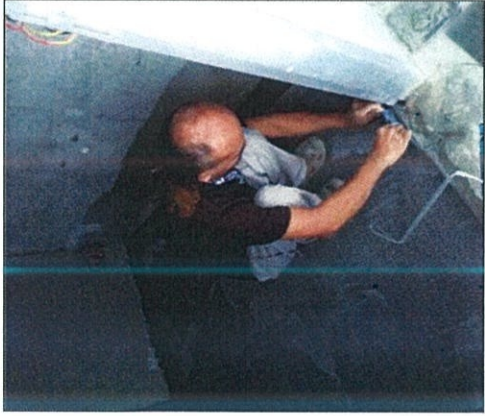
NO	OPERATION	SEQUENTIAL DIAGRAM	MACHINERY AND PLANT	LABOUR	EQUIPMENT	DURATION
6.	Install the protection carpet. - This is to protect the floor tiles during installation wall tiles.

<p data-bbox="1043 1218 1126 1574">Figure 3.24 : Installation of protection carpet.</p>		<ul style="list-style-type: none"> • Worker 	<ul style="list-style-type: none"> • 1 role of protection carpet • Scissor 	30 minutes

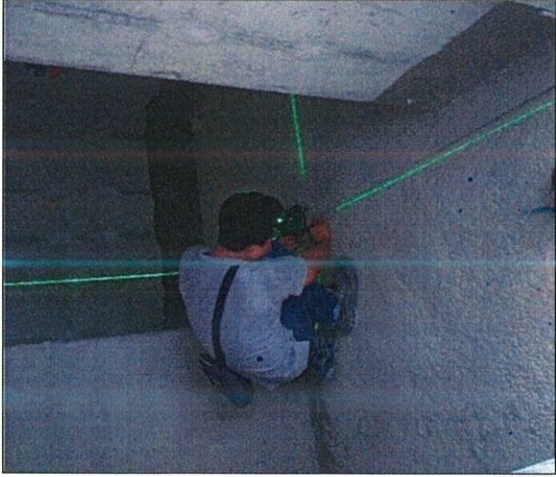
NO	OPERATION	SEQUENTIAL DIAGRAM	MACHINERY AND PLANT	LABOUR	EQUIPMENT	DURATION
1.	Setting Out - Marking to find the center of wall.

<p>Figure 3.25 : Setting out using laser for find the center of wall..</p>		<ul style="list-style-type: none"> • Supervisor • Skilled labor 	<ul style="list-style-type: none"> • Setting out laser • Oily thread • Measuring tape • Permanent marker 	10 minutes

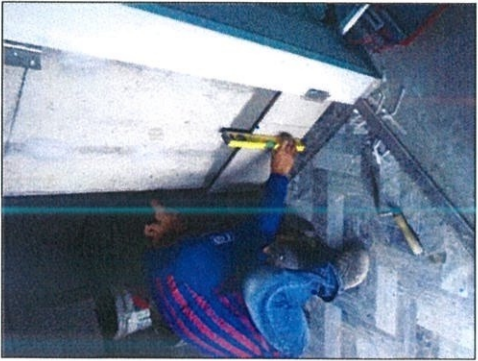
NO	OPERATION	SEQUENTIAL DIAGRAM	MACHINERY AND PLANT	LABOUR	EQUIPMENT	DURATION
3.	Install the wall tiles - Installation of wall tiles is based on the architecture drawing.

<p>Figure 3.27 : Measuring the verticality and horizontality using spirit level.</p>		<ul style="list-style-type: none"> • 1 Skilled worker 	<ul style="list-style-type: none"> • Rubber hammer • Notched trowel • Spirit level • Spacer 	2 day

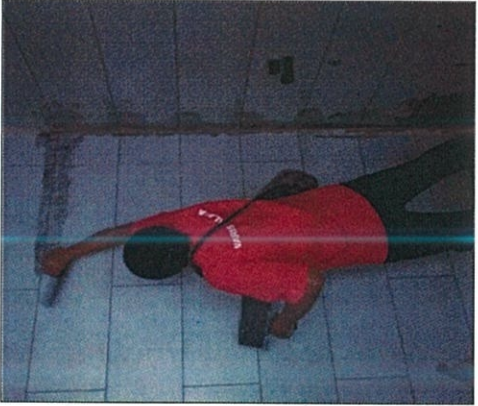
NO	OPERATION	SEQUENTIAL DIAGRAM	MACHINERY AND PLANT	LABOUR	EQUIPMENT	DURATION
4.	<p>Grouting</p> <ul style="list-style-type: none"> - Grouting process is filling the space among the tiles with the grouting cement. In this project, Kerjaya Prospek (M) Sdn Bhd using cement grout with code 132.

<p>Figure 3.28: Grouting process.</p>		<ul style="list-style-type: none"> • Skilled worker 	<ul style="list-style-type: none"> • Sponge trowel • Small container bucket • Large sponge 	30 minutes

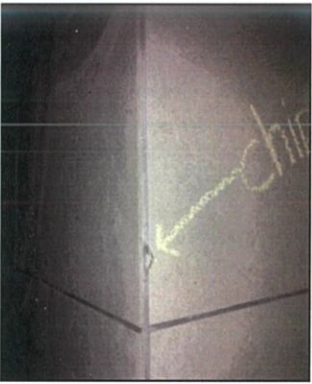
Problem	Solution
<ul style="list-style-type: none"> Tiles chipping

<p>Photo 3.29: Tile chipping</p> <p>The problem of tiles chipping is because of the shocking that apply to the tiles. Other than that, the tiles are already chipping when it produce by the suppliers.</p>

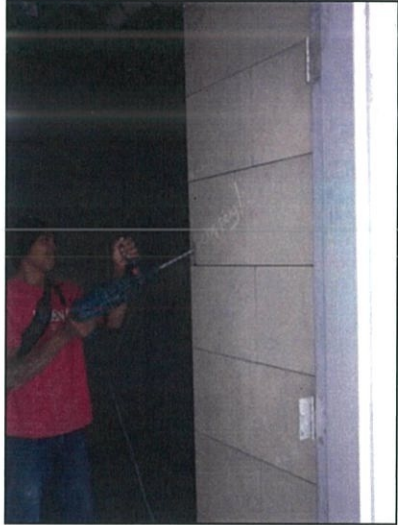
<p>Figure 3.30: Tile layer drill the chipping tile for install the new one.</p> <p>According to client representative, they do not want any chipping or crack at the tiles. So as a solution, tiler from Kerjaya Prospek (M) Sdn Bhd will install the new tiles that do not have any crack or chipping.</p>

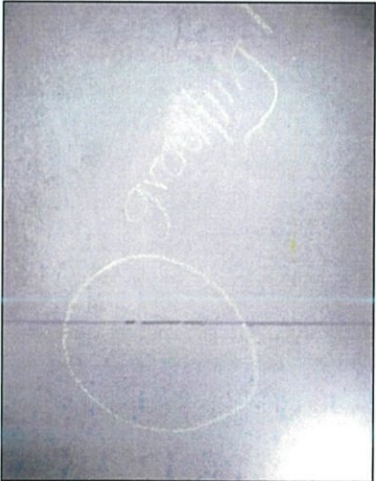
<p>Figure 3.31: Example of poor grouting.</p> <p>The tile layer maybe overlooked during the grouting process. Because of that, there are a place that do not full with grouting mortar.</p>	<p>The tiler layer from Kerjaya Prospek (M) Sdn Bhd have to fill the place that do not full with grouting mortar again.</p>

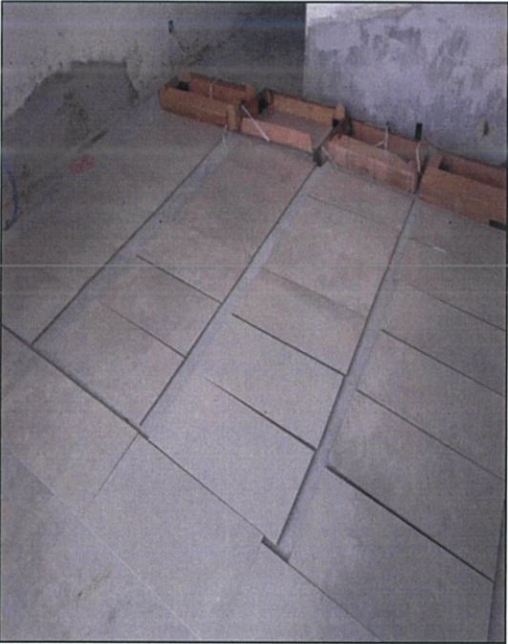
Problem	Solution
<ul style="list-style-type: none"> • Different shading of tiles

<p>Figure 3.32: Tiles that have a different shading.</p> <p>The different shading of the tiles also can be a problem. This is can cause the tiles look different than before.</p>	<p>As a solution, Kerjaya Prospek (M) Sdn Bhd will contact the supplier to see this problem with their own eyes. They have to fixed this problem such as supply the new tile with the same design as before. All the losses will not be borne by Kerjaya company.</p>

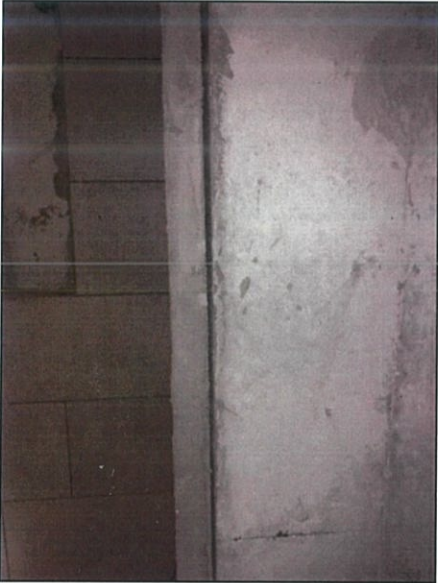
Problem	Solution
<ul style="list-style-type: none"> Floor and wall having hollow

<p>Figure 3.34: The condition of wall that cause by improper plaster.</p> <p>Based on the upper photo, Kerjaya Prospek (M) Sdn Bhd will plaster the wall because the length of the wall is decrease compare to the length that mention in architecture drawing. During the plastering work, the worker that do the job negligent and use a wrong method during plastering work. Because of that, the wall become hollow and crack.</p>	<p>As a solution ,they will hack the wall and plastering the wall again using the correct method and materials.</p>

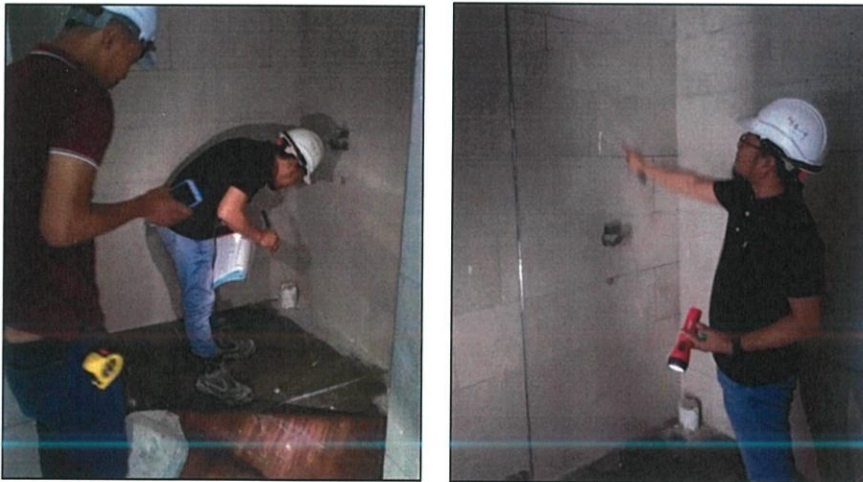
Secondly, client representative will be using drum sound detection hammer for hollow checking. They will check both which are floor and wall tiles. The reason for hollow checking in tile is if unchecked, this can lead to the tiles crack and potentially break. Aside from the aesthetics of such a result, it could and also pose a tripping hazard. For example, when the tiles are break, it can cause a wounds on foot due to injuries or other limbs due to infringement. Those are the danger especially for children.

Figure 3.36 : Inspection with client representative.

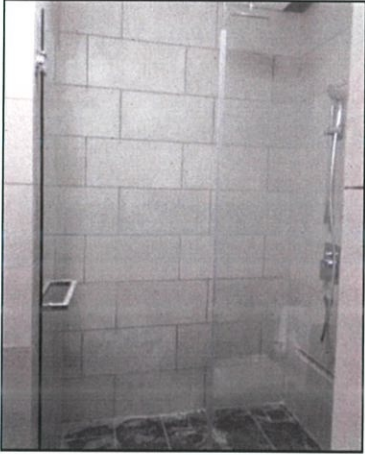
Figure 4.1: After the installation process.

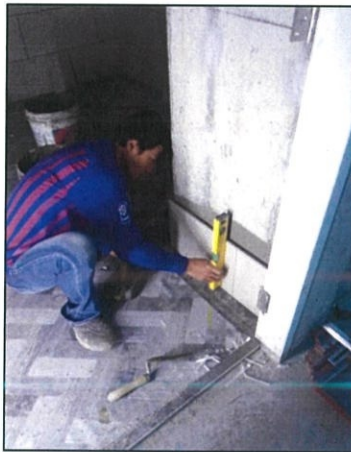
Figure 4.2: The workers make sure the verticality of tiles during installation.
