**DEPARTMENT OF BUILDING
UNIVERSITI TEKNOLOGI MARA
(PERAK)**

**MAINTENANCE WORK AT KUALA LUMPUR
INTERNATIONAL AIRPORT**

The title of the project is Refurbishment of Staff Washroom at Main Terminal, Contact Pier and Satellite Building, KL International Airport. This project consists of two phase. This project involved Mazos Sdn Bhd as main contractor, Yusma Bina Sdn Bhd, Urusan Teknologi Wawasan Sdn Bhd and TMR Urusharta (M) Sdn Bhd as sub-contractor. The period of the project is from 16 July 2018 to 16 December 2018. The scope of works are including painting work, tiling work and manpower. Soffit slab, existing wall tile, main door or entrance, cubicle door and panel, cleaner door and toilet duct door are in the scope of painting works meanwhile manpower scope such as dismantle existing metal ceiling, clear clogging and cleaning works. Tiling scope of works are removing existing tiles or hacking existing floor tiles and install new floor tiles.

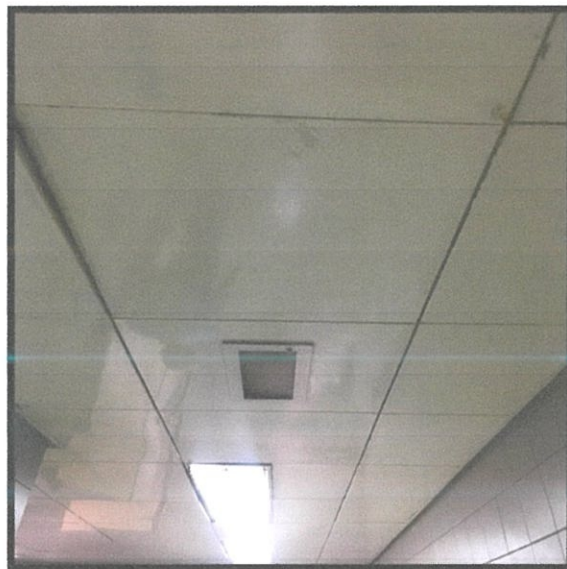
Figure 3.9 Before Paint The Ceiling

Ceiling is the first to be paint on. Brush is used to paint around the edges where the ceiling meets the walls. By using a roller on the end of an extension pole, the process of painting is quicker. After the paint is dried, second coat of paint is applied to the ceiling. Refer Figure 3.10 and Figure 3.11 for the process of painting the ceiling.

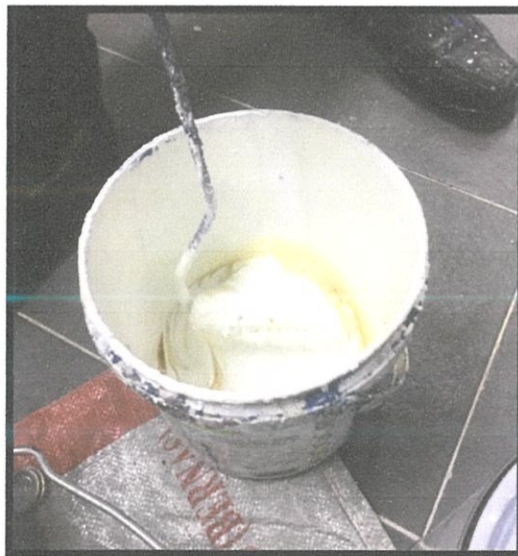
Figure 3.12 Oil Based Paint Are Mixed With Hardener and Thinner

Paint application consists of four layers. Those are undercoat, first layer, second layer and final layer. Oil based paint is typically used especially when painting the toilet walls, cubicle door, panel and ceiling. The size of tiles are 8 inch x 8 inch. The oil paint is mixed with hardener to ensure the paint can dry quickly. The oil based paint then mixed with thinner to make it thin so that the paint not lumpy when painting works is carry out and the thinner is also used to clean up after using paint. Refer Figure 3.13 for the mixing of paint with thinner and hardener. The process took at least a week to finish.

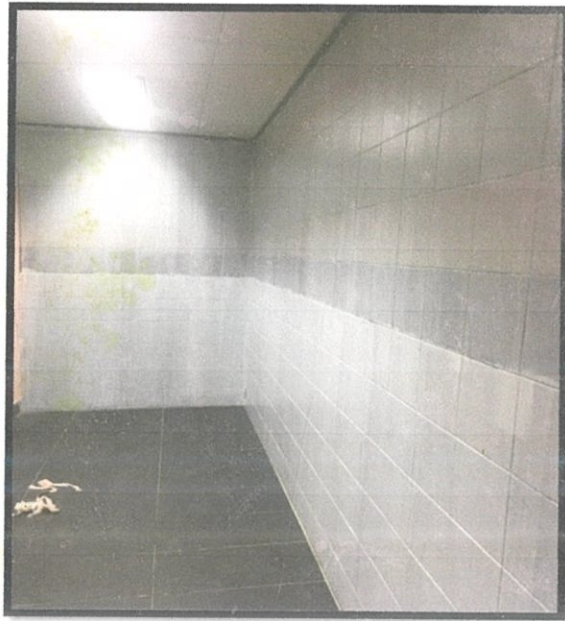
Figure 3.13 Undercoat Layer of Paint

The undercoat layer is leave overnight to let it dry. Before the first layer, painter's tape is put on tiles (to separate the color) and cubicle, door and other fittings that can't be removed to avoid dripping paint on these areas. The first layer also leave overnight to let it dry and following by the second layer and finally the final layer leave for a night to let it dry. After the four layers are completed, the inspection request needed to be submitted for checking and approval of client. If the surface after painting is not smooth, the wall is paint for a final touch up. Figure 3.14, Figure 3.15, Figure 3.16 and Figure 3.17 shows the progress of the wall painting.

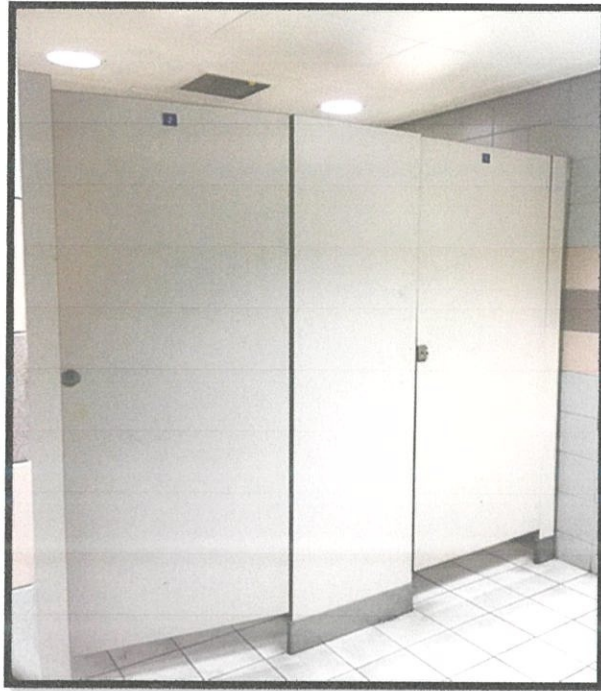
Figure 3.17 Before Cubicle Paint

Areas that don't need to be painted with painter's tape were mask off. Tape is placed around the cubicle frame or main door frame, ironmongeries such as door latch and hinges and the edge where cubicle or door meets the skirting or floor. This will help keep these surfaces from accidentally being painted. A thin coat of primer is applied to the doors. Brush is used to cover the edges with primer, and finish by covering the flat surfaces with a foam paint roller. The primer is let dry overnight so the paint can sit and harden. Apply a coat of paint to the doors and let it dry overnight.

After letting the first layer dry overnight, the paint may has some patchy areas. Second coat is applied by brushing on paint over edges and corners and using a foam roller on flat surfaces. The doors and all of the painted pieces are leave to let it sit undisturbed for a full night. Inspection request needed to be submitted for checking and approval of client. Scratches are patch up by gently sanding and painting over them. Fine grit sandpaper is used to lightly sand the chipped area. Brush with the same paint that's already on the doors is used to paint over the scratch. Figure 3.18 and Figure 3.19 shows before and after applying the paint of the cubicle doors.

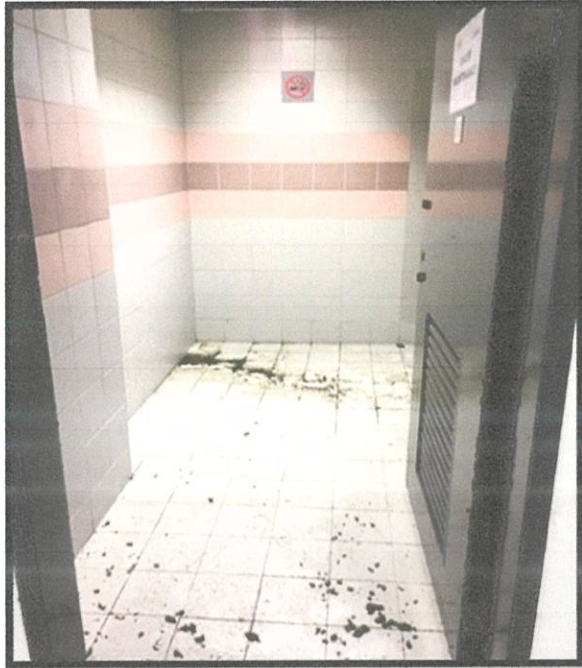
Figure 3.19 Before Removing Tiles

The area is emptied and take out any fixtures that may disturb the process of removing the tile. Water supply is turned off before removing tiles. A hammer and chisel is used to form a starting point for prying up tiles to break out a tile. Tiles that were attached with mortar possibly will come up easily or need great energy to remove it. The tiles then removed by using electric demolition hammer. From the starting point, Prying up tile is carry on. Tiles are dump in sacks as they are removed to lessen wastes. The sacks then carried on a wheelbarrow to dump it on dumpster. Finally, the mess is clean up with a broom and a dust pan. Shovel can be used to remove large debris.

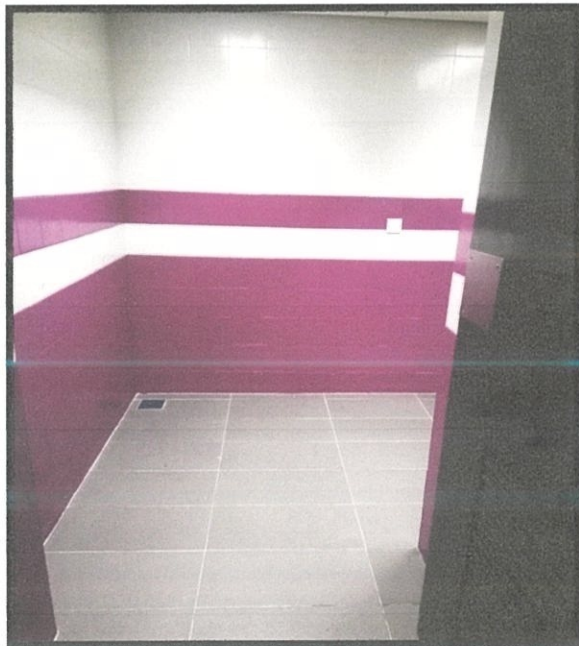
Figure 3.20 After Installing Tiles

Measuring tape is used to calculate how much tile and mortar will be needed. The tiles size are 1 feet x 2 feet. If using a different trim, edge tile is lay first. Then lay tile in a formation that will use the most whole tiles and best fits the space. Tiles is arrange in position to reduce visibility of tiles that must be cut to size. Once the best arrangement has been finalized, tiles that must be cut are determined to complete coverage. Tile cutter is used to cut tiles required to complete floor. Cement and cement gum is mixed by the 2:1 ratio to form mortar. A thin layer of thin set mortar is spread to floor in small sections using a notched trowel. Replace tiles a few at a time. Tiles surface level can be verified by using a spirit level.

After tiles are completely in position, let mortar to dry for 24 hours before continuing. Once mortar is dry, grout is mix and use a grout float to fully fill spaces between tiles. Once grout has been completely applied, use a damp sponge to rub away excess grout, allowing tiles clean and grout smooth and even. Grout left on tile results in “grout haze” and hard to remove as soon as grout has set. Grout is ready to walk on within 24 hours, although may take several weeks to fully cure. Refer Figure 3.20 and Figure 3.21 for before and after installing new tiles.

The tiles are move from one place to another place hence it cause some of the tiles are chipping on the edge. By carrying the tiles in a proper way may prevent from chipping. When installing the tiles, the mortar that spread can be uneven distributed causing gap between tiles. When this happened, grout is filled between the tiles.

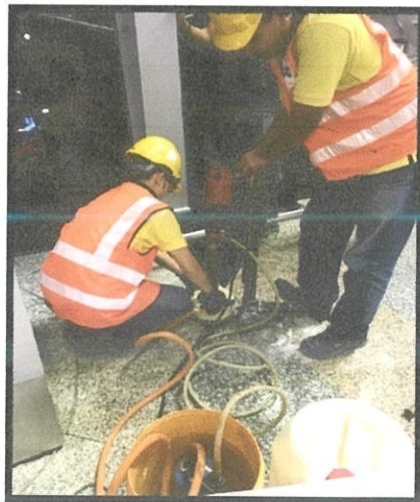
Figure 3.21 Coring Process

Before set up a goalpost signage, coring work was perform with coring machine. Refer Figure 3.22 for the coring process. The goalpost light box signage is installed at Level 5 of Main Terminal Building which is an area for check in for flight departure. The size of the light box is 5600 mm x 440 mm. The strip ceiling and rock wool above the ceiling below Level 5 was detached by riding a scissor lift to avoid water from the coring activity. The floor thickness is 280mm. After coring, strip ceiling and rock wool are put back in place. Holes for screw are made on the floor by using heavy duty rotary hammer and the goalpost are installed by joining screw at the hole at the bottom of the goalpost to the floor. The process is repeated once more because there are two goalpost. Light box are then installed by riding a scissor lift. Lastly, install rubber at the goalpost. Figure 3.23 and Figure 3.24 shows the process of installation goalpost light box signage.

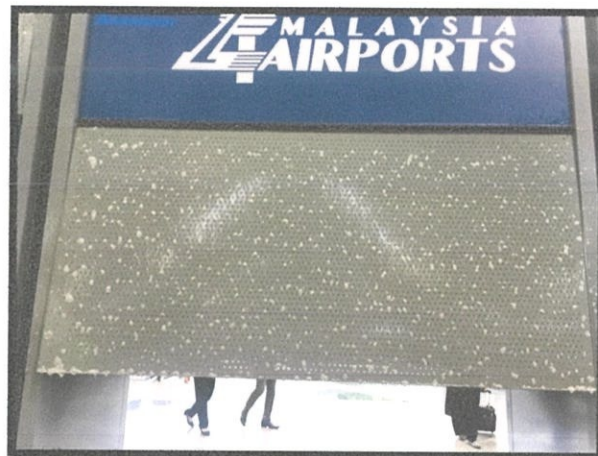
Figure 3.24 The board is Sprayed Soap Water

The board is sprayed soap water and the back of the sticker to remove the air bubbles when applying the sticker on the board. Sticker is then applied on the board. By using a sponge, the air bubble are removed slowly. If there are air bubbles left, lighter is light lightly to heat the sticker to make it melt a bit thus removing the air bubbles inside. The leftover of the sticker are cut by cutter and then the sticker are wipe to remove the stain of soap water and to ensure the sticker is applied properly. Figure 3.25 and Figure 3.26 shows before and after the installation of the inkjet sticker.

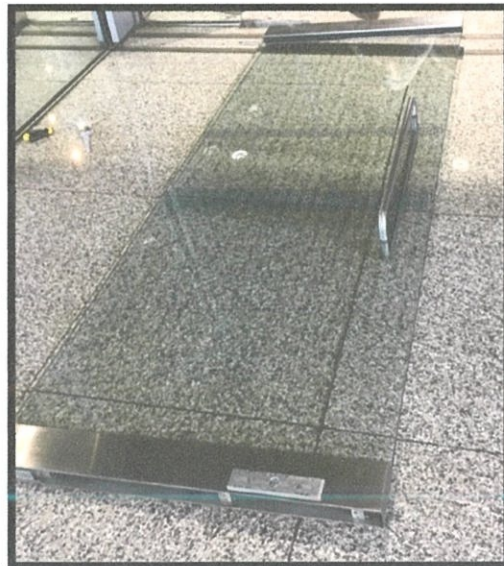
Figure 3.26 The Door Leaf was Remove

Skilled workers are required in the installation process. Door is repair when the alignment of the door is dislocated. Dismantle the door and install butt hinges. Door is installed in its place. If the door is not fitted to its frame, the door leaf is scrape using grinder to reduce its size.

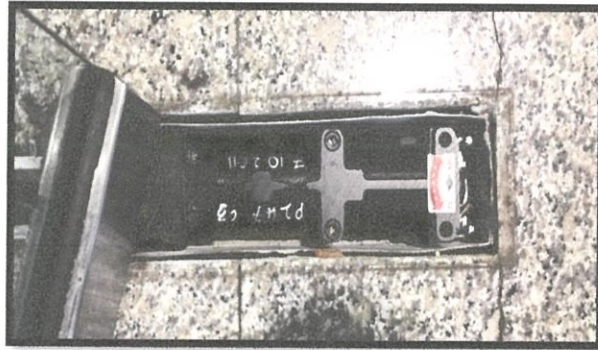
Figure 3.27 Before Replace Floor Spring

Floor springs is replace for single and double action doors up to 300 kg leaf weight, with adjustable hold-open start point and delayed action. It is featured with hydraulically fully controlled closing cycle and back check door closer. The door leaf is removed from the frame. The door leaf is put on the floor to remove the floor spring at the bottom strap of the door. The floor spring is replaced. The closing speed and height adjustment screw is adjusted. The floor spring is covered and door leaf is reattached to the frame of the door. Figure 3.27, Figure 3.28, Figure 3.29 and Figure 3.30 shows the process of installing new floor spring.

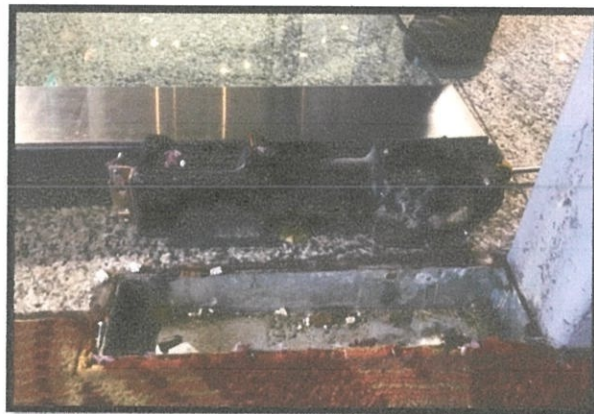
Figure 3.28 The Floor Spring is Remove from Bottom Strap

Glass door is consists of many components and one of them is bottom strap. The function of bottom strap is to hold the floor spring. Floor spring weight is up to five to six kilogram which can lead the bottom strap to be damaged when removing the floor spring from the bottom strap. The only solution to face this problem is by replacing with a new bottom strap.
