**DEPARTMENT OF BUILDING
UNIVERSITI TEKNOLOGI MARA
(PERAK)**

**THE CONSTRUCTION FOR ISMAIL PETRA MOSQUE
EXTENDED BUILDING**

DEPARTMENT OF BUILDING
FACULTY OF ARCHITECTURE, PLANNING AND SURVEYING
UNIVERSITI TEKNOLOGI MARA
(PERAK)

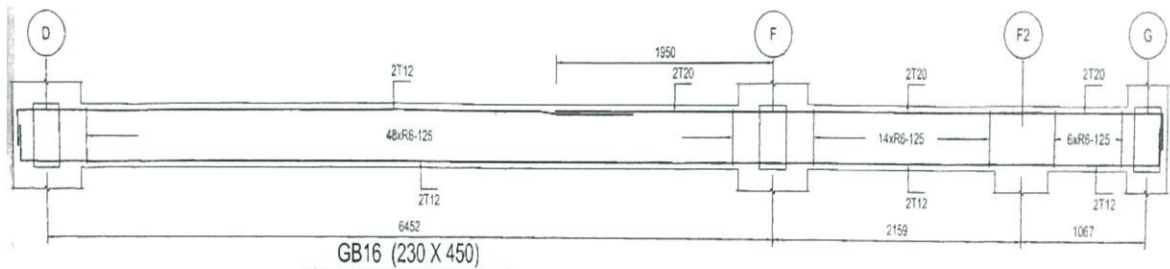
Figure 10: Plan ground beam detail GB16 in structural drawing

The ground beam was built after the construction of pad foundation. The position of ground beam was determined using water pipe levelling and marked using thread. The thread acts as a pointer to erect 12mm thick plywood of formworks. Detail drawings were needed to measure the size of the ground beam, for example, for Ground Beam No. 16 (GB16) as shown in Figure 10, the total length of formwork was measured from the centre of footing D to the centre of footing G (5,452mm + 2159mm + 1067mm).

This made the total length count 9,678mm in length, with 230mm thick and 450mm wide as according to the section detail drawing. The formwork was built (like a rectangular box as Figure 10, without soffit) using a hammer and nail. The engineer checked to ensure that the connections of the formwork have no openings to avoid leakages and loss of water from concrete that may cause honey comb. The aspects of the formwork that were examined were the size, the verticality, the alignment, the rigidity and that it was free from dirt. As the plywood had smooth surface, it did not require oil/grease to be applied at the inner surface of the plywood. Smooth surfaced plywood made it easy to be removed once the concrete is set, although no oil applied onto it. The strut was then erected at every 500mm as bracing to hold the box formwork so that it would not bulge when tonnes of concrete are poured inside.

After that, main reinforcement bars was formed and tied (also in a box shape based on ground beam detail) using a bar bending machine as shown in Figure 11. Four main bars were required to form the box shape. Stirrups were tied perpendicular to all four bars at every 125mm to resist shearing action and to prevent the bars from bending outwards. The sizes of the main bars varies according the load as calculated by the consultant. For example, for GB16, as shown in Figure 10, two main reinforcement bars of

12mm diameter, high tensile (2T12) started from footing D were overlapped with two bigger bars (2T20) at 1950mm before it reached the footing F to provide structural continuity. The 2T20 continued until the gridline footing G. The other two main bars at lower part of ground beam continued to use similar smaller reinforcement bars, 2T12.

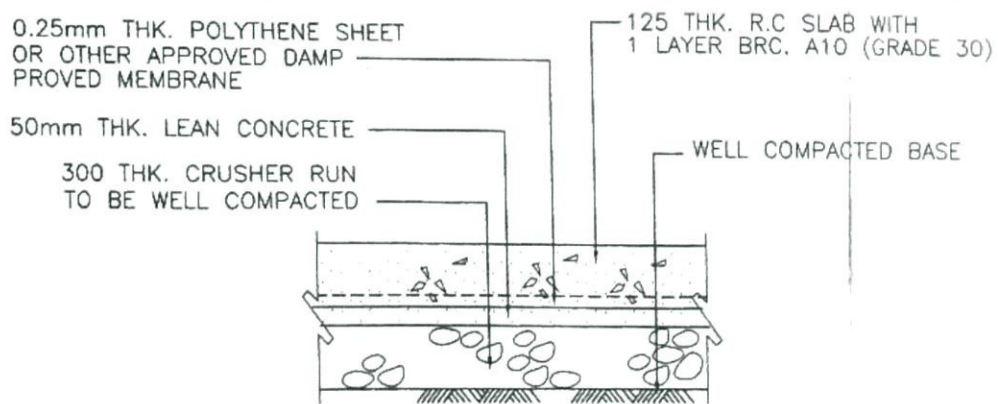
Figure 12: The plan detail of ground floor slab in structural drawing

The ground (base) was compacted for every 1 feet by using compactor machine so that it is able to receive load. After that, 300mm thick of crusher run was used to increase the load bearing capacity. The crusher run was levelled and compacted as shown in the plan detail of ground floor slab in structural drawing as in Figure 12. Concrete

grade 15 ordered from the batching plant was then poured for form 50mm thick lean concrete to provide uniform surface and prevent direct contact with the crusher run. Next, the damp proof membrane (DPM) was overlaid on the lean concrete once it was dry. The material of DPM used was 0.25mm thick polythene sheet. BRC A10 was laid on top of the lean concrete and 50 mm spacer bars were tied at the bottom of the BRC A10. 125mm thick of concrete grade 30 was poured directed from the mixer truck. The workers used hoe to spread the concrete to slab area. Vibrator was used to ensure that no airspace is left in the concrete mix. The trowel was used to smooth the surface.

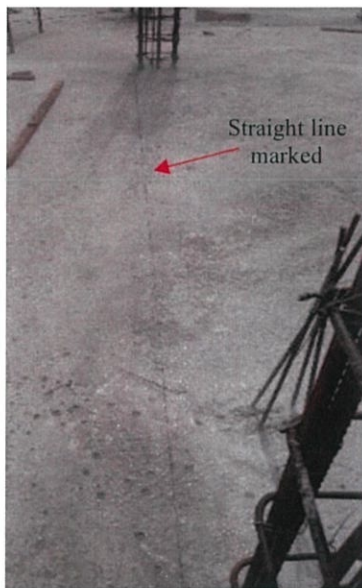
Figure 15: The straight line was marked on the ground slab

The column was built after the construction of ground slab. The position of column was determined by using water pipe levelling and the straight line was marked to the ground slab by using a nail. Figure 15 shows the straight line was marked with nail to the ground slab to make sure the position of column was same as in structural drawing. The column schedule was referred to measure the size of the column, for example, for tied column in ground floor (C5) as shown in Figure 13. The size of tied column (C5) was 450mm×450mm. The 10 main reinforcement bars 20mm, high tensile (10T20) was overlapped with the column stump. The stirrups reinforcement bars were cut by

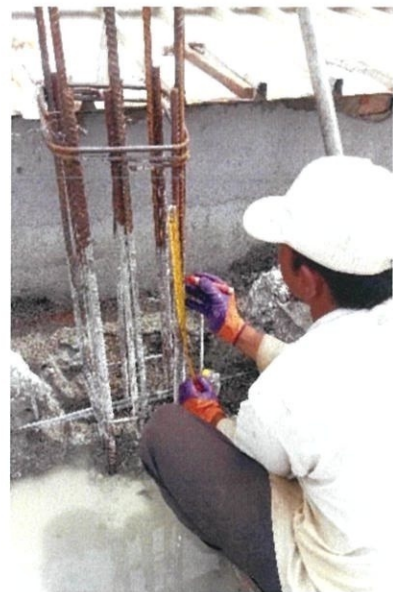
Figure 13: The worker marked the location of stirrup to the main bars

using rebar cutting machine according to the length specified in the structural drawing and bent at a radius of 90 by using bar bender machine. The stirrups for C5 used three mild steel round bars size 10mm with spacing 175mm centre to centre (3×M10-175). The location of stirrups on main bars was measured 175mm using measuring tape and marked with red marker pen as shown in Figure 14. The stirrups were tied perpendicular to the main reinforcement bars to all ten bars at every 175mm using a rebar tie wire by using bar-tie wire twister.

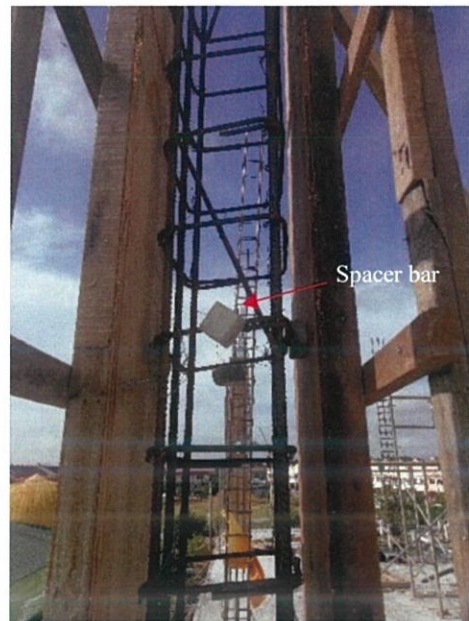
Figure 16: The spacer bar was tied to the reinforcement bar

The engineer checked whether the binding was correct and approved it before the formwork were installed. The 50mm thick spacer bar was tied to the main bars column to allow space for the concrete to fully cover all reinforcement bars as shown in Figure 16. The height of formwork was measured from the ground floor level to the first floor level, 6,096mm. This made the height tied column 6,069mm, with 450mm length and 450mm width according to the column schedule for C5 as shown in Figure 13. The formwork was built using a hammer and nail. The engineer checked to ensure that

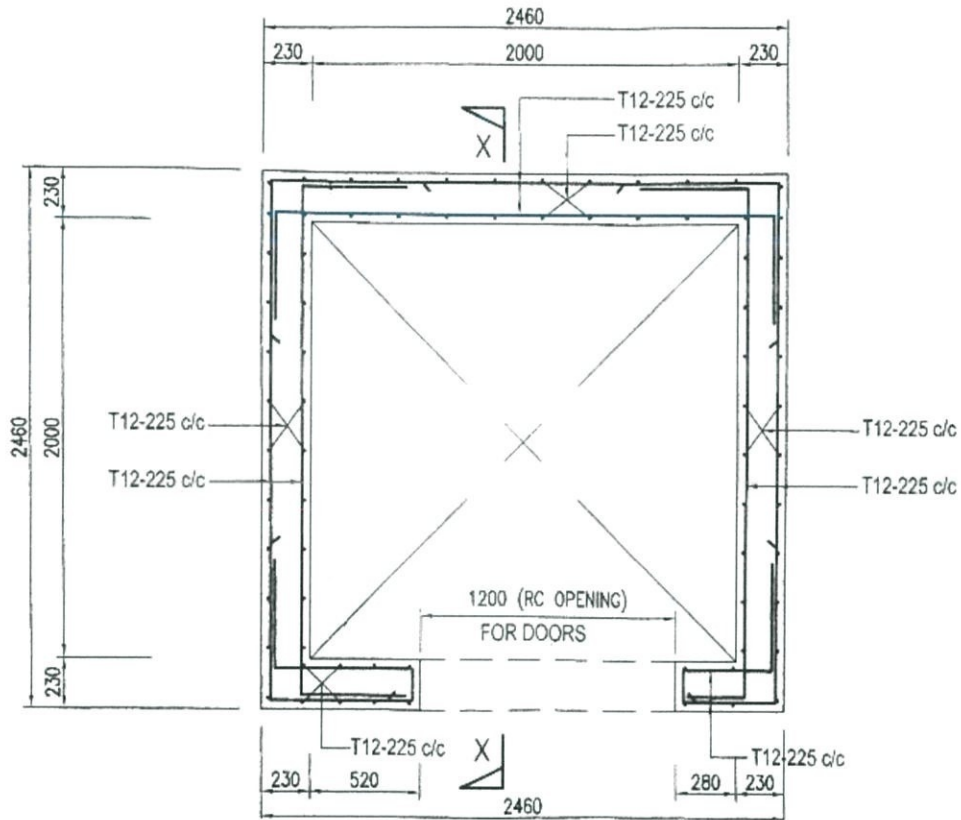
Figure 17: The typical lift shaft plan

The construction of lift shaft was built concurrently with columns. Detail drawings were needed to measure the size of the lift shaft, for example the typical lift shaft plan

shown in Figure 17. The height of lift shaft was measured from ground floor level to the first floor level, 6096mm. This made the height lift shaft was 6,096mm, with 2400mm length and 2400mm width as according to the typical lift shaft plan as shown in Figure 17.

The formwork for inside of lift shaft was built in a shape of box with an opening 1200mm while the length of lift shaft was 2000mm and width 2000mm. Inside the lift shaft the staging was installed to support the formwork of lift shaft. The main bar for lift shaft used size 12mm, high tensile with spacing 225mm centre to centre (T12-225

After that, the spacer bar with 50mm thick was tied to the main bars to provide spacing between main bars and formwork. The outer formwork of lift shaft was built according to the typical lift shaft plan as shown in Figure 17. The engineer has to ensure that the connections of the formwork have no openings to avoid leakages and loss of water from concrete that may cause honey comb. Concrete casting was carried out to complete the construction of lift shaft. Ready-mix concrete was ordered from concrete batching plant. The grade for crushing strength of concrete was used 30N/mm² (Grade 30). The concrete was poured from the truck to a bucket and in the formwork using a crane. The concrete was properly vibrated by using vibrator to ensure satisfactory compaction.

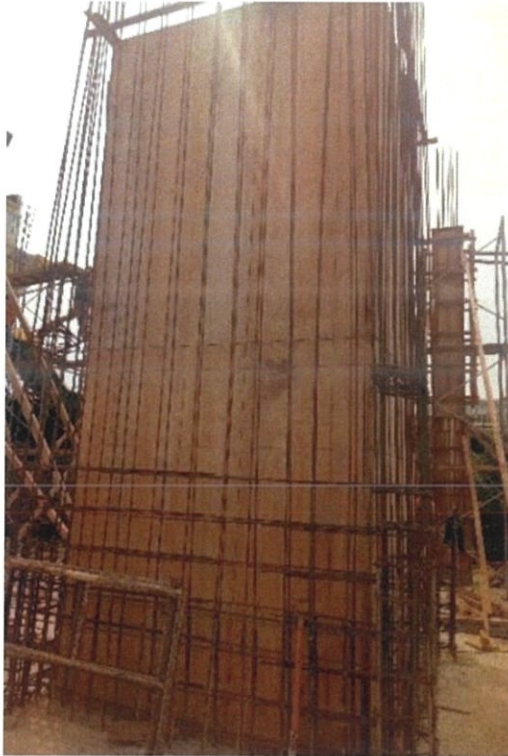
Figure 19: The starter bar for lift shaft

c/c). It was cut by using rebar cutting machine according to the length specified in the structural drawing. The main bars (T12-225 c/c) was overlapped vertically with starter bar for lift shaft as shown in Figure 19. For main bars in horizontal also used T12-225 c/c were tied perpendicular to the main reinforcement bars with a rebar tie wire by using bar-tie wire twister. The 1000mm (T12) was bent at a radius of 90 into “L” shape by using bar bender machine. It was used to connect between main bars and column as shown in Figure 18. The engineer checked whether the binding was correct and approved it.

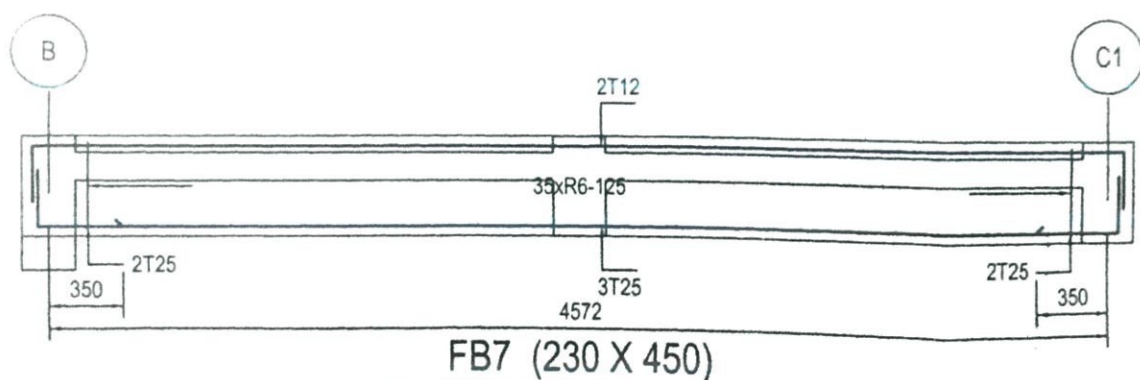
Figure 20: The plan for first floor beam in structural drawing

The first floor beam was built after the construction of column and lift shaft at ground floor level. The staging was erected on the firm ground to hold the box formwork. Detail drawings were needed to measure the size of the first floor beam, for example, for First Floor Beam No. 7 (FB7) as shown in Figure 20, the length of formwork was measured from the centre of footing B to the centre of footing C1. This made the length 4572mm in length, with 230mm thick and 450mm wide as according to the section detail drawing. The first floor beam formwork was built (like a rectangular box as Figure 19) using a hammer and nail. The formwork for first beam and slab was used

Main reinforcement bars for first floor beam was formed and tied (also in a box shape based on first floor beam detail) using a bar bending machine. Five main bars were required to form the box shape. Stirrups were tied perpendicular to all five bars at every 125mm to resist shearing action and to prevent the bars from bending outwards. The sizes of the main bars varies according the load as calculated by the consultant. For example, for FB7, as shown in Figure 20, two main reinforcement bars of 12mm diameter, high tensile (2T12) started from footing B to footing C1. 2T12 were overlapped with two bigger bars (2T25). The other three main bars at lower part of first floor beam continued to use similar reinforcement bars, 3T25.

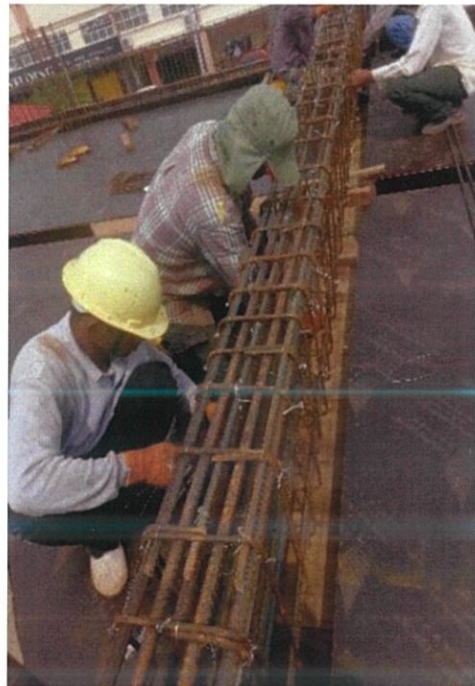
Figure 21: The workers tied the stirrups to the main bar

The stirrups from footing B until C1 used 35 mild steel round bars size 6mm with spacing 125mm centre to centre (35×R6-125). The stirrups reinforcement bars were cut by using rebar cutting machine according to the length specified in the structural drawing and bent at a radius of 90 by using bar bender machine. The stirrups were tied perpendicular to the main reinforcement bars with a rebar tie wire by using bar-tie wire twister as shown in Figure 21. 50mm thick spacer was tied at lower part of main bars first floor beam to allow space for the concrete to fully cover all reinforcement bars. The engineer checked whether the binding was correct and approved before reinforcement bars were inserted in formwork.

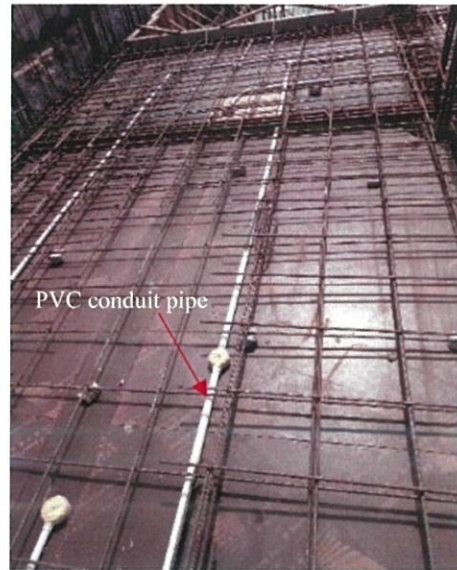
Figure 22: The BRC laid on first floor slab

Next, the PVC conduit pipe for electrical wirings (ground floor) were installed on the formwork of first floor slab. The electrical wirings were put into PVC conduit pipe with diameter 25mm as can be seen in Figure 22. The BRC A10 was then laid on top of the PVC conduit pipe and 50 mm spacer bars were tied at the bottom of the BRC A10 as shown in Figure 22. The reinforcement bar was bent into 'S' shape acts as spacer was put on the BRC A10. The second layer BRC A10 was laid on top 'S' shape spacer.

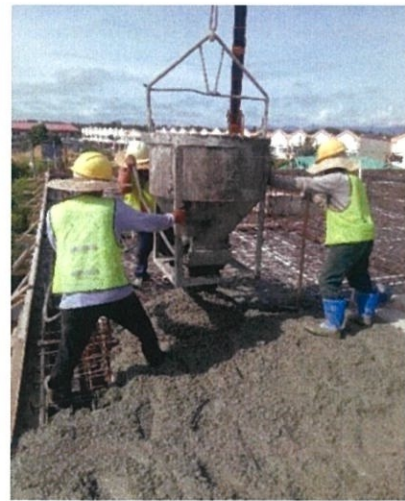
Figure 23: The workers handling the concrete bucket lifted up by the crane for the first floor beam

Concrete casting was carried out to complete the construction of first floor beam and slab. Ready-mix concrete was ordered from concrete batching plant. The grade for crushing strength of concrete was used $30\text{N}/\text{mm}^2$ (Grade 30). The concrete was poured from the truck to a bucket and in the formwork using a crane as shown in Figure 23. The workers used hoe to spread the concrete to slab area. Vibrator was used to ensure that no airspace is left in the concrete mix. The trowel was used to smooth the surface.

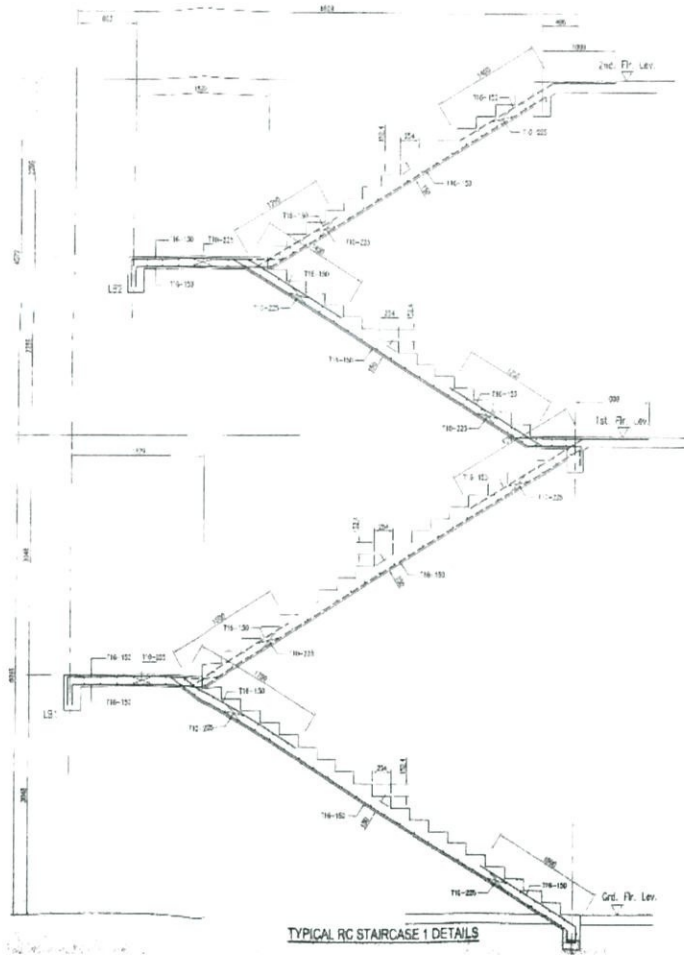
Figure 24: The typical RC staircase 1 detail in structural drawing

The RC staircase was built after the construction of the first floor slab. The staging was erected on the firm ground to hold the formwork of staircase. 12mm thick plywood of formworks was built by using hammer and nails. Detail drawings were needed to refer the size of staircase, for example, the typical RC staircase 1 details as shown in Figure 24. The total height of RC staircase was measured from the ground floor level to the first floor level was 6,096mm (3,048mm + 3,048mm). The landing of staircase was built

at height 3,048mm measured from ground floor level used high tensile reinforcement bars size 16mm with spacing 150mm centre to centre (T16-150). The T10-225 was tied perpendicularly to the main reinforcement bars (T16-150) with a rebar tie wire by using bar-tie wire twister. The first flight has 20 runs with length 254mm for each run while the height of rises was 152.4mm each.

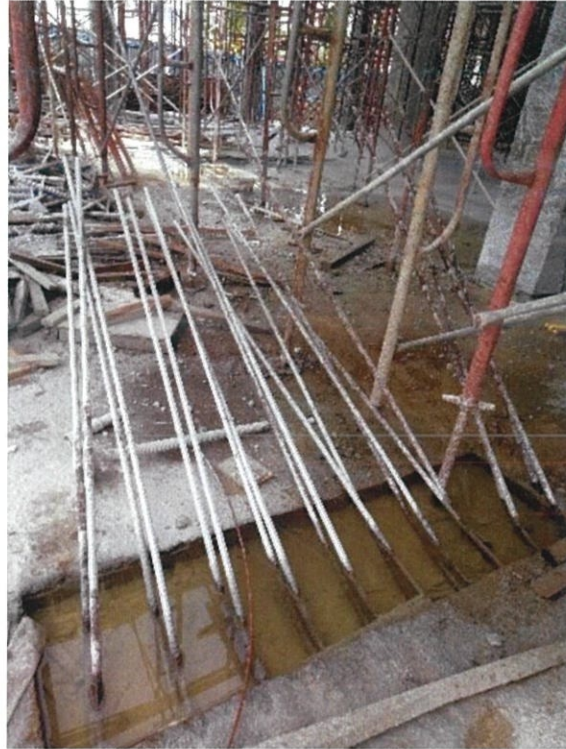
Figure 25: The starter bar for staircase

The high tensile reinforcement bars size 16mm with spacing 150mm was overlapped with the same size (T16-150) starter bar for staircase. Figure 25 shows the starter bar for staircase. The T10-225 were tied perpendicularly to the main reinforcement bars (T16-150) with a rebar tie wire by using bar-tie wire twister. The trim board was nailed to the side of stairs by using hammer and nail. Then, the timber with height 152.4mm was placed to be made as formwork for rises. Concrete casting was carried out to complete the construction of landing and first flight. Ready-mix concrete was ordered from concrete batching plant. The grade for crushing strength of concrete was used 30N/mm² (Grade 30). The concrete was poured from the truck to a bucket and in the formwork using a crane. The workers used hoe to spread the concrete to landing area and rises. Vibrator was used to ensure that no airspace is left in the concrete mix. The trowel was used to smooth the surface of runs.

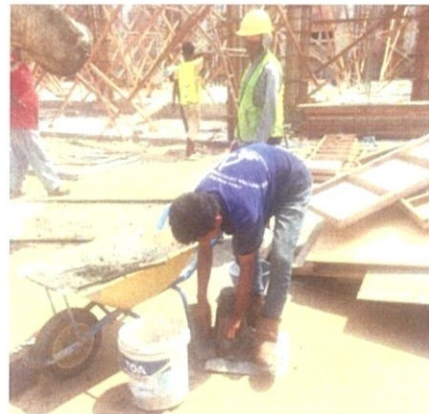
Figure 26: The worker does not wear a proper Personal Protective Equipment (PPE)

Another issue was about improper usage of personal protective equipment. At the site, only a small number of workers wore Personal Protective Equipment. This was dangerous especially for workers who worked at a high level as well as those at the ground floor. It exposed the workers to high risks of accidents. The simplest personal protective equipment that was not used on the site was the safety helmet. Due to this problem, the site supervisor has reported to the main contractor to provide more personal protective equipment. The site supervisor also imposed penalties on employees who did not use personal protective equipment properly.
