**DEPARTMENT OF BUILDING
FACULTY OF ARCHITECTURE, PLANNING AND SURVEYING
UNIVERSITI TEKNOLOGI MARA
(PERAK)**

DECEMBER 2019

PERIMETER WALL AND GATE

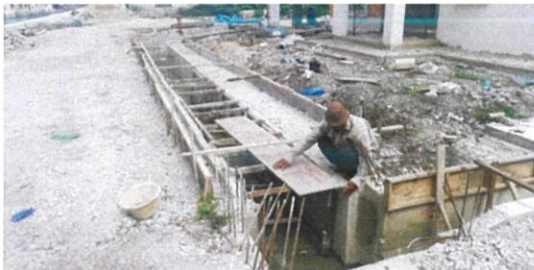
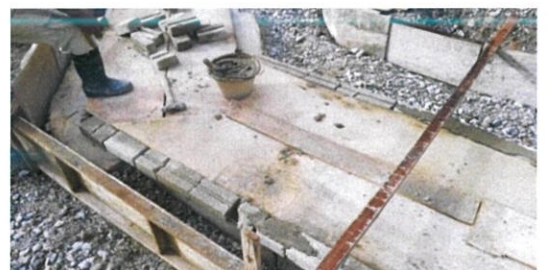
Figure 11: Formwork installation

Then, the workers installed formworks for ground beam. The slab was above the drain, so this process need to take more serious on safety to avoid collapsed during installation. The formwork was made of wood. Struts were also needed to support the base of the slab. Formworks for grating were also were installed. Besides, position and joints were correctly done. The formworks were designed to withstand construction loads such as fresh concrete pressure and weight of workers and operators and their machine.

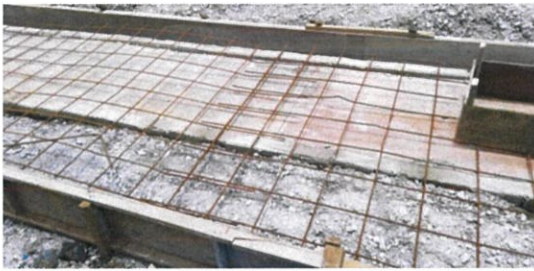
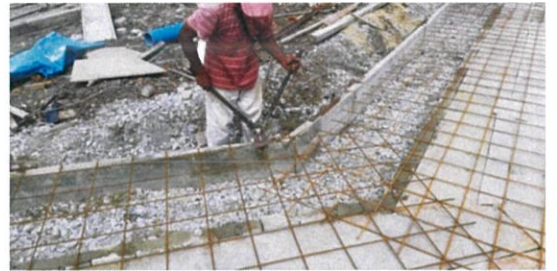
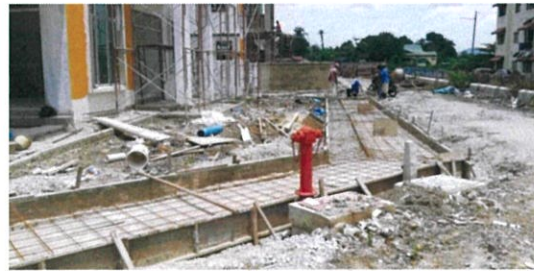
Next, reinforcements were installed inside the formwork. Priority to the placement of reinforcement for concrete floor slab construction, inspection and checked forms to confirm that the dimensions and the location of the concrete members confirmed to the structural plans. Added to that, the reinforcement were properly cleaned and oiled but not in such amount as to run onto bars or concrete construction joints. The reinforcement were also overlapped each other. These processes were referred to design drawings that designated bar size, cutting required length, and make necessary hooks and bents. The concrete cover and spacing for floor slabs can be maintained by introducing spacers and bars supporters. Therefore, incorrect reinforcing steel placement can lead to serious concrete structural failures.

Figure 14: Overlapped reinforcements

Figure 12: Cutting over reinforcements

Figure 13: Reinforcements installation

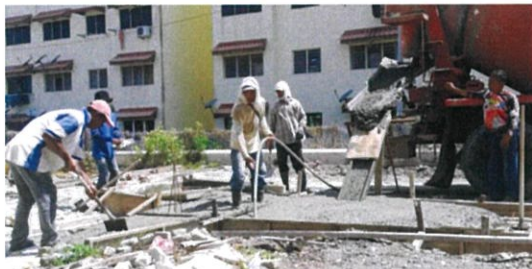
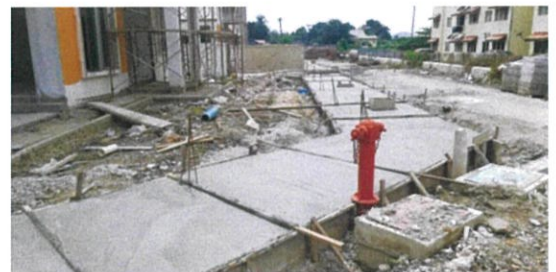
Pouring the concrete was most important things and took cautious. The processed started by placing the concrete against one edge of the formwork and added further batches worked away from the edge, spread with a shovel to ensure that all of the edges and corners of the formwork were completely filled. Fill all the way to the top of the formwork, the labor used shovel to tamp the product into position to get any air pockets out of the concrete. The concrete was leveled with a screed held against the top of the formwork and by working from side to side and moving from one end of the formwork across to the other. It was necessary to repeat this process to ensure that the surface was flat. Furthermore, the fresh concrete was compacted adequately in order to mould it within the forms and around embedded items and reinforcement and to eliminate stone pockets, honeycomb, and entrapped air. Vibration also was used to consolidate the concrete. The concrete were left for curing for 2 to 3 days.

Figure 16: Concrete pouring and vibrating

Figure 15: Curing process of concrete

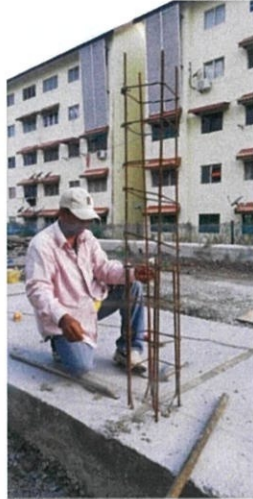
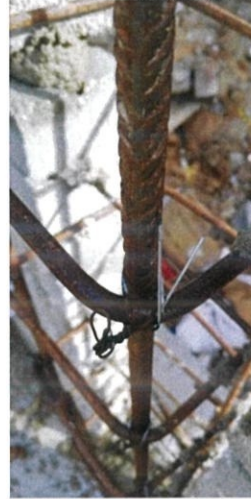
Then, after the concrete were cured, the labor continued installed reinforcement for columns. The columns were tied with links.

Figure 19: Installation of column reinforcement

Figure 18: Link that attached to column

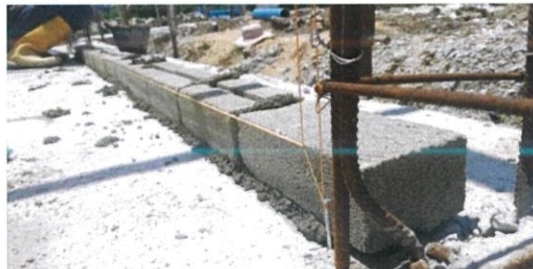
The labor made a guideline with string for brick layering. Guideline was a must for setting bricks in perfectly straight rows.

Figure 20: Thread as guideline

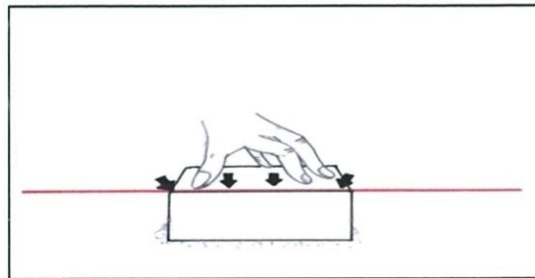
The first brick pressed into the mortar. The labours pushed down slightly, then level used to check that the brick even with the ground. To do so, the labours pressed the level up against the side of the brick and then check it with string. Once the first brick was set, the labours laid down some mortar for the next few bricks. For the next bricks, the labours took a slab of mortar and coat the end of the brick that will be pushed up against the first brick. The level used again to ensure that the bricks are flush and at an even height, pushing on the bricks lightly to make sure that they fit perfectly. The labours scraped away any excess mortar.

Figure 21: Brick being push down

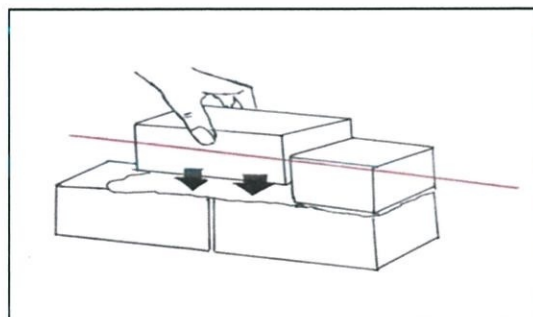
To build second additional rows, the labours moved the guideline up to the next marker. The labours started the second row with 1/2 a brick on both ends. Mortar and one full brick placed on top of the ends. With each row, the process was the same. However, the labours used half-bricks every other row to ensure that the joints in each row are not perfectly lined up.

Figure 22: Lay brick half to a brick Size

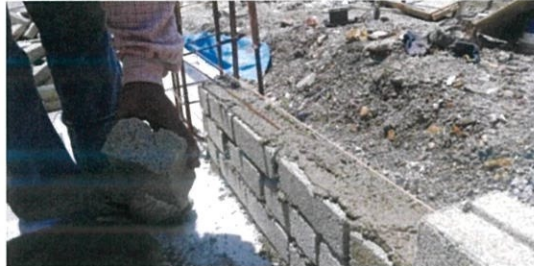
At every three or four of brick layering, the labours applied reinforcement bar then continued till the end of the wall. This forms an integral structure to absorb stress and vibration in building. After done build the wall with the height that measured, the labours filled in any missing patches of mortar along the wall.

Figure 23: Reinforcement every 3 layers

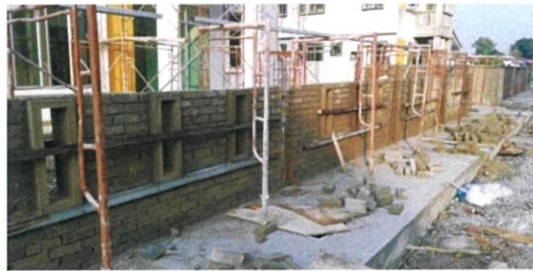
Besides, frames were also layered after reaching at some point. The process was still similar to layering brick. The frames were made of concrete. Therefore, these frames were only had at unit KP Perdana Tambahan .At the top, capping also was build. It were still used bricks but in different position.

Figure 24: Laying of frames

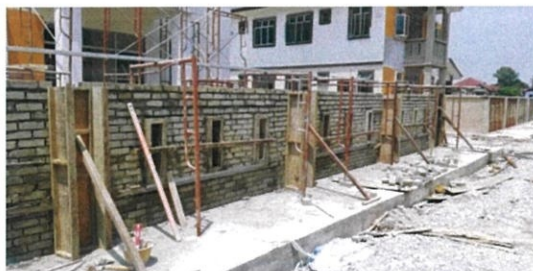
After reaching near the end, the labour installs the formwork for column. Then quickly proceed to concrete it. Curing process took place after worked done. The duration to construct these perimeter walls between two residential building which takes around four weeks for KP Perdana Tambahan and six weeks for 5A. 5A took more time because had long distance and area needed.

Figure 25: Column formworks

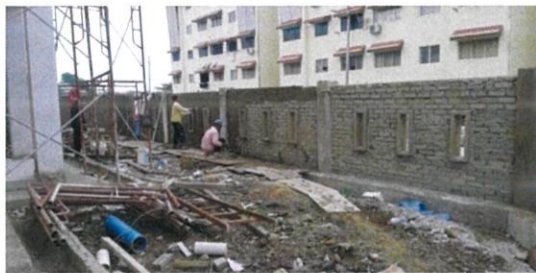
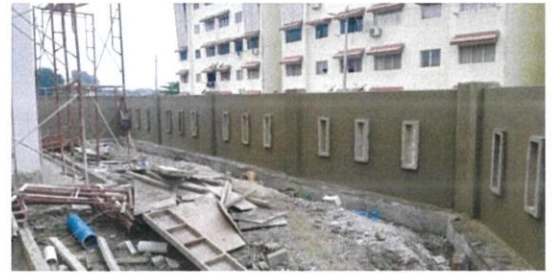
Plastering was one of the final steps in finishing an interior or exterior wall. While applying plaster was a highly technical process that usually best left to professionals, any homeowner can do it themselves provided they follow a few key guidelines. First, the labor started with a batch of thick, freshly-mixed plaster. Then spread the plaster onto a clean wall with a trowel, then use a handheld float to smooth it from corner to corner. After that, labor worked out lumps and inconsistencies.

Figure 26: Plastering process

Figure 27: Finished plastered

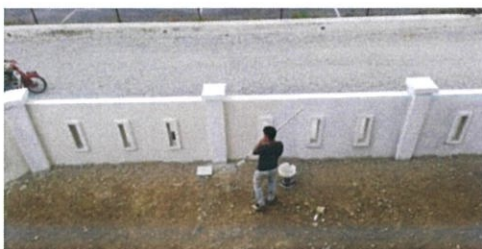
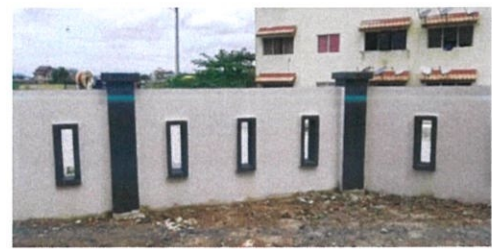
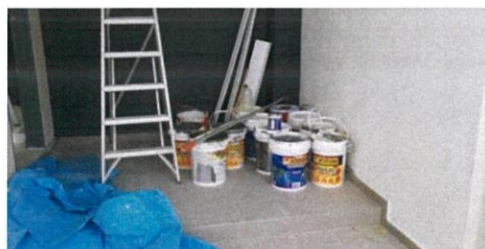
Lastly, painting works took place. This work needed 4 to 5 labor. Common procedures for painting work were firstly painting the primer which was white paint. Then proceed to secondary paint that was other colours. For KP Perdana Tambahan project used Jotun Jotaplast (Crystal White) as primer, Jotun Jotashield 1135 (Croissant) and Jotun Gardex 7249 (Adele). Besides, for 5A used same primer as KP Perdana Tambahan. The labor used rollers to paint the wall fence instead of brush because it was more time efficient. Then, the painted wall being dried.

Figure 29: Painting work

Figure 30: Painted fence

Figure 28: Type of paints

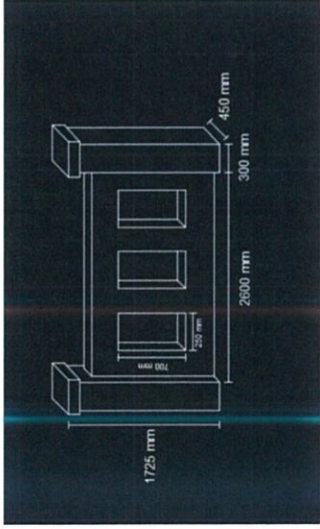
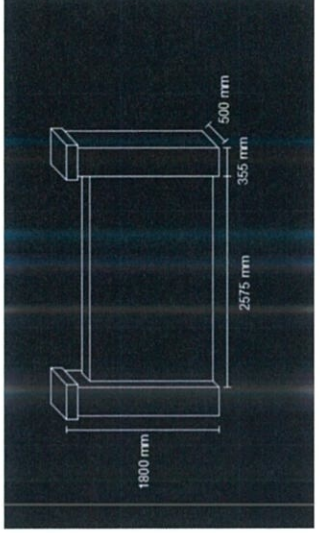
<p>Dimension (Length x Width x Height)</p>

<p>(drawn using AUTOCAD – not to scale)</p>

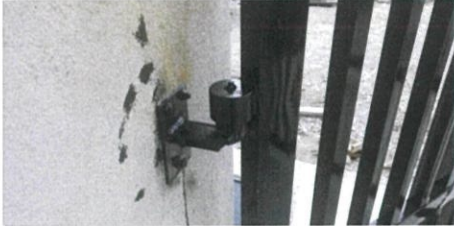
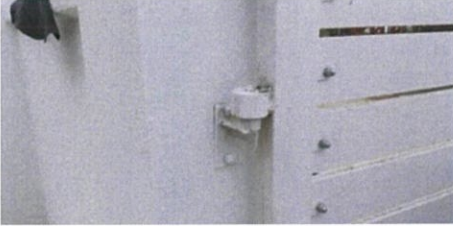
<p>These locks provide more safety to the area.</p>	
<p>Hinges (1)</p>

<p>Funtion of the hinges is to connect leaf gate to the wall attach each other with bolt.</p>		
<p>Hinges (2)</p>

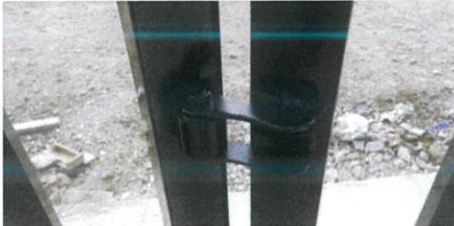
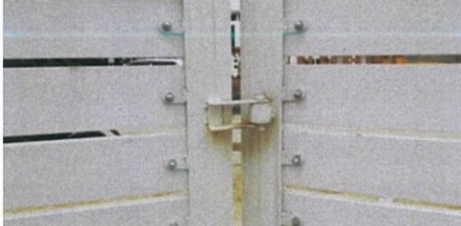
<p>Funtion of the hinges is to connect between 2 leaf gate.</p>

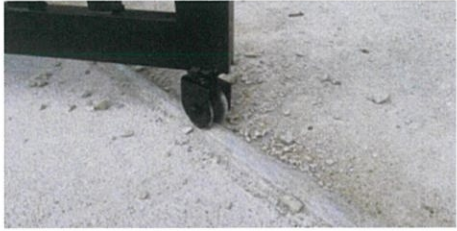
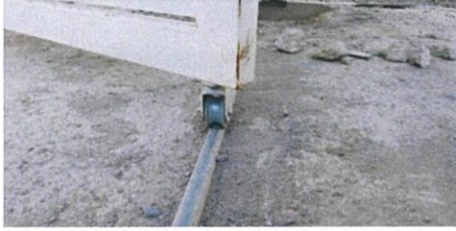
<p>Track Line And Steel Roller</p>

<p>Function of track line is to make sure the gate stay on the track which make it easier to slide open or close and to prevent the gate from swinging or fall. Steel roller is to move the gate from one point to another point.</p>		
<p>Stopper</p>

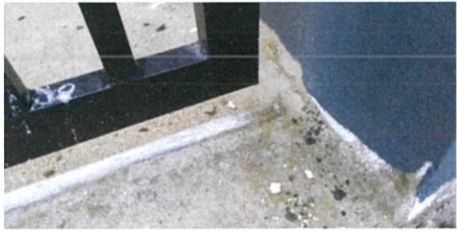
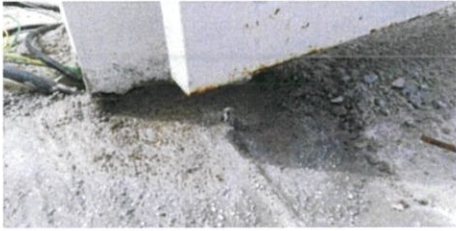
<p>The funtion of stopper is to prevent the gate from overslide. Both gate are not finish installing.</p>		
<p>Rear Door</p>	<p>850m x 1530mm</p>

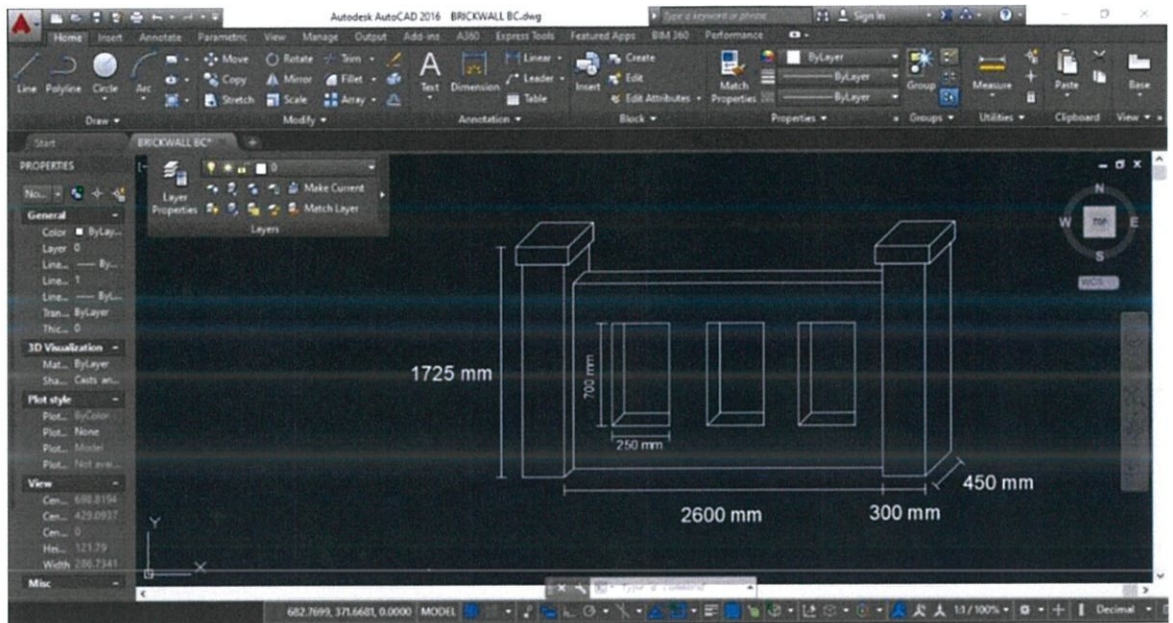
Draw Using AutoCAD Software for Fence at Project KP Perdana Tambahan

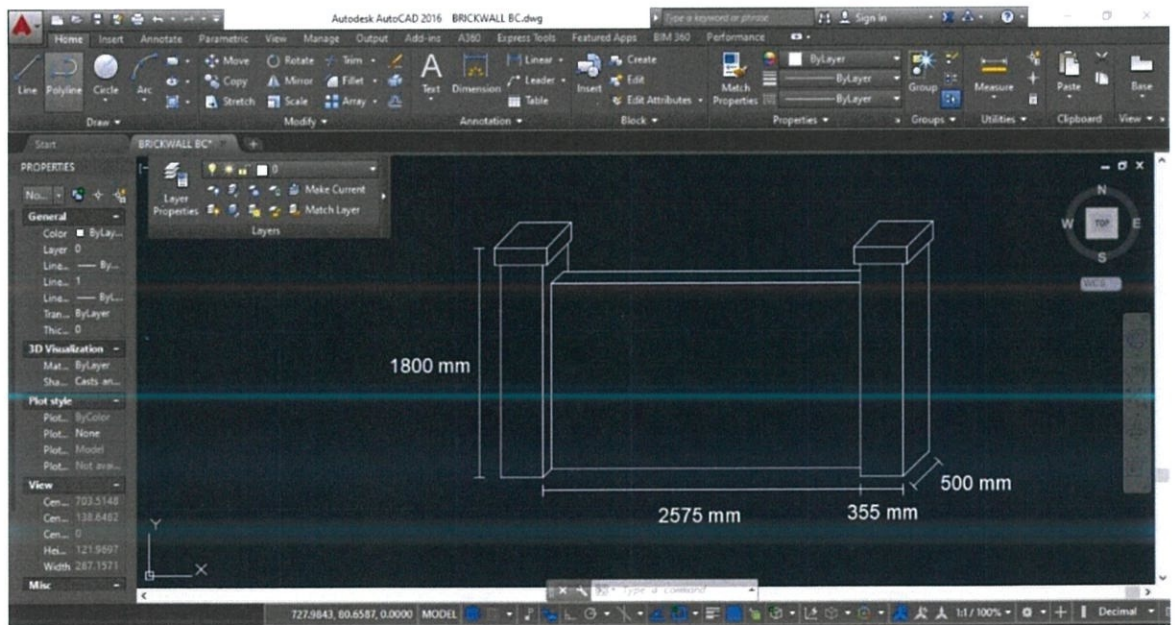
Draw Using AutoCAD Software for Fence at Project 5A

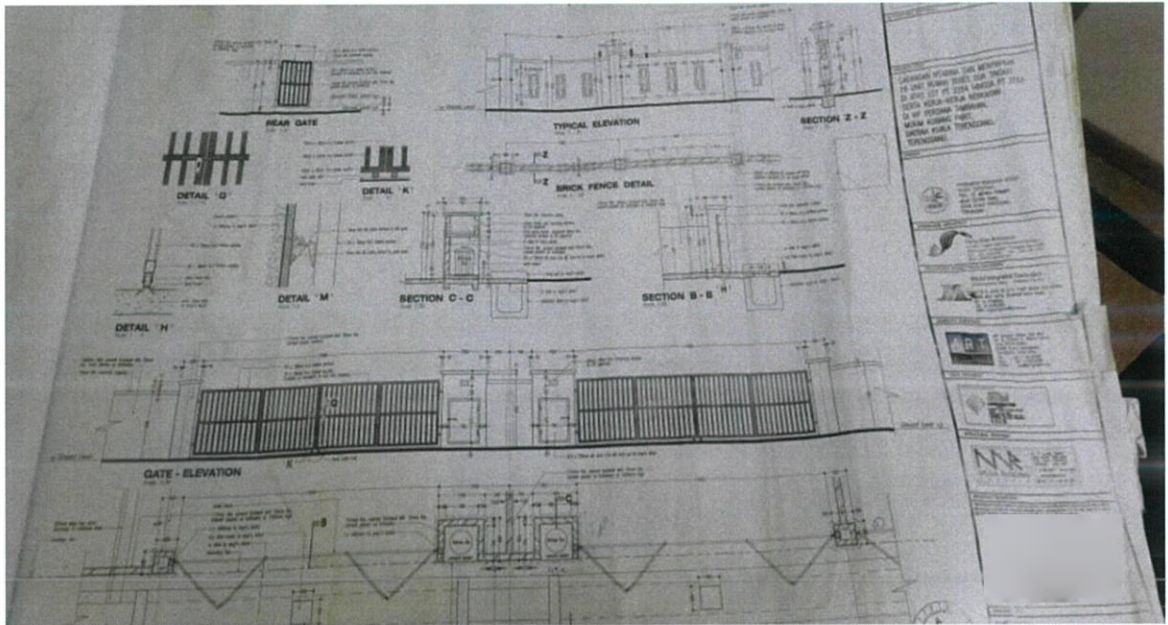
Detail Drawing of Gate at KP Perdana Tambahan
