FABRICATION AND INSTALLATION OF STEEL TRUSS

**Prepared by:
MOHAMMAD FIRDAUS BIN MOHD ISMAIL
2016458476**

**DEPARTMENT OF BUILDING
FACULTY OF ARCHTECTURE, PLANNING AND SURVEYING
UNIVERSITI TEKNOLOGI MARA
(PERAK)**

DECEMBER 2018

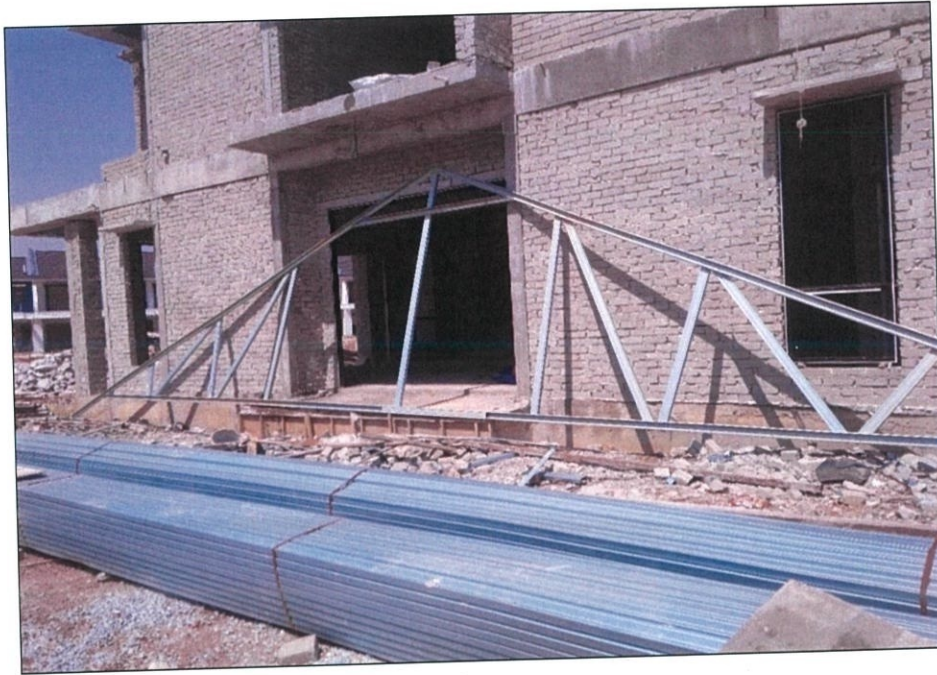
Figure 3.3: Steel truss template

First of all, the steel truss template is created according to the drawing specifications to ensure the subsequent trusses have the same configuration and slope. The steel truss is fabricated from 6 metres length C7575 channel sections from material of high-tensile steel of thickness 0.75mm and the yield strength of 550 Mpa. The channel sections are measured using the measuring tape to the right dimension according to the drawing specifications for every part and marked with a pen marker. After that, all the channel sections are cut to the length of subsequent trusses in the right measurement by using a disc cutter and angle grinder.

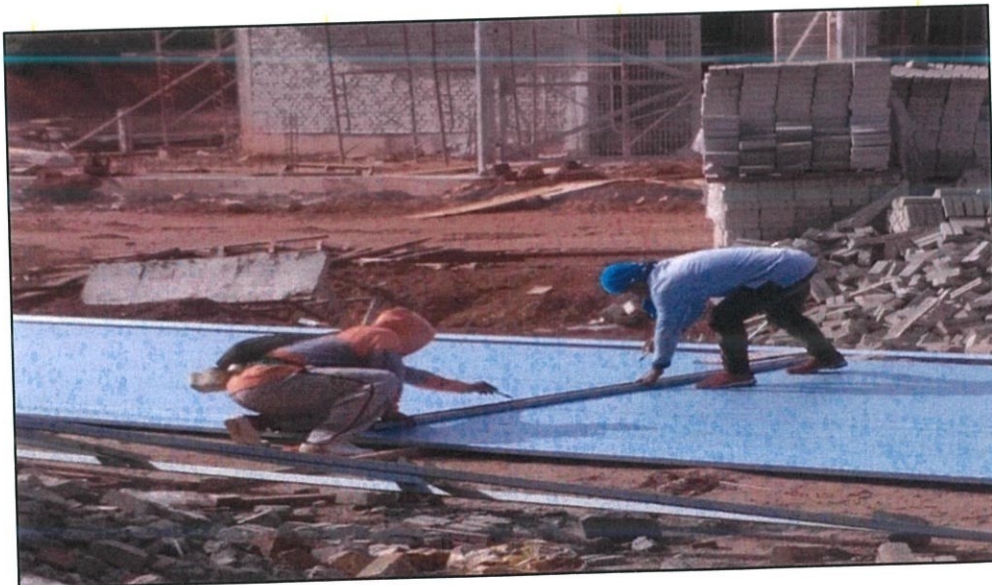
Figure 3.4: Workers are measuring and marking the length required on the steel truss

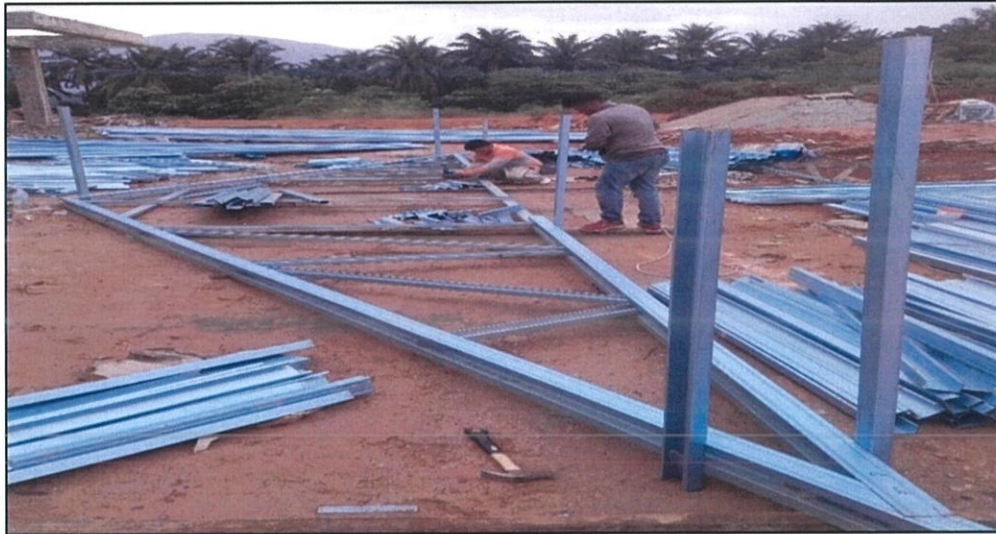
Then, the inverted stools are built to align the truss members. The inverted stools are built around the template trusses as shown below in the figure 3.5. The subsequent parts are assembled over the truss template and the workers would fasten up the members together with bolt screws using the electric drill machine.

Figure 3.5: Workers are fasten the subsequent members

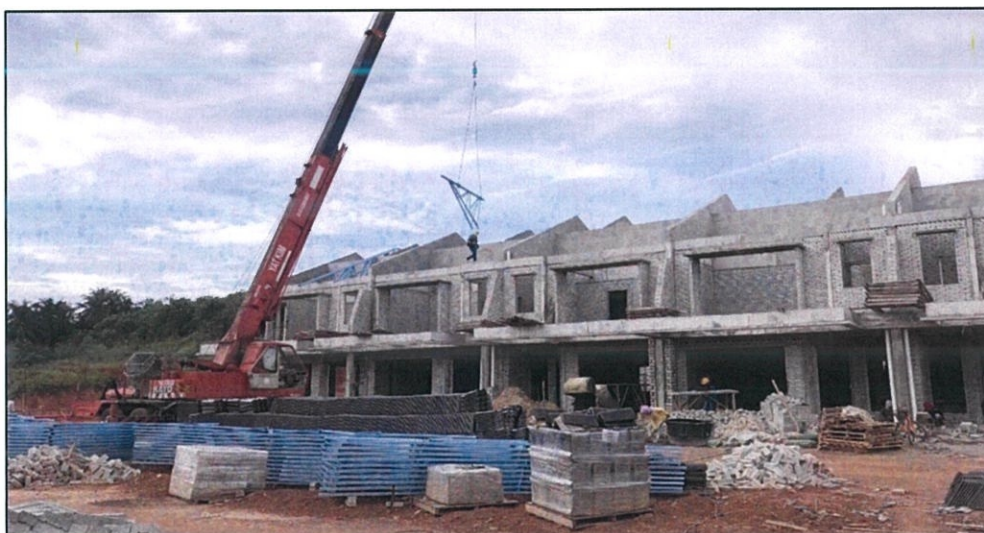
After completing the fabrication of trusses, the subsequent trusses are then moved from the template stack and transported to the worksite and sorted bundle by bundle. Then, the bundles are lifted by the mobile crane to the top of roof beams for installation. Before installing the subsequent roof truss to the roof beam, the workers measured and mark the right position of each subsequent trusses at the front and back of the house.

Figure 3.6: Mobile crane lifting up the bundle of truss to the roof beam

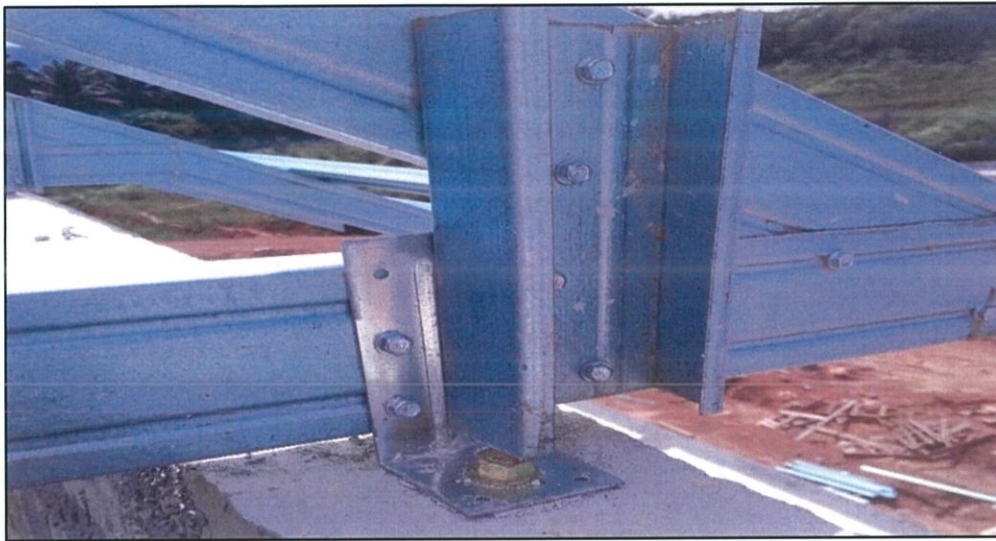
The bundle of subsequent trusses are arranged to the right position. After all the subsequent trusses have arranged to the right position, the 'L' bracket are installed to the subsequent truss on the roof beam by using bolt to hold it down to the roof beam. The 'L' bracket are installed at the both sides of the roof beam which is in the front and back of the house.

Figure 3.7: 'L' Bracket installed to the roof beam and truss

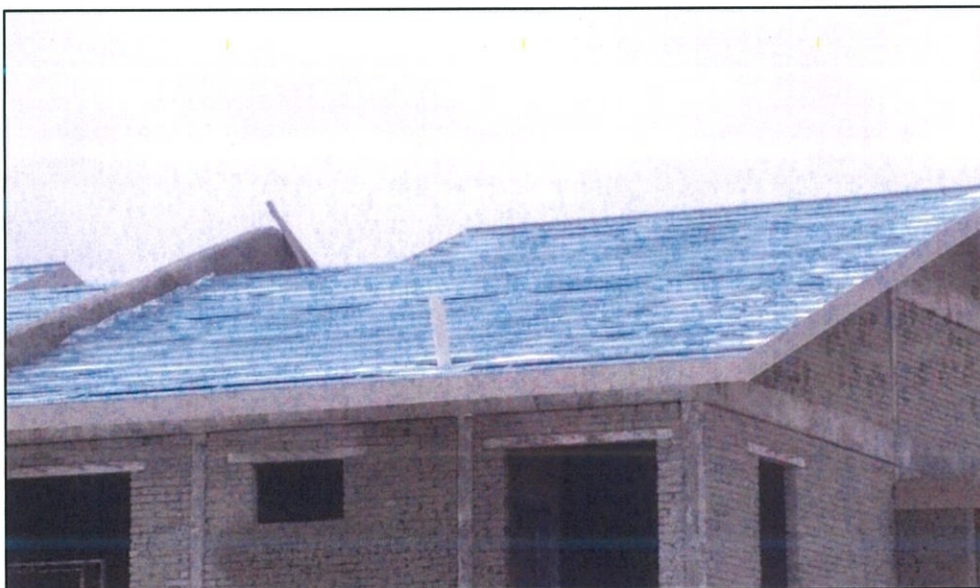
Then, all the subsequent trusses are braced together at the front and back of the house according to the required specifications. After that, the workers started to install and fasten up the battens on the trusses using the bolt screws. The workers then install the foil paper and proceed to lay the roof tile.

Figure 3.8: Foil paper and battens finished fixed

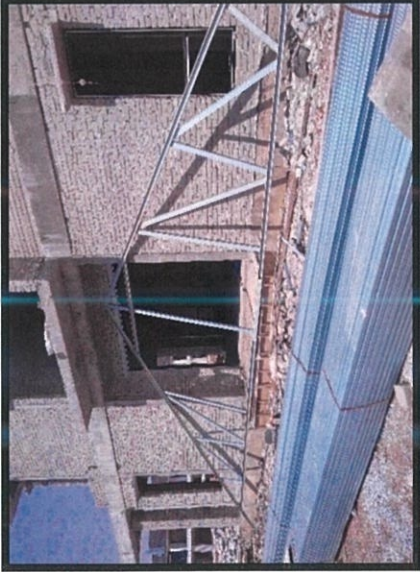
NO	OPERATION	SEQUENTIAL DIAGRAM	MACHINERY & PLANT	LABOUR	EQUIPMENT	DURATION
1.	Creating a truss template.

<p>Figure 3.9: Trusses template</p>	<ul style="list-style-type: none"> - Drill Gun - Rotary disk cutter 	<ul style="list-style-type: none"> - 1 Skilled workers - 3 Semi-skilled workers 	<ul style="list-style-type: none"> - Steel truss c-sections - Bolt screw - Measuring tape - Pen marker 	2 Days

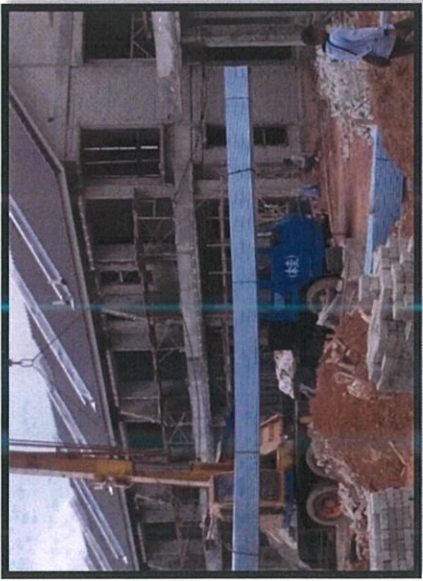
2.	Unloading steel truss long channel sections steel truss at the worksite

<p>Figure 3.10: Unloading steel truss bars</p>	<ul style="list-style-type: none"> - Backhoe - Mobile Crane 	<ul style="list-style-type: none"> - 2 Operator - 1 skilled worker - 2 Semi Skilled worker 		1 Day
3.	Measuring to the required length and marking

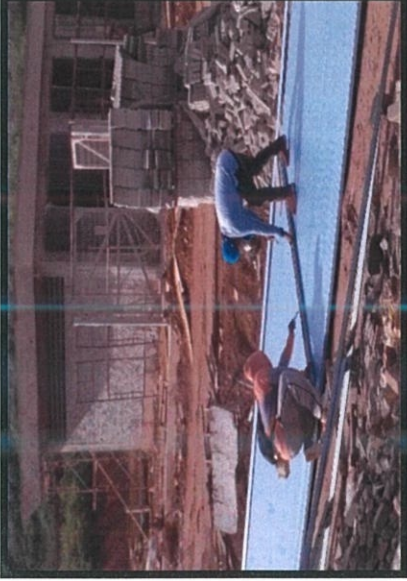
<p>Figure 3.11: Measuring and marking the required length</p>		<ul style="list-style-type: none"> - 1 Skilled worker - 1 Semi-skilled worker 	<ul style="list-style-type: none"> - Measuring tape - Pen marker 	3 Days for 36 trusses

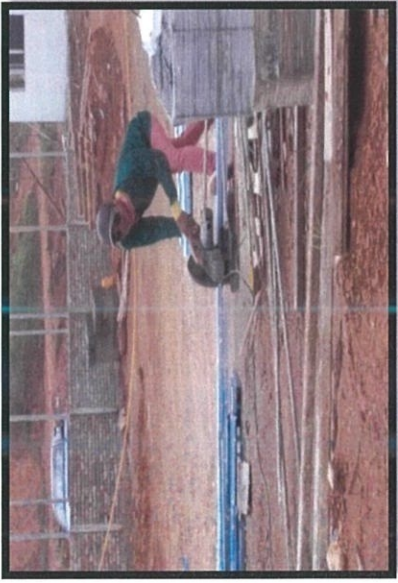
4.	Cut the channel sections to the required length

<p>Figure 3.12: Worker cut the steel truss using disc cutter</p>	<ul style="list-style-type: none"> - Disc cutter - Angle grinder 	<ul style="list-style-type: none"> - 1 skilled worker - 3 semi-skilled worker 		3 Days

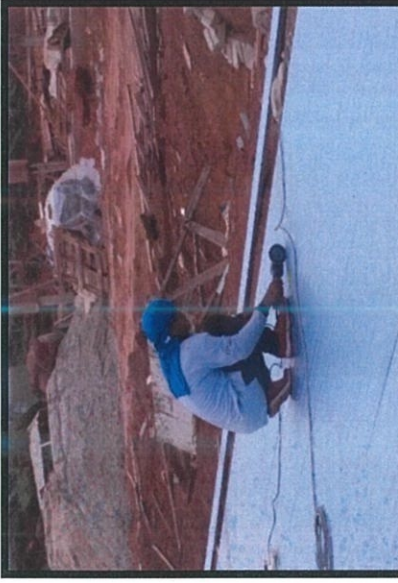
<p>Figure 3.13: Worker cut the steel truss using disc cutter</p>

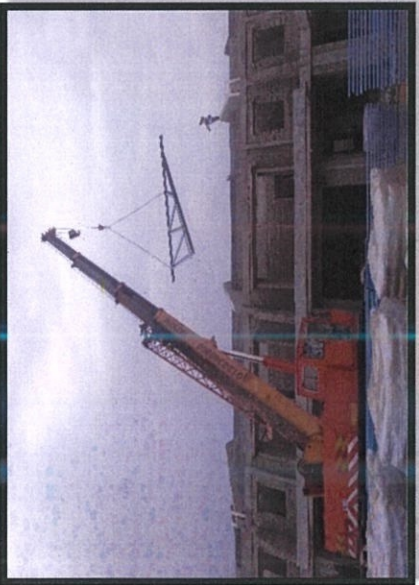
7.	Lifting the bundle of trusses to the top of the roof beam using the mobile crane.

<p data-bbox="662 1124 718 1706"><i>Figure 3.16: Lifting the bundle of subsequent trusses to the top of roof beam</i></p>	- Mobile Crane	- 1 Operator - 1 skilled worker - 2 semi-skilled worker		1 Day
----	-----------------------------------------------------------------------------------	---------------------------------------------------------------------------------------------------------------------------------------------------------------------------------------------------------------	----------------	---------------------------------------------------------------	--	-------

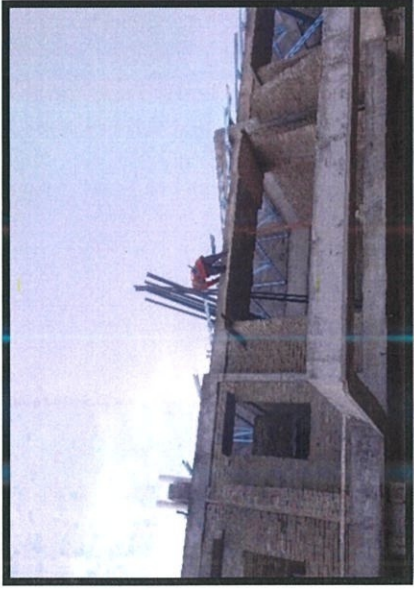
NO	OPERATION	SEQUENTIAL DIAGRAM	MACHINERY & PLANT	LABOUR	EQUIPMENT	DURATION
1.	Measure and marking the right position of steel truss on the roof beam

<p data-bbox="1023 1144 1075 1693"><i>Figure 3.17: Workers measure and mark the position for trusses</i></p>		<ul style="list-style-type: none"> - 1 Skilled worker - 2 Semi-skilled worker 	<ul style="list-style-type: none"> - Measuring tape - Pen marker 	1 Day

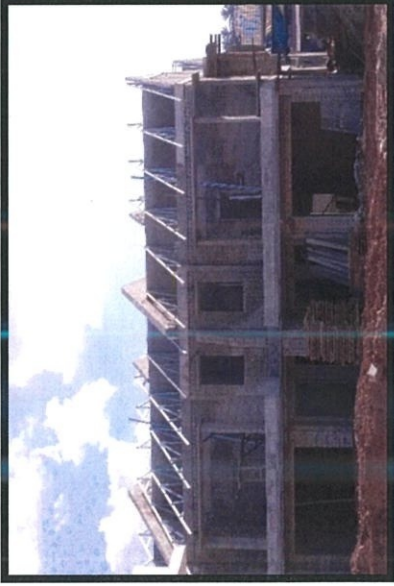
2.	Arranged the steel truss to the right position 1.5 metres distance between frames

<p>Figure 3.18: Trusses are arranged to the right position</p>	- 1 Skilled worker - 3 Semi-skilled worker		1 Day
3.	Install the 'L' bracket to the truss and roof beam

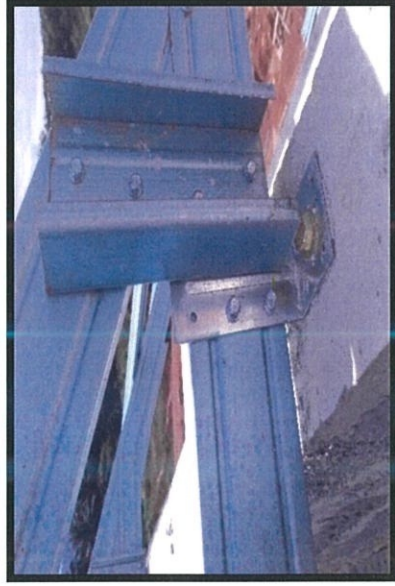
<p>Figure 3.19: 'L' bracket are installed to the beam and truss</p>	- 1 Skilled worker - 1 Semi-skilled worker	- Bolt screw - 'L' bracket - Hammer	2 Days

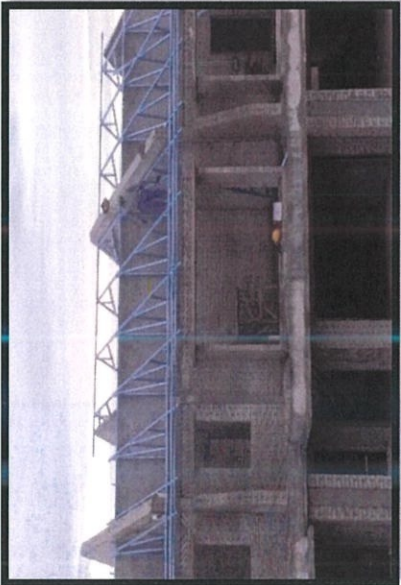
4.	Braced all the trusses to specifications

<p data-bbox="643 1144 667 1693"><i>Figure 3.20: The subsequent trusses are braced together</i></p>	- Drill gun	- 1 Skilled worker - 1 Semi-skilled worker	- Bolt screw	3 Days
5.	Fixing the battens and foil paper

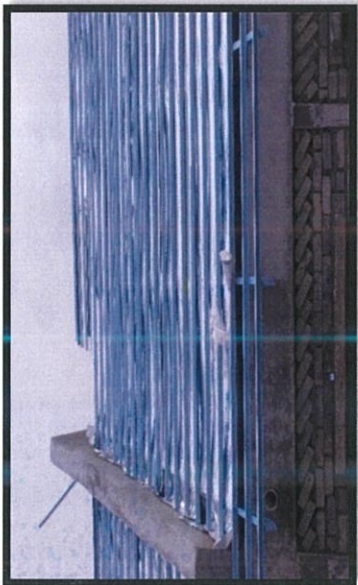
<p data-bbox="1158 1200 1182 1637"><i>Figure 3.21: Battens and foil paper are fixed</i></p>	- Drill gun	- 1 Skilled worker - 3 Semi-skilled worker	- Bolt screw - Battens - Foil paper	2 Days

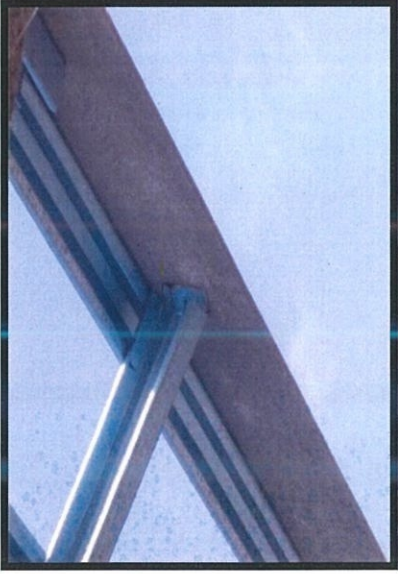
6.	Install fascia board by fixing the edge of trusses to the board

<p data-bbox="647 1149 671 1666"><i>Figure 3.22: Fascia board are fixed at the end of truss</i></p>	- Drill gun	- 1 Skilled worker - 3 Semi-skilled worker	- Bolt screw - Fascia board	2 Days
7.	Laying roof tiles

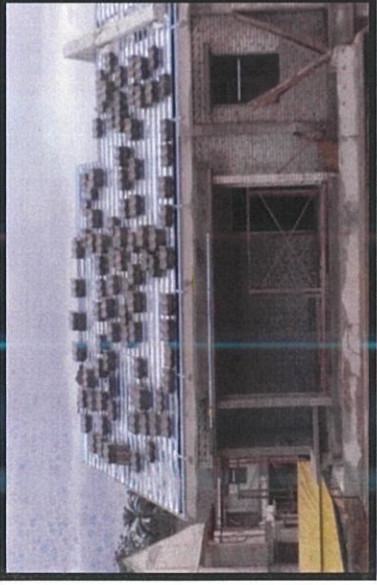
<p data-bbox="1187 1137 1241 1675"><i>Figure 3.23: Roof tiles are layed on the battens and foil paper</i></p>		- 1 Skilled worker - 3 Semi-skilled worker	- Roof tiles	3 Days
