Issue #4 | Oct. 2024

# RISE

# Landslide Prone Area in Malaysia and the Prevention Measures

**Ir Ts Dr Diana Che Lat**  
College of Engineering,  
UiTM Johor Branch, Pasir Gudang Campus

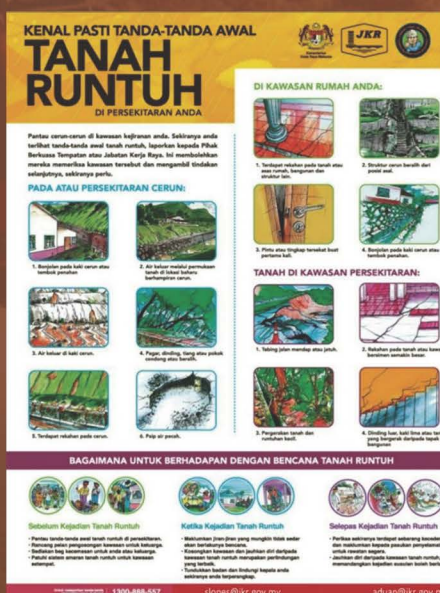
Figure 1. Landslide indicators within and outside of buildings, as well as on and near slopes by JKR

While there are instances when landslides happen suddenly, there are typically warning indicators that people in hillside areas miss because they are not aware of them. Slope safety depends on keeping an eye out for indications of slope collapses when urban expansion encroaches on slopes. Particularly, man-made slopes are become increasingly common and require periodic inspections. In order to do this, JKR assembled a set of photos, as seen in Figure 1, that depict landslide indicators as they manifest within and outside of buildings, as well as on and near slopes. Equipped with this understanding, locals may visually assess slopes in their neighborhood.
