UNIVERSITI  
TEKNOLOGI  
MARA

**Proceeding for International Undergraduates Get Together 2024 (IUGeT 2024)**  
"Undergraduates' Digital Engagement Towards Global Ingenuity"

## SOLAR PANEL INSPECTION USING UAV THERMAL IMAGE

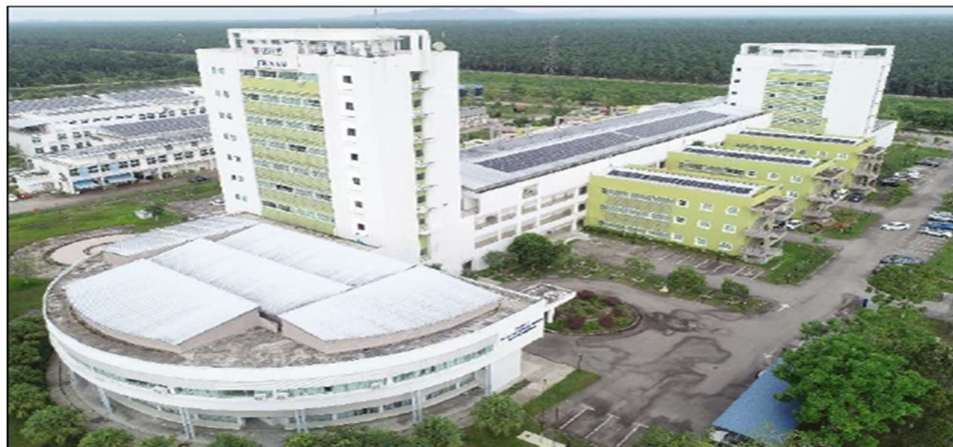
This paper discusses solar panel inspection using thermal imagery. The scope of this study is to inspect solar panels using a UAV thermal image at FKAAB, UTHM Batu Pahat, as shown in Figure 1, which was chosen as the research area. This building was selected because the surrounding features have a large open space and fewer obstacles for UAV flight missions. Ultimately, this research contributes to a deeper and more comprehensive understanding of the various types of defects in the monocrystalline P-type solar panels at the FKAAB building. Moreover, it aims to popularize the use of UAVs, enabling broader access to this technology for more productive, efficient, cost-effective, and safer inspection procedures. A thorough plan was established to achieve the objective of the project.

Figure 1. The installation of panel solar at FKAAB UTHM.
