MONITORING VERTICAL DISPLACEMENT OF REINFORCED CONCRETE BEAM BY DIGITAL PROCESSING TECHNOLOGY

S.F. Senin¹, R.Rohim¹, A.Yusuff¹, M.I.F. Rozli¹ & J.Ahmad¹

¹Faculty of Civil Engineering, UiTM Pulau Pinang, Permatang Pauh, Malaysia

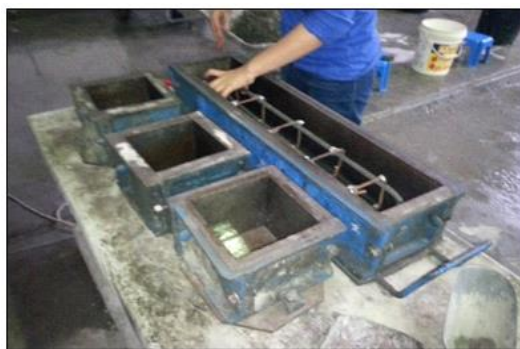
Figure 3. Steel mould used for the cube and beam samples

In order to ensure all beam samples meets the minimum compression strength of 25 MPa, the compression strength of another three (3) cube samples of 150 x 150 x 150 mm were tested using similar mix composition as presented in Table 1. Figure 3 shows the cube and beam mould made of steel used for this study. Compression test machine was used to exert compression force on the cube surfaces until failed due to compression stress. The compression forces was recorded for each sample at 7, 14 and 28 days. The compression strength development of each cubes was monitored and recorded for checking the minimum compression strength compliance.

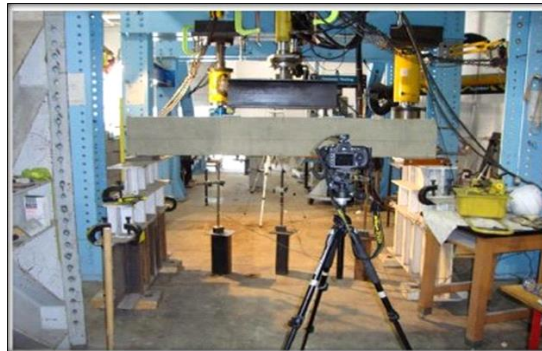
Figure 5. The camera setup and LVDT installation of the work

Before the bending test executed, the beam is supported at both ends by a simply support condition and placed in the right position (Figure 5) on the frame of tensile machine. A camera was used in this experiment where the camera was statically fixed using a tripod. The distance of the camera to the specimen is based on the space for flexural test available in the laboratory and the ability of the camera to be able to capture image for whole specimen.

LVDT sensors were installed to the beams and connected to the data loggers to record the beam's displacement during the bending test.

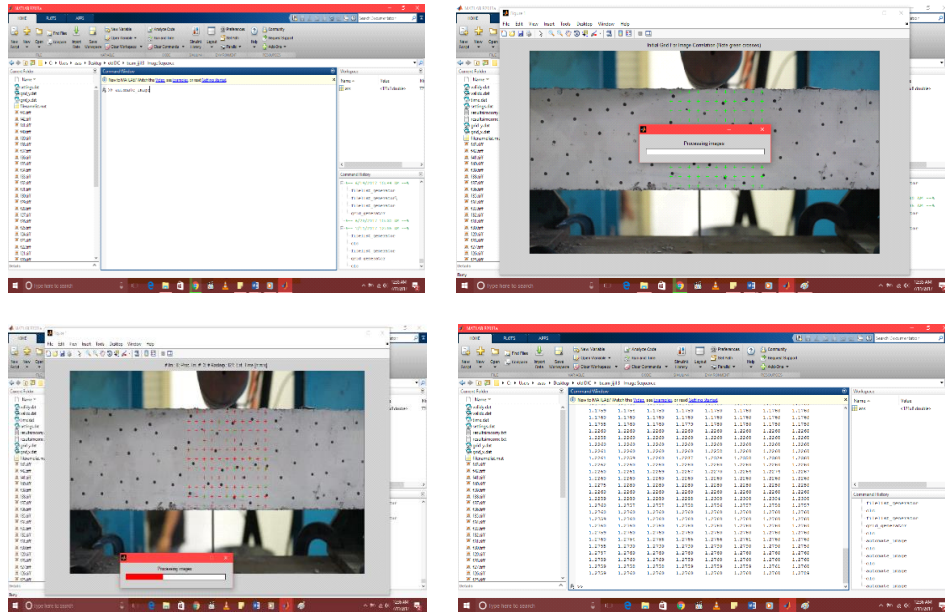
Figure 6a -d. The automated process done by MATLAB script on the captured data by camera

All beams were tested under two-point bending test using the Universal Testing Machine. The compression loading rate was set as 0.06 mm/s for all beam specimens. During the bending test, two point loads were applied on the top of the beam and the beam displacement were measured by LVDT and stored to the data logger. The camera recorded the black circle ink movement of the beam and will be processed by the in-house MATLAB script (Figure 6).
