The Effect of Surface Texture on the Joint Shear Strength of AR500 Steel and AA7075

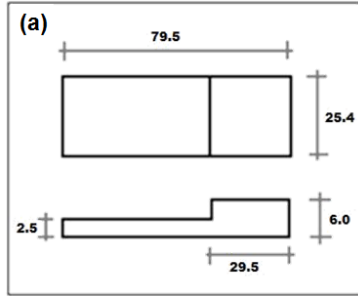
Figure 1: Dimensions of steel and aluminium sample

The materials were supplied as plate and were cut to lengths suitable for shear strength testing. The ends of both the steel and aluminium samples were machined by a wire-cutting machine to 79.5 mm in length, 25.4 mm in width, and 2.5 mm in thickness, as shown in Fig. 1. The surface of the specimen was prepared by removing the oxide film on both plates using silicon carbide sand paper and set with different surface condition as in Table 3 and micrograph of surface texture as shown in Fig. 2(a-d).

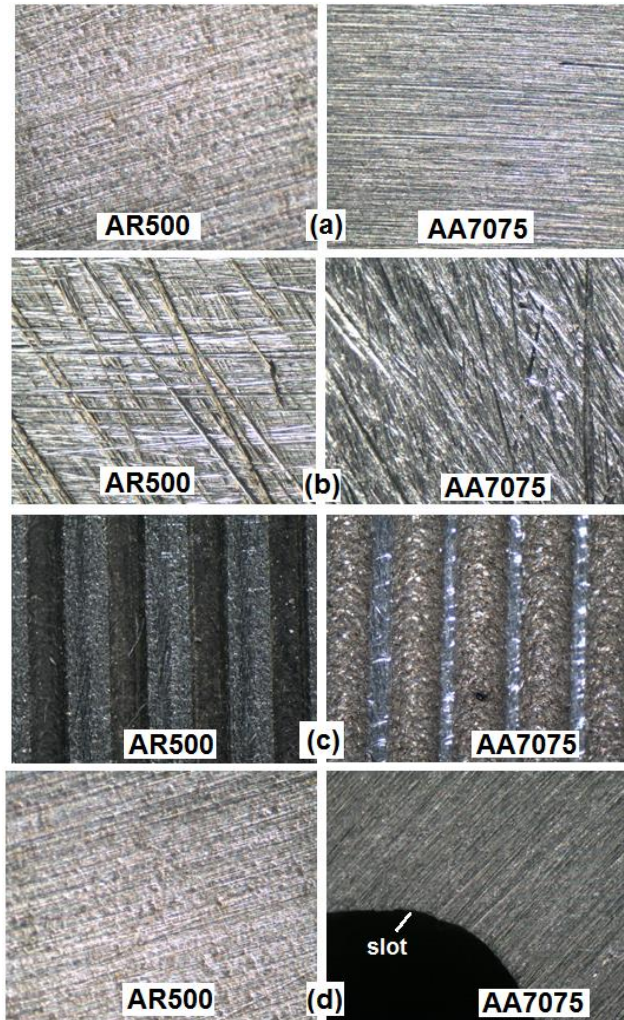
Figure 2: Micrograph of surface texture: (a) polished by 180 grit SiC paper, (b) polished by 40 grit SiC paper, (c) micro scale groove, (d) polished by 180 grit SiC paper + slot on AA7075

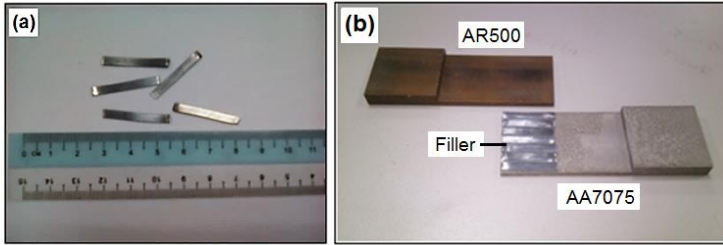
Figure 3: Filler metal preparation: (a) filler metal, (b) filler metal arrangement in specimen

The filler prepared by rolled the filler wire to 0.5 mm thickness and cut into strips of 3.5 mm x 25 mm and arranged to fill the surface of the base metal, as shown in Fig. 3(a, b). The chemical composition of the filler metal is shown in Table 4. The joining process start with the AA7075 aluminium alloy overlapped the high-strength steel plate and the filler metal is between the two metals, as shown in Fig. 4(a) and then torch-brazing process involved the burning of butane gas was heated to the surface of base metal (AR500 steel), the joining method between these two metals is shown in Fig. 4(b).

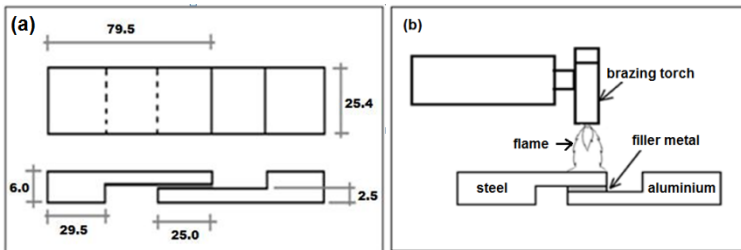
Figure 4: Joining process: (a) overlap of steel and aluminium for joining process (b) torch brazing process

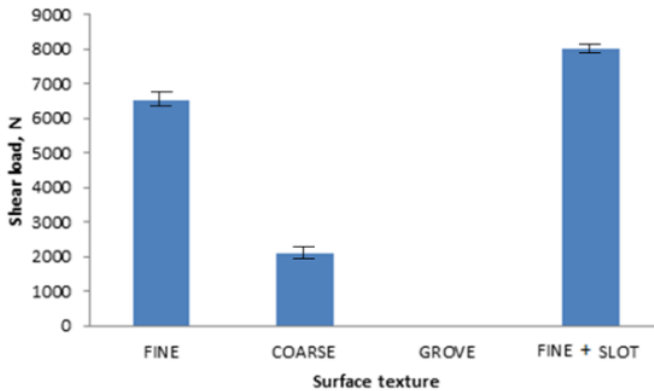
Figure 5 summarizes the shear strength of the joints brazed in four types of surface condition (the result was average of 3 sample of specimen). The results indicated that the strength of the brazed joints are different in relation to the surface condition. The joint on fine surface with slot showed the highest value-8010N, while the joints of fine and coarse surface condition were 6540 N and 2080 N, but the joining on groove surface was unsuccessful. The joint strength on fine surface content slot increased 18% compared to only on fine surface. Therefore, the surface content slot is beneficial to increase the strength of the joints. From these preliminary results, it appears that fine surface gives favourable joint strength than the coarse surface.

Figure 5: Shear load vs surface texture for torch brazing of joint between AR500 steel and AA7075 aluminium alloy

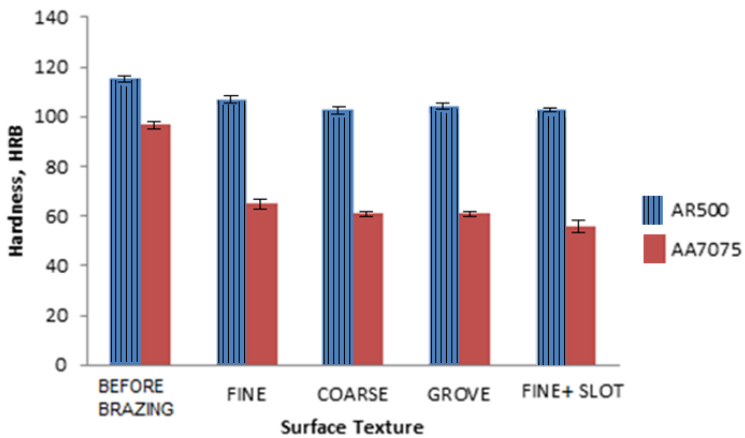
The resulting hardness on AR500 steel and AA7075 aluminium alloy after brazing process was also investigated. The hardness of base metal was tested on the outer surface of the joint metals (average hardness values of 3 readings for each condition). Figure 6 shows these hardness values of metals. Figure 6

indicates there was no significant change in the hardness of the steel base metal. The temperature has start an effect on the microstructure and properties of steel at around 738°C (eutectoid temperature which is the minimum temperature for austenite)[15]. The temperature used in the brazing process in the current study was 477°C, therefore no significant change in the hardness value of the steel took place. The hardness of aluminium decreased as a result of annealing. According to Isadare et al., coarse grains of the MgZn₂ phase were formed during the annealing process at 470°C and non-uniformly distributed in the aluminium matrix [16]. This brazing process caused the reduction of base metal hardness by approximately 10% on AR500 steel and 35% on AA7075 aluminium alloy.

Figure 6: Hardness vs surface condition for AR500 and AA7075 specimen plates

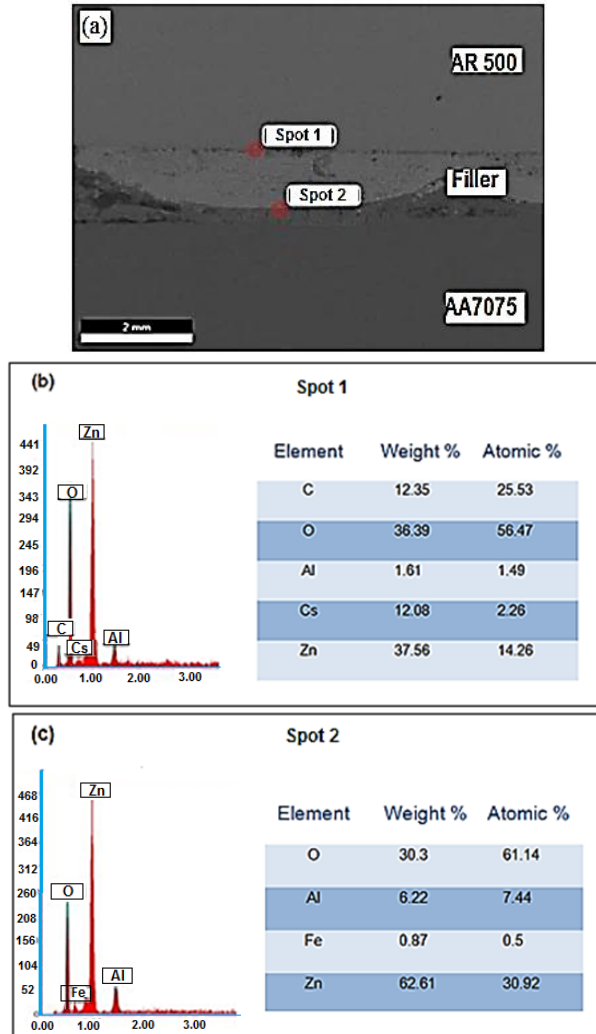
Figure 7: EDX analysis of torch-brazed joint between AR500 steel and AA7075 aluminium alloy: (a) SEM image of spot areas, (b) analysis of spot area 1 (reaction layer of AR500/filler), (c) analysis of spot area 2 (reaction layer of AA7075/filler)

The results of the SEM and EDX analysis on AR500 steel and AA7075 aluminium alloy joint shown in Fig. 5. They show that the reaction layer or the IMC formed on the AR500/filler consisted of C, Cs, Al, Zn and O elements, whereas on the AA7075/filler metal the reaction layer and IMC consisted of Fe, Al, Zn and O elements. The formation IMC (Fe-Al) and oxide in the interface of filler metal and base metal caused the joint strength to reduce [13,14]. The EDX analysis in Fig. 7 shows that the IMC formed in the brazed joint consists of a Zn -rich compound. The side containing low zinc compound causes the IMC to decrease and increase the shear strength [17,18]. This condition causes the fracture occurred in the AA7075 aluminium alloy and filler interface where the IMC consists of a high zinc

compound. The several spot area in EDX analysis was done, the results show the constant value of element and compound form in reaction layer and IMC area.

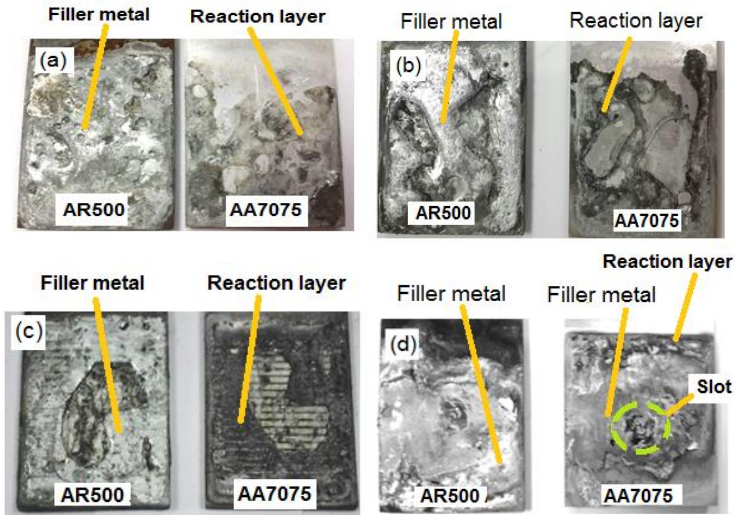
Figure 8 shows images of the fracture surfaces after the shear test. In all specimens, fractures occurred at the metal and filler interface except for the joint with groove surface in which the joining was unsuccessful. The joint fracture of AR500/AA7075 joint occurred between AA7075 and filler interface for fine and coarse surface. While, for the joining on fine with slot surface, the fracture was occurred on AR500 and filler interface. Observation on failure surfaces shows dark reaction layer formed on aluminium surface considered as oxide and entrapped flux [19]. This formation of layer caused the problem in the joining process by reducing capillary action between filler metal and base metal.

Figure 8: Fractured surfaces of AR500 steel and AA7075 brazed joint: (a) joint fracture surface for fine surface, (b) joint fracture surface for coarse surface, (c) joint fracture surface for groove surface, (d) joint fracture surface for slot surface.

Observation in Fig. 8(b) and 8(c) shows, the amount of dark reaction layer was high and covered the aluminium surface on coarse and groves surface. This was inline with several studies, whereby, the increase in surface roughness of the base metal influenced the spreading of molten filler on it. According to the studies, asperities present on a rough and groves surface acted as barriers needed to be overcome by molten filler while spreading. [20,21]. This situation caused some flux to be entrapped and the filler metal prevented from spreading to whole joint area and reacting with aluminium surface. This situation caused the joint process to fail or led to decrease in the strength.

The joint in Fig. 8(a) and 8(d) shows only small quantity of reaction layer formed in the surface of aluminium, this situation influenced the better capillary action between filler metal and aluminium. This situation caused the joint strength to increase. The result shows, the join strength on fine surface with slot is better than fine surface. This is due to the fact that the slot hole on the surface helped the flowing out of flux and reduced the entrapped flux in joint surface. The filler metal brazed in the slot area also caused the joint strength increased. The joint at this surface condition was the highest joint strength acquired.
