Proceedings of Civil Engineering Colloquium 2020

The Transcona Grain Elevator Failure Revisited Using Numerical Approach

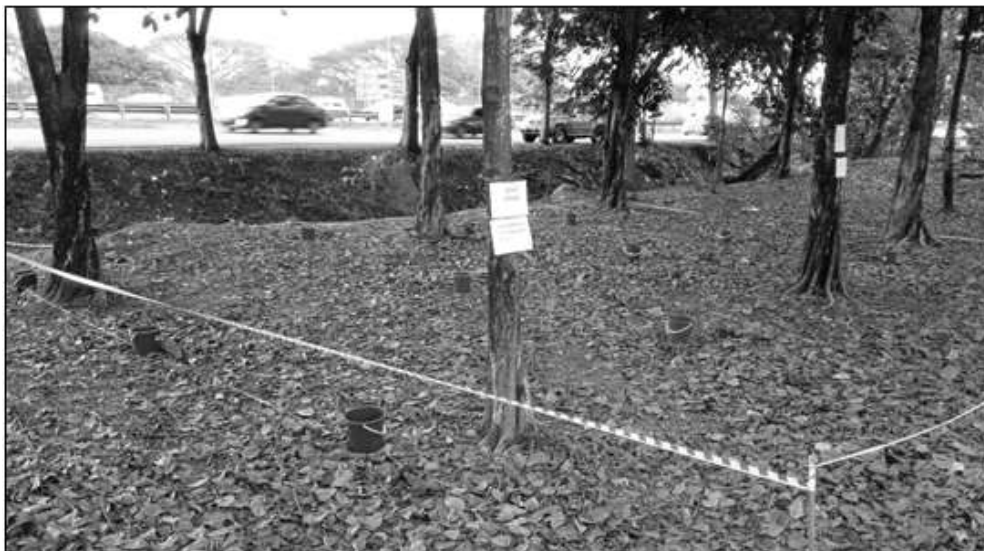
Fig. 1: Throughfall Collectors within the Plot Area

Meanwhile, for gross rainfall measurement, the rainfall is measured by placing a 22 cm diameter bucket at the study area. The plastic bucket was placed at the open area so it will receive direct rainfall as it should works as rainfall gauge. The rainfall volume was measured after each rainfall event. The gross rainfall collector should be placed near to the study area, preferably less than 30 m from the sampling area (Van Dijk and Bruijnzeel, 2001). The rainfall volumes were collected daily on-site using the plastic measuring cylinder. In this study, all related variables such as temperature, relative humidity, wind speed and wind direction were assumed to be homogeneous at all rainfall gauge locations. The rainfall distribution rate at study area are even and occur throughout the year.

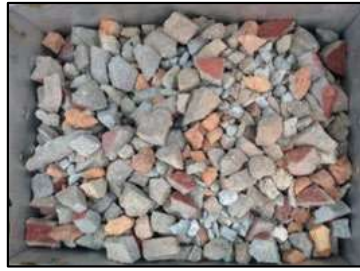
Fig. 1. Crushed Aggregate, C&D Debris and Roof Waste

Roofing materials are manufactured in variety types such as concrete, metal, shingle roof and clay roof tiles. Roofing material has a good durability under all exposure conditions. This roofing material are non-combustible, which give good protection from heat and fires. The used of roof waste or also known as roof shingles reduced the amount of materials disposed to the landfills. Roof wastes can be applied in granular base stabilization for layers underlying the pavement surface, patching materials for repairing potholes or in hot mix asphalt concrete and surface layers (Newcomb, 1993). Figure 1 shows the mixture of crushed aggregate, C&D debris and roof waste used in this study.

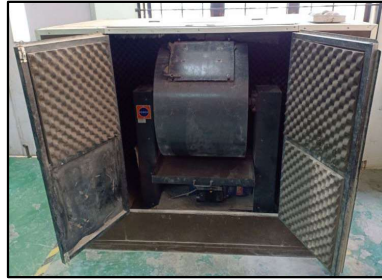
Los Angeles (LA) Abrasion test is a measure of degradation of mineral aggregates of standard grading resulting from a combination of action including abrasion and grinding in rotating steel drum containing specified number of steel spheres (Sohadi, 2001). The LA Abrasion test is performed in order to determine the resistance to abrasive wear of an aggregate in accordance to ASTM C131:2006. The mixtures are washed and oven-dried for 24 hours. Then, the mixture is placed inside the drum as shown in Fig. 3 with 11 steel balls. The drum is rotated for 500 revolutions at a speed of 30 to 33 rpm and the mixture is then sieved on a sieve size 1.7 mm. Then, the retained sample is washed and kept in oven for 24 hours.

Fig. 3. Los Angeles (LA) Abrasion Test.

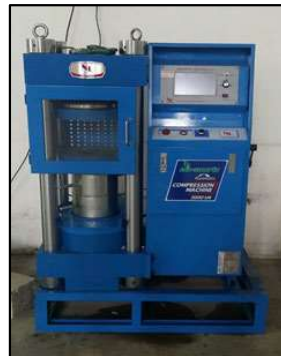
Fig. 4. Aggregate Crushing Value (ACV) Test.

Aggregate Crushing Value (ACV) test is a measurement of the resistance of material to crushing under a gradually applied compressive load. The ACV test is carried out on material that passing 14 mm and retained on 10 mm sieve size. The procedures for ACV test are in accordance to BS812-110:1990. The mixture is put in a standard mould and for a period of 10 minutes, the load of 400 kN is gradually applied to the mixture as shown in Fig. 4. The mixture is then taken out from the mould and being sieved with 2.36 mm sieve. The amount of material passing 2.36 mm sieve is then weighted.

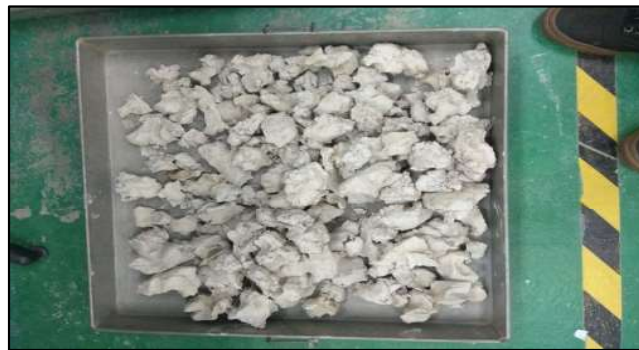
Fig.2. 24-Hour oven-dried clay

Sucrose and cement have been prepared for usage as stabilizer material for clay. Figure 2 shows the 24-hour oven-dried clay while Fig. 3 shows sucrose that have been crush into powder.

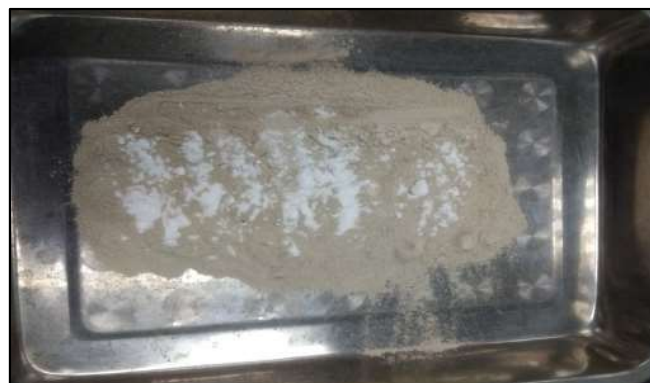
Fig. 3. Sucrose that have been crush into powder

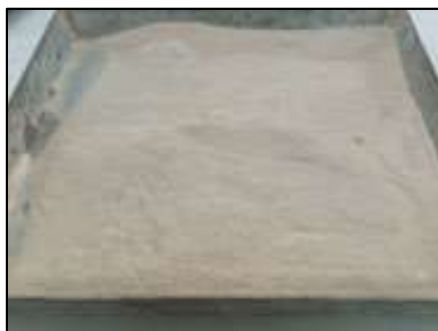
Fig. 1. Dried fine clay soil.

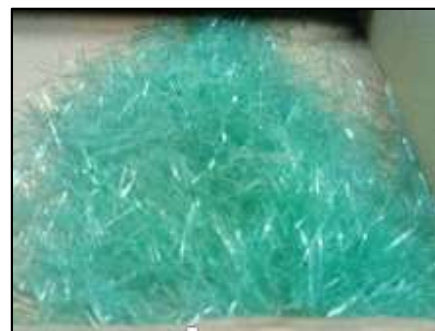
Fig. 2. Nylon reinforcement strip.

Nylon fibre reinforcement material used in this study is cut into small pieces with certain length around 5mm -10mm as shown in Fig. 2. The percentage of mixture used were as follow; 0.25%, 0.5%, 0.75% and 1.0% respectively based on the dry weight of soil. The mixing process was manually performed before the mixture is transferred into cylinder steel mould for controlled compaction process. After the compaction process was completed, the compacted soil will be trimmed out to prepare specimen for unconfined compression test. Reliable reconstituted samples are obtained through consistent 27 blows of hammer for each layer during systematic process of sample preparation.

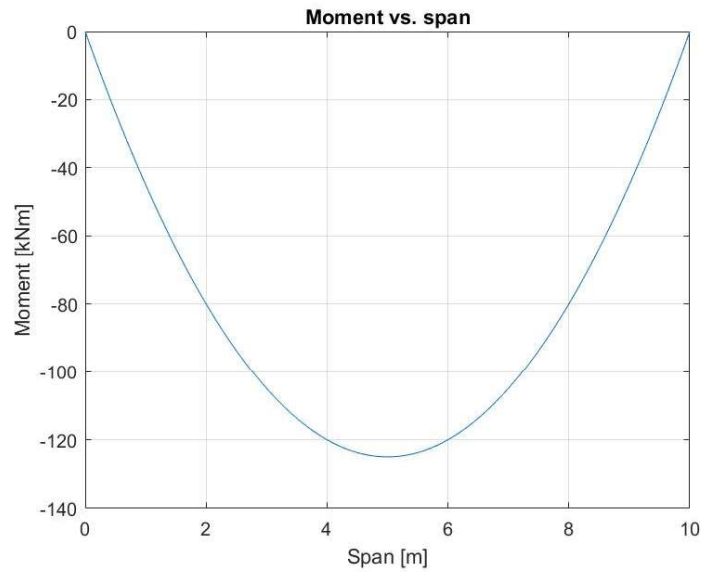
Fig. 9 Bending Moment Plotting

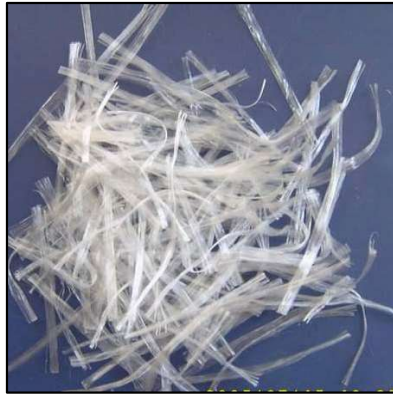
Fig. 1. Polypropylene Fiber (PPF)

The polypropylene fiber (PPF) as in Fig. 1 was used in this study has the properties as stated in Table 1 below.

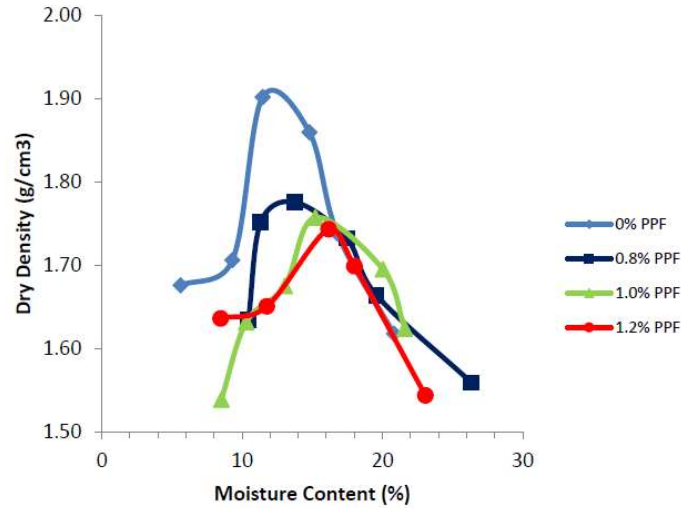
The reduction pattern obtained when percentage PPF increased but instead, the optimum water content obtained were increased.

Fig. 3. Compaction Curve from Standard Proctor Test of Unreinforced and Reinforced Soil at Various Percentage of PPF

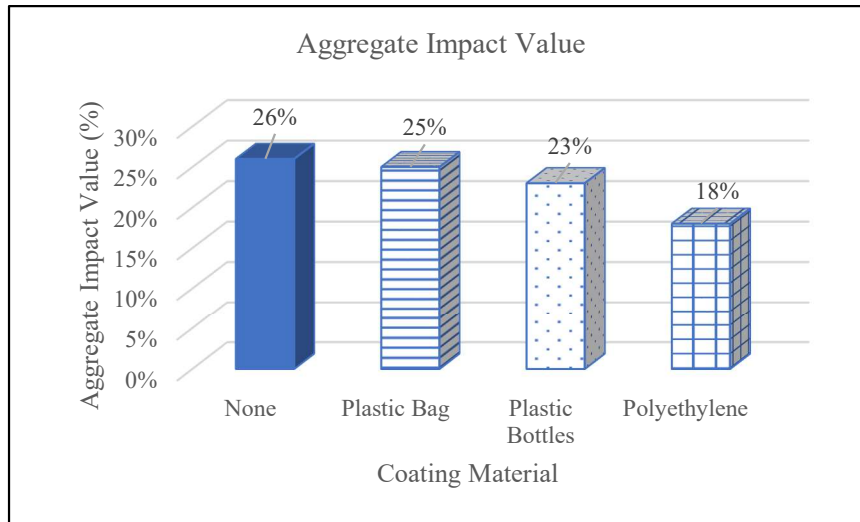
Fig. 1. Aggregate Impact Value.

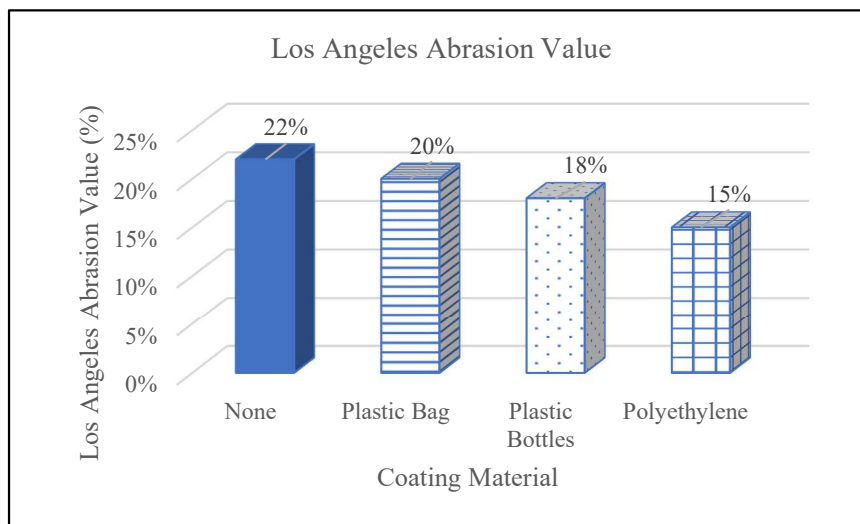
As shown in Fig. 2, the Los Angeles abrasion value is lowest on polyethylene-coated aggregate. The graph shows a similar pattern of aggregate impact value. By coating the aggregate with plastic, the aggregate hardness is increased. A thin film of plastic coating protects the aggregate surface from rubbing between each other and steel balls in the abrasion machine, hence increase the resistance to abrasive wear. The maximum reduction of abrasion loss is by using PE which is 31.8%.

Fig. 2. Los Angeles Abrasion Value.

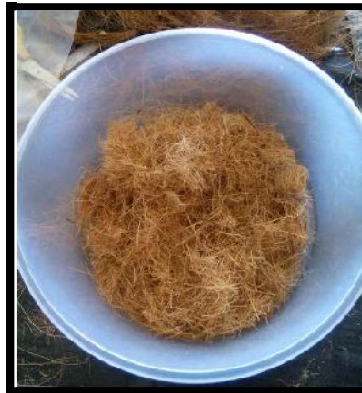
Fig. 1. Sample of Coconut Coir Fibre (CCF)

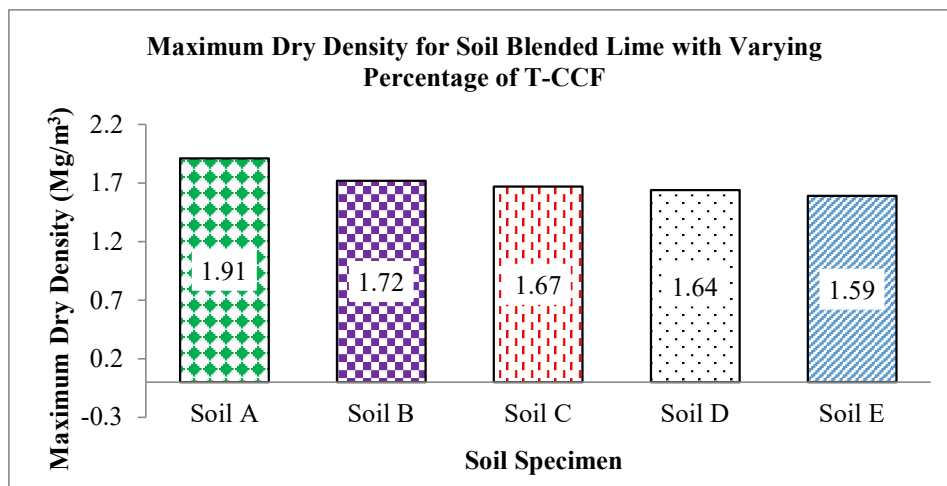
Optimum Moisture Content (OMC) and Maximum Dry Density (MDD) values obtained from SPT conducted on different soil Mix Design as referred in Table 1 and were plotted in Fig. 2 and Fig. 3. Table 3 shows OMC and MDD obtained from SPT for soil with varying percentages of T-CCF.

Fig. 2. Graph of Maximum Dry Density (MDD) vs Soil Specimen.

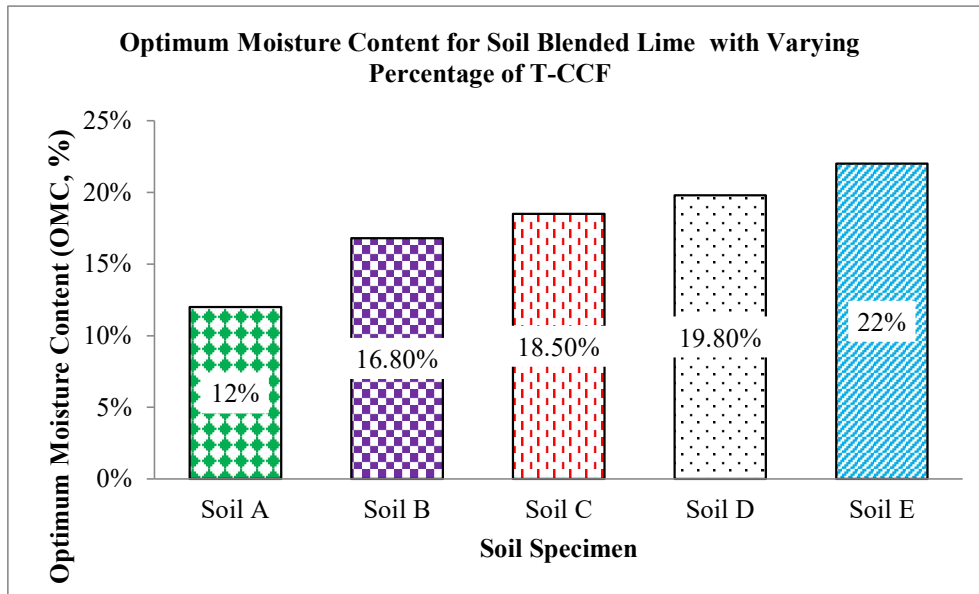
Fig. 3. Graph of Optimum Moisture Content (OMC) v/s Soil Specimen.

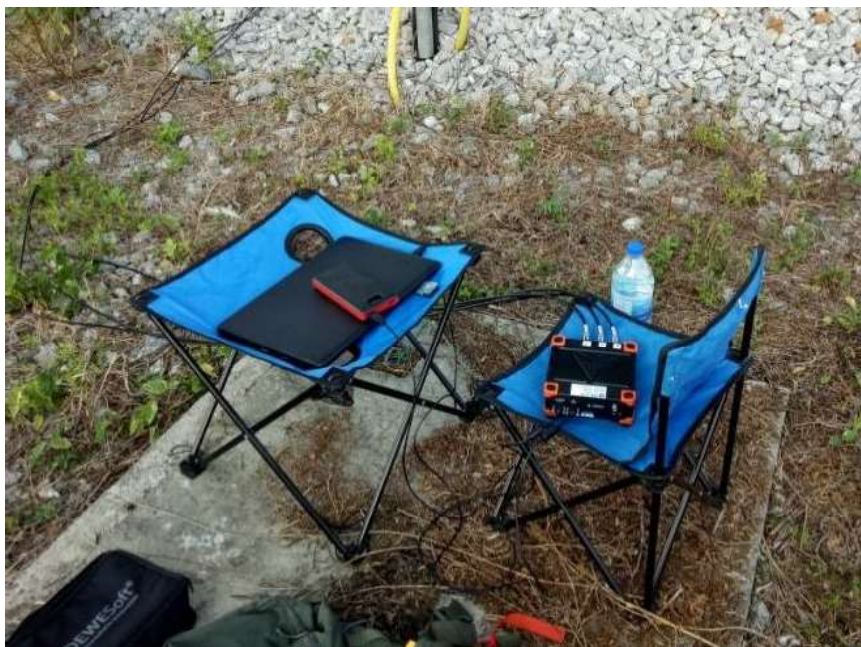
Figure 2 showed the equipment called Sirius Mini to measure the acceleration against time of trains tamping on PCSs. The piezometer sensor was attached to selected PCS and connected to the computer as shown in Fig. 3. Dewesoft is software to store the data taken at site investigation. It is storing deflection, sound and acceleration reading. The measurements were taken for the type loading of the train as per title six car set and three cars set coaches which are called commuter as daily ride for passengers from Padang Besar to Butterworth and vice-versa. 10 days data collected from the site investigation. The raw data train loading was captured by Dewesoft software as shown in Fig. 4, before they were extracted to Microsoft Excel.

Fig. 2. Measuring data equipment called Sirius-M

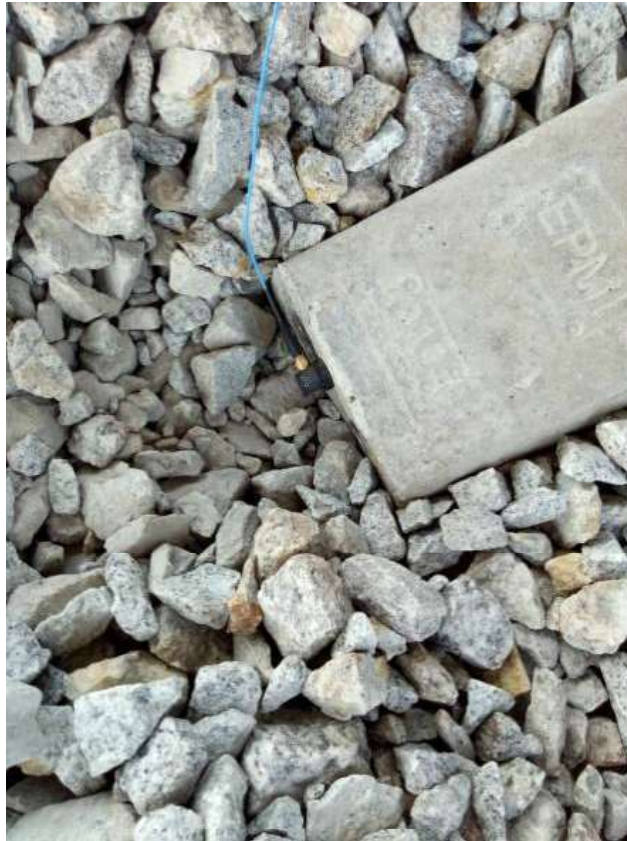
Fig. 3. The installation piezometer on prestressed concrete sleeper

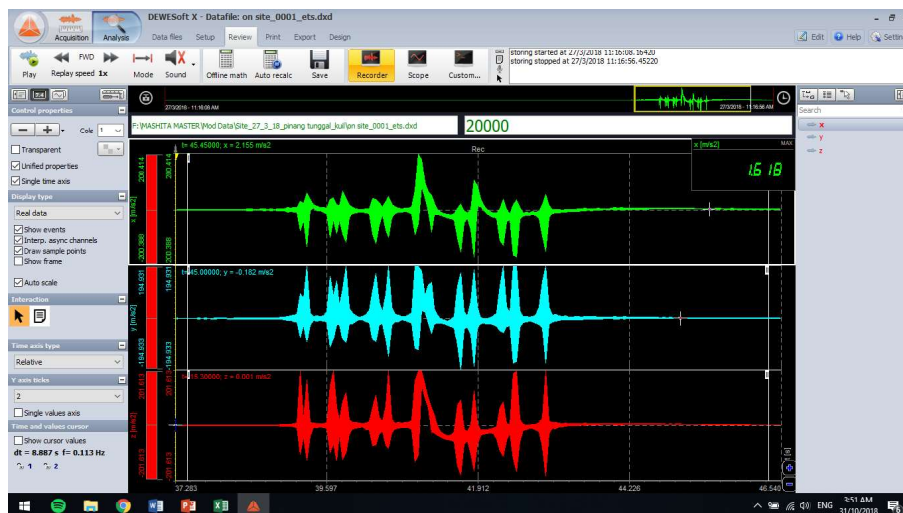
Fig 4. Data captured by Dewesoft Software

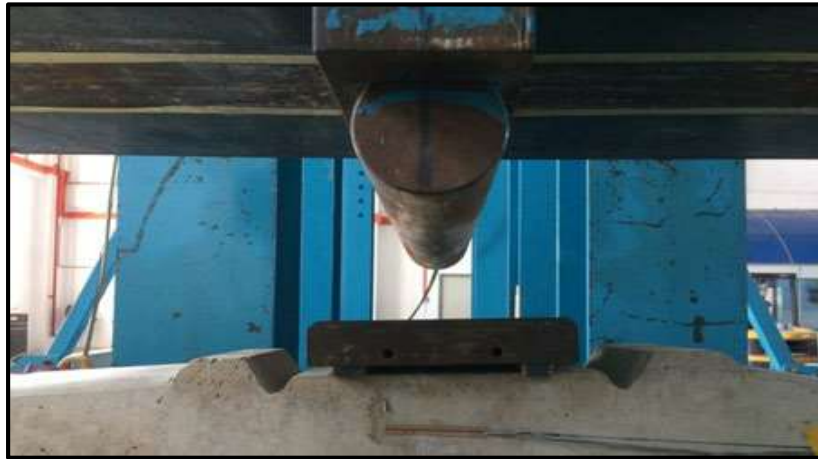
Fig. 9. Plywood Supports Positioned in Laboratory Testing

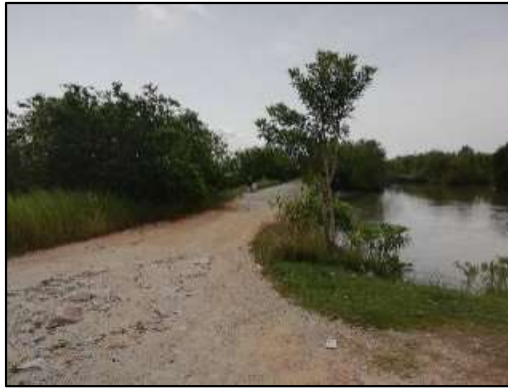
Fig. 1. The Soft Soil Brought from Marine Area Located at Batu Kawan

The main material used in this study is tile waste, rice husk ash, and the soft soil shown in Figs. 1 and 2 was brought from marine area located at Batu Kawan. The tile waste was crashed into powder to enable material preparation for the soil sample. Rice husk ash was taken from the rice factory in Kuala Kedah, Kedah.

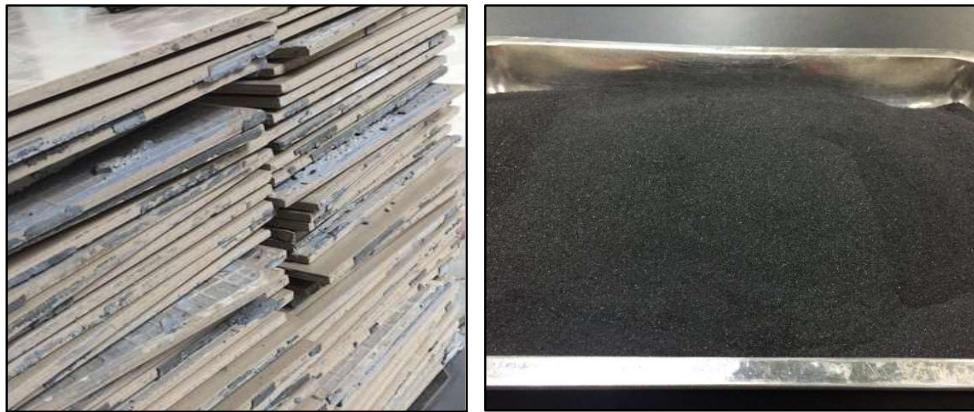
Fig. 2. Tile Collected from UiTM Pulau Pinang and Rice Husk Ash from Factory in Kuala Kedah

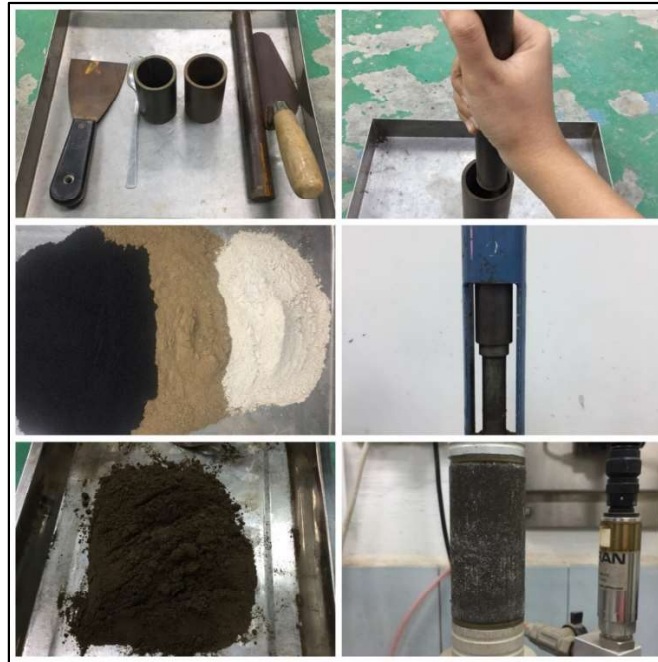
Fig. 3: Preparation of UCT Specimen

Several tests were carried out as per BS1377 (1990) to determine the physical properties of soil, including Particle Size Distribution, Hydrometer, Atterberg Limit Test and Particle Density Test. Liquid limit was obtained using Cone Penetration apparatus. Plastic limit was determined by rolling the soil between the palms of the hand. The soil sample was compacted using Standard Proctor Compaction Test. About 3 kg of soil was compacted in a mould of 105 mm diameter using a rammer of 2.5 kg in 3 layers with 27 number of blow each layer. These tests were conducted to find the maximum dry density (MDD) and optimum moisture content (OMC) needed in the soil. Then, 5% of water from the OMC was added to the sample to represent rainy season condition and 5% of water was reduced from the OMC to represent dry season condition. These 3 conditions were applied to prepare the specimen for unconfined compression test (UCT) (Fig. 3).

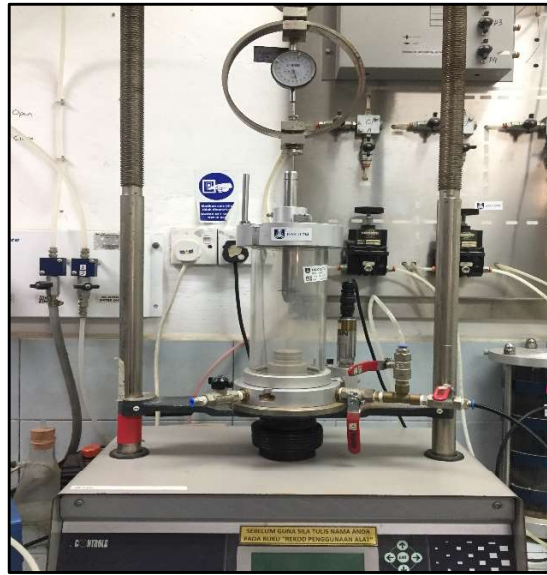
Fig. 4. Unconfined Compression Test Machine

Specimen was prepared by replacing the soft soil with tile waste passing 4.25mm. To find the optimum percentage of tile waste for stabilization of soft soil, tile waste was varied from 15% to 35% at increment of 5% with a constant 10% of rice husk ash as an activator agent as shown show in Table 1. Soil sample was compacted in a mould with 38 mm diameter and 76 mm height. All specimen is then cured for 0, 7 and 14 days of curing period. Specimen were tested for unconfined compression test (UCT) at a strain rate of 1.25mm/min in triaxial machine show in Fig. 4.

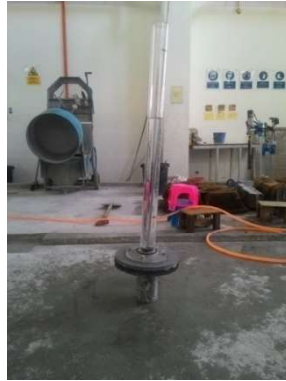
Fig.2. Flow Meter Test

Pervious concrete samples were cast into 2 shapes which are 100 mm x 100 mm x 100 mm cube and 100 mm diameter x 200 mm height cylinder for compression test and permeability respectively. There were 9 cubes and 9 cylinders for each series. After 24 hours, pervious concrete specimens were demoulded and cured for 7, 14 and 28 days. Pervious concrete samples were tested their compressive strength and permeability. Compression test were conducted using compression machine in accordance to BS EN 12390-3 (2009). Meanwhile, the permeability test of the pervious concrete specimens were conducted using flow meter as shown in Fig. 2. Testing method for measuring pavement texture drainage was referred to EN 12697-40:2011. This method is adopted from Test Method of Hot Mix Asphalt – Part 40 (In situ Drain ability). The time taken for the specific volume of water to pass through the voids of the pervious concrete specimens under the gravitational pull were recorded.

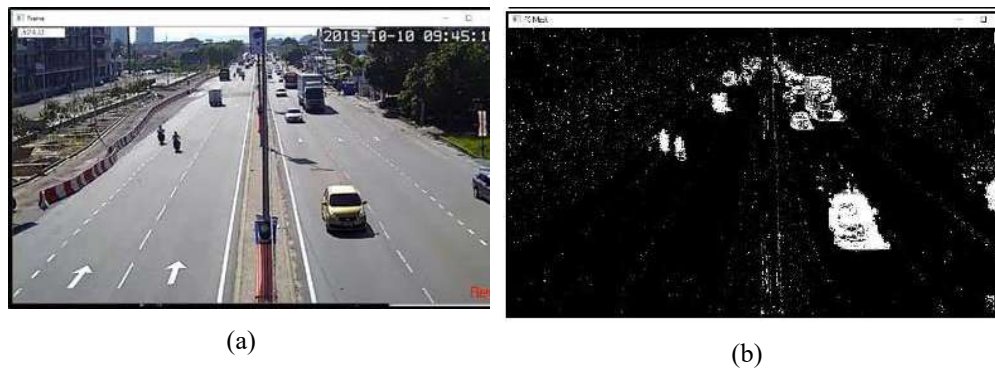
Fig. 1. (a) Input Frame and (b) Reconstructed Background Model in Background Subtraction Module

subsequent stages. The module of *BackgroundSubtractorMOG2* developed by Zivkovic & Van Der Heijden (2006) was adopted. It was selected because it is proven to be robust and effective by outperforming all other available algorithms used on the *OpenCV* dataset. One important feature of this algorithm is that it selects the appropriate number of gaussian distribution for each pixel. A sample of the background subtraction module output can be seen in Fig. 1. Figure 1 represents respectively the correspondent input frame and the reconstructed background model.

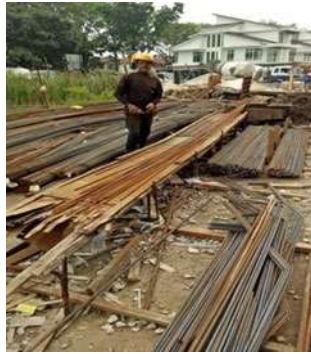
Fig. 1. Bar Bender Work

The method of performing site assessment started after receiving the description of the worker's output from the interview. Observation of the site undertaken to see the impact of heat stress on staff efficiency. Few variables needed to establish the relationship between heat stress and productivity of the worker, for example heat stress (temperature), working period, and efficiency of the job. There are three types of work to be observed as shown in the Fig. 1, Fig. 2 and Fig. 3 which are bar bender work, rebar wall installation work and tiles installation work.

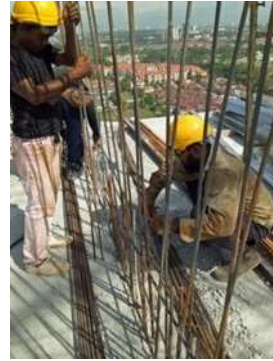
Fig. 2. Installation Rebar Wall

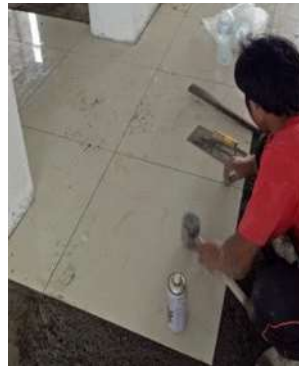
Fig. 3. Installation Tiles Work
