RISING DAMP STUDY IN UITM PERAK'S ACCOMMODATION: A PILOT STUDY

Zaimah Zainal Abidin^{1*}, Nur Azfahani Ahmad² and Alia Abdullah Salleh³

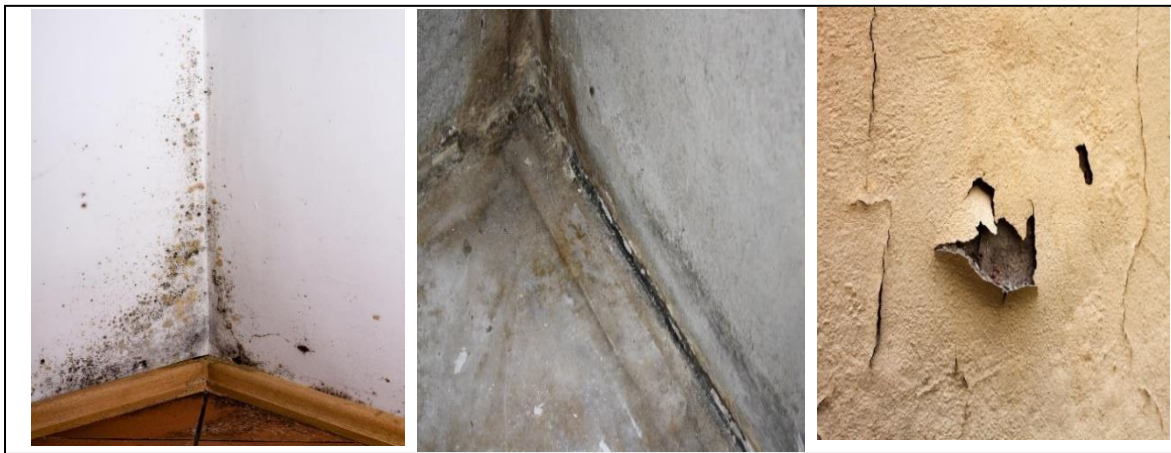
Figure 1: The example of building defects occurs at building due to high humidity
(Source: Halim et al., 2012)

The moisture problem that occurs at buildings is usually take place on the connection between the floor and the wall of a building. This situation can be seen in Figure 1. The occurrence of water seepage that is related to the improper waterproofing installation may lead to mould growth, flaking of paint and water stain (Luca, 2014). The affected area is usually occurring on vinyl or carpet floorings (Shuib & Baharum, 2015).

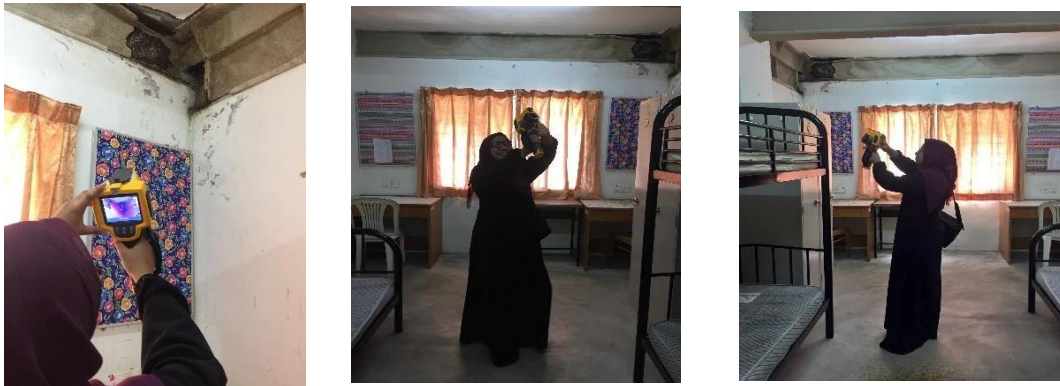
Figure 2: The Thermal Imager used during pilot study

Figure 2 and 3 shows the function of thermal Imager. Thermal imager is one of important tool that can be used by Building Surveyors to get an accurate result about defects happened toward the buildings that is related to dampness. It can give many benefits to Building Surveyors during inspection works especially when they want to inspect the buildings which are related to issue of humidity in buildings. Some of the fact about thermal imager, the image that have been taken by Building Surveyors can be recorded on videotape and can be viewed through the eyepiece of a video scanner (Szokolay, S.V 2008). According to Roos, (2008) the difference of contamination of inside air temperature between outside temperature can be reduced, this tool will be showed the greatest contrast between the parts of the building which is in cold area and warm area on the video image. Besides, according to Chris Linville, (2002) thermal imaging also can identify root sources of defects happen to buildings and can make the owner take an immediately action to repair their building and through this way, they can solve their problems early. Roos, (2008) stated that thermal imaging camera can assist a building diagnostic inspection through:

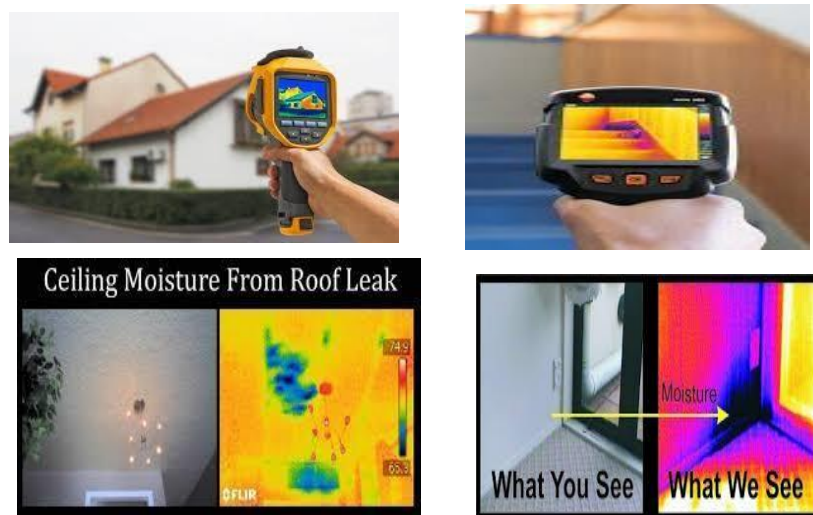
Figure 3: Function of thermal imager (Centers et al., 2017)

- Visualize energy losses
- Detect missing or defective insulation
- Source air leaks
- Find moisture in insulation, in roofs and walls, both in the internal and the external structure
- Detect mold and badly insulated areas
- Locate thermal bridges
- Locate water infiltration in flat roofs
- Detect breaches in hot-water pipes
- Detect construction failures Monitor the drying of buildings
- Find faults in supply lines and district heating
- Detect electrical faults

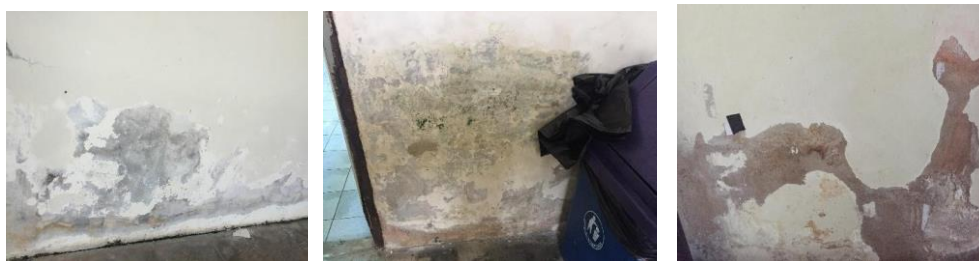
Figure 6: Example taken from a pilot study of this study: Rising damp at Student's accommodation, UiTM Perak.

Figure 6 above is an example of rising damp found in student's accommodation, UiTM Perak. The figure has shown a clear defect occurs due to moisture. All photos related comes from rooms that are located next to the toilet. It is significant to carry out this research based on the proof shown, where the defect is due to fungus attack because of high humidity (Abass, K., 2009).

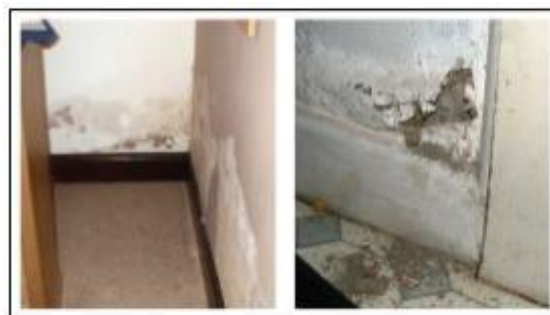
Figure 10 Decorative Spoiling

Decorative Spoiling can happen when moisture and ground salts existed and it will call as a rising damp and can cause peel of wallpaper, deteriorate of plaster and blister of paint (Burns, 2010). This issue is usually found in many high-rise accommodations, for example flat, apartments, condominium, including hostel and student’s college. Burkinshaw, (2012) has highlighted that rising damp always occur inside student accomodation which affect the health condition of the room.
