## **ICITSBE 2012**

## **A BUILDING CONTROL POINT OF VIEW ON DEMOLITION OF FULL PRECAST CONCRETE BUILDINGS IN HONG KONG**

**KUNG Shu-hang, Raymond and WU Po-tak, Alex**  
Housing Department of Hong Kong Special Administrative Region

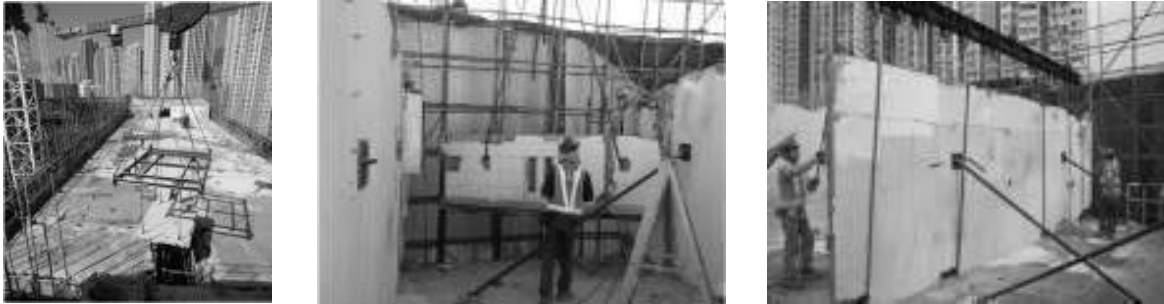
Figure 6 Trial Run of Demolition

On 11 October 2010, ICU was invited by the project team to witness the trial run to be conducted at roof of Block 10. Before lifting up the first precast slab, the existing grout around the gap and in the slots of the slab had been removed. The exposed reinforcement bars were then cut. Below the subject precast slab, the jaws of four special ordered hydraulic wedge spreaders were inserted into the slots. The precast slab was connected to a prefabricated steel frame by four chains which in turn hanged from the tower crane by lifting wire. The lifting wire would then be gradually retracted and stopped when a very small force of 0.5kN had been induced. This was to avoid the precast slab from falling down suddenly as well as to assist for slackening off the precast slab from its position. Upward force was then applied through the four hydraulic wedge spreaders. The precast slab slowly moved up without bouncing up. Before the next step to proceed, ICU inspected the subject precast slab to check the integrity of the precast slab and surrounding supports. Minor cracks were found appearing on sides of the precast slab. Uneven rising up of the precast slab at four sides was also noted. The observed defects were immediately conveyed to the project team for investigation. The project team soon reported that the cracks were due to the incomplete removal of the existing grout at one slot. This rendered one set of the reinforcement bars had not been cut. As a consequence, uneven rising up of the precast slab was observed. After knowing the reason, the affected portion was rectified at once. The precast slab was then lifted up and lowered down to the ground.

Demonstration for precast wall demolition was subsequently followed. The precast wall was first tightened and fixed by four chains from bottom to top and around the wall element to ensure the stability from falling sideway. The chains were connected to the lifting wire of the lift tower through a steel section. The lifting wire was then gradually retracted and stopped when the chains had just got “straightened”. The grout of the pre-formed openings had been broken in advance. The exposed reinforcement bars were cut and the bracings for the precast wall were also released. Two hydraulic jacks were installed at locations close to two ends near bottom of the precast wall to slightly move it up. Before lifting up of the precast wall, inspection was conducted to check its integrity. No anomaly was found on the precast wall so it could be moved away by the tower crane.

From building control point of view, the demolition procedure and sequence demonstrated in the trial run were considered acceptable. However, the problems noted during removal of the precast slab might cause accident which needed to be addressed before the consent could be granted. Project team responded that in order to ensure the precast slab has been completely disconnected from other members, a minimum up-rise of 10mm at all four sides of the precast slab had to be confirmed before it could be lifted up. ICU accepted the proposed solution.
