# High Temperature Corrosion Behaviour of Steel with a Carbonate Deposit at 1123K

Habsah Md Ishak M.Misbahul Amin Nazree Derman Khairel Rafezi Ahmad

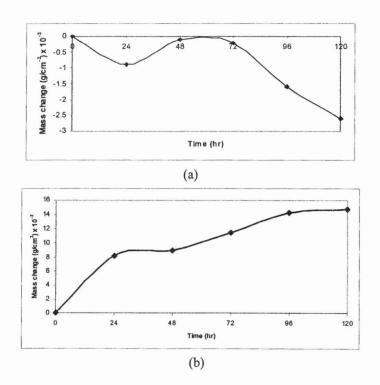
Figure 1 (a & b) shown oxidation kinetic (mass change vs. time) curves of AISI 304 stainless and S45C carbon steel coated with  $CaCO_3$  oxidized at 1123K for 24 to 120 hr. The curves for AISI 304 shows a mass loss up to 48 h followed by a relatively small gain at 72 h and mass loss up again to 120 h. While for the curves of S45C carbon steel shows mass gain with increasing of time up to 120 h exhibiting approximately parabolic behavior.

Formation of oxide layer by CaCO3 deposit on the metal surfaces cause mass change of the steel There is evidence for AISI 304 stainless steel showed mass loss due evolution of CO2 resulting cracks and voids. While S45C Carbon steel coated with CaCO3, oxidized at 1123 K showing mass gain due to alloy is soft and malleable, exhibiting formation of ferrous oxides. It is because chromium containing on iron AISI 304 as a major element for corrosion resistance at high temperature. Meanwhile the carbon steel not contain these element as a corrosion resistance. With the lack of compact scale formed on the carbon steel surface and not be used for oxidation resistance application, especially in oxidizing environment at elevated temperatures.

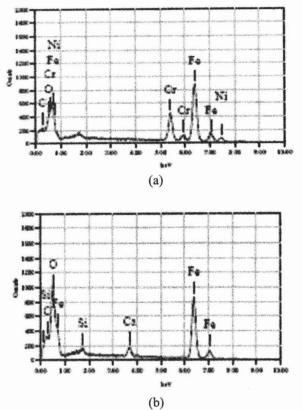
Figure 3: EDAX Analysis Result of the Scale on the Alloy Surface Oxidized at 1123 K for 72hr

The inner layer of scales of AISI 304 steel and S45C carbon steel corroded at 1123K for 72 hr in the presence of CaCO<sub>3</sub> contain  $Cr_2O_3$ , FeO, SiO, NiO are shown in Fig.3 (a) and (b) and Table (2 & 3)

For these study the scale consist of inner oxide layers of Cr<sub>2</sub>O<sub>3</sub>, NiO,SiO<sub>2</sub> and CaO while external layer of FeO.
