**DEPARTMENT OF BUILDING SURVEYING
FACULTY OF ARCHITECTURE, PLANNING AND SURVEYING
UNIVERSITI TEKNOLOGI MARA
PERAK**

DEFECT AT EAST BLOCK, POLITEKNIK MERSING, JOHOR DARUL TAKZIM.

**PRACTICAL TRAINING REPORT
JUN 2013 – SEPTEMBER 2013**

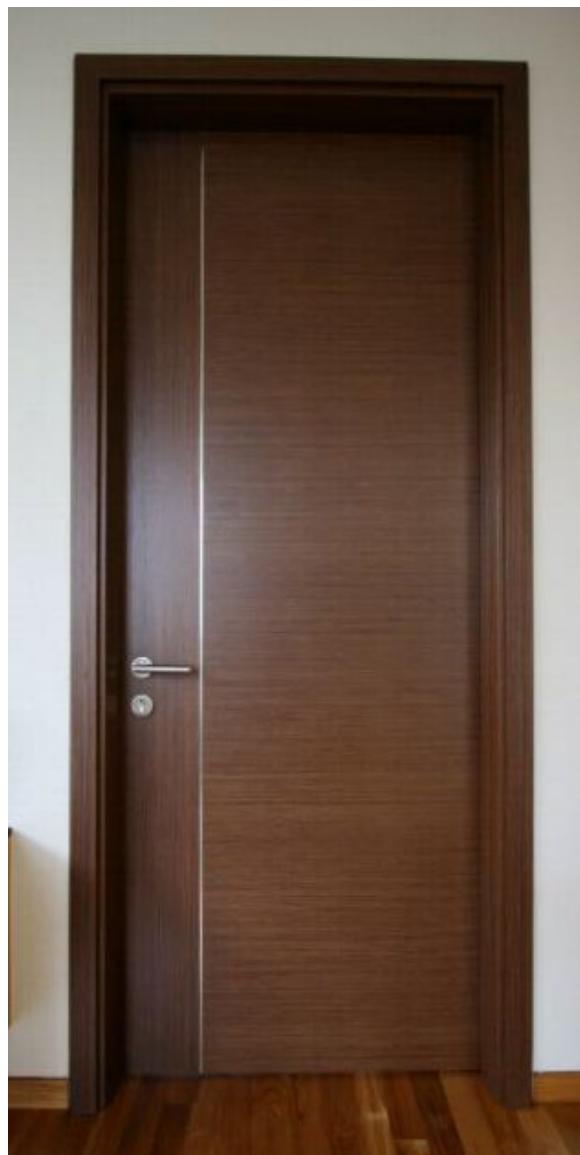
Figure 3.4.2.1 | Single Leaf Door of East Block Politeknik Mersing

Figure 2.2.1 show the double flush timber door. The double flush timber door has two panels and the door usually made from the wood. At the every lecture room and other room have two doors to go inside the room; it is the panel doors same like the figure. The doors used brown color paint as the finishes. At my case study's door, the entire door use double leaf timber flush door.

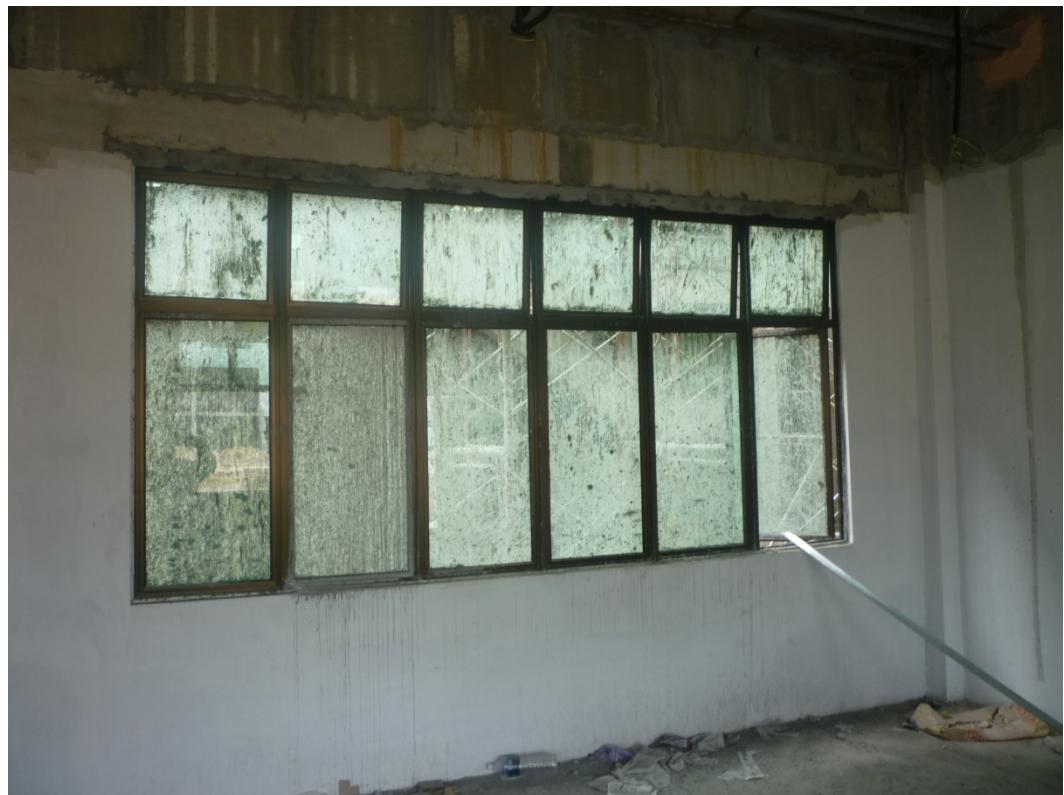
Figure 3.4.2.3 | Window Type Of East Block Politeknik Mersing

Figure 4.4.2.3 show the type of the window is adjustable louver window. As see the figure, we know the window using glasses casement window. All the entire building uses the same window for the opening.

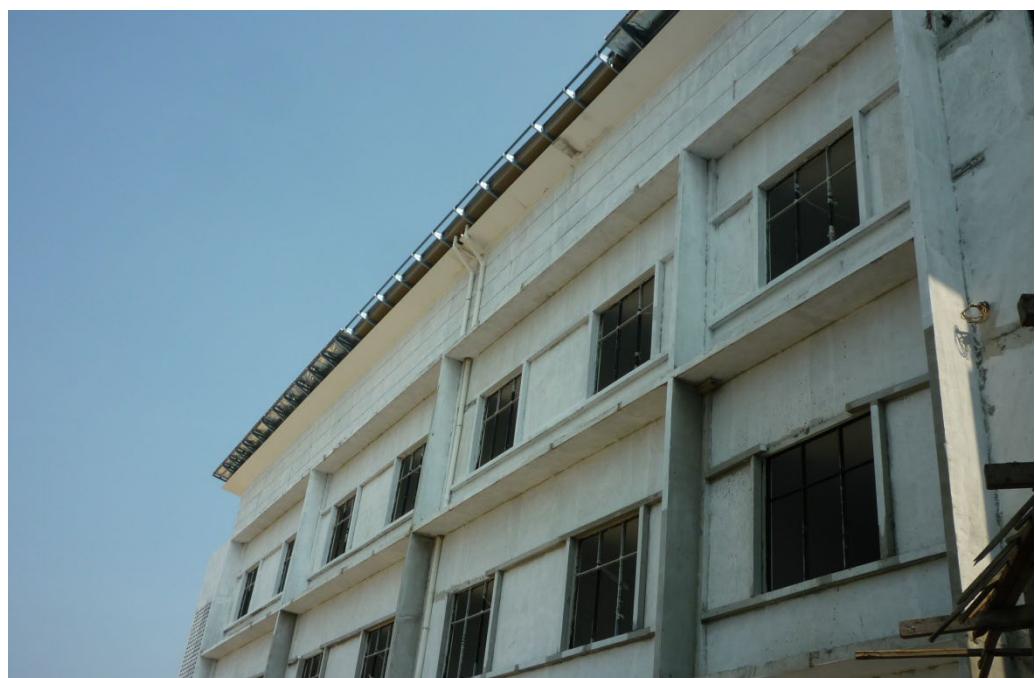
Figure 3.4.3.1 | Panel Wall Of East Block Politeknik Mersing

Wall is the important element for each building. Wall usually is a solid structure that defines and sometimes protects an area. Commonly, wall delineates a building and supports its superstructure, separates space in the buildings into rooms and protects or delineates a space in the open air. Type of wall use in the building is panel wall and brick wall. The panel wall and brick wall was installed at all the East Block building. We can see at the figure 3.4.3.1 and 3.4.3.2.

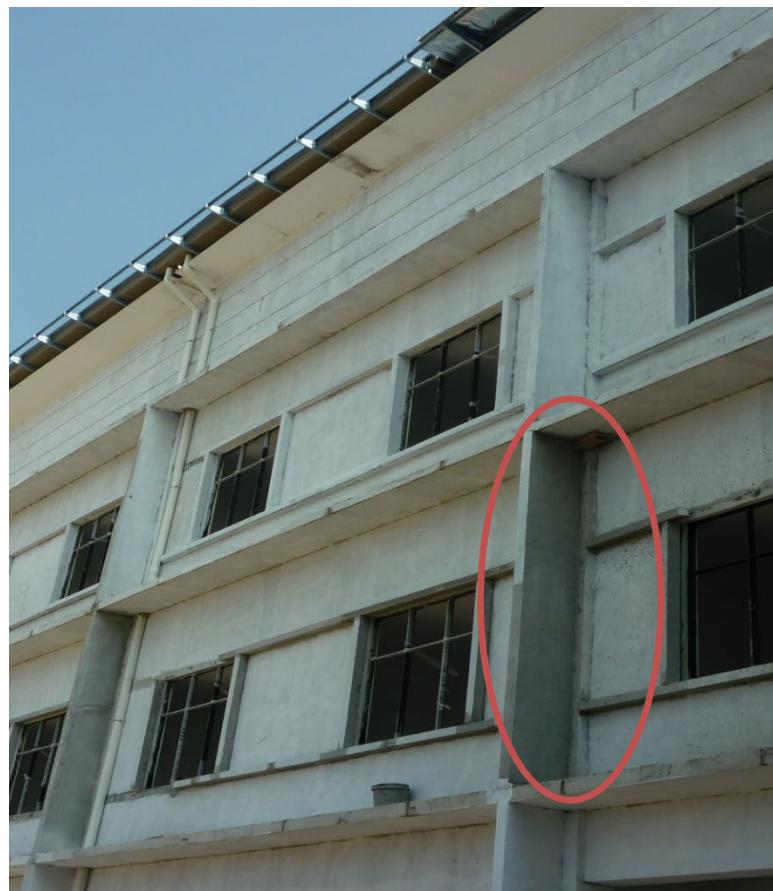
Figure 3.4.4 | Column of East Block Politeknik Mersing

A column in structural engineering is a vertical supported element that transmits through compression, the weight of the structure above to other structural elements below. For the purpose of wind or earthquake engineering, columns may be designed to resist lateral forces. Refer figure 3.4.4.1

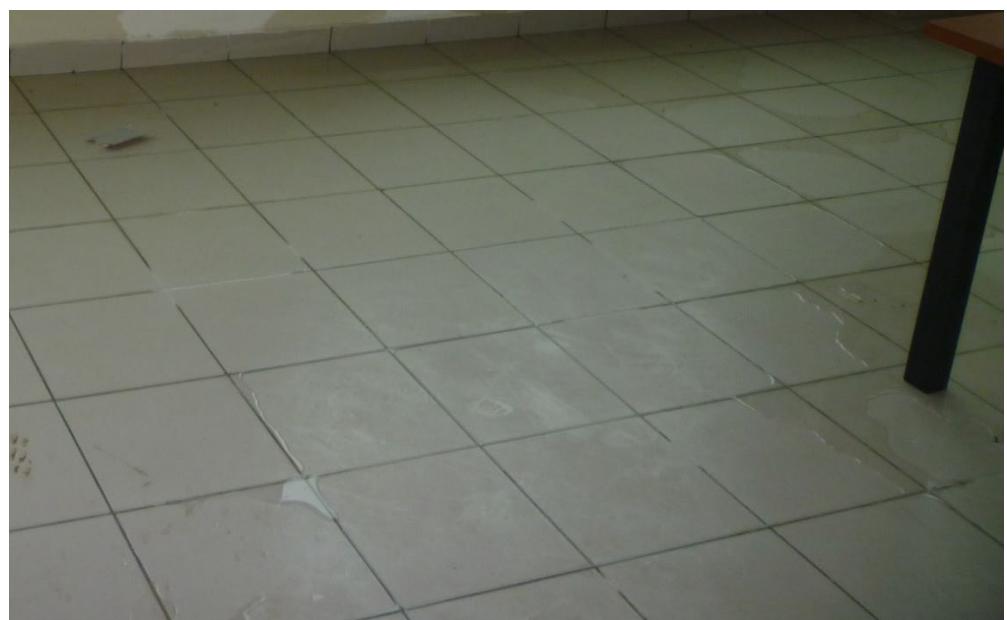
Figure 3.4.6.1 | Floor Tiles at East Block Politeknik Mersing

At The East Block Politeknik Mersing have two type of the floor. It's is cement render at pavement, AHU room, etching room and use floor tiles in the other room. Refer at the figure 3.4.6.1 for the cement render floor and figure 3.4.6.2 for the Floor tiles at East Block Politeknik Mersing.

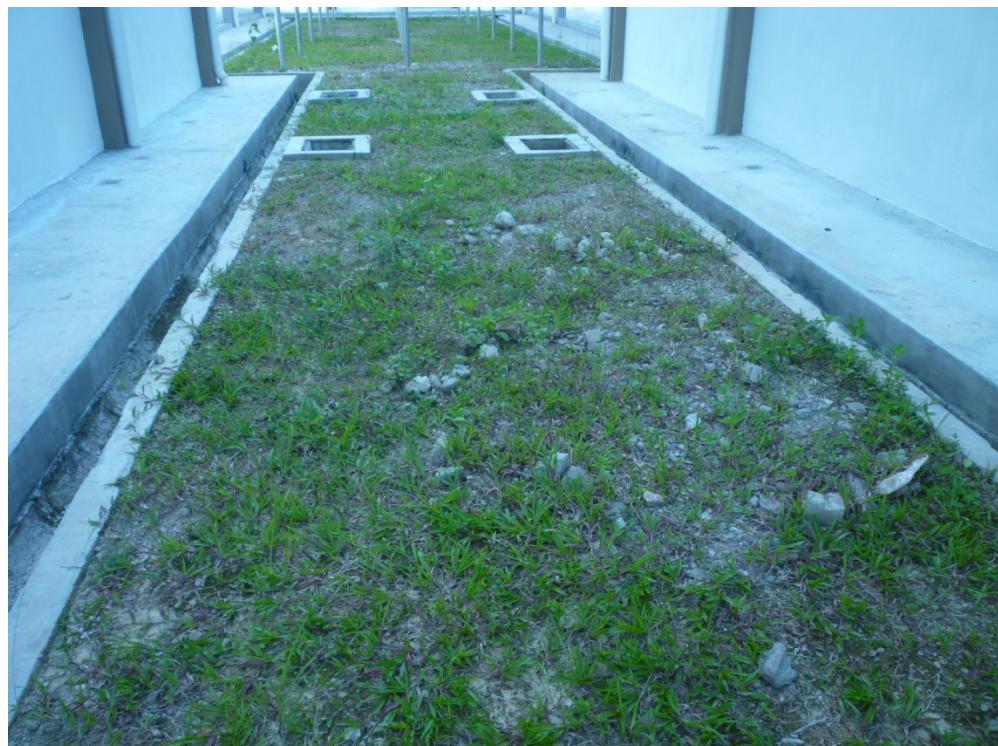
Figure 3.4.7.1 | Cement Render at East Block Politeknik Mersing

The drainage of the building uses the standard drainage at the other building because the function is to flow the water out. Drainage is the natural or artificial removal of surface and subsurface water from an area. For East Block Politeknik Mersing, the drainage is around the building and the drainage follows the floor plan of the building. Refer figure 3.2.15.

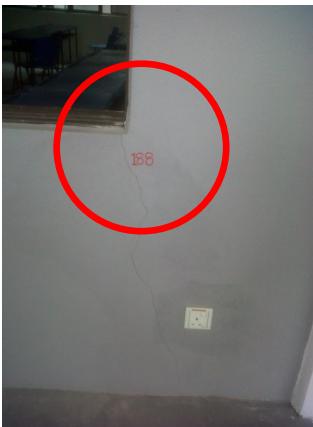
Defect Sheet No. 1	Level	Ground Floor		
Photo/Sketch	Location	Bilik Kuliah 1

Element	Wall		
Component				
Baris				
Condition	Priority	Matrix	Colour	
2	2	4		
Defect description				
Cracks that occur in between the wall panel connection exceed 25 cm.				
Possible causes				
The joint between the wall panel connections are not properly connected. The extension also does not use the correct grade of concrete.				
Remedies				
<ol style="list-style-type: none"> 1. Remove the concrete at the cracks. 2. Use the high concrete to replace the existing concrete 3. Apply skin coat on a concrete replaced. 4. Paint the wall using the correct paint code.

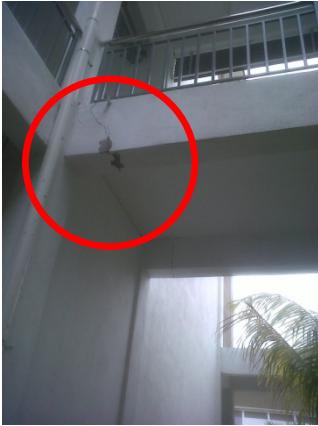
Defect Sheet No. 20	Level	Ground Floor	
Photo/Sketch	Location	Route

Element	Beam	
	Component		
Baris			
Condition	Priority	Matrix	Colour
3	2	6	
Defect description			
Cracks that occur at the beam between the corridor and building 30 mm long.			
Possible causes			
The joint between the first beam made and second beam connections are not properly connected using the correct method.			
Remedies			
<ol style="list-style-type: none"> 1. Remove the concrete at the cracks. 2. Use the high concrete to replace the existing concrete 3. Apply skin coat on a concrete replaced. 4. Paint the wall using the correct paint code.

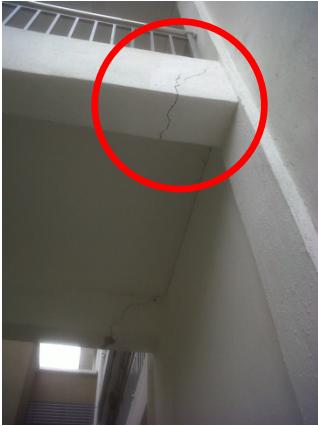
Defect Sheet No. 21	Level	Ground Floor		
Photo/Sketch	Location	Route

Element	Beam		
Component				
Baris				
Condition	Priority	Matrix	Colour	
3	2	6		
Defect description				
Cracks that occur at the beam between the corridor and building 30 mm long.				
Possible causes				
The joint between the first beam made and second beam connections are not properly connected using the correct method.				
Remedies				
<ol style="list-style-type: none"> 1. Remove the concrete at the cracks. 2. Use the high concrete to replace the existing concrete 3. Apply skin coat on a concrete replaced. 4. Paint the wall using the correct paint code.

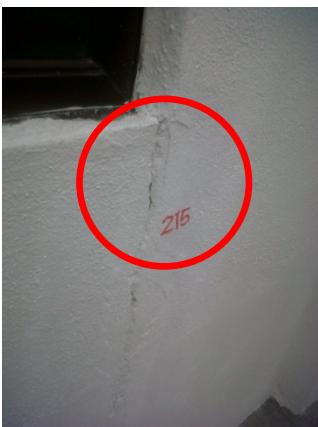
Defect Sheet No. 30	Level	Ground Floor		
Photo/Sketch	Location	Etching Room

Element	Wall		
Component				
Baris				
Condition	Priority	Matrix	Colour	
2	2	4		
Defect description				
Cracks that occur in between the wall panel connection exceed 50 cm long.				
Possible causes				
The joint between the wall panel connections are not properly connected. The extension also does not use the correct grade of concrete.				
Remedies				
<ol style="list-style-type: none"> 1. Remove the concrete at the cracks. 2. Use the high concrete to replace the existing concrete 3. Apply skin coat on a concrete replaced. 4. Paint the wall using the correct paint code.

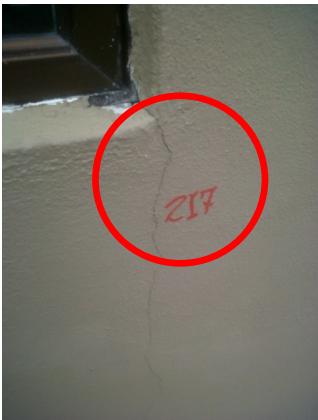
Defect Sheet No. 32	Level	Ground Floor		
Photo/Sketch	Location	Left Building

Element	Wall		
Component				
Baris				
Condition	Priority	Matrix	Colour	
2	2	4		
Defect description				
Cracks that occur in between the wall panel connection exceed 50 cm long.				
Possible causes				
The joint between the wall panel connections are not properly connected. The extension also does not use the correct grade of concrete.				
Remedies				
<ol style="list-style-type: none"> 1. Remove the concrete at the cracks. 2. Use the high concrete to replace the existing concrete 3. Apply skin coat on a concrete replaced. 4. Paint the wall using the correct paint code.

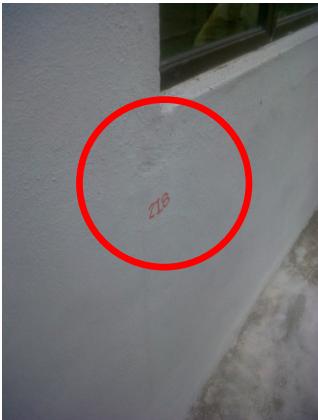
Defect Sheet No. 33	Level	Ground Floor		
Photo/Sketch	Location	Left Building

Element	Wall		
	Component			
Baris				
Condition	Priority	Matrix	Colour	
2	2	4		
Defect description				
Cracks that occur in between the wall panel connection exceed 50 cm long.				
Possible causes				
The joint between the wall panel connections are not properly connected. The extension also does not use the correct grade of concrete.				
Remedies				
<ol style="list-style-type: none"> 1. Remove the concrete at the cracks. 2. Use the high concrete to replace the existing concrete 3. Apply skin coat on a concrete replaced. 4. Paint the wall using the correct paint code.

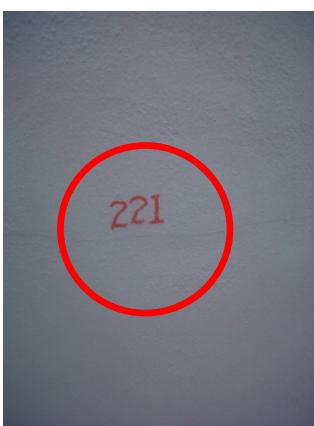
Defect Sheet No. 35	Level	Ground Floor		
Photo/Sketch	Location	Left Building		
	Element	Wall		
	Component			
Baris				
Condition	Priority	Matrix	Colour	
2	2	4		
Defect description				
Cracks that occur in between the wall panel connection exceed 50 cm long.				
Possible causes				
The joint between the wall panel connections are not properly connected. The extension also does not use the correct grade of concrete.				
Remedies				
<ol style="list-style-type: none"> 1. Remove the concrete at the cracks. 2. Use the high concrete to replace the existing concrete 3. Apply skin coat on a concrete replaced. 4. Paint the wall using the correct paint code.

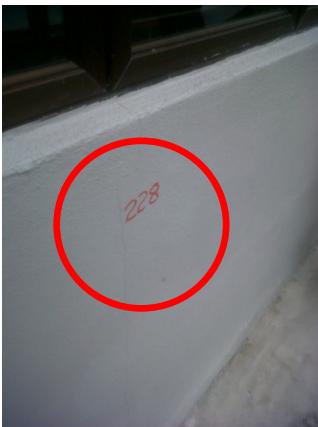
Defect Sheet No. 41	Level	Ground Floor	
Photo/Sketch	Location	Workshop

Element	Wall	
	Component		
Baris			
Condition	Priority	Matrix	Priority
1	2	2	
Defect description			
Cracks that occur in between the wall panel connection exceed 25 cm long.			
Possible causes			
The joint between the wall panel connections are not properly connected. The extension also does not use the correct grade of concrete.			
Remedies			
<ol style="list-style-type: none"> 1. Remove the concrete at the cracks. 2. Use the high concrete to replace the existing concrete 3. Apply skin coat on a concrete replaced. 4. Paint the wall using the correct paint code.

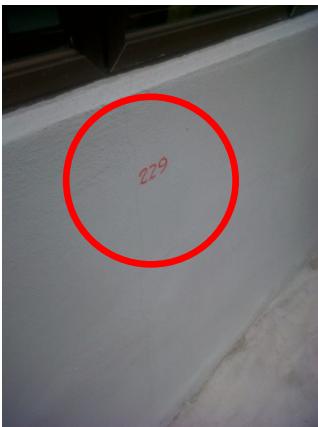
Defect Sheet No. 42	Level	Ground Floor		
Photo/Sketch	Location	Workshop

Element	Wall		
	Component			
Baris				
Condition	Priority	Matrix	Priority	
1	2	2		
Defect description				
Cracks that occur in between the wall panel connection exceed 15 cm long.				
Possible causes				
The joint between the wall panel connections are not properly connected. The extension also does not use the correct grade of concrete.				
Remedies				
<ol style="list-style-type: none"> 1. Remove the concrete at the cracks. 2. Use the high concrete to replace the existing concrete 3. Apply skin coat on a concrete replaced. 4. Paint the wall using the correct paint code.

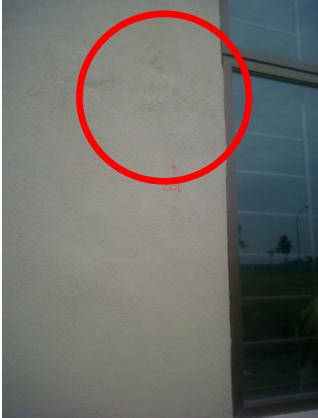
Defect Sheet No. 44	Level	Ground Floor		
Photo/Sketch	Location	Workshop

Element	Wall		
	Component			
Baris				
Condition	Priority	Matrix	Priority	
2	2	4		
Defect description				
Cracks that occur in between the wall panel connection exceed 15 cm long.				
Possible causes				
The joint between the wall panel connections are not properly connected. The extension also does not use the correct grade of concrete.				
Remedies				
<ol style="list-style-type: none"> 1. Remove the concrete at the cracks. 2. Use the high concrete to replace the existing concrete 3. Apply skin coat on a concrete replaced. 4. Paint the wall using the correct paint code.

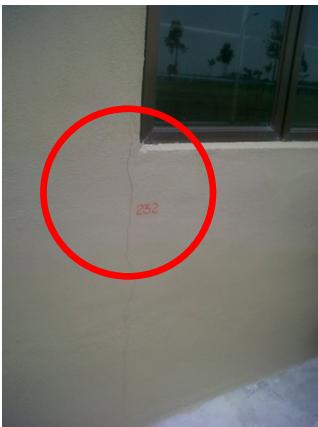
Defect Sheet No. 45	Level	Ground Floor		
Photo/Sketch	Location	Workshop

Element	Wall		
	Component			
Baris				
Condition	Priority	Matrix	Priority	
1	2	2		
Defect description				
Cracks that occur in between the wall panel connection exceed 50 cm long.				
Possible causes				
The joint between the wall panel connections are not properly connected. The extension also does not use the correct grade of concrete.				
Remedies				
<ol style="list-style-type: none"> 1. Remove the concrete at the cracks. 2. Use the high concrete to replace the existing concrete 3. Apply skin coat on a concrete replaced. 4. Paint the wall using the correct paint code.

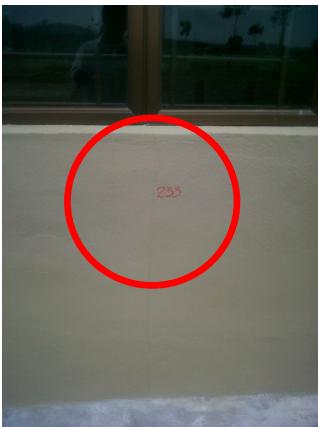
Defect Sheet No. 46	Level	Ground Floor		
Photo/Sketch	Location	Workshop

Element	Wall		
	Component			
Baris				
Condition	Priority	Matrix	Priority	
1	2	2		
Defect description				
Cracks that occur in between the wall panel connection exceed 15 cm long.				
Possible causes				
The joint between the wall panel connections are not properly connected. The extension also does not use the correct grade of concrete.				
Remedies				
<ol style="list-style-type: none"> 1. Remove the concrete at the cracks. 2. Use the high concrete to replace the existing concrete 3. Apply skin coat on a concrete replaced. 4. Paint the wall using the correct paint code.

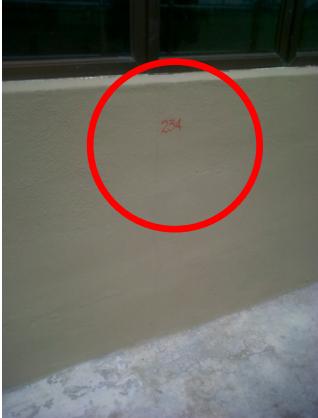
Defect Sheet No. 47	Level	Ground Floor		
Photo/Sketch	Location	Workshop

Element	Wall		
	Component			
Baris				
Condition	Priority	Matrix	Priority	
1	2	2		
Defect description				
Cracks that occur in between the wall panel connection exceed 20 cm long.				
Possible causes				
The joint between the wall panel connections are not properly connected. The extension also does not use the correct grade of concrete.				
Remedies				
<ol style="list-style-type: none"> 1. Remove the concrete at the cracks. 2. Use the high concrete to replace the existing concrete 3. Apply skin coat on a concrete replaced. 4. Paint the wall using the correct paint code.

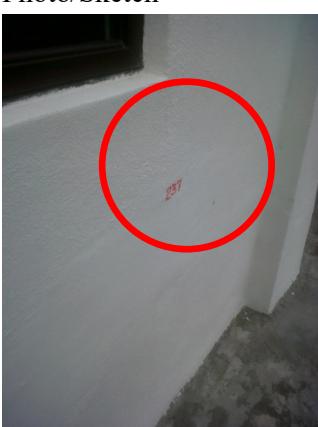
Defect Sheet No. 50	Level	Ground Floor		
Photo/Sketch	Location	Workshop

Element	Wall		
	Component			
Baris				
Condition	Priority	Matrix	Priority	
1	2	2		
Defect description				
Cracks that occur in between the wall panel connection exceed 25 cm long.				
Possible causes				
The joint between the wall panel connections are not properly connected. The extension also does not use the correct grade of concrete.				
Remedies				
<ol style="list-style-type: none"> 1. Remove the concrete at the cracks. 2. Use the high concrete to replace the existing concrete 3. Apply skin coat on a concrete replaced. 4. Paint the wall using the correct paint code.

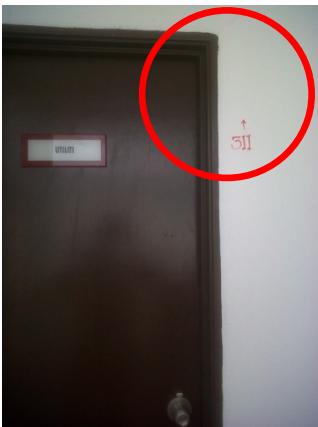
Defect Sheet No. 51	Level	Ground Floor		
Photo/Sketch	Location	Utility Room

Element	Wall		
	Component			
Baris				
Condition	Priority	Matrix	Priority	
1	2	2		
Defect description				
Cracks that occur in between the wall panel connection exceed 15cm long.				
Possible causes				
The joint between the wall panel connections are not properly connected. The extension also does not use the correct grade of concrete.				
Remedies				
<ol style="list-style-type: none"> 1. Remove the concrete at the cracks. 2. Use the high concrete to replace the existing concrete 3. Apply skin coat on a concrete replaced. 4. Paint the wall using the correct paint code.

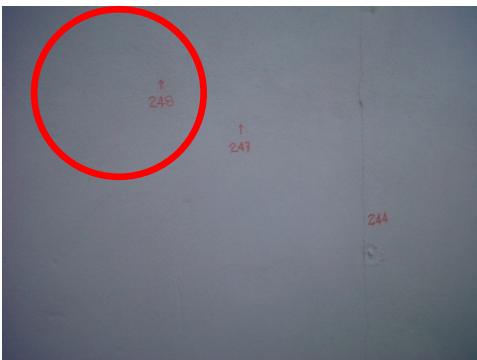
Defect Sheet No. 54	Level	Ground Floor		
Photo/Sketch	Location	Right Building

Element	Wall		
Component				
Baris				
Condition	Priority	Matrix	Priority	
1	2	2		
Defect description				
Cracks that occur in between the wall panel connection exceed 50 cm long.				
Possible causes				
The joint between the wall panel connections are not properly connected. The extension also does not use the correct grade of concrete.				
Remedies				
<ol style="list-style-type: none"> 1. Remove the concrete at the cracks. 2. Use the high concrete to replace the existing concrete 3. Apply skin coat on a concrete replaced. 4. Paint the wall using the correct paint code.

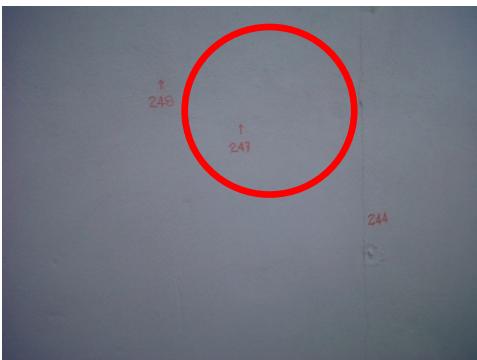
Defect Sheet No. 55	Level	Ground Floor		
Photo/Sketch	Location	Right Building

Element	Wall		
Component				
Baris				
Condition	Priority	Matrix	Priority	
1	2	2		
Defect description				
Cracks that occur in between the wall panel connection exceed 50 cm long.				
Possible causes				
The joint between the wall panel connections are not properly connected. The extension also does not use the correct grade of concrete.				
Remedies				
<ol style="list-style-type: none"> 1. Remove the concrete at the cracks. 2. Use the high concrete to replace the existing concrete 3. Apply skin coat on a concrete replaced. 4. Paint the wall using the correct paint code.

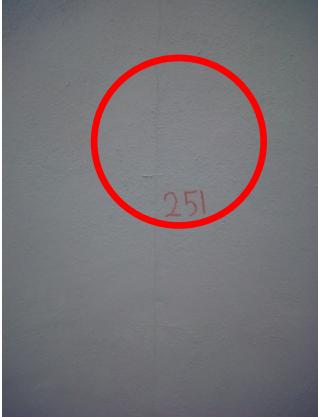
Defect Sheet No. 57	Level	Ground Floor		
Photo/Sketch	Location	Left Building

Element	Wall		
Component				
Baris				
Condition	Priority	Matrix	Priority	
1	2	2		
Defect description				
Cracks that occur in between the wall panel connection exceed 50 cm long.				
Possible causes				
The joint between the wall panel connections are not properly connected. The extension also does not use the correct grade of concrete.				
Remedies				
<ol style="list-style-type: none"> 1. Remove the concrete at the cracks. 2. Use the high concrete to replace the existing concrete 3. Apply skin coat on a concrete replaced. 4. Paint the wall using the correct paint code.
