Installation Of Roof Main Trusses

This report, described the Installation Of Roof Main Trusses on construction site of 'Cadangan Merekabentuk Dan Membina 1 Blok Pusat Pameran Matrade 3 Tingkat Jalan Dutamas 2, Mukim Batu, Wilayah Persekutuan Kuala Lumpur'. This report was reported based on the observation and experience of five month at the construction project. The objective of this report is to identify the procedure of roof main trusses installation and to identify the problem of roof main trusses installation. Besides that, search more information using two method which is from primary data is from book and article and secondary data from internet. The company background will explain about the company where the practical training of students placed. It began with an introduction followed by objectives, information about companies and managers, organizational charts and concluded with a list of completed projects, some undergoing projects and appendix. This report fully explained about procedure installation of main trusses roof and problem and solution installation of main trusses. Next, in this report described about the equipment and process for installing the trusses and pr

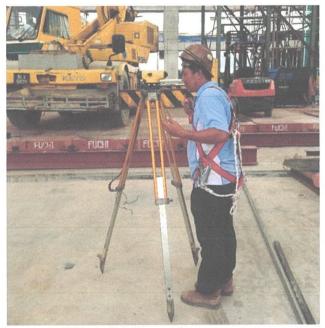
Photo 3.1 Surveying

Firstly, setting out is the most important in construction before start work. Using this method can get the straight line, coordinate, angle and etc. Before workers start install the supported main trusses, surveyor must take the point first to make sure the supported main trusses want to install is straight and the level same in the drawing.

The equipment for surveying work which is theodolite, it is capable of finding both vertical and horizontal angles, and when is combined with technical studies also can determinate horizontal distance and a differentiation elevations. Next is tripod use for stand the theodolite, and prism used for take the length.

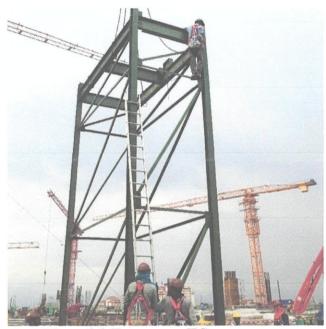
Photo 3.2 Temporary JIG support

Second, installation of temporary support for main trusses and call it jig. Temporary support is using I beam size 15mm thickness. Every one gridline have fourteen segment for install the main trusses and every one segment use one temporary jig supported. The high of every jig is different because the design of main trusses is curve. Make sure the location of jig is must at the point surveyor marking. The duration to install one temporary support is about 1 hours and need six workers to install.

The equipment used for this jig installation is a bolt and nut size 30x50mm to screw the joint or connection of I beam. Next is used richet to tighten the bolt and nut.

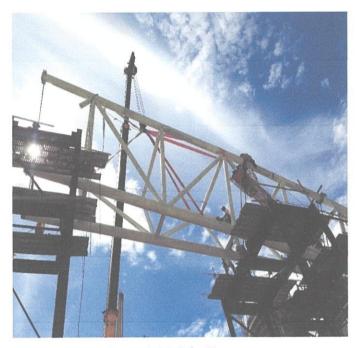
Photo 3.3 Main Trusses

Next, after all temporary supported jig already install at their point, then main trusses can install step by step. Firstly, workers install the main trusses from middle which is from segment 6 because it can easy for install the next segment and can make sure the main trusses in straight line in their point. In one gridline have 14 segment of main trusses and continued until finish all segment. Every installation main trusses the connection must proper with drawing and inspection. The duration of installation main truss is about 2 hours to 3 hours and need four skilled worker to install.

The equipment used to install main truss is oxy cutter, it used to cut or setting the temporary plate. Next is welding set, before welder weld all of the joint the workers tack weld at the joint as a temporary to hold the segment of main truss.

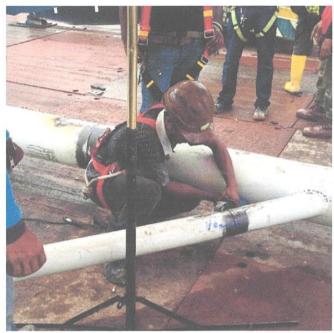
Photo 3.4 Bracing

Next, every connection of main trusses must install bracing it used for make the connection of segment main trusses more strength. Between connections have two bracing install. The duration to install bracing is about 1 hours and need 3 workers for installation.

The equipment used to install the bracing is oxy cutter, at the between of the joint have backing plate. With oxy cutter, cut a little of backing plate and the joint can closed and don't have a gap. Next, use a hammer to tap the connection of bracing to get closed. Grinder also use, it's for grind the ends of bracing to be smooth. The last equipment is welding set, before welder weld all of the joint the workers tack weld at the joint as a temporary to hold the bracing joint.

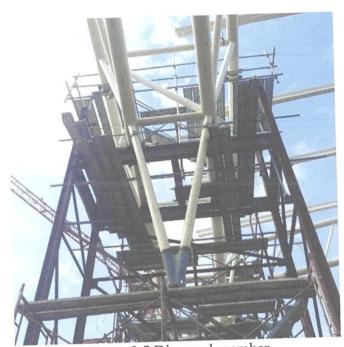
Photo 3.5 Diagonal member

Diagonal member is for put the cable roof at bottom main trusses for give the tension at main trusses more strength and the welding connection not crack. In one gridline have five diagonal member to install. The duration for install diagonal member is about 3 hours and need four workers to install.

The equipment used to install the diagonal member is oxy cutter, at the between of the joint have backing plate. With oxy cutter, cut a little of backing plate and the joint can closed and don't have a gap. Next, use a hammer to tap the connection of diagonal member to get closed. Grinder also use, it's for grind the ends of bracing to be smooth. The last equipment is welding set, before welder weld all of the joint the workers tack weld at the joint as a temporary to hold the diagonal member joint.

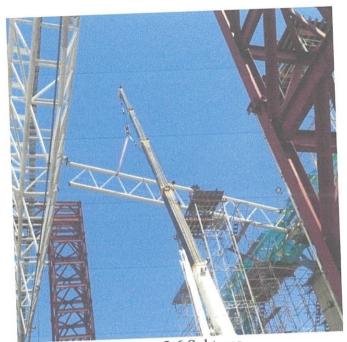
Photo 3.6 Subtruss

Install sub truss between two gridline main trusses. The sub truss connect between the main truss. The function of the sub truss is to support load from main trusses. It is an important part for main trusses installation. The duration time of installation is about 5 hours. The installation need five general worker and two certificate welder.

The equipment used to install the subtruss is oxy cutter, at the between of the joint have backing plate. With oxy cutter, cut a little of backing plate and the joint can closed and don't have a gap. Next, use a hammer to tap the connection of segment subtruss to another subtruss to get closed. Next equipment is welding set, before welder weld all of the joint the workers tack weld at the joint as a temporary to hold the bracing joint.

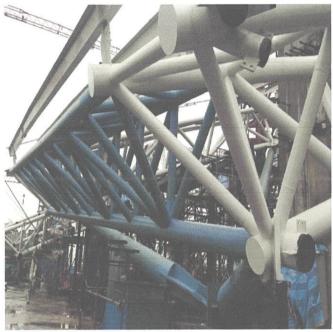
Photo 3.7 Eaves truss

Eaves truss is joint for end of both main truss. Eaves truss is an important part of main truss to joint both of main truss at the end. The function of eaves truss is for a joint for two main truss two stand at top column. The duration time to install the eaves truss about 5 hours include repair work. The installation need six general worker and two certificate welder.

The equipment used to install the bracing is oxy cutter, at the between of the joint have backing plate. With oxy cutter, cut or setting the backing plate and the joint can closed and don't have a gap. Next, use a hammer to tap the connection of eaves truss to get closed. Grinder also used, it's for grind the ends of eaves truss to be smooth. The last equipment is welding set, before welder weld all of the joint the workers tack weld at the joint as a temporary to hold the eaves truss joint.

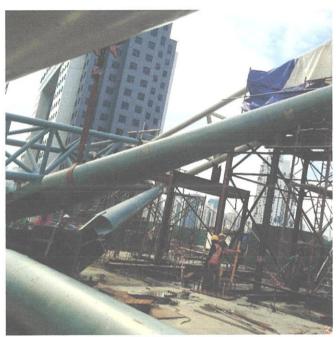
Photo 3.8 Tapper column

Tapper column is joint of four pipe to one base. The function as a joint to main truss and connected to the base plate tapper column. When the joint one set main trusses finish so they can lifting the whole main truss to the base on the top of the column. The base of tapper column connected to the top on the embedded plate on top of the column. The tapper column connected to base plate column used plate and bolt and nut to joint. The duration to install tapper column to main truss take 3 hours and need 6 worker to install.

The equipment used to install tapper column is richet, use for tighten the bolt and nut at the jointing of tapper column to base plate, mobile crane used lift up the tapper column to connect at main truss and base plate. Next, use jack to setting the tapper column so it can make the workers easy to screw the bolt and nuts.

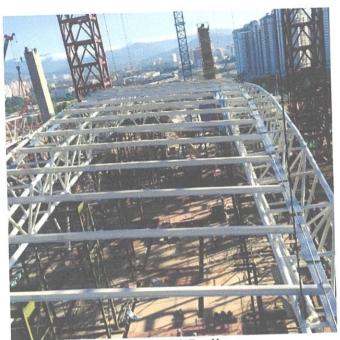
Photo 3.9 Purlin

Purlin is a frame for others contractor to make a finishes of roof top such as cladding. For one main truss need thirty three nos. For installation, before lifting the purlin need to install the purlin bracket, for one purlin need two purlin bracket. After purlin bracket has install they can lift up the purlin to the actual place on top main truss. Next, after the purlin at the actual place so, the welder can start welding the joint. The duration time for install the purlin is about 1 hours and for one main truss take it 5 days to complete included finishing paint.

The equipment used to install purlin is welding set to make temporary tack weld to hold the purlin then used flux-cored welding machines to weld all the jointing purlin to main truss. Tower crane used to lift up the purlin from ground floor to top of main truss.

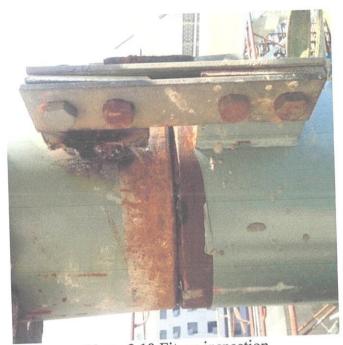
Photo 3.10 Fit-up inspection

Inspection fit up is to confirm that the joint of the connection are follow the specification from the approval drawing. All the inspection is from welder inspector they use inspection test plan (ITP) based on American Welding Society (AWSD1.1) to measure all the dimensional of the connection. Before the inspector inspect the joint the worker weld to plate for each pipe and jointing used bolt and nut to make sure the joint was in the place. After the inspection pass the welder can start to welding the joint. This inspection take about 5 minutes to inspect and two inspector certificate.

The equipment used for fit-up inspection is welding gauge, it's for measure Weld Throat Thickness, Butt Fillet Type Welds, Weld Length, Misalignments (High-Low), and much more depending upon the Gauge selected. Next, calliper use for check the gap of jointing.

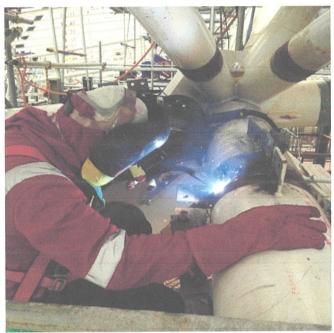
Photo 3.11 Welding

Firstly, need a certificate welder to make sure all the joint and welded parts follow the American Welding Specification (AWS) and their classification according to material. Each of joint need to be weld by layer to layer. One joint need three layer for give more strengthen to the joint. For pass the strengthen test by inspector the thickness must be at 3mm-4mm follow the Inspection Test Plan (ITP). The duration for complete one joint according size of diameter of the pipe. Normally it take 2 hours to complete weld hole diameter of the pipe. For one joint need one certificate welder and two helper.

The equipment used for welding is welding set flux-core and weld the jointing with three layer or 'capping'. Then, used grinder to grind the welding to make the joint smooth and remove spatter.

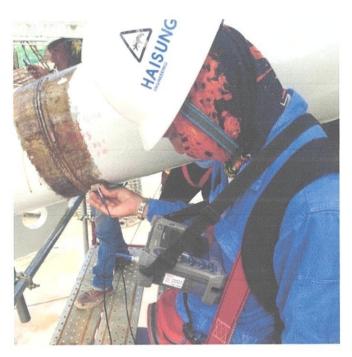
Photo 3.12 Ultrasonic inspection (UT)

Ultrasonic test inspection is for to check the thickness of the weld layer to make sure the thickness follow the Inspection Test Plan (ITP). Normally, this test use Ultrasonic and operate by certificate inspector. All the data was collected and can be approve the welder part is passed. The ultrasonic operate by sending vibration wave to the welding part and sending data to the ultrasonic reader.

The equipment used for ultrasonic inspection (UTI) is brush, cuplant and ultrasonic test machine.

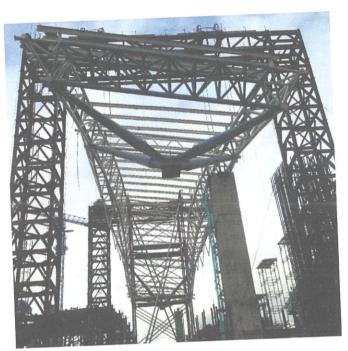
Photo 3.13 Jacking of main truss

The last method of main truss is by jacking by main truss using hydraulic lifting hoist that can lift weight about 160 tone. It takes several hour to lift the main truss from the floor to the top of the column. To make sure the safety while jacking this huge parts it must to be observe by Jabatan Kesihatan Dan Kebajikan Pekerja (JKKP) and the area must be barricaded. This is one of the important procedure to jacking the main truss by using hydraulic lifting hoist.

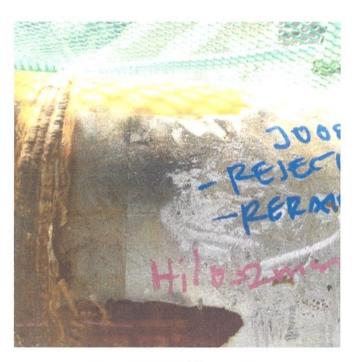
Photo 3.14 Welding spatter

Problem in this joint is welding at the segment is not proper with American Welding Specification (AWS) because the joint have a spatter and the welding must be clear. Inspector cannot to inspect if the jointing have spatter and rusty. All joint want to inspect must clear with welding spatter and rusty.

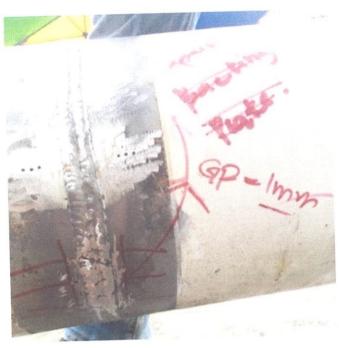
Photo 3.15 Welding spatter removal

The solution to solve is used grinder and remove all spatter welding and power brush. After all joint welding already grinder and power brush, inspector can checking the jointing. The equipment used to repair welding spatter is used grinder and power brush. This repair work need one worker only and duration to finish is about 30 minutes.

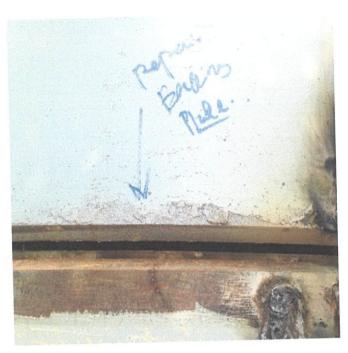
Photo 3.16 Backing plate repair

Problems that often occur when connecting the segment of main truss the backing plate difficult to install at the jointing with another segment closely. The gap of the joint is not follow the American Welding Specification (AWS) so it must repair before proceed the next procedure is welding.

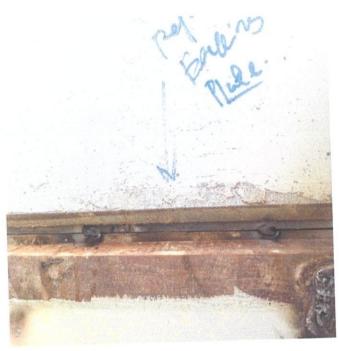
Photo 3.17 Backing plate repair

The solution to solve this problem of backing plate at the jointing is repair the connection and take a backing plate and then connect in this joint so the gap can closed. The duration time to connect the backing plate is about 2 hours and need three workers to repair. The equipment for repair this backing plate use welding set for tack weld the bracing to hold at the joint and use oxy cutter for cut the backing plate if to long.

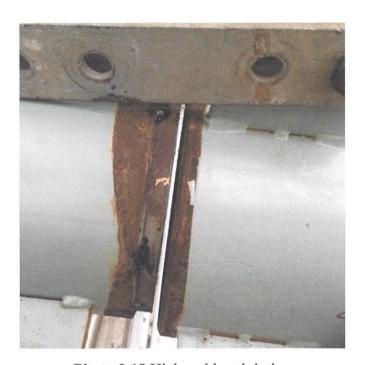
Photo 3.18 High and low jointing

High and low jointing is must proper with Inspection Test Plan (ITP) based on American Welding Society. The minimum high and low based on (ITP) is 2mm-4mm. If the joint above so inspection for fit-up cannot pass and welder cannot to start welding.

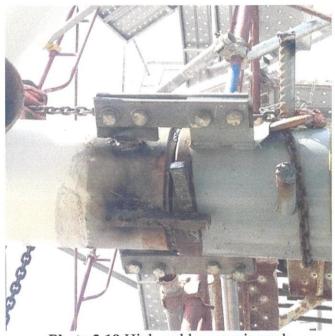
Photo 3.19 High and low repair work

The solution to solve this problem is repair the high and low until the jointing does not have a gap and the jointing can pass from Inspection Fit-up Test. The duration to repair is about 1 hours and need two workers to repair. The equipment for repair this hig and low is hammer to setting the high and low until the joint straight and can pass from inspection fit-up and use welding set machine.
