DEPARTMENT OF BUILDING
FACULTY OF ARCHITECTURE, PLANNING AND SURVEYING
UNIVERSITI TEKNOLOGI MARA
(PERAK)

SEPTEMBER 2015

Concrete Test

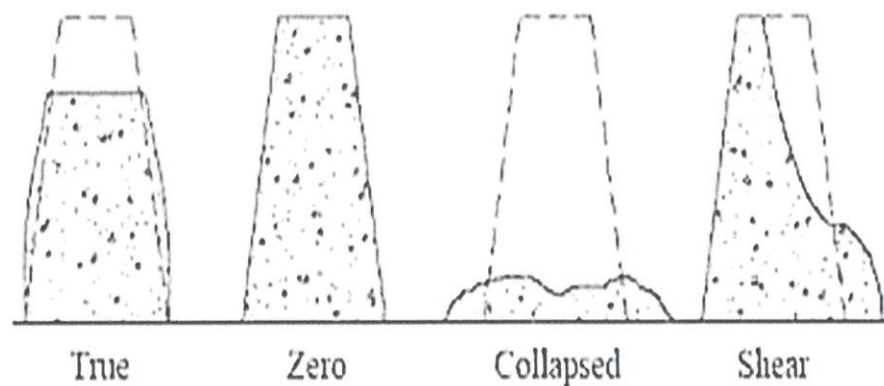
Figure 3.1: Result of slump.

under the action of gravitational forces. This test can be carried out anywhere either at batching plant or on site. There are 4 different kind of possible slump exist. It is true slump, zero slump, shear slump and collapsed slump.

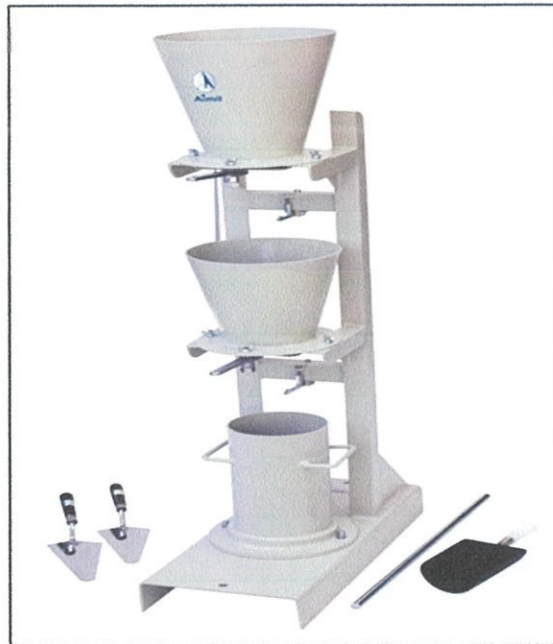
Figure 3.2: Compact factor apparatus.

This test is carried out by using main apparatus which is compacting factor apparatus. The other apparatus also is needed such as trowels to fill the concrete in upper hopper, graduated cylinder, balance, tamping rod and iron buckets. All the apparatus is important to achieve the result that needed.

Compaction factor test is appropriate for the concrete that use a maximum aggregates size of 40mm. This test usually has been done at the laboratory. The disadvantage of compaction test is this test not suitable for field application. It is also because this test is not consistent and the mixes can stick to the side of the hoppers.

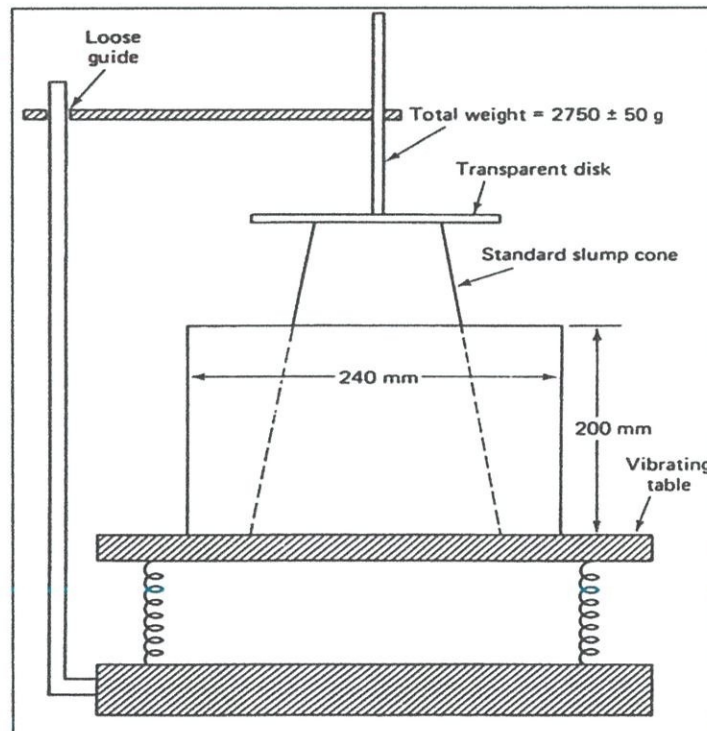
Figure 3.3: Vebe Consistometer.

Vebe time is defined as the time taken to complete covering of the underside of the disc with concrete container. Vebe test is same as slump test that measures the consistency only. However, it is more meaningful for mixtures of concrete with a low consistency. This test is most suitable test to determining the differences in consistency of very dry mixes. This test can be carrying out if the size of aggregates that use in concrete is less than 40mm.

The result of vebe test determined the workability of concrete. The workability of concrete is depends on the time taken to remould the concrete from the conical to the cylindrical shape until the disk is completely covered with concrete. The result of vebe test shows that the higher time taken to vibrate the concrete, the lower workability of concrete.

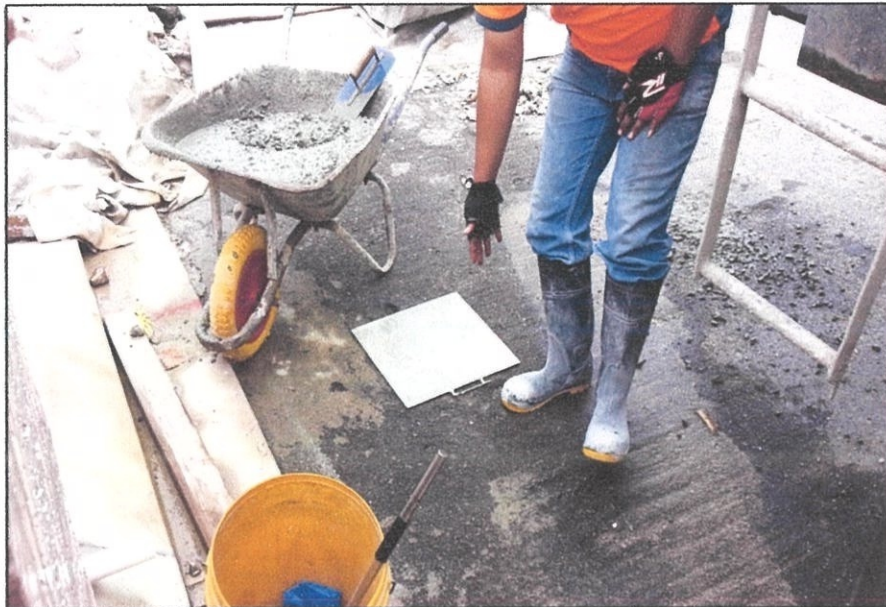
1. Setting and clean the apparatus of slump test.
2. Put the base plate on the smooth surface.

Photo 3.2: The base plate is put on the smooth surface.

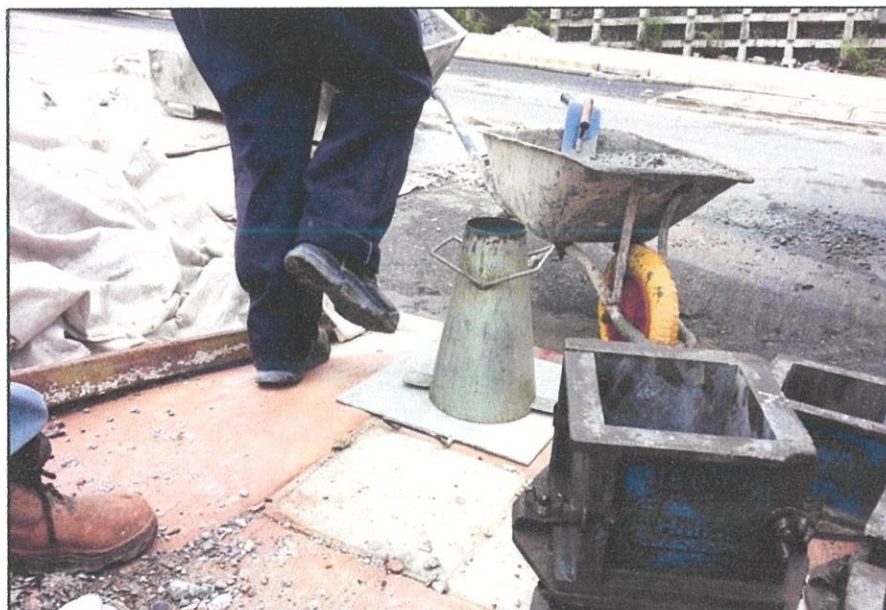
3. Place the frustum cone on the plate where the large opening at the bottom while the small opening at top.

Photo 3.3: Frustum is place on the base plate.

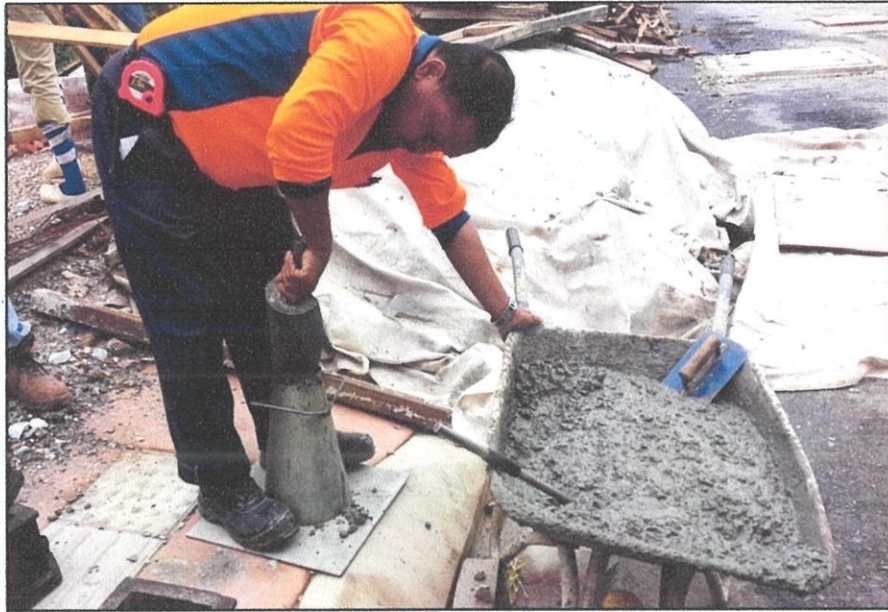
4. Fill in the frustum cone is with concrete in 3 layers.

Photo 3.4: The frustum is fill with concrete.

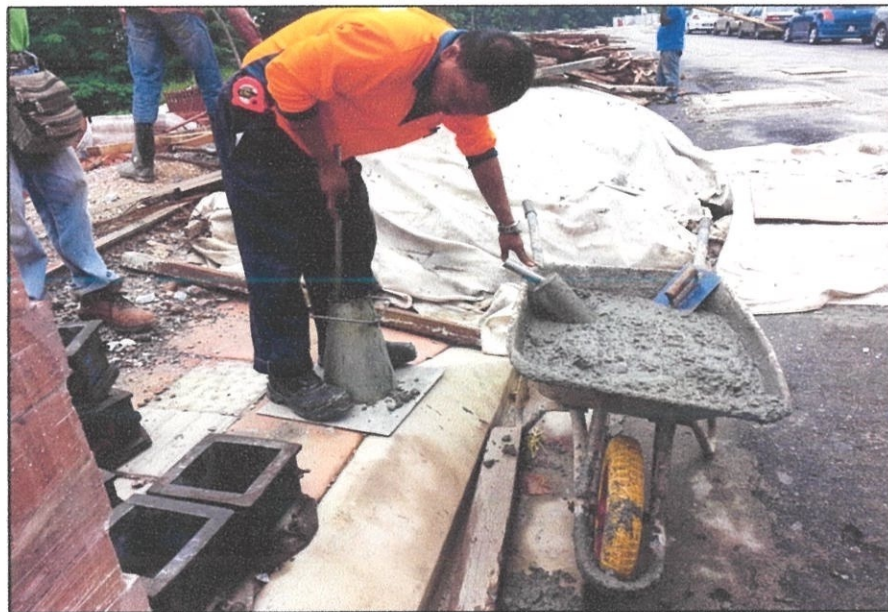
5. Each layer of concrete is temped 25 times with the steel rod.

Photo 3.5: The concrete is temped for 25 times.

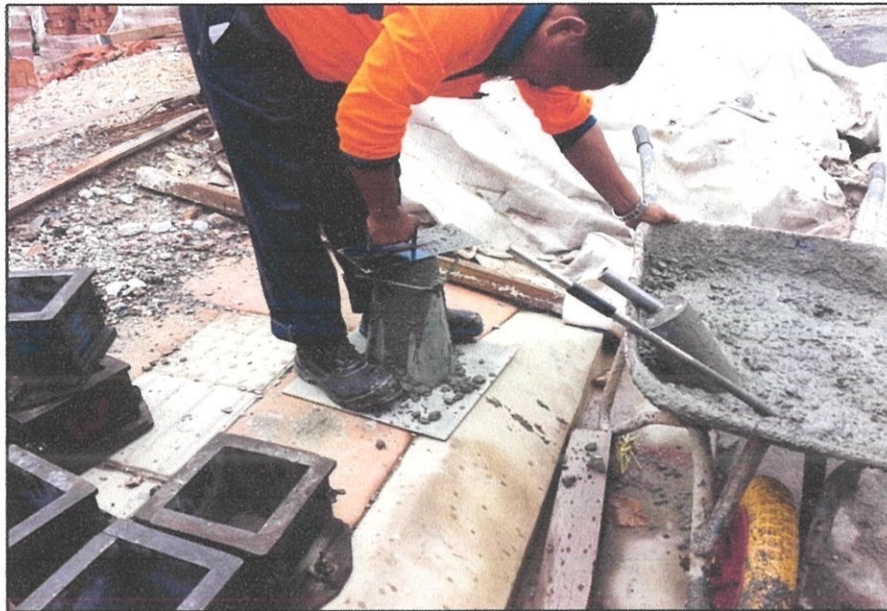
6. After the cone is completely filled with concrete, struck off the top surface of cone by using scrapper.

Photo 3.6: The top surface of frustum is struck off with the scrapper.

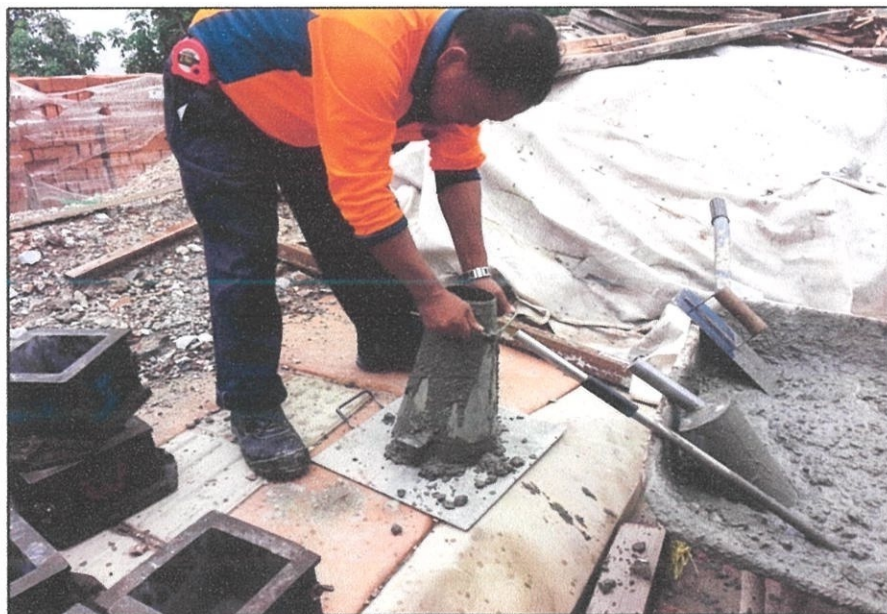
7. Then, lifted the cone in vertically slowly and carefully to get the result.

Photo 3.7: The frustum is pull out slowly.

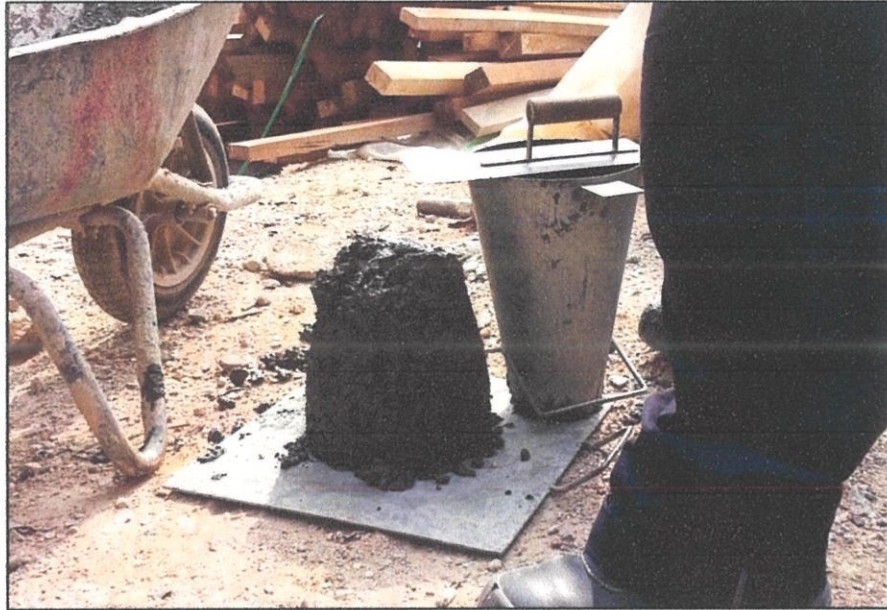
9. Placing the reverse cone beside the slump and the scrapper over the cone.

Photo 3.8: The frustum and scrapper is placed beside the concrete.

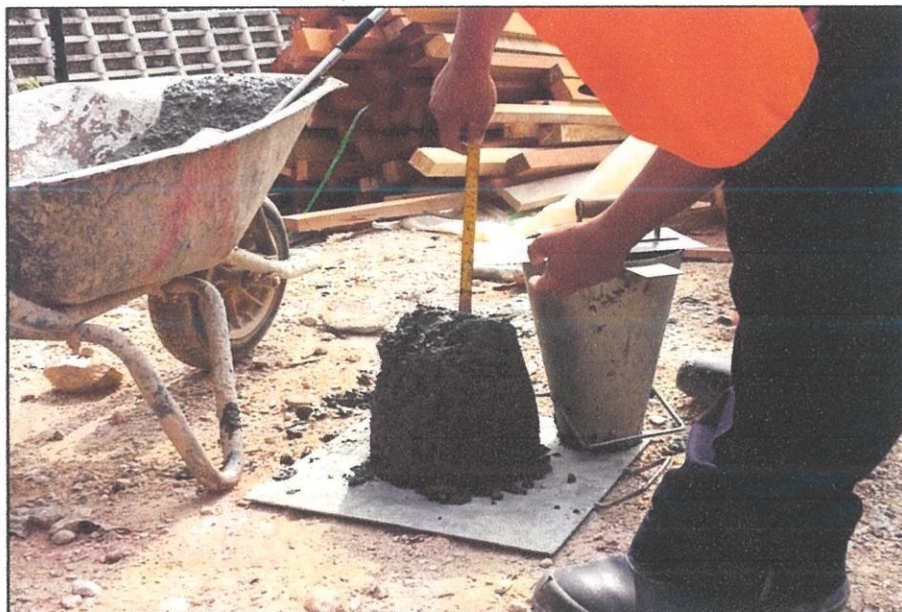
10. Then, measure the height of slump by using measuring tape.

Photo 3.9: The slump of concretes is measured.

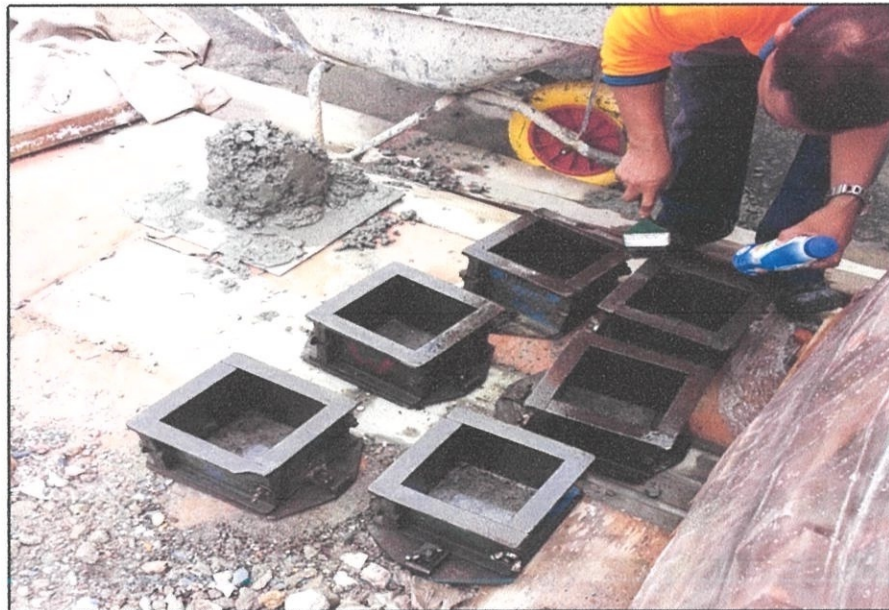
1. Setting up the apparatus by using bolt and nut to attached the mould and base plate.
2. Clean the mould and base plate.
3. Applied the mould and base plate with oil to prevent concrete from sticking to the side of the cube.

Photo 3.10: The oil is put on the mould and base plate.

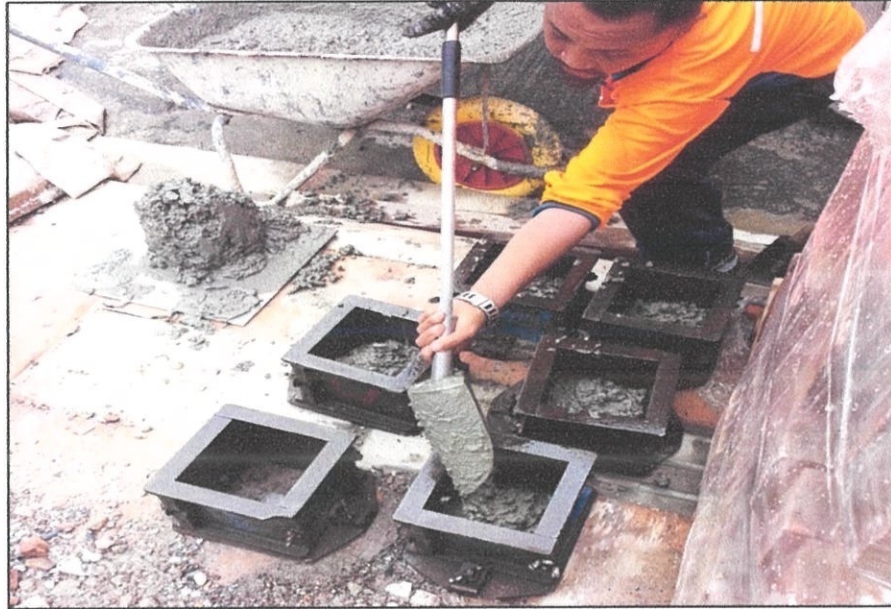
4. The cube is fill with a three layer of concrete.

Photo 3.11: The mould is fill with concrete.

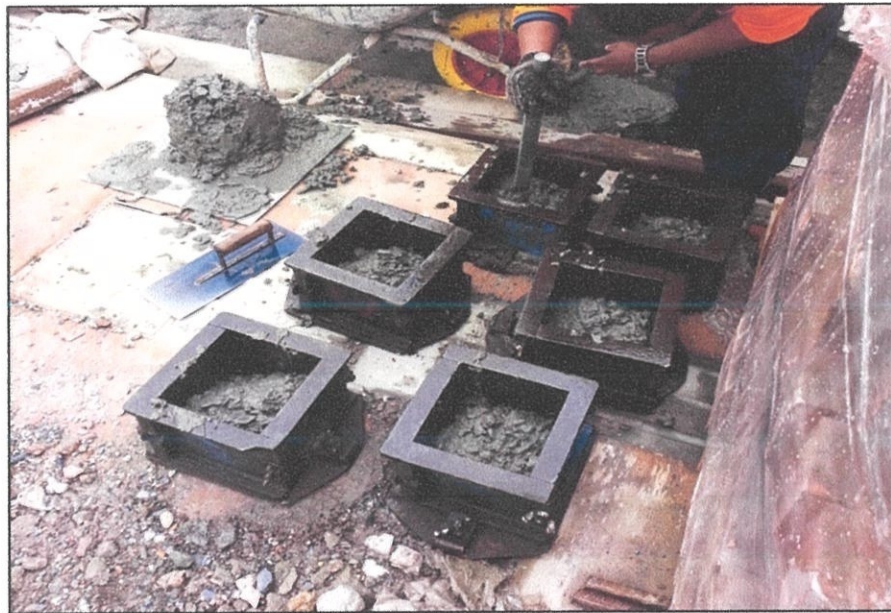
5. Compact every layer of concrete for 25 times by using the steel rod.

Photo 3.12: The concrete is compact for 25 times.

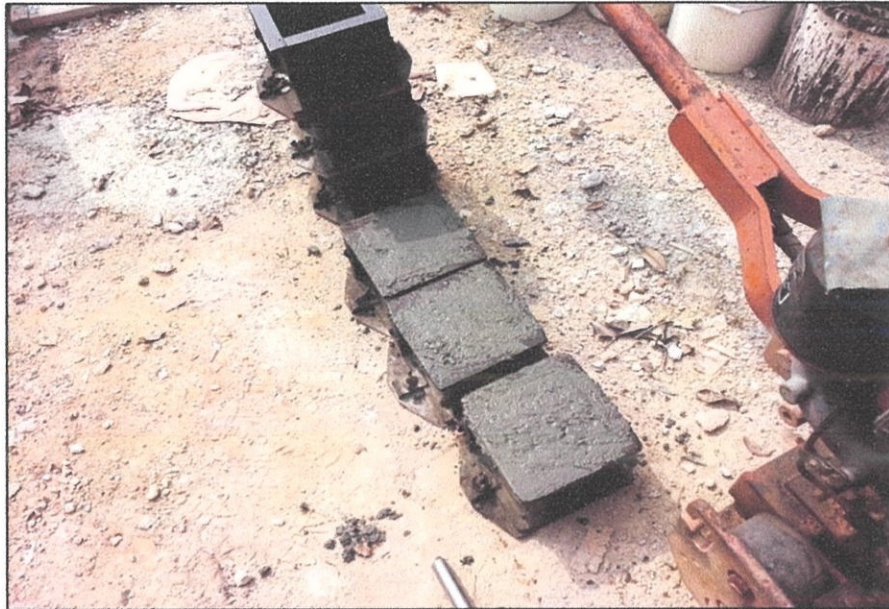
6. The upper surface of cube is struck off to produce a smoothen surface.

Photo 3.13: Struck off and smoothen the upper surface of mould.

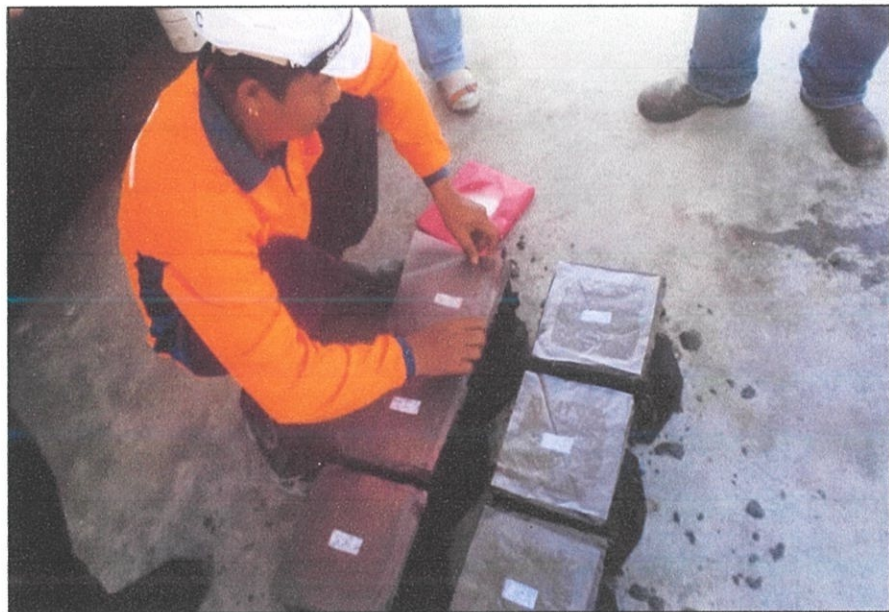
7. Label the cube and cover the upper surface of cube with a plastic.

Photo 3.14: Labelling the cube.

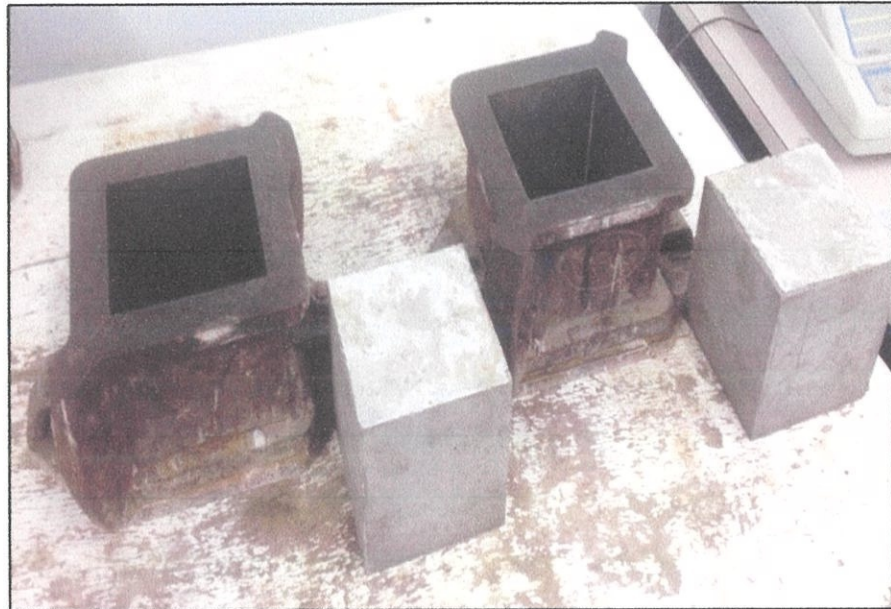
8. Dismantle the cube after 24 hours from the cube is done.

Photo 3.15: The cube is dismantled from mould.

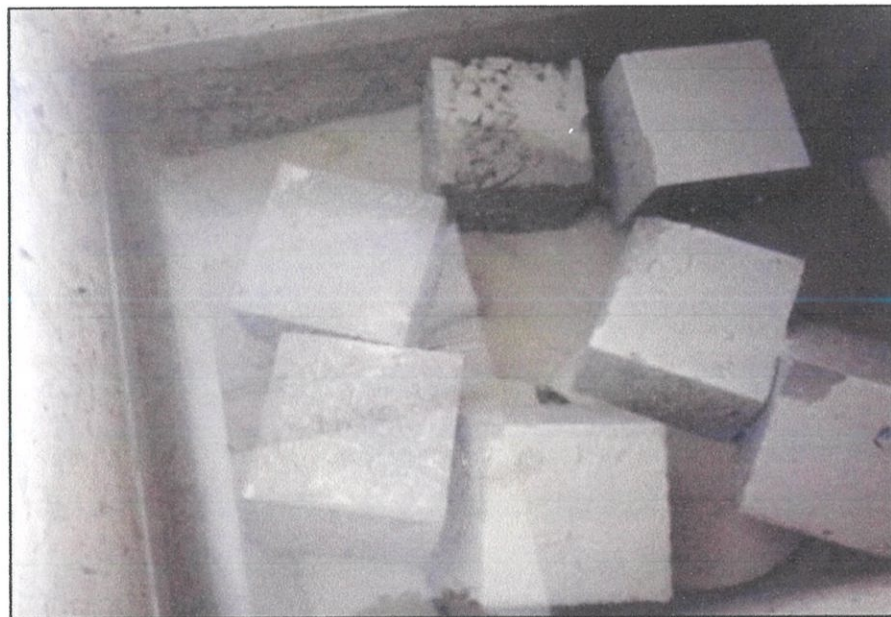
9. Submerge the concrete cube in water for curing.

Photo 3.16: The cube is cured in water.

10. After that, carried out the compression test at age 7 and 28 days by using compression machine.

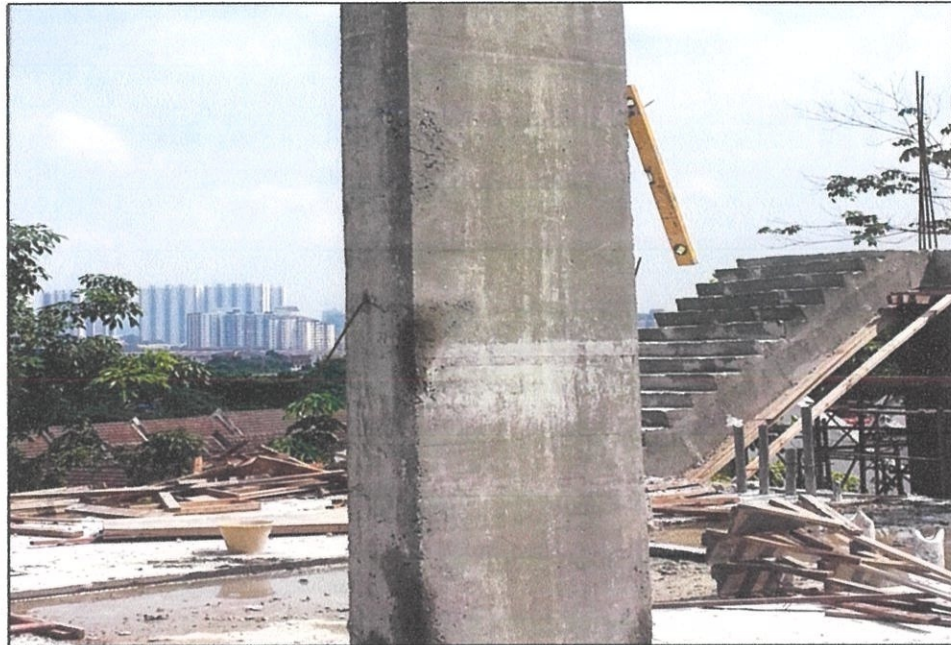
Photo 3.17: Colour Variation.

Colour variation is a surface of concrete that has a difference in colour. The colour may appear as patches of light and dark. This defect of concrete is happen because of uneven and variable of curing condition. The curing time at least must be done in 3 days or 7 days. It is also happen because of different brand or type of cement is applied on the surface of concrete as a drier.

This defect can be prevented by using an even concrete mix when placing and compacting. Besides, the defect also can be prevented by keep the concrete evenly moist without using drier. However, this occurrence may keep appear on site because the people cannot control everything in one time. So that, people can applying the coat on the surface of concrete to hide the variation if this defect appears.

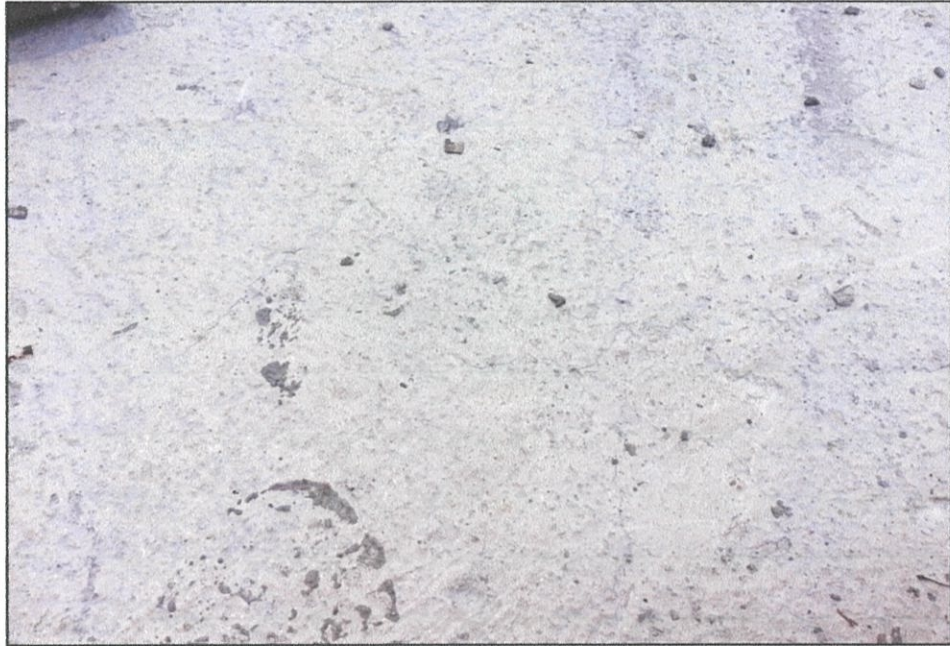
Photo 3.18: Dusting.

Dusting is also one of the defects that can occur in concrete. Dusting is a fine powder on the concrete surface which comes off on the fingers. The causes of this type of defects is because of the finishing is done before the bleed water has dried and also the finishing is done during the rain. It is also happen because of the concrete is not curing properly.

However, this defect can be prevented by protecting the concrete from drying out too quickly either in hot or windy weather. In that case, the wet plastic is used to prevent the concrete drying out too quickly. Besides, the dusting also can be prevented by let any bleed water dry up before trowelling. Another way to prevent it from happen is by remove the water in cold conditions. The water can be removed if the curing process is done correctly.

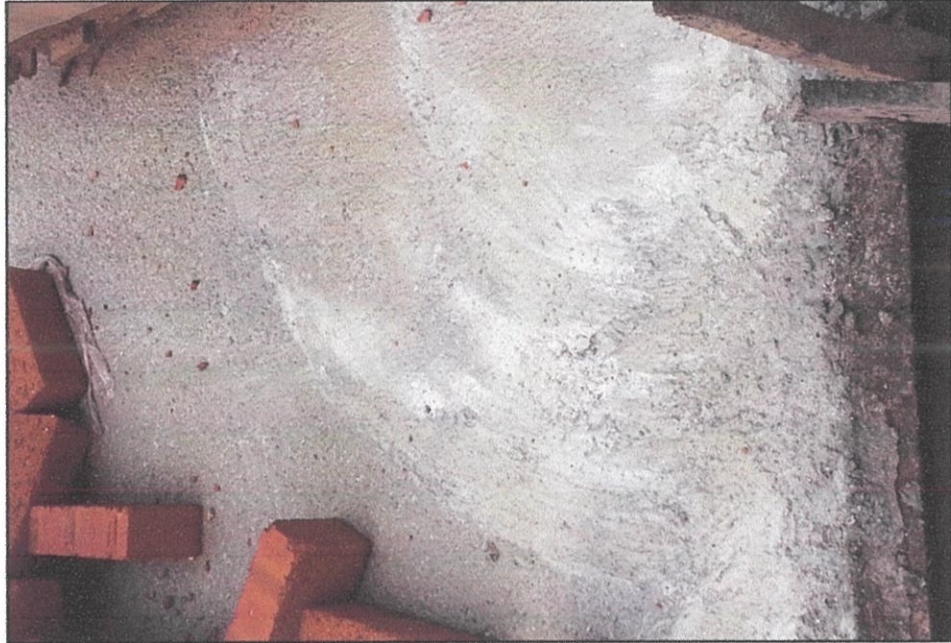
Photo 3.19: Efflorescence.

Efflorescence is a one more defect that happen in concrete. Efflorescence is a white crystalline deposited that sometimes has found on the surface of concrete soon after it is finished. This defects is appear on the surface of concrete because of the mineral salts are dissolved in water. The deposits of water evaporates salt has left on the surface if the water with dissolved mineral salts collects on the concrete surface. Besides, efflorescence also appear because of excessive bleeding on concrete.

This defect can be prevented. The way is make sure the water used in concrete clean from impurities and salt-free water. However, this efflorescence defects may keep appear unexpectedly even if the prevention has been taken. So that, dry brushing is used to repai it. Then, wash it with the clean water. The wire brush is not allowed to clean the efflorescence. After that, wash the area with the dilute solution of hydrochloric acid.

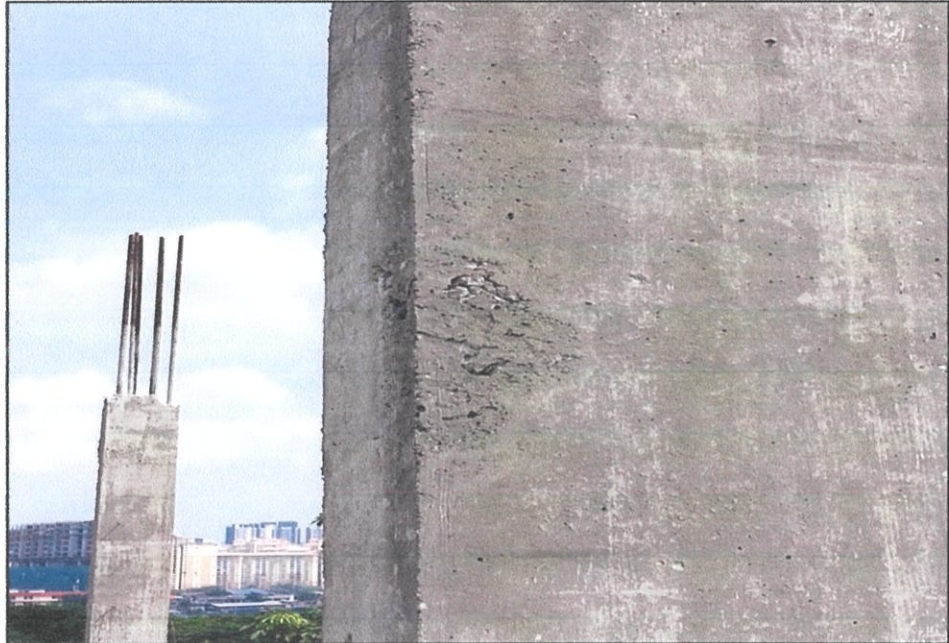
Photo 3.20: Honeycombing.

Honeycombing is another defect that has happen in concrete. Honeycombing means that there are too much of coarse aggregate appear on the surface of concrete. The cause of this honeycomb is because of the poor compaction during concreting. It is usually happen in a structure of column. Column has more than 2 meter high, so that the robin engine cannot reach the bottom and it's allow the honeycomb appeared in the surface.

Other than that, honeycomb also appear because of the paste leakage from forms. The poor characteristic of cement and water has been used to form the paste. This defect can be repaired by rendering if it appears on the surface only. Otherwise, if honeycomb appears throughout the concrete it must be removed, replaced and the surface require rendering. Rendering means cover the surface with a layer of mortar.
