**DEPARTMENT OF BUILDING**  
**FACULTY OF ARCHITECTURE, PLANNING AND SURVEYING**  
**UNIVERSITI TEKNOLOGI MARA**  
**(PERAK)**

**SEPTEMBER 2014**

**MATERIAL WASTAGE AT CONSTRUCTION SITE**

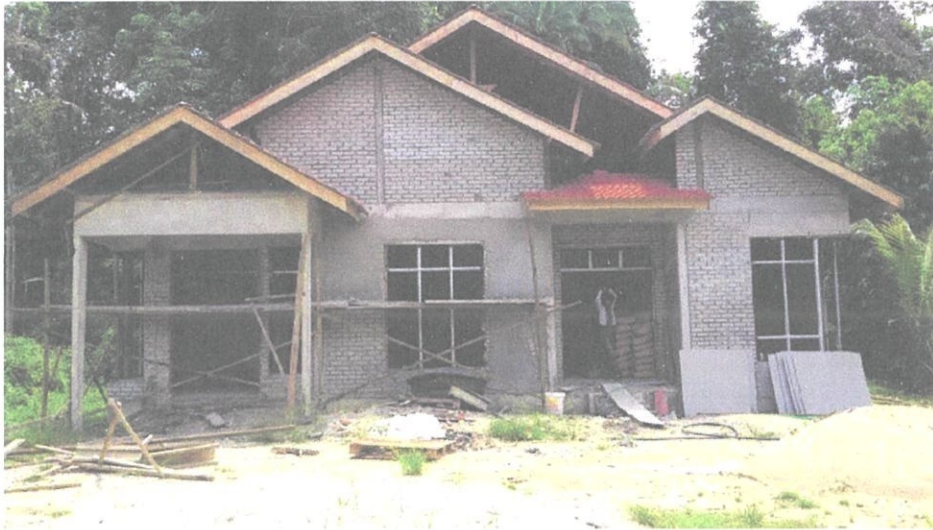
Photo 3.1 Front elevation of Bechah Semak project.

The reason of the choose a house because this house is under writer site supervisor and has a little uniqueness. The uniqueness for this house when happen a problem on this house that can cause wastage to building material because writer has choose that topic to do as a practical report. On the other hand, this house has been taken from another site supervisor because the old site supervisor is resign before writer start the practical training at ATGH Sdn. Bhd. Apart from that, this house also near from office and enable to writer always visit this house. This house is owned by a woman that works as medical assistants. Owner stays at Kuala Lumpur while her house is completed. This house also already delays for 3 month because there is fraud by old subcontractor which presently has thrown away. Many things had broken down by weather and many thefts had occurred during this project is interrupted and has make this site is one of most site that have a higher wastage in ATGH Sdn. Bhd project in this year.

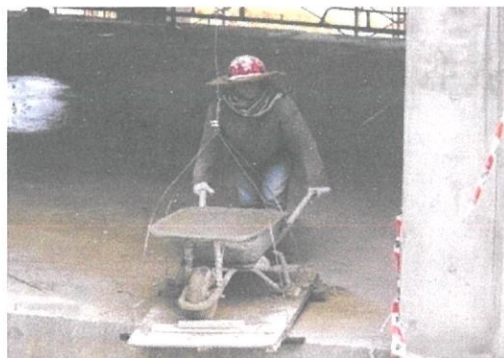
Besides that, concrete wastage also happens when concrete poured into unprovided mould. Apart from that, tools usage transport concrete like wheelbarrow also resulted concrete wastage if worker not use carefully.

Photo3.2 Concrete transport by wheelbarrow.

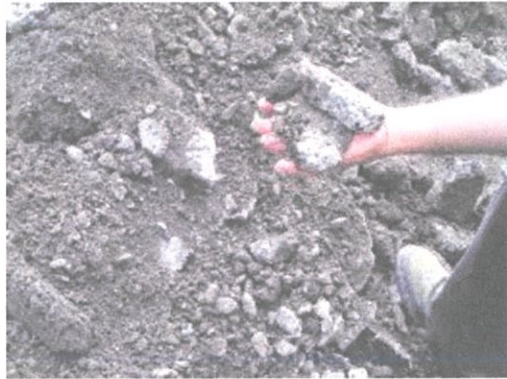
Photo 3.3 Concrete have to be broken up.

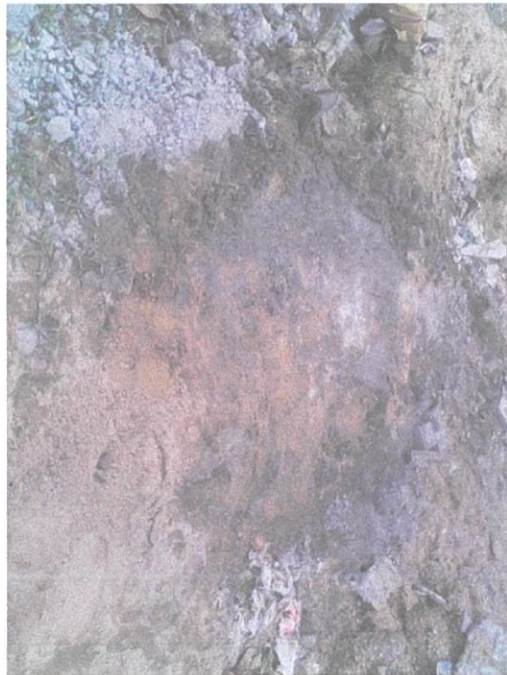
Photo 3.4 Cement mixing place on soil can cause wastage to quantity of mortar.

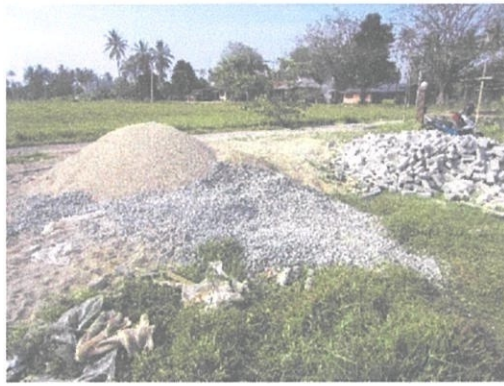
Aggregate wastage can be viewed on way of the storage whether placed far or near the sand at site build. Aggregate that already mixed is difficult to be segregated and this will cause it ignored by contractor.

Photo 3.5 Aggregate mixed with sand.

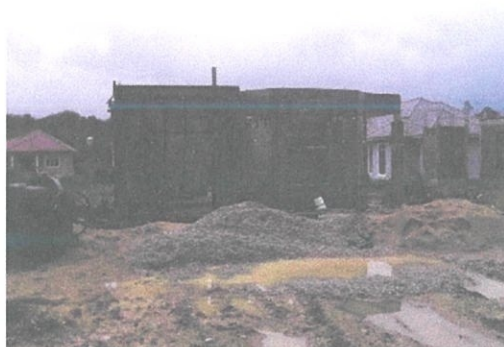
Photo 3.6 Aggregate mixed with mud.

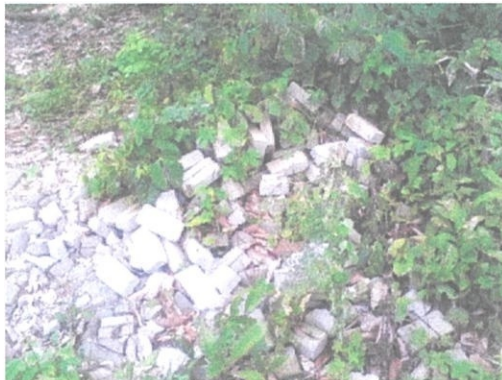
Usually bricks will experience to damage during delivery stage and wrong management on site build. During delivery, wastage can happened if bricks are poured directly from lorry and location of storage not suitable. Bricks will also break and lose when it is poured at the muddy place. For example low area of storage and likely muddy large probability will cause lost or damaged bricks. On the other hand, bricks that not wrapped well can give high humidity problem will inconvenience to works tie brick wall. At the same time, extra bricks permitted planted underground when the quantity is small to avoid additional cost to move it to different site.

Photo 3.7 Brick left too long.

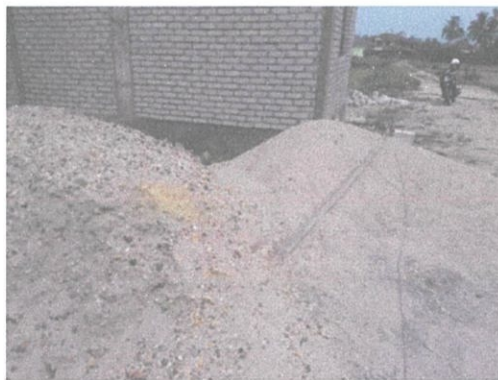
Sand is building material that always wasted. This problem visible during sand delivery to site build where lorry which bring excess sand load will cause sand spilled during delivery process to site build. Then, usually sand will be poured at unlined where it will mix with soil and other sand which will cause the quantity of sand is decrease. Apart from that, sand placed nearby work area can complicate measuring because sand can experience process expansion.

Photo 3.8 Sand placed near with work area.

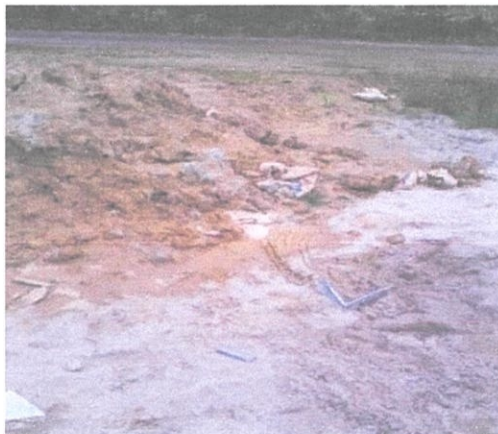
Photo 3.9 Sand mixed with soil on unlined area.

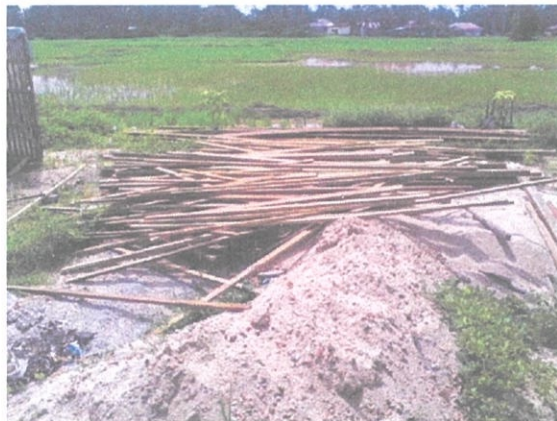
Most wooden wastage happening during cutting and storage process. Wastage due to cutting cannot avoid because woods size not obtained as to how determined. Woods storage way is wrong when it kept in place that not hidden than sunlight which will cause distortion like crooked, warped and so on. Wooden defect also happens due to fluid issued by some hardwood when compilation space between woods not prepared well. Apart from that, woods that unused will burned after ending a project because it is simplest management.

Photo 3.10 Wood on open area.

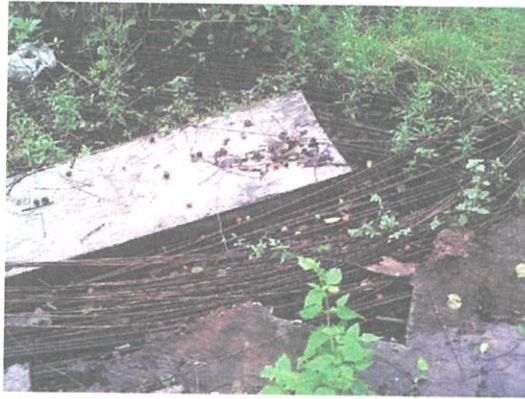
Fabric reinforcement placement and both high and soft stress steel type should give attention more because it influences the strength of reinforcement. Reinforcement should be separated from subsoil, humidity and machinery route. Small reinforcement quantity can be stored at site build but when great amount is not practiced to store at site. For unused reinforcement, it must be returned to suitable placed to avoid occurrence congestion on site build and damage by weather factor, wind and so on which can cause reinforcement rusty.

Photo3.11 Reinforcement bar on open area.

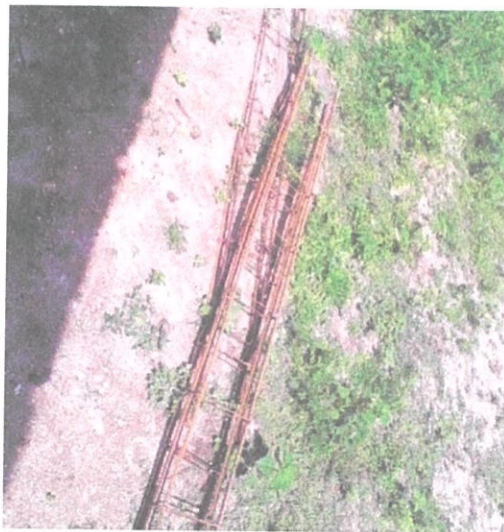
Photo3.12 Reinforcement for roof beam not be placed at right place.

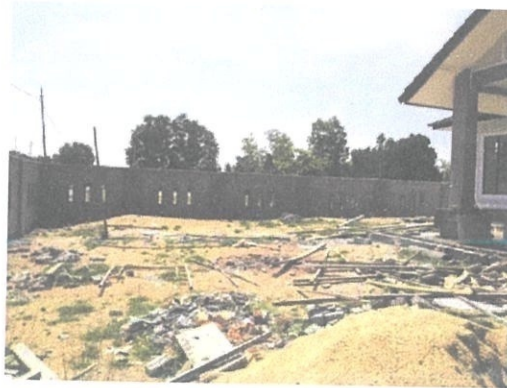
Besides that, failed to record type and material damaged quantity, broken will increase waste rated. If material store guardian not provided that is responsible manage and safeguarding safety of ingredients and control the activity go in and out building material will cause material kept in unsafe situation because it facilitate further theft problem happen.

Photo 3.13 Messy layout at site build.

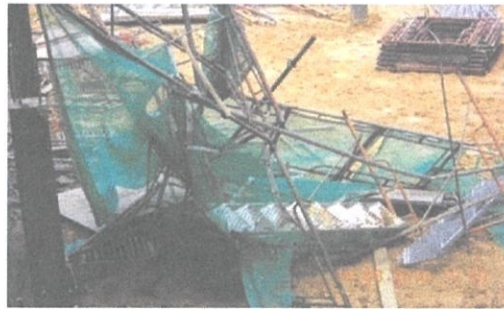
Most accidents occurred at site builds due to employee's negligence itself. For example, does not wear security apparatus, negligent when conducting work and ignore direction from contractor. Compilation procedure that is irregular and not systematic will cause accident if building material like red brick dropped. This will cause that material cannot be used anymore.

Photo 3.14 Staging not tough enough.

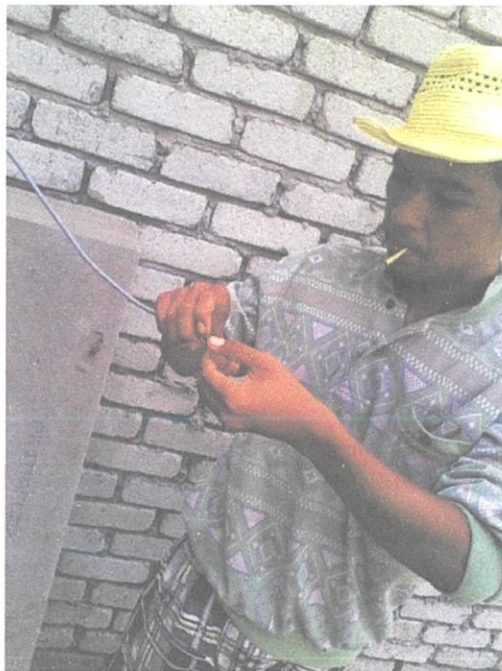
Photo3.15 Smoking when do wiring work.

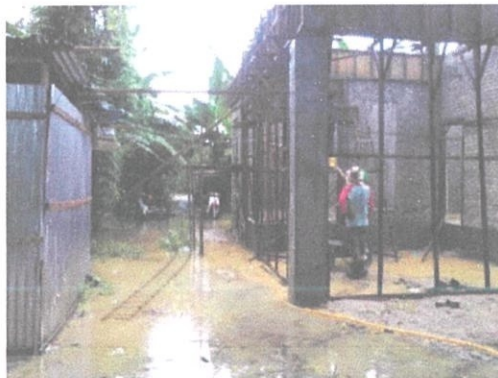
Weather problem and natural disaster is a problem that is inevitable. Factor weather and natural disaster like heavy rain, flood, and thunderstorm is problem that often beset in our country. For example cement hit with water will cause cement become hard, damaged and may not be reused. On the other hand reinforcement can become rusty and wood will break down like become bent, warped and so on.

Photo3.16Site builds flooded.

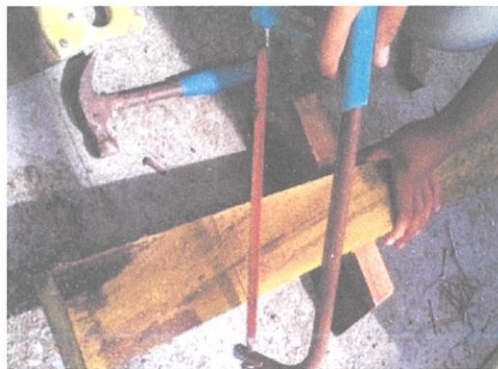
Photo3.17 Wrong equipment used.

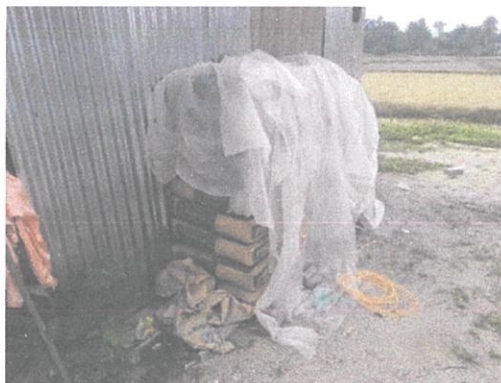
Once arrived at site build, every building material must be kept in most suitable place according types of material. However, contractor and building material operator not considerate on matter like this. Failure make systematic planning while making building material storage always causes these substances suffer damage, lost or broken.

Photo3.18 Cement not over cover.

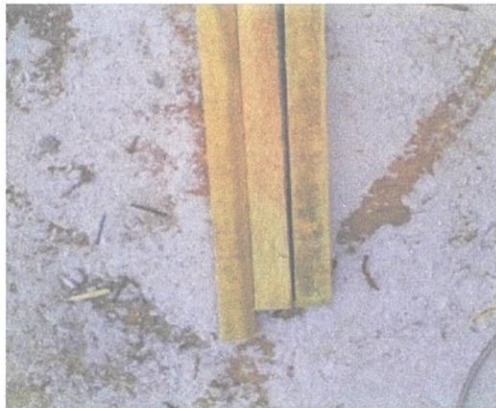
Building material cutting also associated with main cause of building material wastage on site build. Wrong cutting often occur in material like reinforcement and wooden. Cutting mistake often happens due to mistake when designing project and could also happen due to material ordering that not made meticulously.

Photo3.19 Not accurate when cutting material.

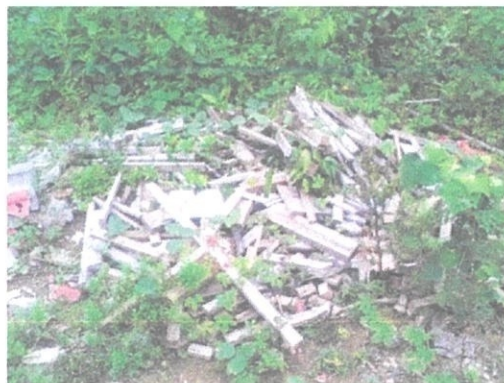
Photo3.20 Wood cannot be used because wrong when cutting work.

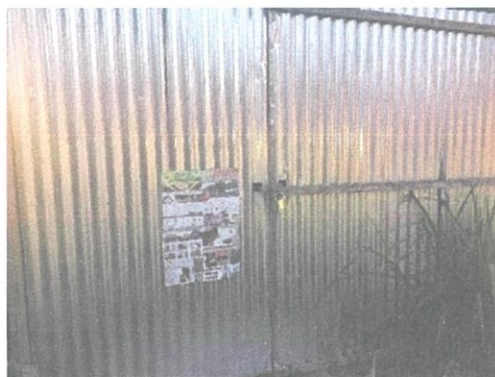
Photo 3.21 Locked store.

- i. Building material that is valuable must be kept in locked store.
- ii. Preparing area light that is sufficient on site build so that lamp can light construction site.
- iii. Made examination to reserve material to make sure materials is safe kept.

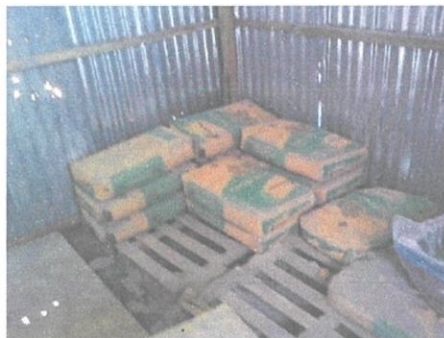
Photo 3.22 Cement lined to avoid contact with water.

Contractor, site engineer and site supervisor should plan in terms of layout on site build and building material quantity that is suitable before making message to supplier. Apart from that, material storage site must be raised in most suitable place where it is easy guarded from storage aspect, usage and care. Product compilation must be made systematic so that product is kept undamaged and broken. Cement especially must be kept in place that high and hidden than rain water.

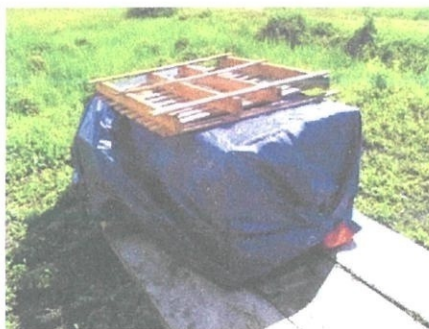
Photo 3.23 Tiles fully cover.
