GABION WALL CONSTRUCTION

DEPARTMENT OF BUILDING
FACULTY OF ARCHITECTURE, PLANNING AND SURVEYING
UNIVERSITI TEKNOLOGI MARA
(PERAK)

Project title : *Kerja-kerja pembinaan tembok penahan tebing di Kg Lubok Bandan*

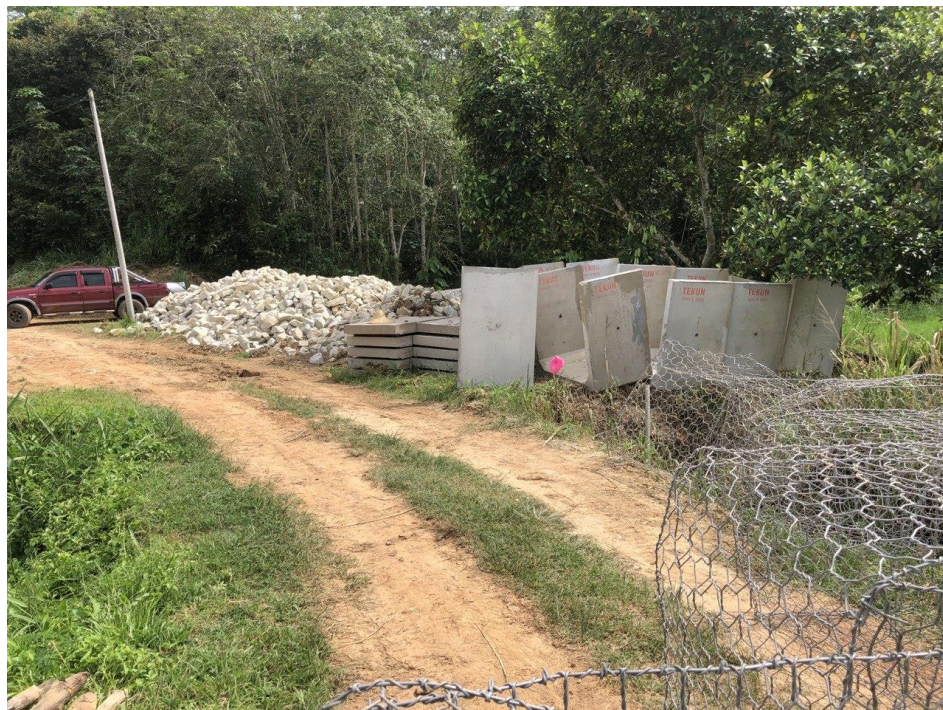
Figure 3.1 The material for gabion wall construction.

After received the tenders, this company preparing the material and start looking for machineries. This company start buy the culvert, the rock, crusher run, cage, mangroves tree trunks and others.

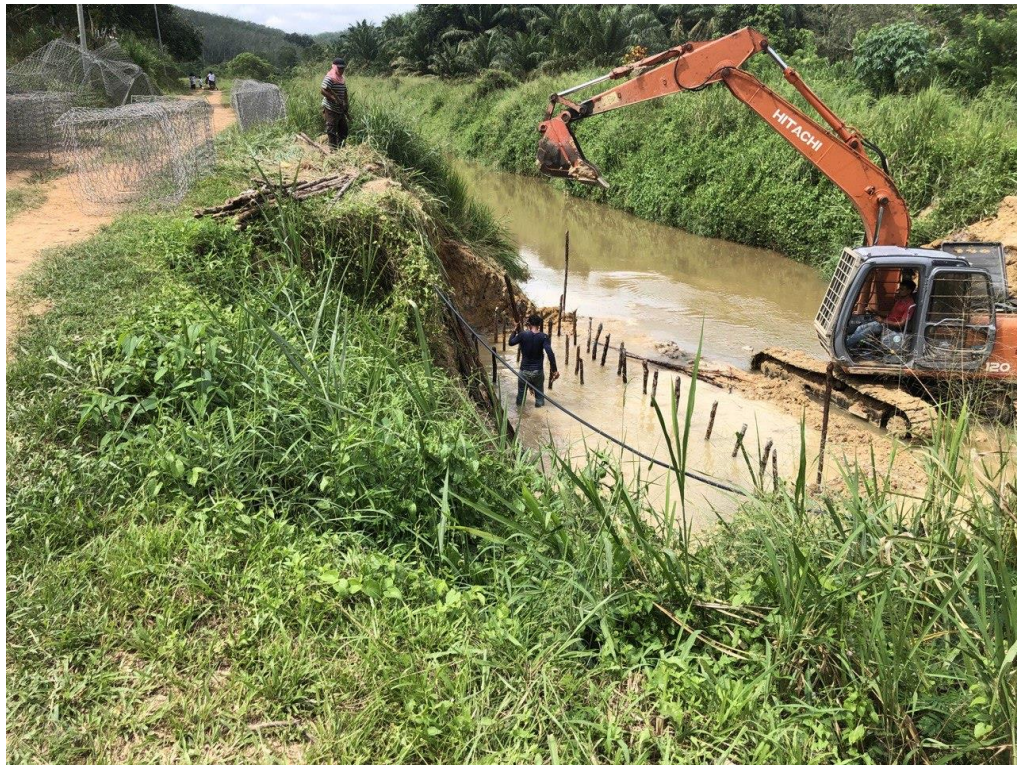
Figure 3.2 Plant the mangroves tree trunks.

First of all, the labors plant the mangroves tree trunks which has the same function as a piling work. It can help strengthen the gabion structure. After that, they starts the process arrange the cage on the mangroves tree trunks. Then, they put the rock into the cage and tie the cage using the wire.

In a nutshell, this report include many thing about the project of Hazuli Construction and Renovation Company. In the process of gabion wall construction, mangrove wood has been used as a foundation to strengthen the gabion wall on the surface. It is the same thing as the process for the construction of a building. There is no need to use boards or wooden sticks on the walls of the cage to prevent them from inflating when the rock are inserted, but it is enough to manually stack the rock on the edge surface of the cage to prevent the cage from inflating and to show a neat work. The workers were able to do nothing when it was raining because the river water level rose and made the gabion construction work difficult

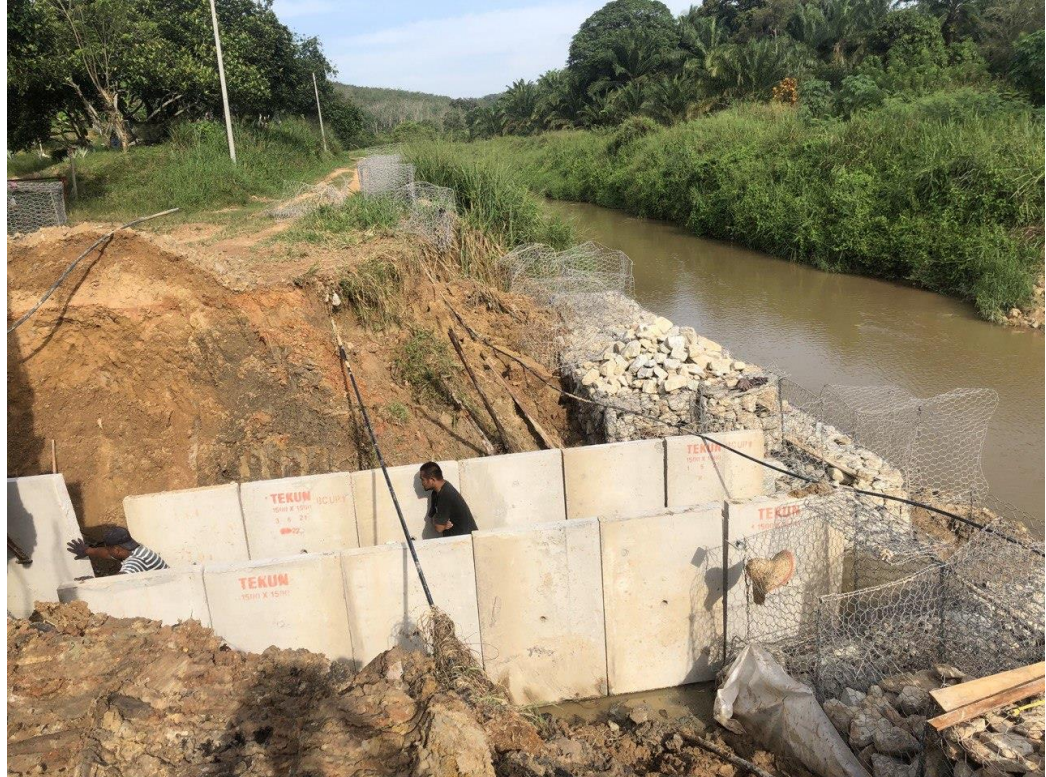
Figure 3.3 Installing culvert.

After that, they install the geotextile behind the cage to avoid the soil get in the cage. This process is until the gabion has two level. Next, they install the culvert as drainage for the water from. After that, they continue construct the gabion for the third level.

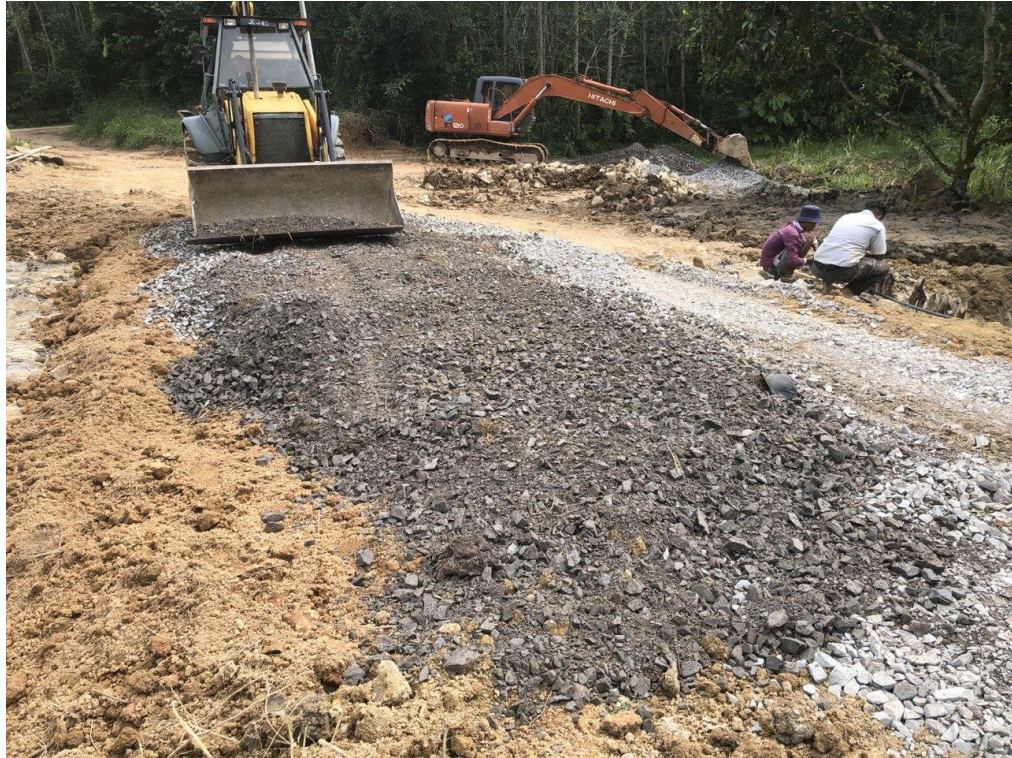
Figure 3.4 put crusher run on top of the road.

They put the extra rock and soil behind the gabion wall. Then, they level the road using the soil. Next, they put the crusher run on top of the road.

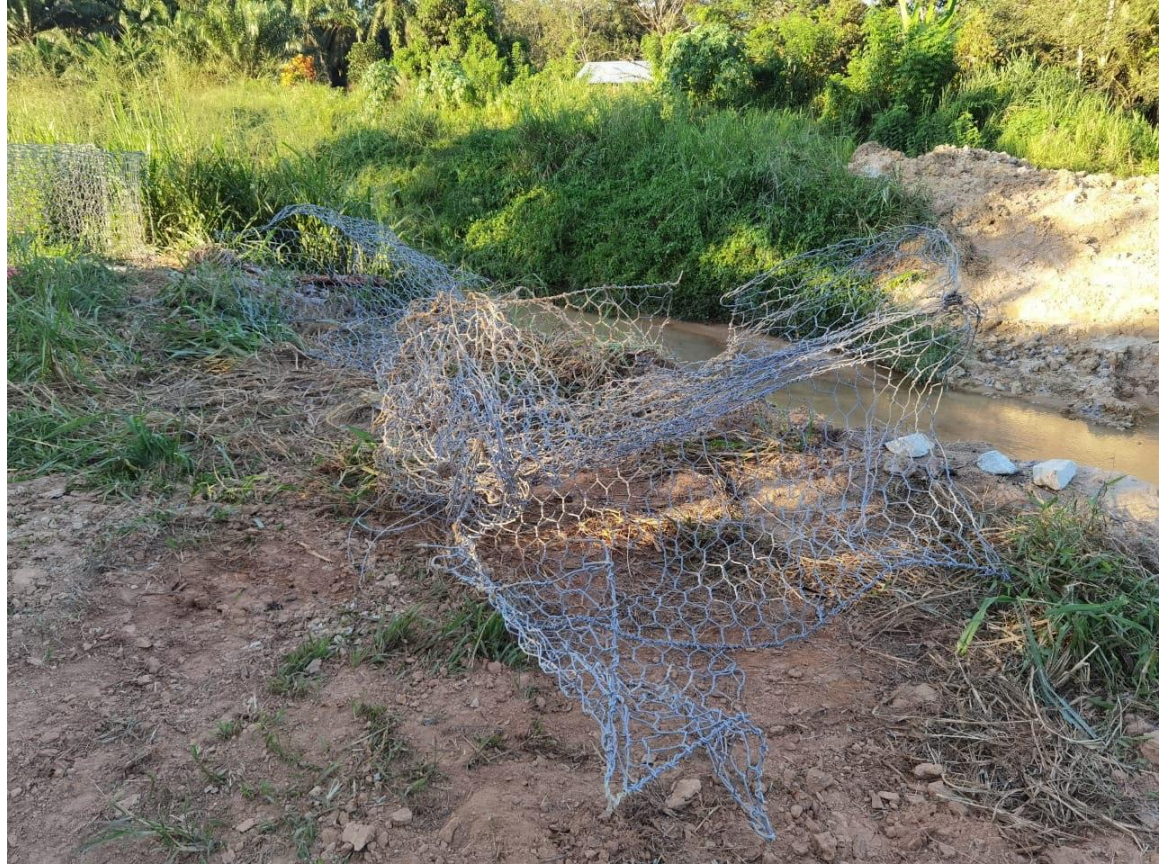
Figure 3.5 the broken cage effect from landslide.

The problem during the construction work is landslide. This is very dangerous to the lives of the workers. It has also caused losses when the soil hits the cage. This causes the cage to be damaged and can no longer be used.
