**DEPARTMENT OF BUILDING  
UNIVERSITI TEKNOLOGI MARA  
(PERAK)**

**STEEL STRUCTURE INSTALLATION  
(FRAME STRUCTURE)**

**STEEL STRUCTURE INSTALLATION**  
**(FRAME STRUCTURE)**

### INSTALLATION OF ROOFING SYSTEM BY USING STEEL STRUCTURE INSTALLATION (FRAME STRUCTURE)

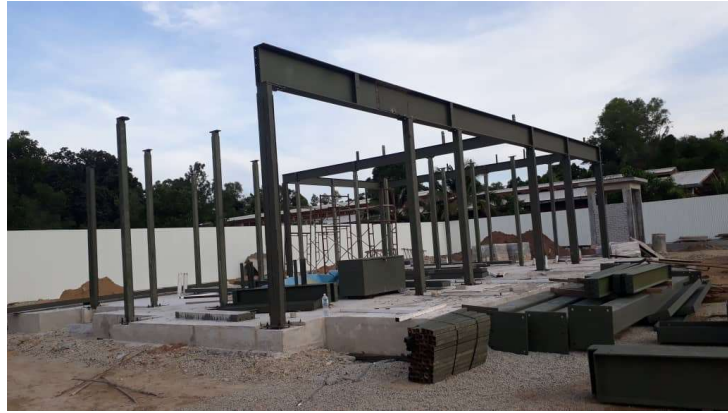
*Figure 3.0 Interrupted Installation*

**Problem: Height and vertical are not uniformly.**

The horizontal error of the embedded anchor bolt after foundation construction is substantial. Columns are not built in a straight line, stagger east, making the look of the building difficult to observe, causing errors in the installation of steel columns, causing the structure cannot be connected.

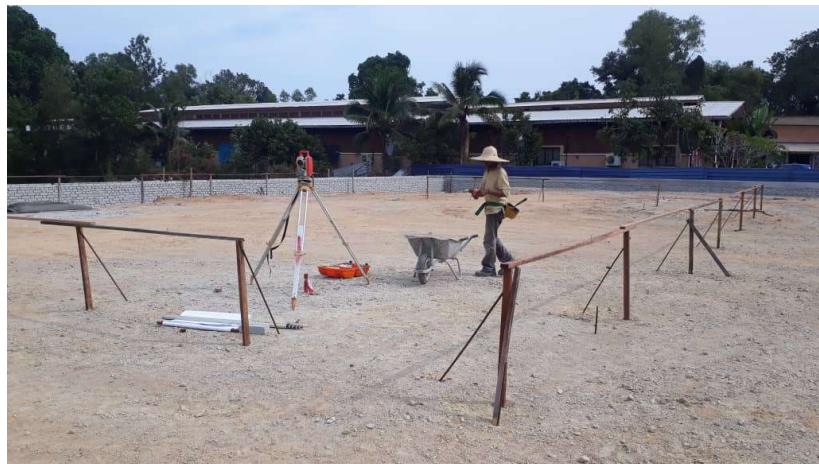
*Figure 3.1 Levelling Process*

The skilled workers are using levelling and measuring objects or line positions either measurement vertically or horizontally such as automatic level, digital waterpass and laser distance meter of the steel structure during installation. These are the best solutions that have been approved by the Consultant and Contractor.
