**DEPARTMENT OF BUILDING
UNIVERSITI TEKNOLOGI MARA
(PERAK)**

**THE CONSTRUCTION OF ROADWORKS AT MASJID KARIAH
TEMERIS - BAHAU, NEGERI SEMBILAN**

DEPARTMENT OF BUILDING
FACULTY OF ARCHITECTURE, PLANNING AND SURVEYING
UNIVERSITI TEKNOLOGI MARA
(PERAK)

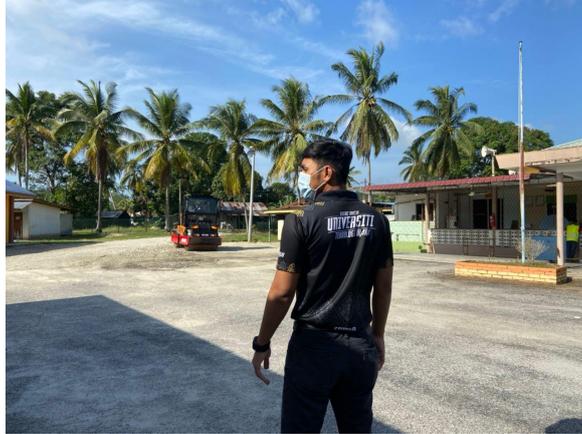
Figure 3.2.1 Checking the original sites to make premix works

Provide workers and other equipment for the work clean, grade and level the existing road shoulders from all unwanted materials from the construction site according to as directed by the supervisor.

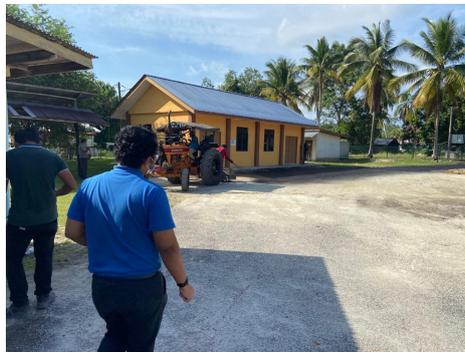
Figure 3.2.2 Seeing the workers put the crusher-run

Supply, transport, unload, level, and compact 300mm thick crusher-run after compaction as directed by the supervisor.

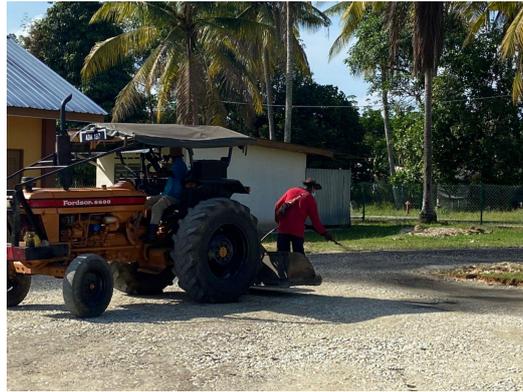
Figure 3.2.3 Worker is watering tack coat on crusher-run

Supply and water tack coat of cationic bituminous RS 1K emulsion with a rate of 0.55 liters square meter and above mixed stone foundation surface or existing road surface as directed by the supervisor.

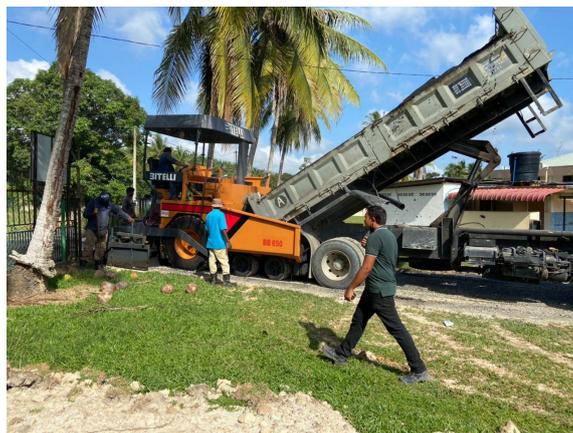
Figure 3.2.4 Workers are pouring premix into the paver from the quarry

The premix that workers take from quarry should maintain the temperature that are between 140 degree celcius to 160 degree celcius, If the temperature drop below than that, the premix cannot be use.

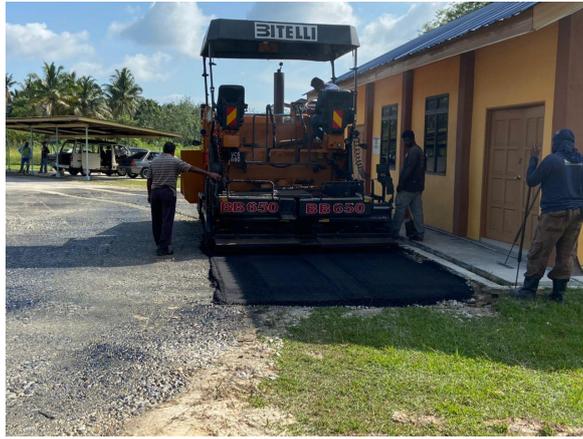
Figure 3.2.5 Workers is pouring premix using paver

The skilled workers have to do the pouring works because it takes more experience to make sure the premix work goes well.

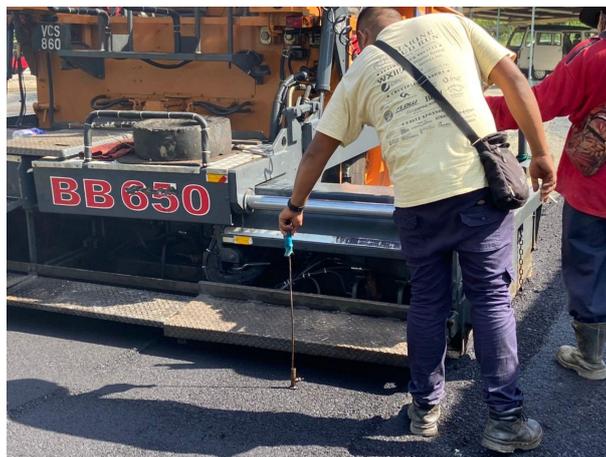
Figure 3.2.6 Measure the thickness of premix before compact

The workers measure the thickness of premix before compact to make sure the thickness of premix according to the correct specifications.

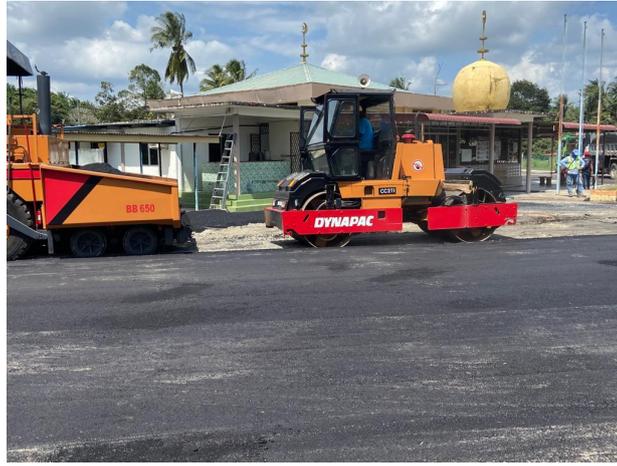
Figure 3.2.7 The worker is compacting the premix

Supply, spread and compact premix concrete including watering tack coat according to specifications and as directed by supervisor. Compaction work should have done not long after the paver pour the premix on the original base to prevent problems occurred when the work done.

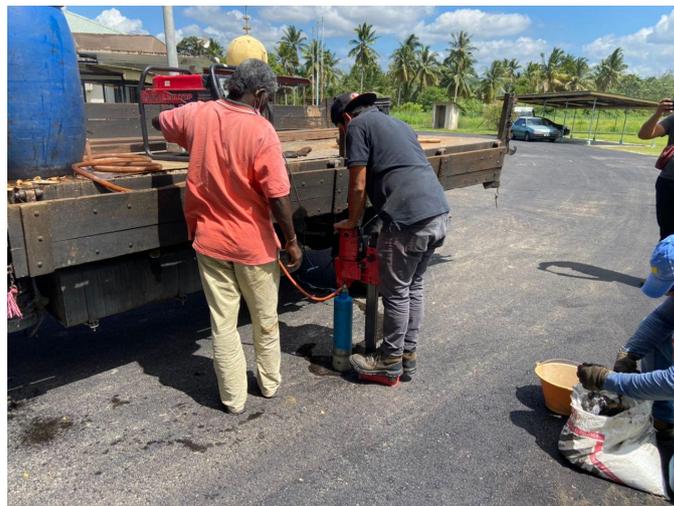
Figure 3.3.1 The workers are doing coring test

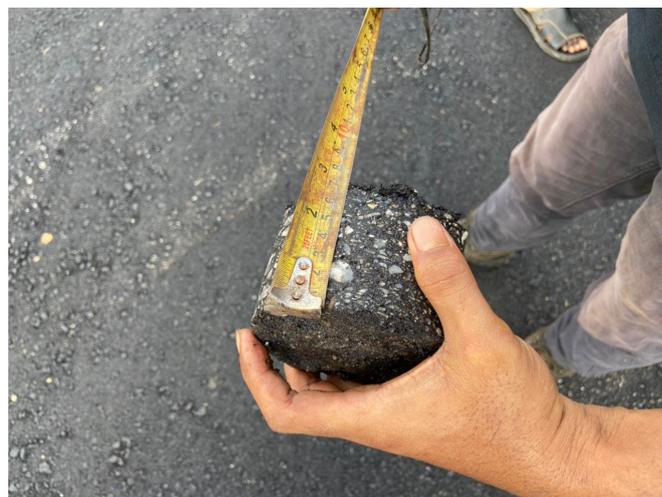
Figure 3.3.2 The worker is measure the part of compacted premix that have been taken from coring test

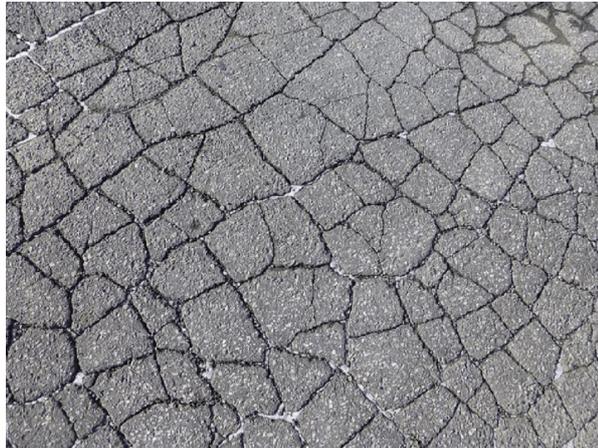
Figure 3.4.1 Road with Alligator cracking

Alligator cracking is a structural failure caused by a load. The failure can be caused by a weakness in the surface, base, or subgrade a too-thin surface or base; poor drainage; or a combination of all three. It frequently begins as longitudinal cracking in the wheel path and progresses to alligator cracking after severe distress.

Because there is a structural failure, the only solution to alligatoring is to perform a full-depth patch.

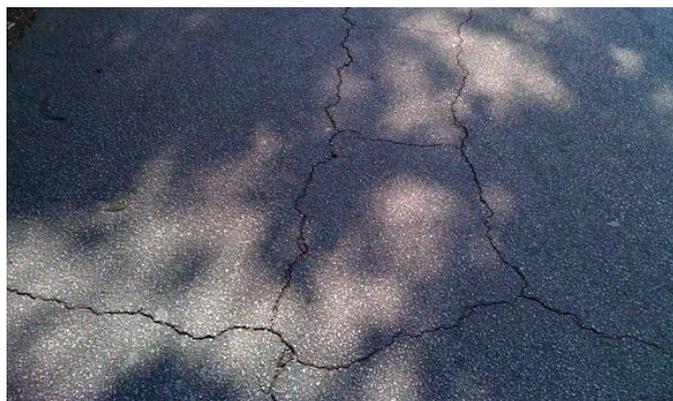
Figure 3.4.2 Road with Block Cracking

Block cracks resemble large interconnected rectangles. Block cracking is not caused by load, but rather by shrinkage of the asphalt pavement as a result of the asphalt binder's inability to expand and contract with temperature cycles. This could be due to the mix being too dry when it was mixed and placed; fine aggregate mix with low penetration asphalt and absorptive aggregates; a poor choice of asphalt binder in the mix design; or ageing dried out asphalt.

Less severe cracks, measuring 1/2 inch or less, can be sealed to keep moisture out of the subgrade. For more severe cracks, the cracked pavement layer should be removed and replaced with an overlay.

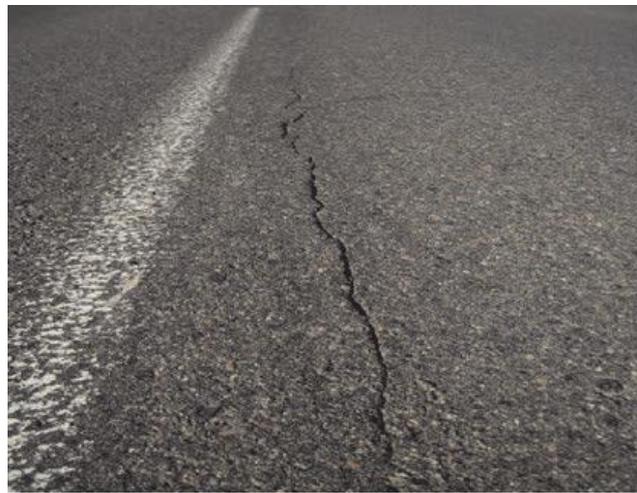
Figure 3.4.3 Road with Linear Cracking

Linear cracking refers to cracks that run parallel to the centerline or laydown direction of the pavement. Pavement fatigue, reflective cracking, and/or poor joint construction can all cause these. Joints are typically the least densely packed areas of a pavement.

Less severe cracks, measuring 1/2 inch or less, can be sealed to keep moisture out of the subgrade. For more severe cracks, the cracked pavement layer should be removed and replaced with an overlay.

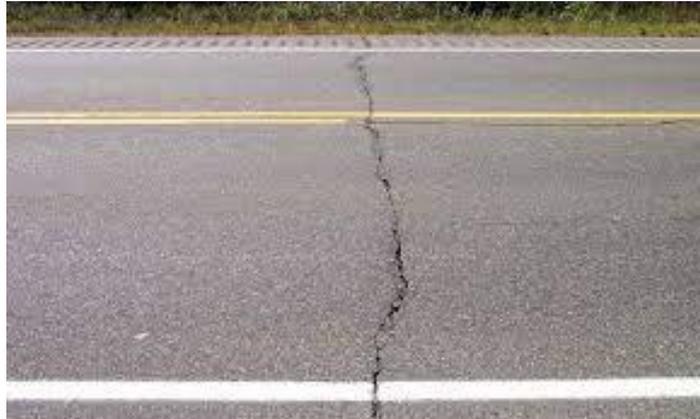
Figure 3.4.4 Road with Transverse Crack

Transverse cracks are single cracks that run perpendicular to the centerline or laydown direction of the pavement. Reflective cracks from an underlying layer, daily temperature cycles, and poor construction due to improper paver operation can all cause transverse cracks.

Less severe cracks, measuring 1/2 inch or less, can be sealed to keep moisture out of the subgrade. For more severe cracks, the cracked pavement layer should be removed and replaced with an overlay.

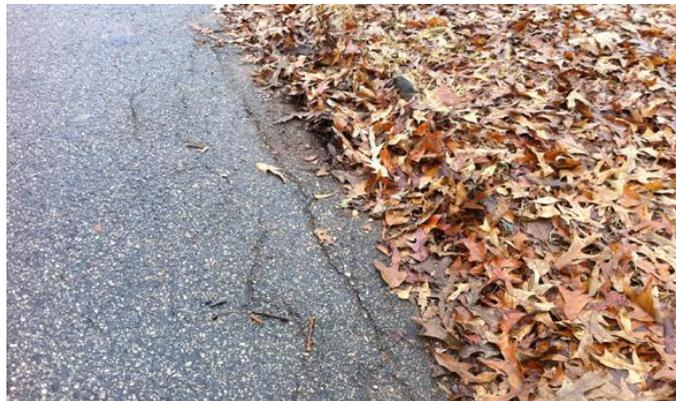
Figure 3.4.5 Road with Edge Cracks

Within one or two feet, edge cracks travel along the inside edge of a pavement surface. Poor drainage and a lack of support at the pavement edge are the most common causes of this type of crack. As a result, the underlying base materials settle and weaken. Edge cracking can also be caused by dense vegetation along the pavement's edge and heavy traffic.

The first step in resolving the issue is to remove any existing vegetation near the pavement's edge and to address any drainage issues. Crack seal/fill the cracks to prevent further deterioration, or remove and rebuild to full depth to address any support issues.

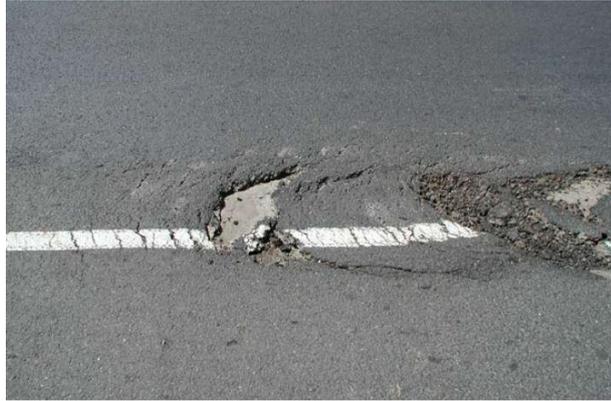
Figure 3.4.6 Road with Slippage Cracks

Slippage cracks are crescent-shaped cracks or tears in the asphalt's surface layer(s) where new material has slipped over the underlying course. This issue is caused by a lack of layer bonding. This is frequently due to the lack of a tack coat to develop a bond between the asphalt layers or the lack of a prime coat to bond the asphalt to the underlying stone base course. A lack of bond can also be caused by dirt, oil, or other contaminants that prevent the layers from adhering together.

All of the "stretch marks" will need to be removed, and a partial or full depth patch will be required.

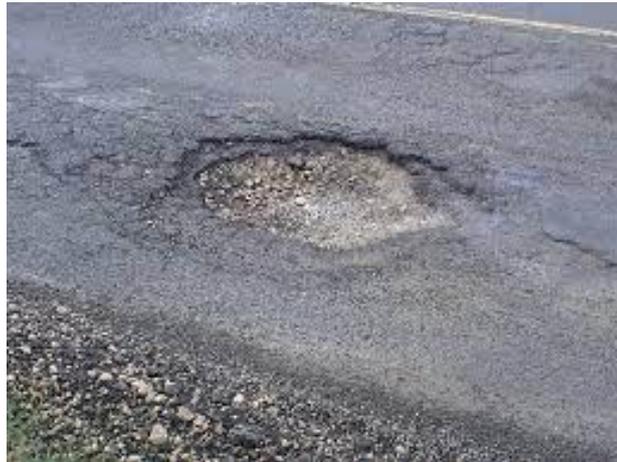
Figure 3.4.7 Road with Pot Holes Cracks

Small, bowl-shaped depressions in the pavement surface that extend all the way down to the base course. They typically have sharp edges and vertical sides near the hole's apex. Potholes are caused by water infiltration and are usually the result of untreated alligator cracking. As alligator cracking worsens, the interconnected cracks form small chunks of pavement that can become dislodged as vehicles drive over them. A pothole is the hole that remains after the pavement chunk has been dislodged.

Full depth replacement patch

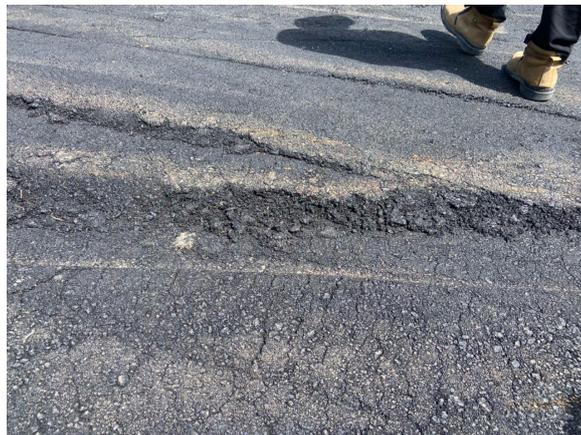
Figure 3.4.8 Road with Rutting Cracks

Ruts in asphalt pavements are depressions in the wheel tracks that have been channelized. Rutting is caused by the lateral movement or consolidation of any of the pavement layers or the subgrade under traffic. It is caused by insufficient pavement thickness, insufficient compaction of the asphalt, stone base, or soil, insufficient asphalt mixes, or moisture infiltration.

The depressions can be filled and overlaid if the rutting is minor or has stabilised. If the deformations are severe enough, the rutted area should be removed and replaced with appropriate material.
