**HOTEL ROOM PREVENTIVE MAINTENANCE**

This room preventive maintenance inspection checklist was made for inspection of guest room 1605 Hotel Le Meridien Putrajaya. This room checklist was made by Maintenance Technician Executive Manager, Sarah Syafinaz Ibrahim for all guest room inspection in hotel building. This inspection was due for one day and done at 25 July 2021.

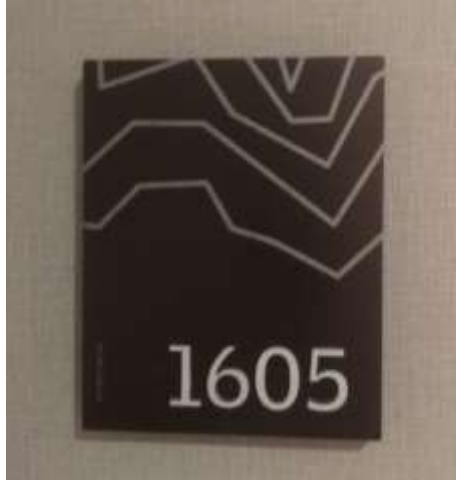
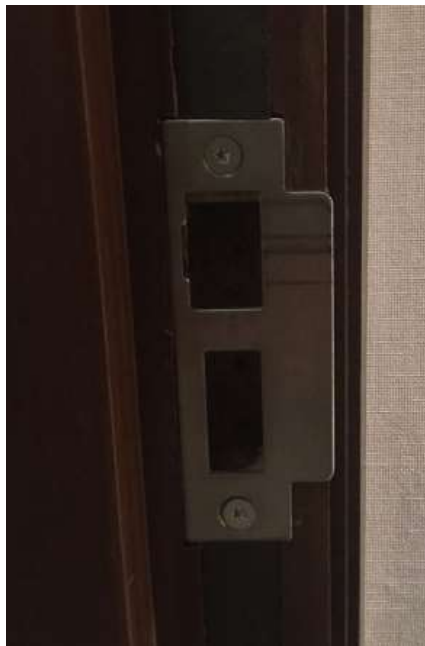
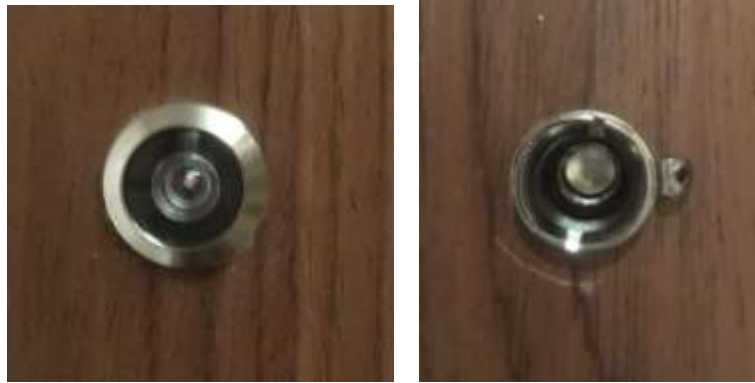
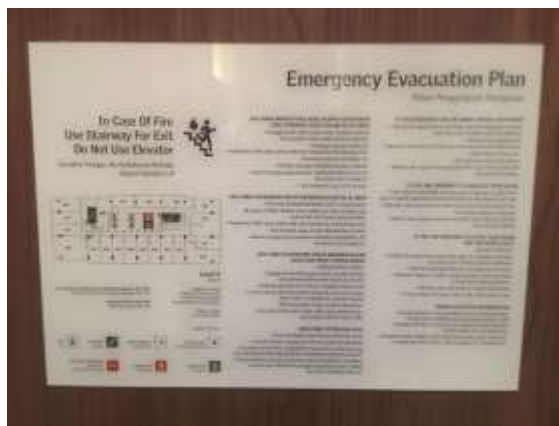
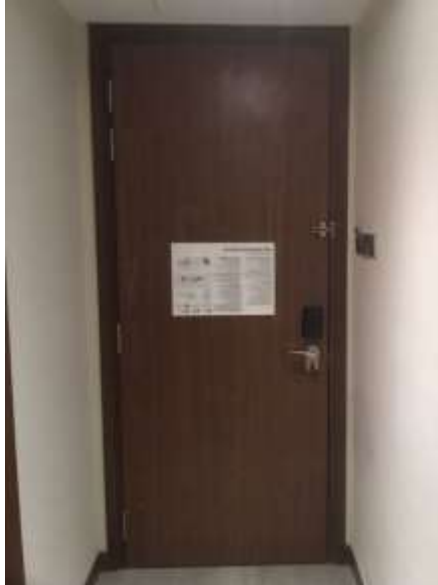
Firstly, starting with entrance door, check the condition of room signage, door closer, viewer peep hole, double latch, evacuation direction and main door whether they are broken or still in good condition. Looking for crack or fracture at the item with detail. If founded broken or in bad condition the item must be changed with a new one.

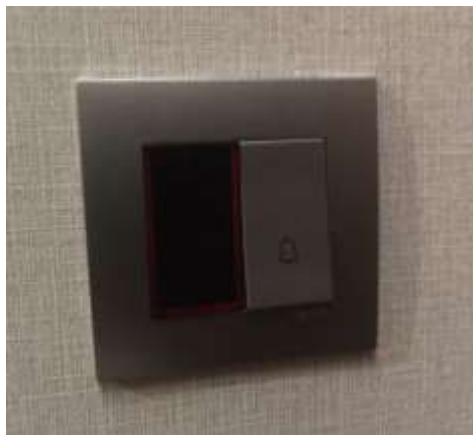
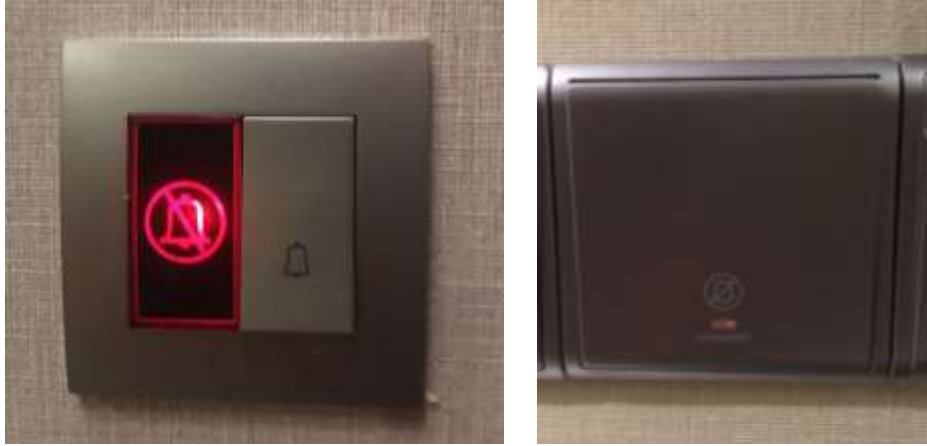
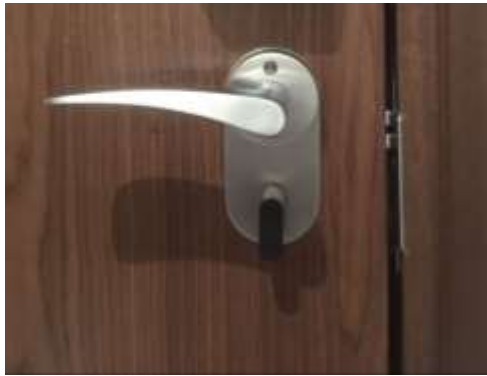
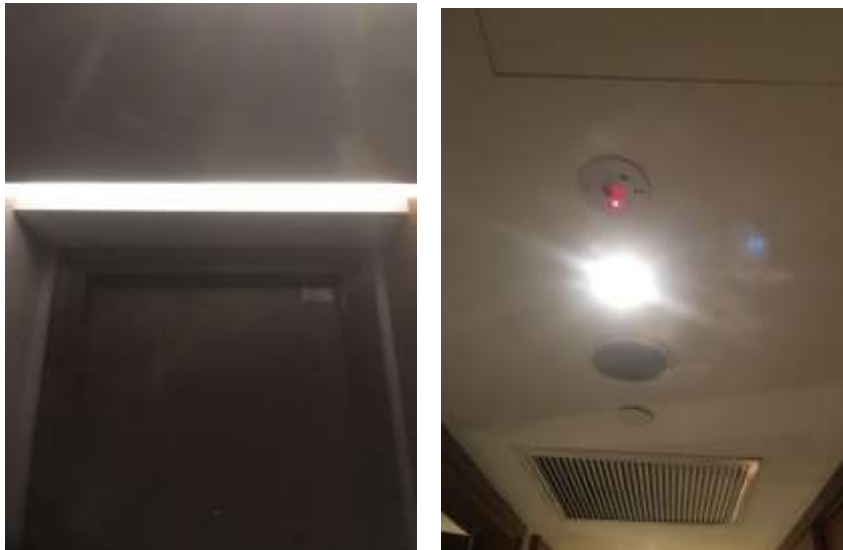
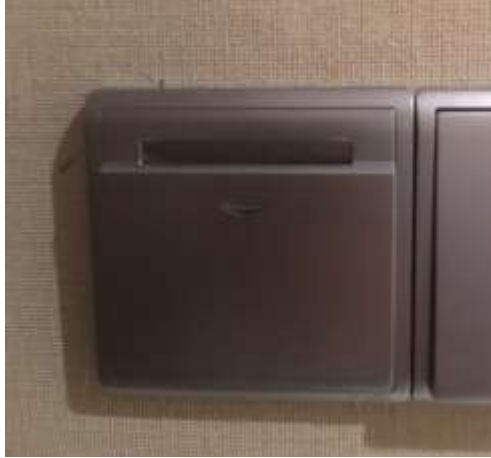
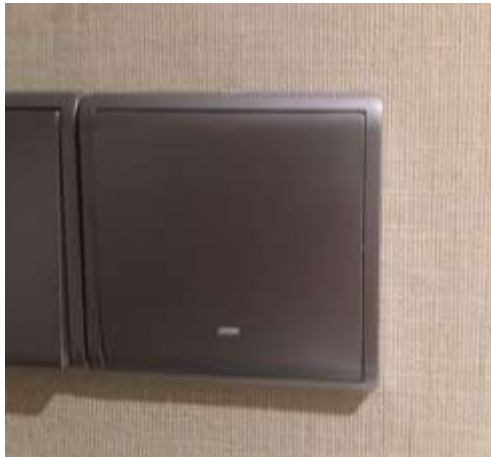
Moreover, check the condition of door bell, do not disturb interlock, lockset, entrance lighting, key card switch and lighting switch whether the item functioning or not. If the item is broken, change it with a new one and if the item are not working check the power supply of the room.

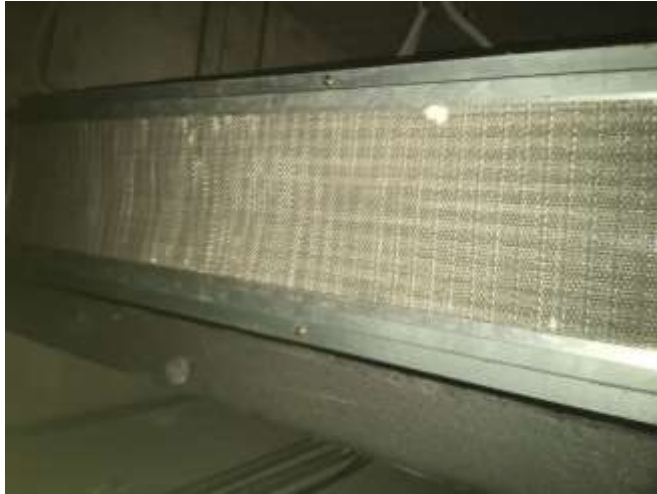
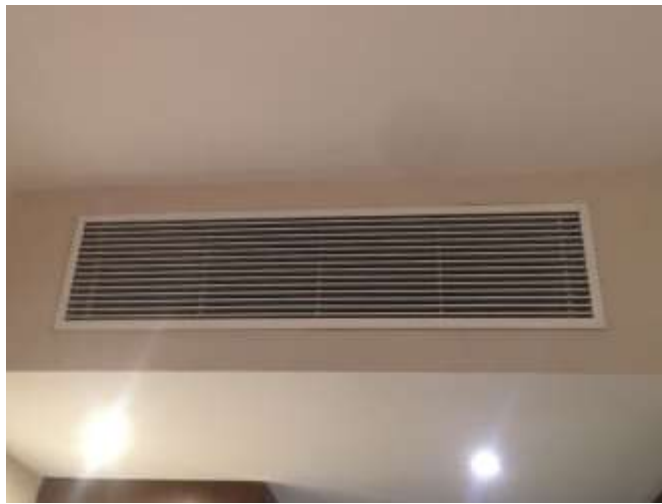
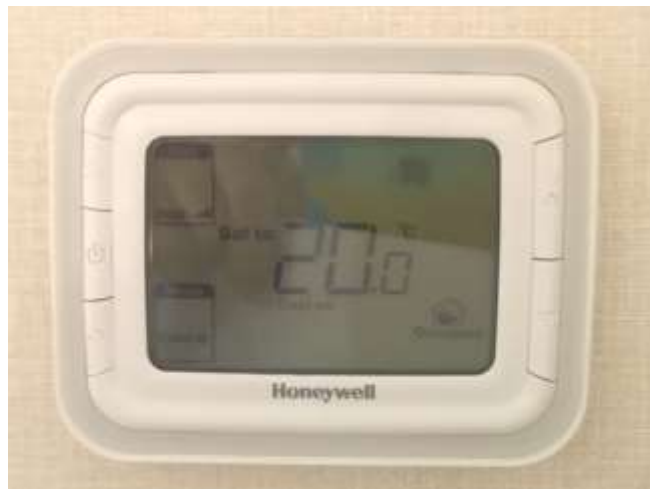
After that, start checking the room air conditioner starting from its filter and grill whether they are dirty or clean. If the filter or grill is in dirty condition can block the air cooling coming through and because of this can affect the room temperature to be high. Always made sure to clean the filter and grill by wash it using water. Continue check the air conditioner thermostat secure and functioning, if the thermostat not working changed it with a new one but before that check the air conditioner relay and wiring.

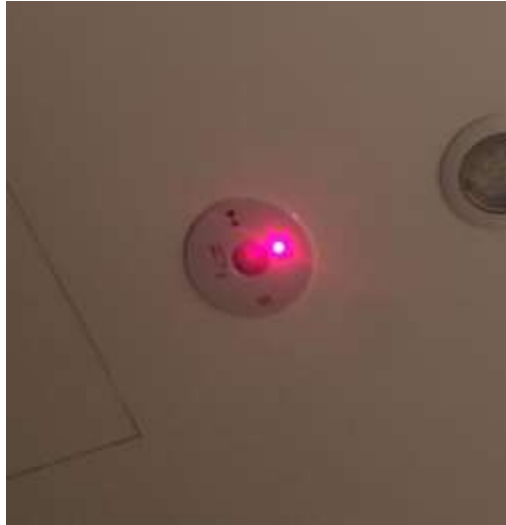
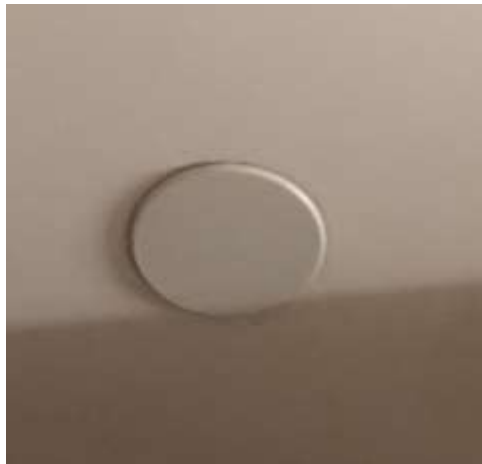
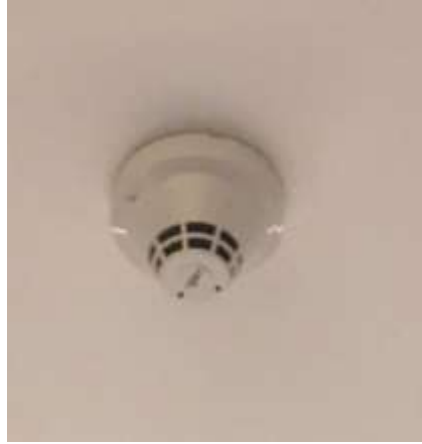
Next, check the fire safety starting with emergency light, sprinkler cover and smoke detector. Make sure these items working by test them for guest safety in the event of emergency. Sprinkler cover need to be left a little gap between the cover and the ceiling to let the water out when fire emergency happening.

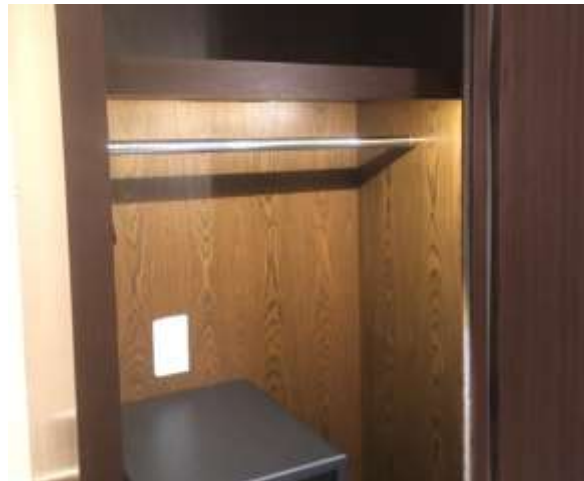
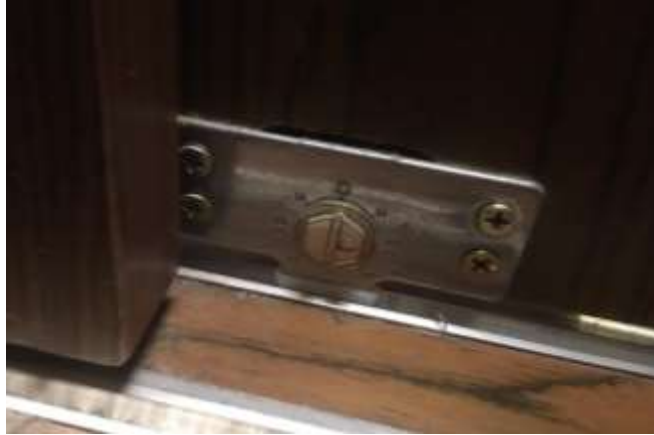
After that, check the condition of closet which is closet lighting if it turned on or light on when the closet door is opened. If the closet light not light on check the micro switch and the LED lamp, change the items if its broken or not working. Then, check the closet roller or door. Closet door often stuck or loose so make sure the roller follows the rail.

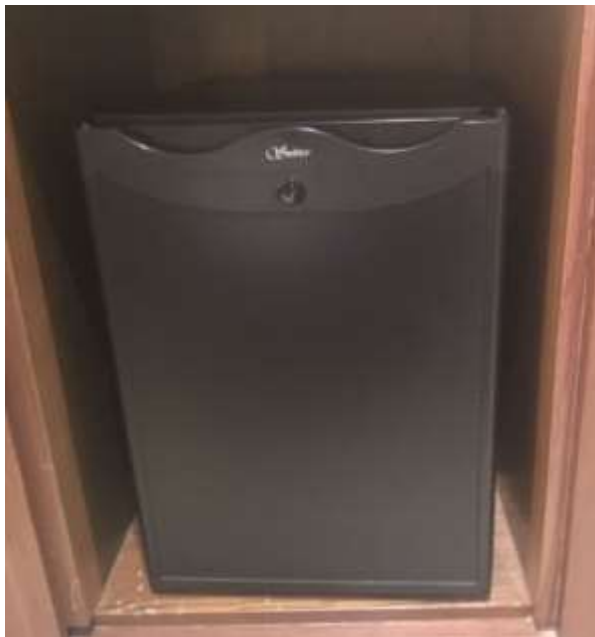
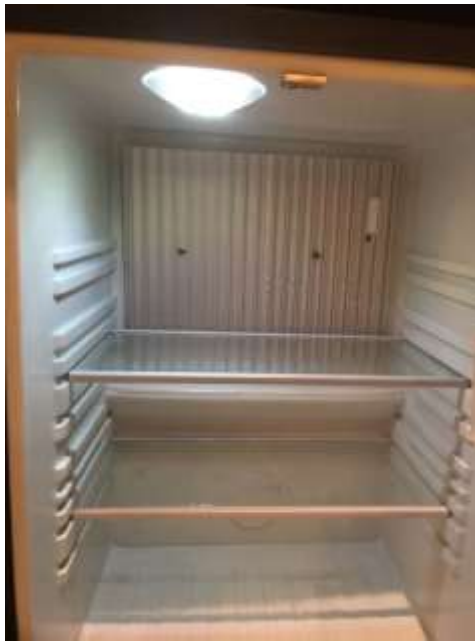
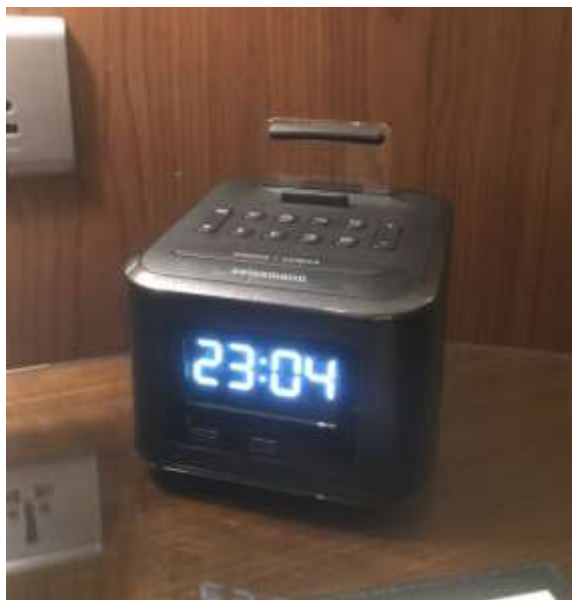
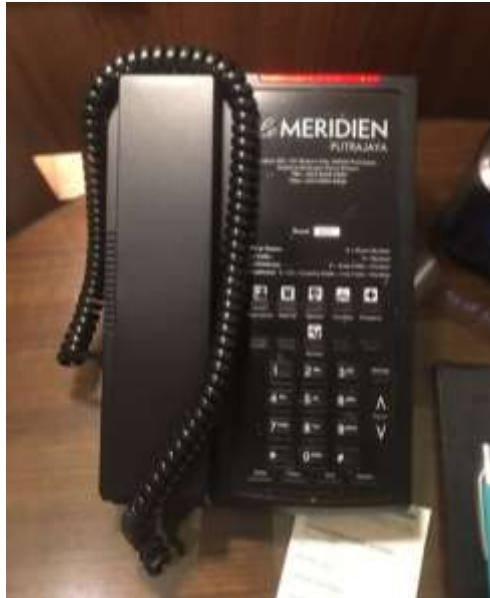
Next, continue with electrical appliance with check the minibar fridge, minibar ventilation and minibar light. If minibar is not working or not cold, change it with a new one other than that we need to call contractor for expert and further checking. Then, check the condition of alarm clock, telephone and television. Television is often lost signal from Astro so reset back or tune back the television.

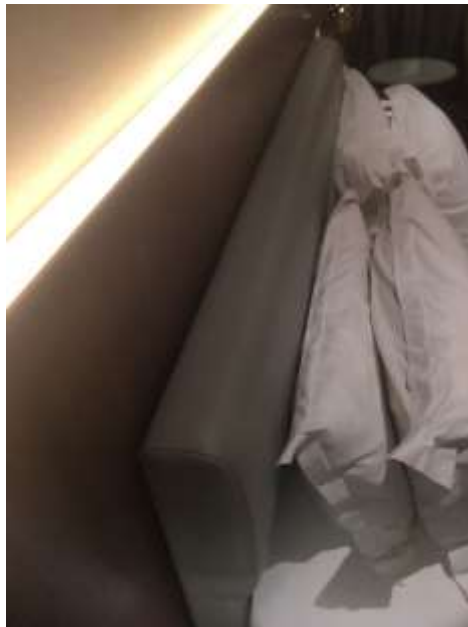
Figure 3.33 : Bedhead

After that, check the condition of bedhead and wood veneer if there any hole or crack. Then check the power socket and switch at bedside if there have power supply.

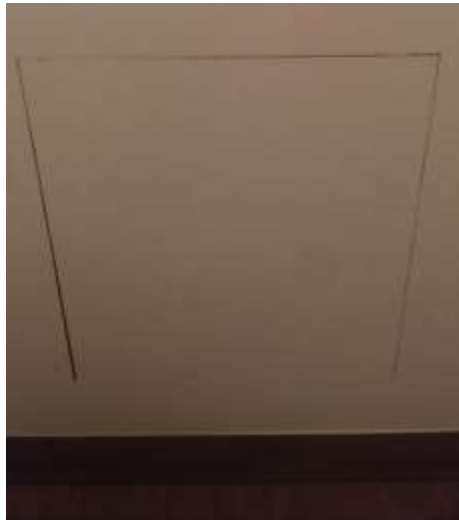
Figure 3.37 : Ceiling manhole

Going on with surfaces in room which is ceiling manhole, ceiling painting, wallpaper, skirting and carpet condition if these features in good condition.

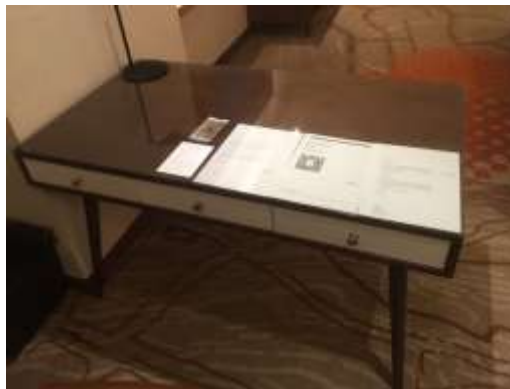
Figure 3.42 : Writing table

Last but not least, check the condition of furniture in the room before the room inspection is finished. Starting with writing table, arm chair, sofa and coffee table is checked with detail if got torn or crack on the table and test swing also sit on the arm chair. Next, test the emergency torch light and safe box can be used and functioning well. Lastly, check the drawer and entrance mirror installed tight to the wall.

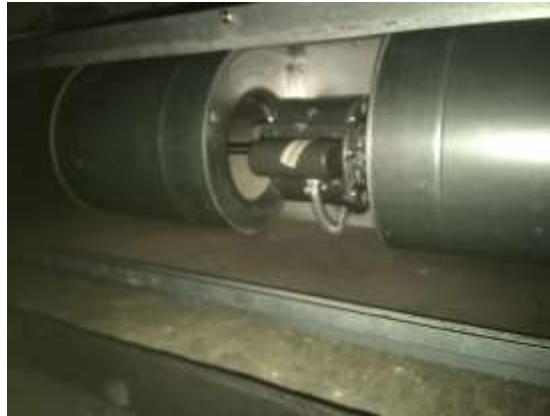
Figure 3.50 : Motor blower air conditioner

There are 3 reasons for this problem to happen, the first one is because of the filter vibrate and hit the cover. Solution for that problem is to adjust and tighten the screw on the filter with the cover. Next, motor blower is vibrating and hitting the top of the cover. Uninstalled the motor blower and reinstalled it back make sure to leave a space between the blower and the top of cover. Lastly, the motor blower bearing already loose and need to change with a new one. The procedure is starting with take-off the filter, unplug the air conditioner wiring but make sure to take a picture for reference later. Uninstall the motor blower, unplug the motor part by part and take off the bearing change it with a new one for both sides. Lastly, reinstalled the motor blower back.

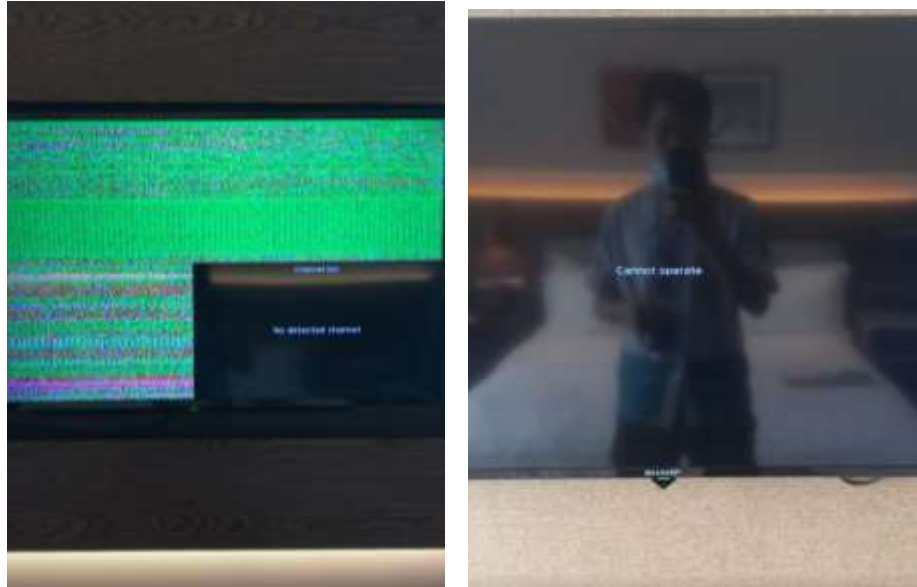
Figure 3.53 : Television no signal

There are 3 items that need to be check if this problem happened which is channel cable, plug socket and television. Firstly, reset the television or channel setting back, if the problem is still no solve yet check cable channel and socket and change it with new one if the items have broken. Lastly, if the problem still not fixed yet after all the step change the television with a new one.

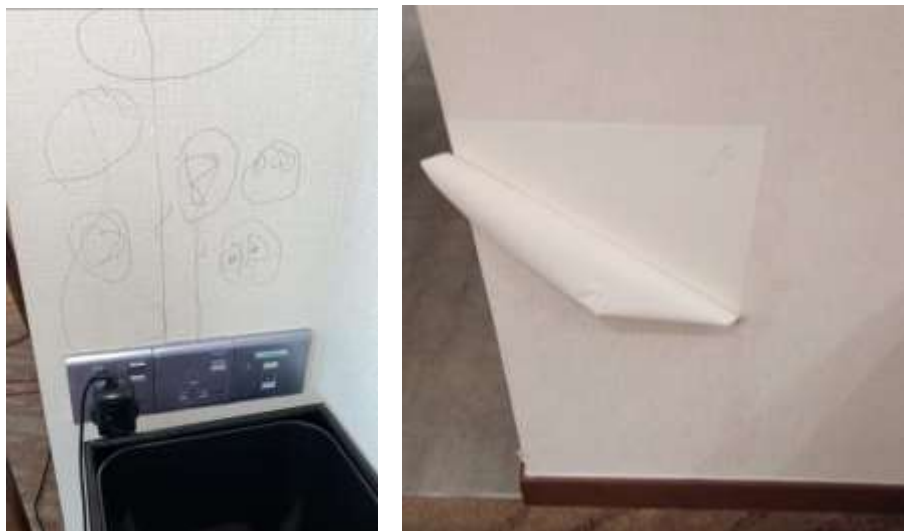
Figure 3.54 : Wallpaper defect

Wallpaper problem occur often because of something hit it such as guest luggage or guest child who painting at wallpaper using pen. The wallpaper need to be change and cannot be used anymore. The part that is torn and dirt need to be peel off using square shape. After that, the wall need to be patch and sand papering to get a smooth surface. Then, glue the wallpaper to the wall and avoid any line arise to be seen. Lastly, wipe the wallpaper using a wet towel to erase the glue to be seen after it dry.
