BUILDING STRUCTURE

However, the aim of this study is to discuss and learn the typical structure design used and sequence of structural works for a 2-storey terrace houses located at Bandar Saujana Perdana.

CADANGAN MEMBINA & MENYIAPKAN 120 UNIT RUMAH TERES 2 TINGKAT
 DI ATAS SEBAHAGIAN PT 9148 (LOT 6240) DAN PT 9147 (LOT 6243), DI FASA 4C,
 MUKIM IJOK, DAERAH KUALA SELANGOR, SELANGOR DARUL EHSAN.
 UNTUK TETUAN KELANA KUALITI SDN. BHD.

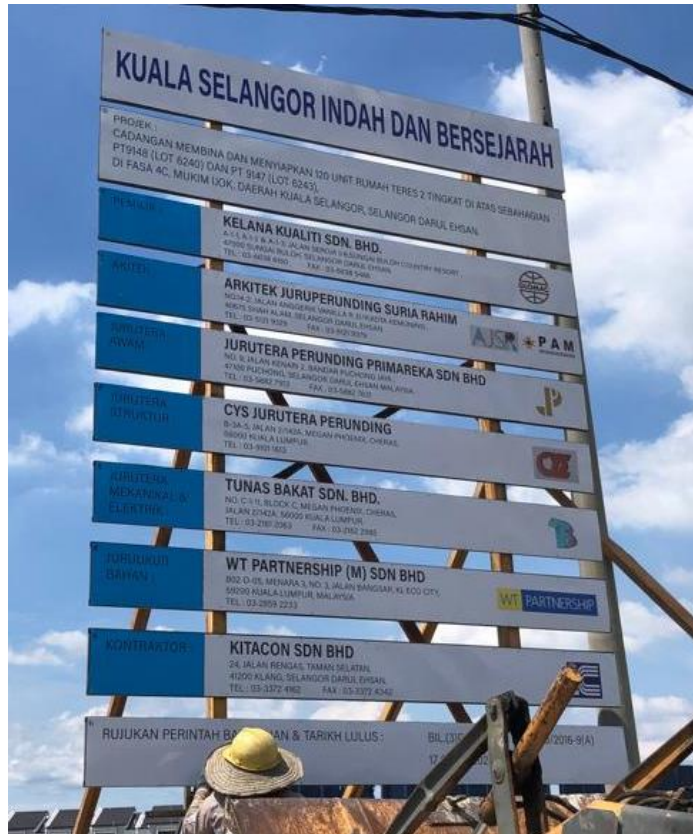
Figure 3: Image shows the signboard of the project where this study was conducted.

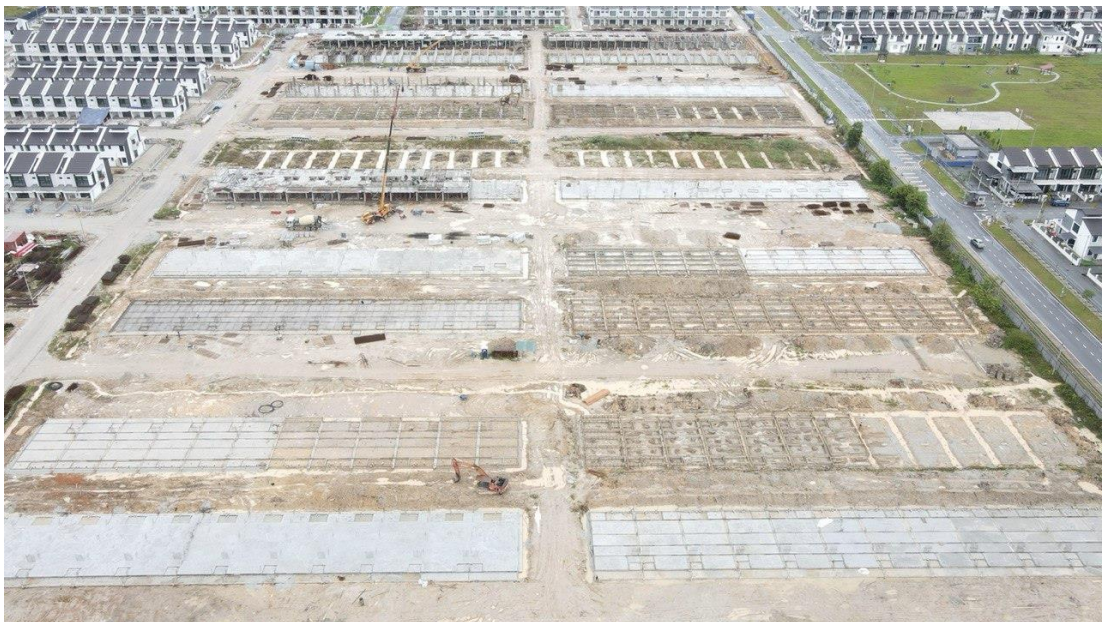
Figure 4: Image shows the site progress as of 3/1/2022

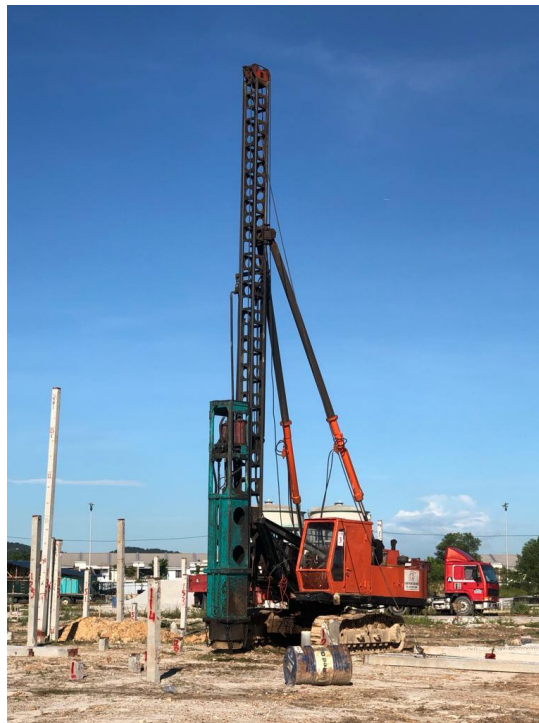
Figure 6: Image shows a piling frame used in this project.

For this project, hydraulic hammer system was used for pile driving with a design working load of 250KN for each pile and its maximum length of pile driven

taken at 30 meters. Other than that, a factor of safety of 2 times of the working load was obtained during test loading of piles.

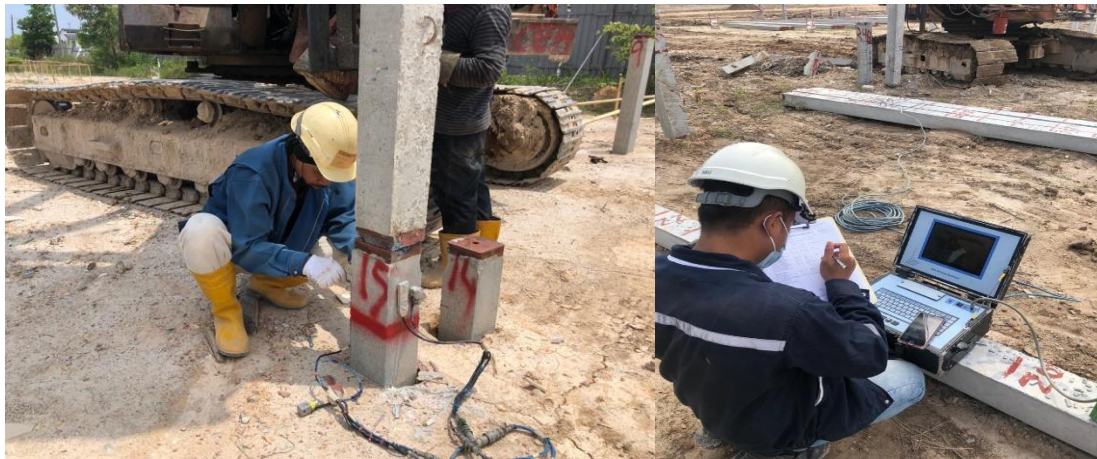
Figure 10: Image (Left) shows 2 sets of accelerometer gauges bolted on pile & image (Right) shows PDA equipment for PDA testing.

Figure 10 shows using wall plugs, two sets of strain and accelerometer gauges were bolted on opposing sides of the pile. These gauges are linked to a PDA (equipment shown in figure 10) for dynamic signal recording and field evaluation of data quality, soil resistance, and pile integrity.

By using the hydraulic hammer with a weight of 250KN and drop height of 0.3 meters, the hammer was dropped to cause a driving force onto the driven pile. Gauges mounted to the pile will collect dynamic force and velocity measurements. At the conclusion of the testing, the transducers and accelerometers will be dismantled. The data from the PDA will be transmitted and saved to a disc for later reporting and analysis. The PDA will process this information to provide an immediate visual and permanent record on location. Max. Resistance (RMX), Pile Integrity (BTA), Max Force (FMX), Max Stress (CXS), and Energy at Pile Top (EMX) are the most important markers for these results.

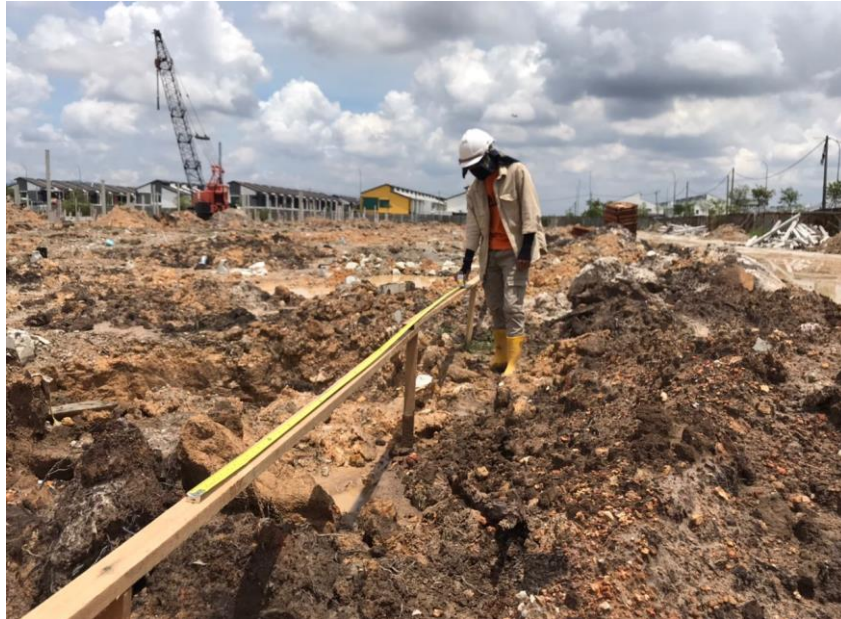
Figure 14: Image shows 'checking' of boundary rails that was marked with the intended pile positions.

Before piling cutting works begin, a boundary rail that was marked based on the dimensions of intended pile positions was installed. This was done to check for deviation of piles that might need an enlargement of pile cap.

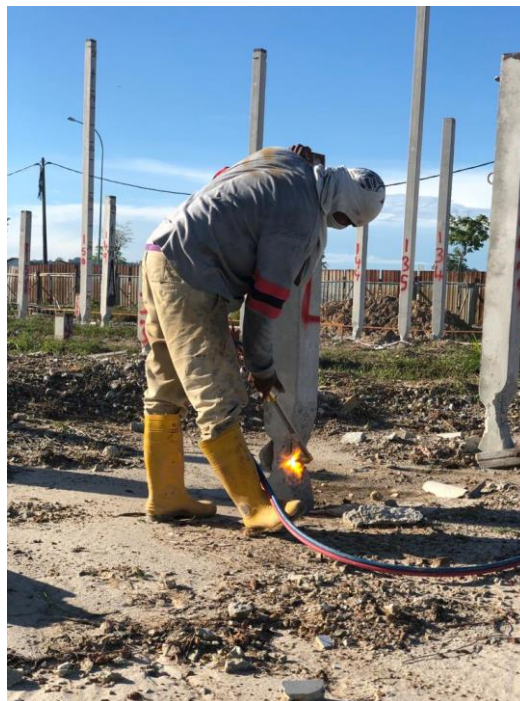
Figure 15: Image shows piling cutting works

Figure 15 shows piling cutting works using oxidation of steel bar inside the pile for easier removal.

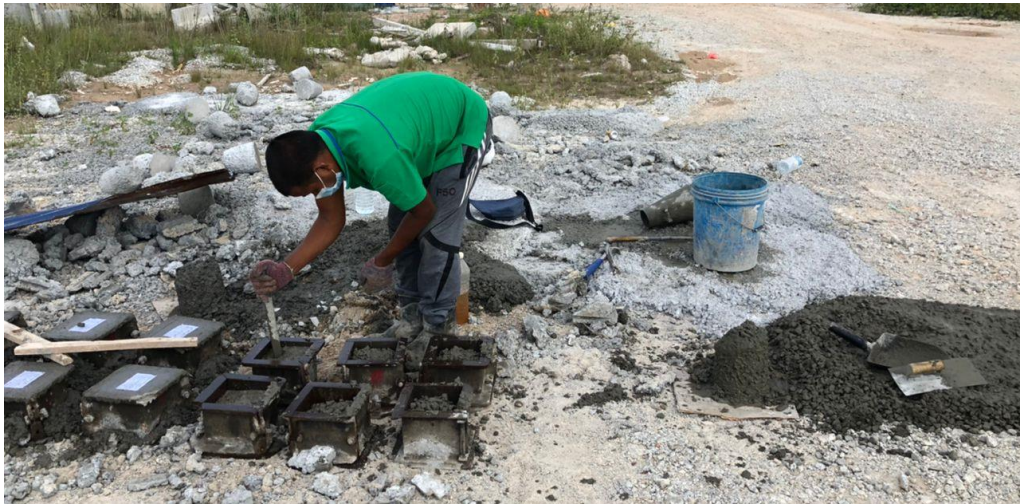
Figure 16: Image shows concrete cube filling and slump test on site

Grade 25N reinforced concrete mix with 315 kg/m^3 cement content was chosen and used in this project. Grade 25N indicates a compressive strength of 25 N/mm^2 after 28 days of cube test. Grade 25 is a standard grade concrete that also indicates a mix proportion of 1:1:2 (Cement: Sand: Coarse Aggregate). Before concreting on site begins, a slump test and a cube test was done (Figure 16). The cube of concrete will then be submitted to a laboratory for cube strength test after 28 days. Reinforced concrete mix grade 25 is a standard grade for the construction of slabs, beams, columns and footings.

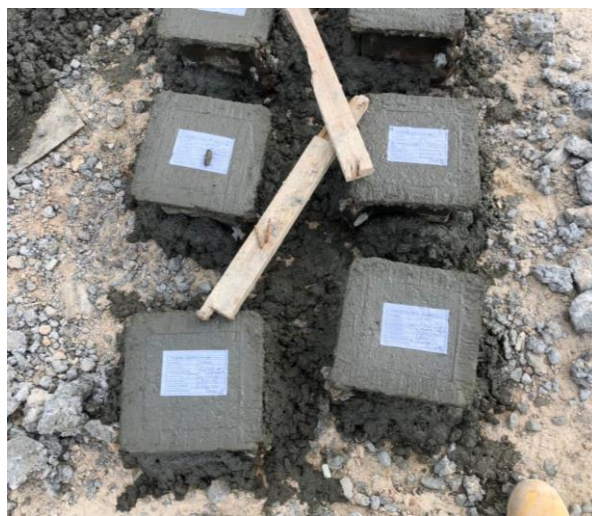
Figure 17: Image shows concrete cube to be submitted to the laboratory for strength test.

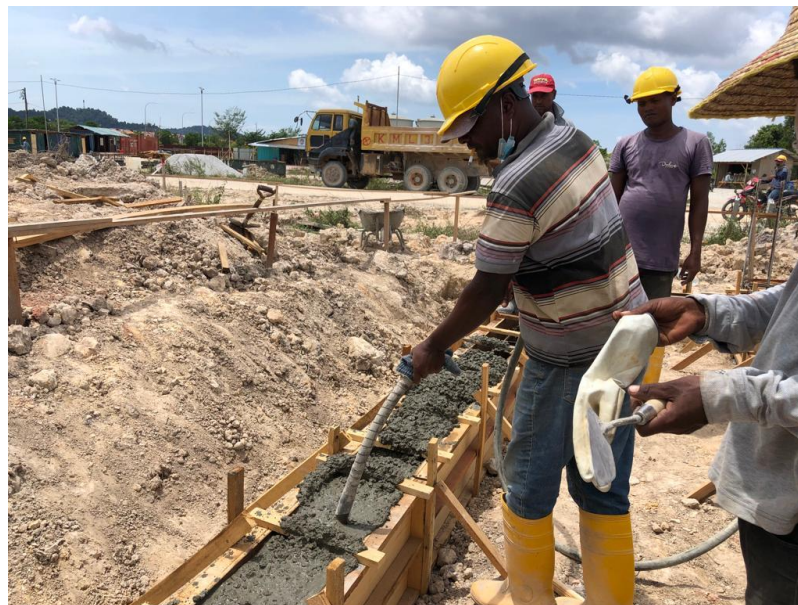
Figure 22: Image shows the vibration of concrete during casting using an immersion vibrator.

Immersion vibrator has been used for this project. Immersion vibrators, often known as "poker" or "needle" vibrators because of their tubular design, with an eccentric weight that causes vibrations to ripple from the casing and across the concrete in which they are immersed. The radius of the vibration is determined by the diameter of the casing, the instrument being used, and the frequency and amplitude settings. Immersion vibrations are currently available in a variety of action radiuses and are powered by fuel, electricity, or compressed air motors. When it comes to the actual process of concrete vibration, it is recommended that the immersion vibrator be inserted for 15 to 20 seconds until air bubbles stop surfacing.

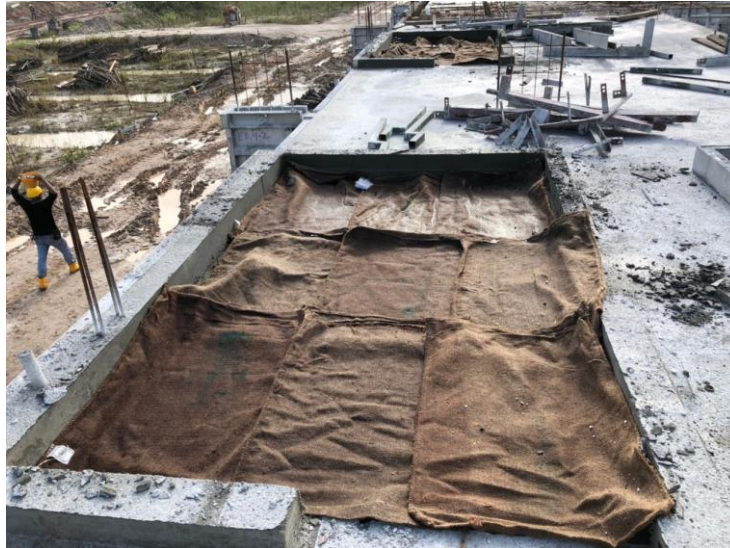
Concrete curing was done by laying wet gunny sack on concrete slab in this project as shown in figure 23. Concrete curing is necessary as it helps prevent problems that could occur afterwards. Firstly, concrete curing helps enhance hydration of concrete to reap better strength. Secondly, it improves the sturdiness of concrete by way of decreasing cracks. Thirdly, it could also provide better serviceability overall performance by way of increasing abrasion resistance.

Figure 23: Image shows the curing of Bathroom.

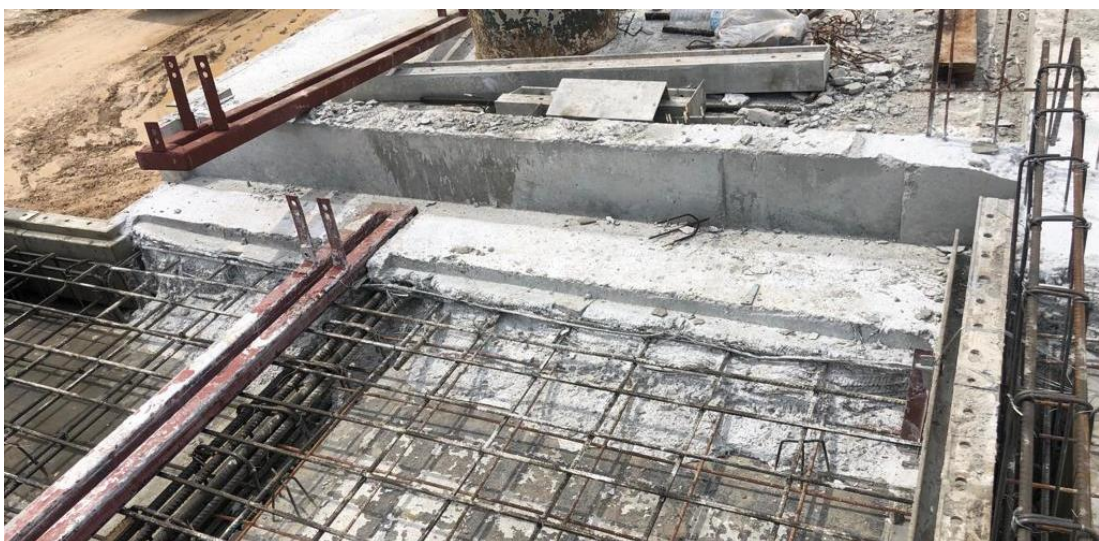
There is no way to build a structure without using construction joints. Because we cannot finish the job all at once, construction joints in concrete are unavoidable. Vertical and horizontal construction joints are provided at various phases of construction depending on the type of structural elements. In this project, construction joint for beam and slab was provided at one third of its whole length. Construction joint was not provided near or on the toilet area of the structure to prevent from leaking. For all construction joints provided in this project, it was shaped as ‘step by step’ for better jointing of concrete. Figure 24 shows an example of construction joint on 1st floor slab provided in this project.

Figure 24: Image shows a construction joint for 1st floor slab.

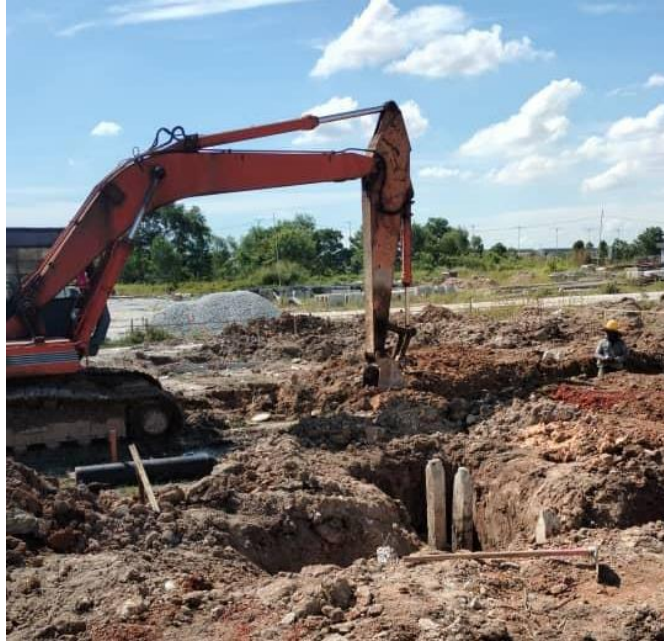
Firstly, excavation works was done after piling cutting works has completed above topsoil. The earth was excavated for 1200mm deep for pile cap with stumps while pile caps without stumps was excavated for 700mm deep as shown in figure 28.

Figure 27: Image shows excavation works for pile cap.

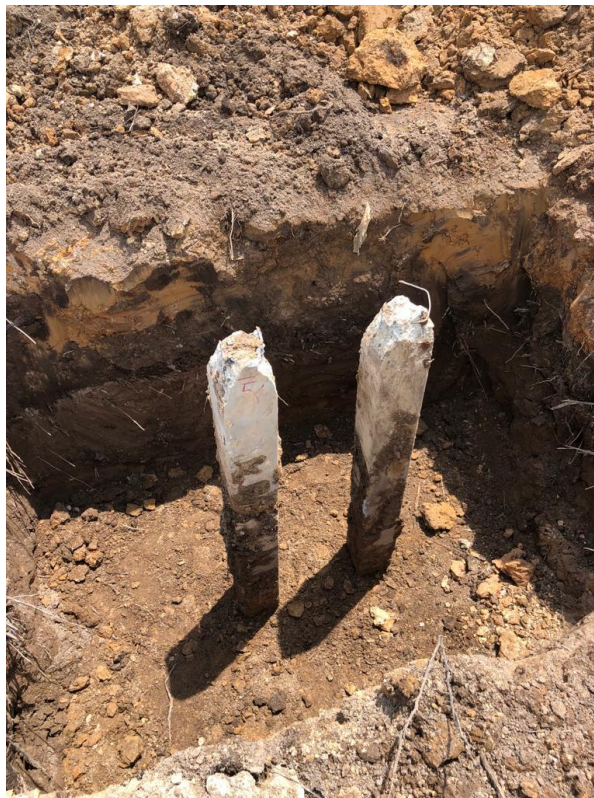
Figure 28: Image shows excavated pile cap point.

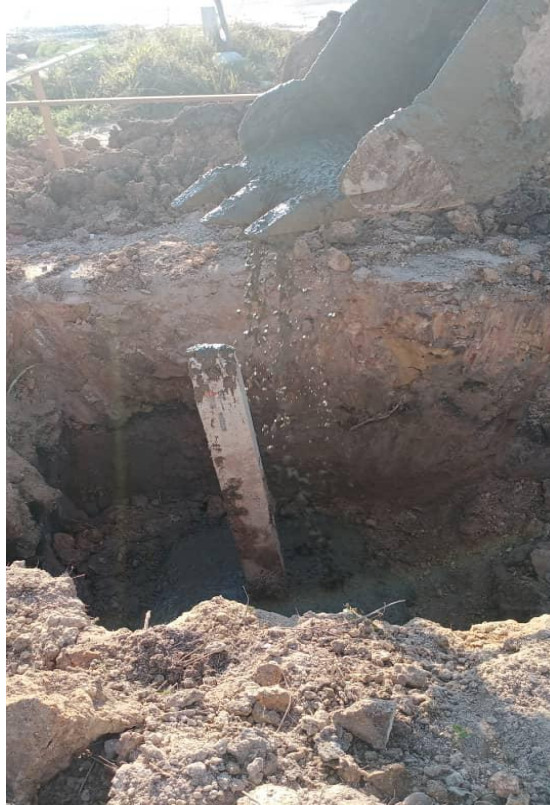
Figure 29: Image shows lean concreting of pile cap.

Figure 29 shows lean concreting of pile cap before piling cutting works begins. Piling cutting works in the pile cap was done by leaving around 4 inches of the pile head to follow the requirements given by the consultant engineer based on structural drawing of pile cap. It also acts as a ‘platform’ for rebar to be installed. After piling cutting works for pile cap has completed, formwork installation of pile cap was done. During this stage, the level using theodolite and a staff of top concrete surface of pile cap was taken by the carpenter and marked using nails hammered on the inside of the pile cap formwork to act as a ‘marker’ for mason workers during concreting. The level of pile cap height for each pile cap design was done by following the structural design of pile cap shown in figure 26 which shows 650mm height for all pile caps. By pulling strings from nails marked as shown in Figure 14, the carpenters can also determine the centre gridline of the pile cap.

Secondly, lean concreting using concrete mix grade 15 of pile cap with thickness of 50mm was done. Lean concreting of pile cap acts as a bedding to avoid water from underground from direct contact with the finished structure.

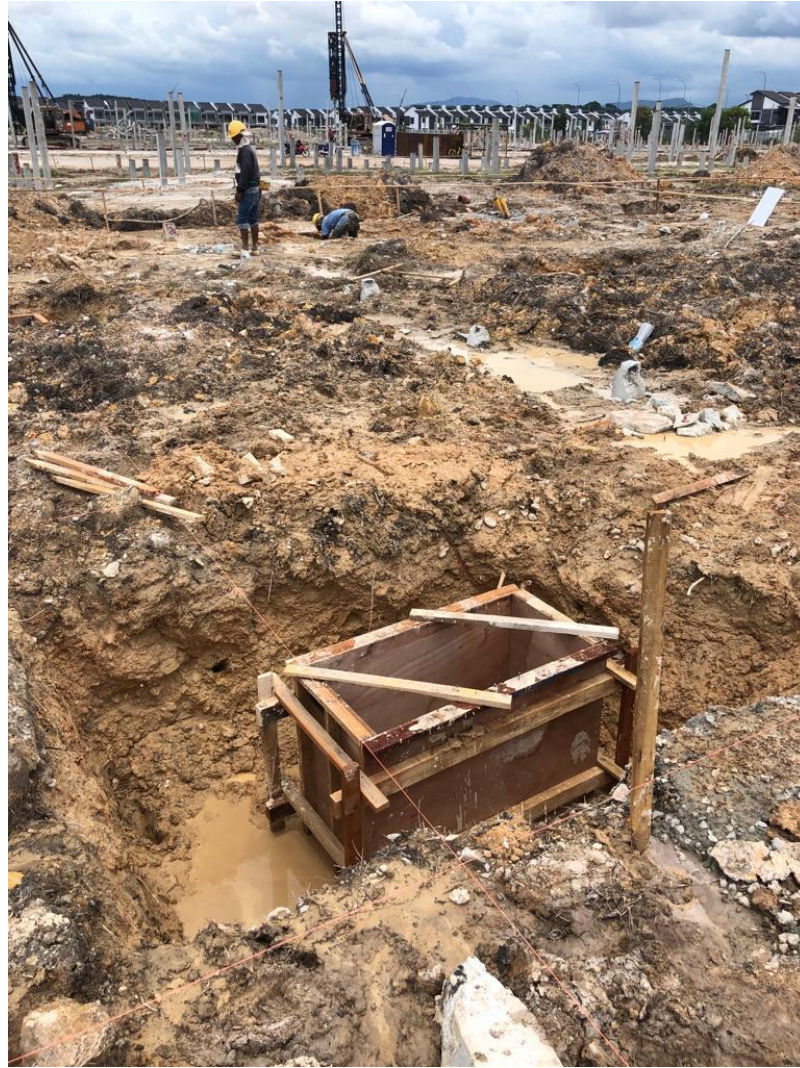
Figure 30: Image shows installation of pile cap formwork.

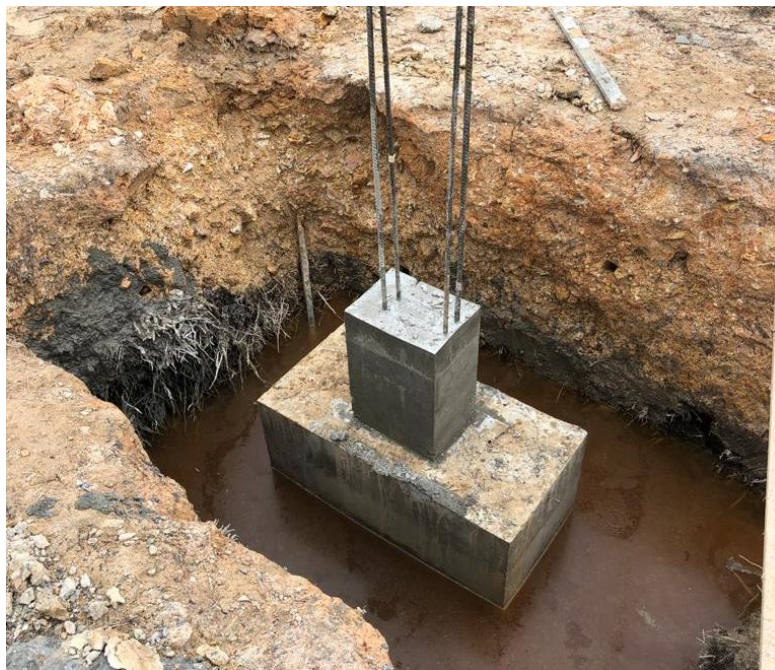
Figure 32: Image shows a completed pile cap.

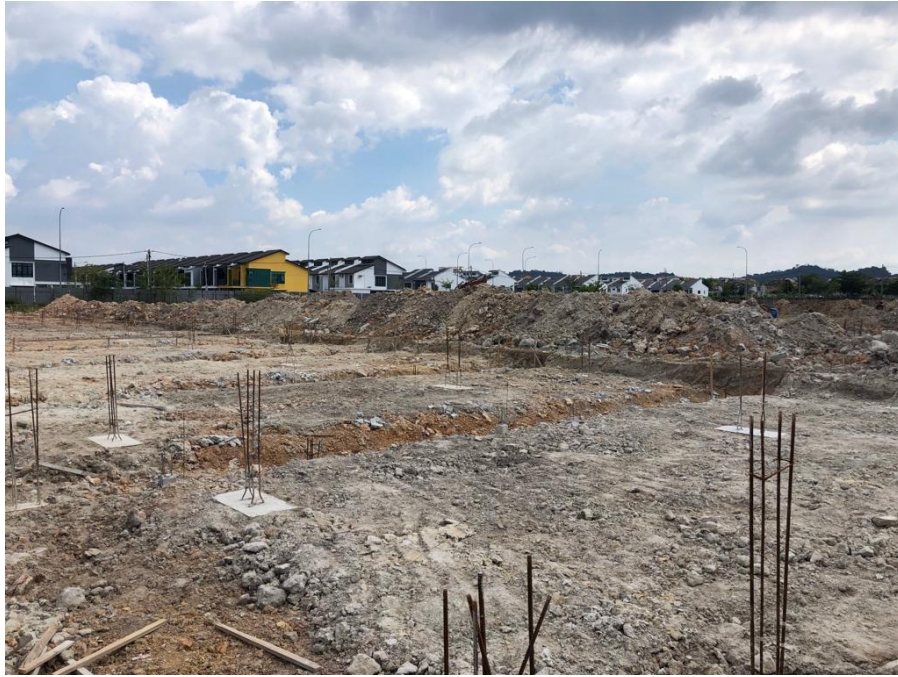
Figure 34: Image shows the excavation site for ground beam works.

Figure 34 shows the pile cap backfilled until the top pile cap surface with ground column starter bars pointing out from the pile cap.

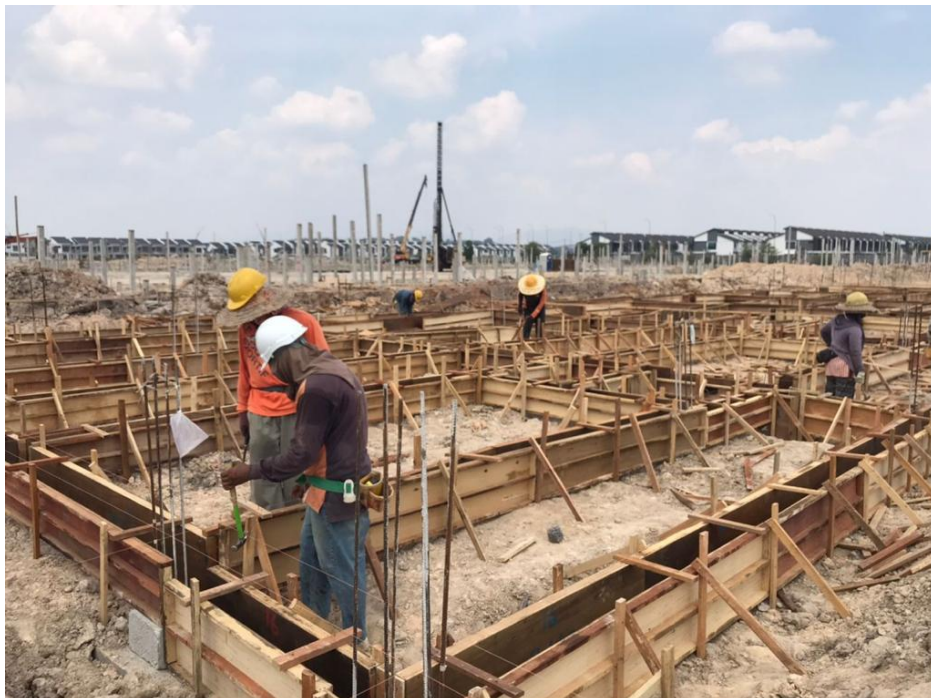
Figure 35: Image shows installation formwork ground beam.

Figure 35 shows the method of installation of ground beam formwork. Firstly, a string was pulled from the site rail marked using nails indicating the sizes of ground

beam. The fabricated ground beam formwork was then layed onto the earth while adjusting the length of the formwork manually by hand to match the string indicator line. The same method was used for either horizontal or vertical beam. Figure 35 also shows the pile cap acting as a platform for ground beams which means that the load acting on the ground beam would be transmitted to the pile cap. Based on this study, the installation of ground beam formwork for 6 units would take 3 days to be completed.

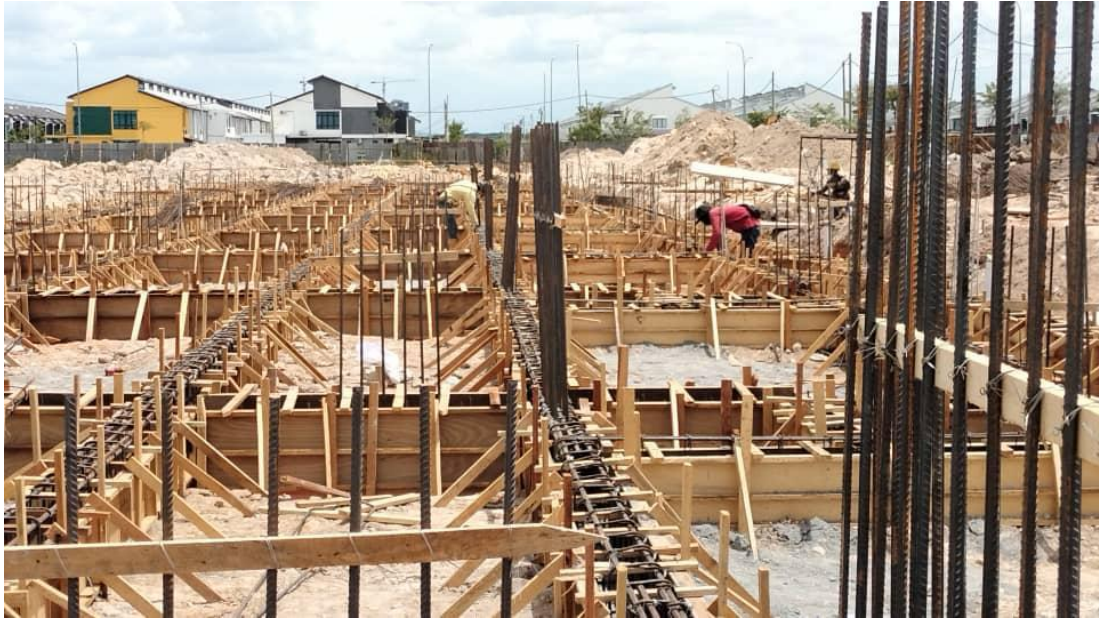
Figure 37: Image shows the completed installation of reinforcement bars for ground beam.

Before installation of reinforcement bar may begin, lean concreting of ground beam with thickness of 50mm was done by using Grade 15 concrete mix to act as a bedding for the reinforced concrete afterwards. Reinforcement bars installed were done by following the requirements of steel bars given by the consultant engineer from the structural drawing. Figure 36 shows the structural design for ground beam reinforcement bars for this project given by the consultant engineer. Based on this study, installation of reinforcement bars for 6 units of houses would take 3 days to be completed.

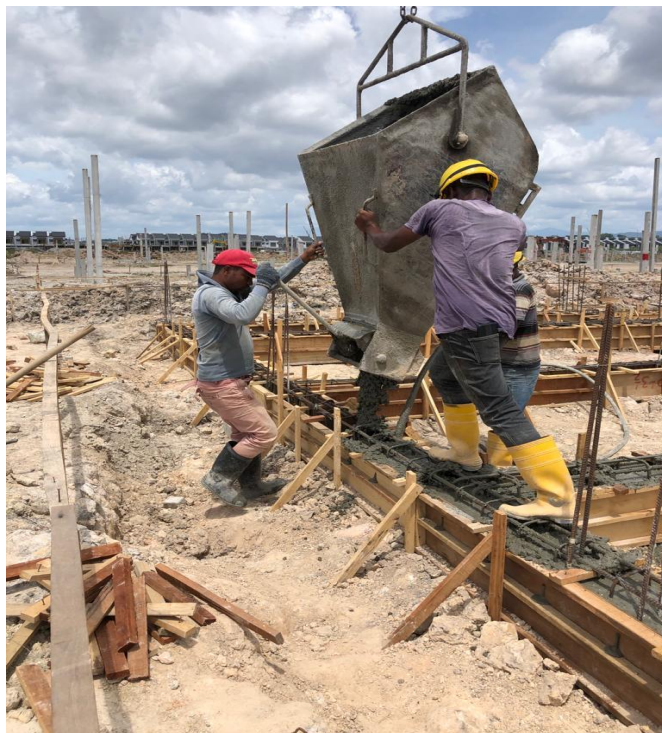
Concreting of ground beam would use the average amount of 80m^3 of concrete mix grade 25. The concreting of ground beam was vibrated thoroughly during the process (shown on figure 22 and 38).

Figure 38: Image shows the concreting process of ground beam.

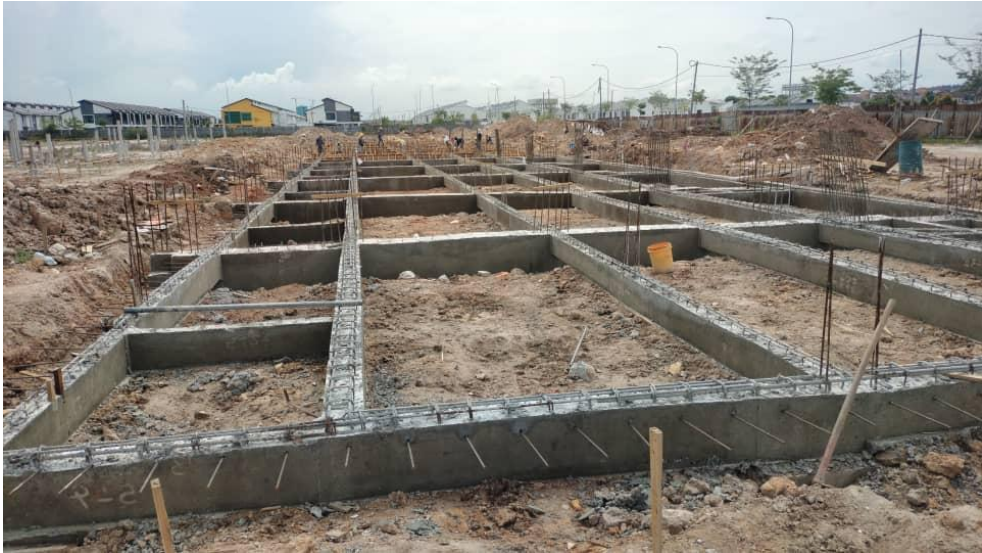
Figure 39: Image shows the completed ground beam of 6 units.

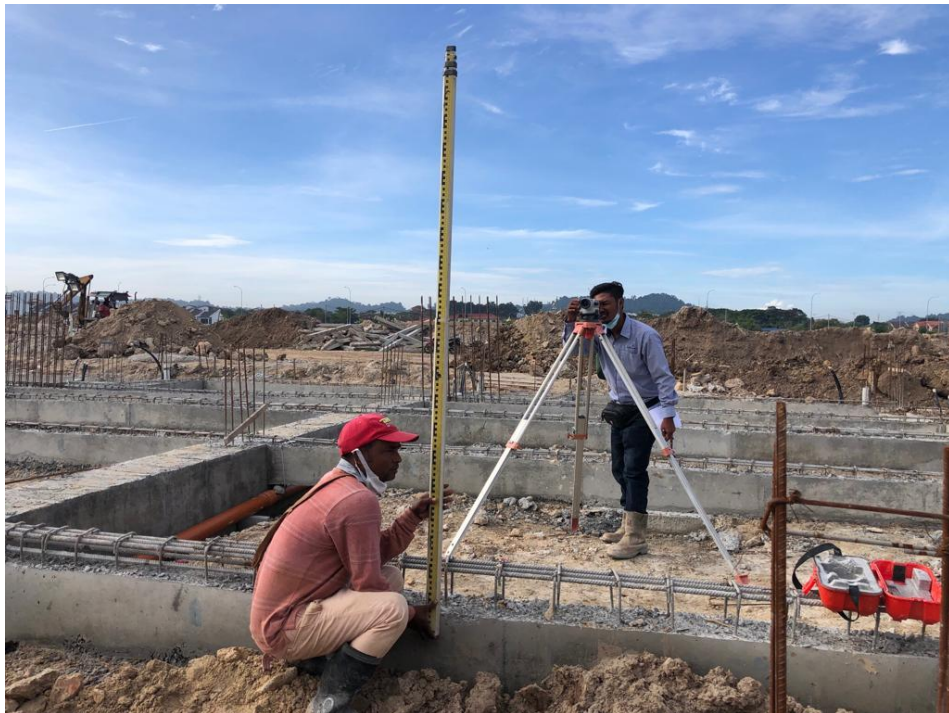
Firstly, the level of reinforced concrete slab (top & bottom) was taken using theodolite and a staff (shown in figure 40) to determine the level for backfilling earth into ground beams and lean concreting of ground floor slab for installation of BRC. The level of bottom surface of reinforced concrete ground slab was marked by using a red marker on the side of ground beams.

Figure 40: Image shows the process of levelling for ground floor slab.

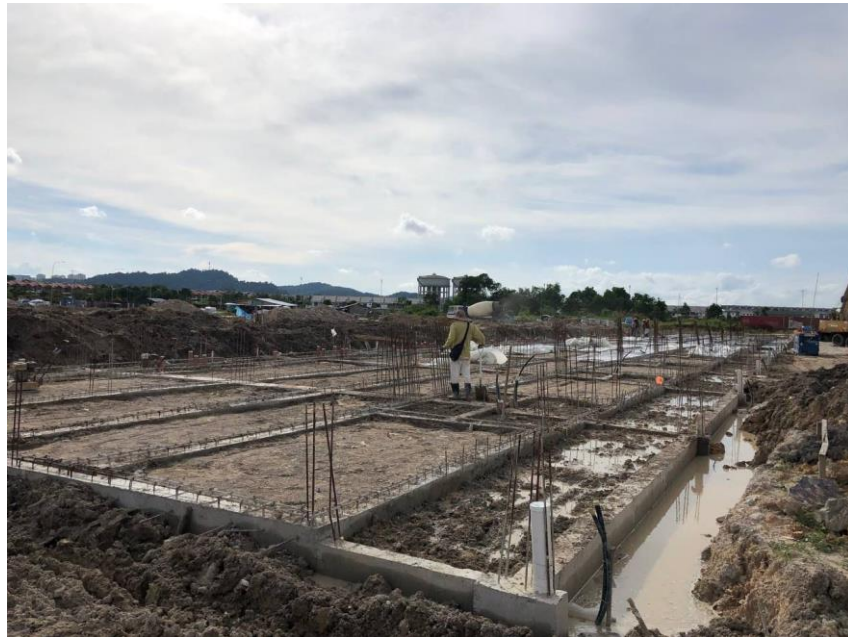
Figure 41 shows the completion of compacting backfilled earth done for preparation of lean concreting of ground floor slab.

Figure 41: Image shows compacted 'backfilled' earth for ground slab.

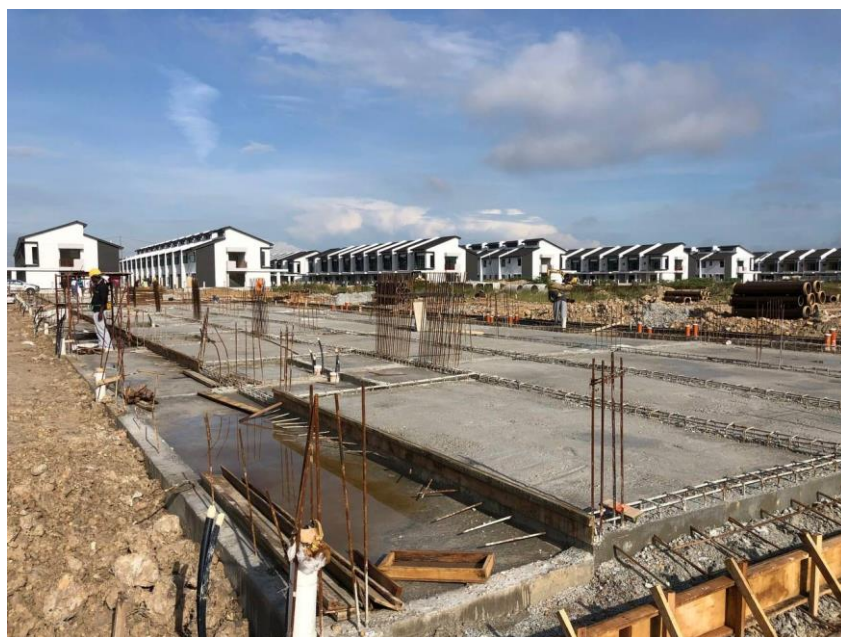
After 'Polyethene sheet' (Damp Proof Membrane) has been laid throughout all the compacted earth of ground slab, lean concreting of ground slab was done with thickness of 50mm using concrete mix grade 15. Lean concreting of ground slab provides smooth surface for installation of BRC as shown in figure 42.

Figure 42: Image shows completed lean concreting of ground slab.

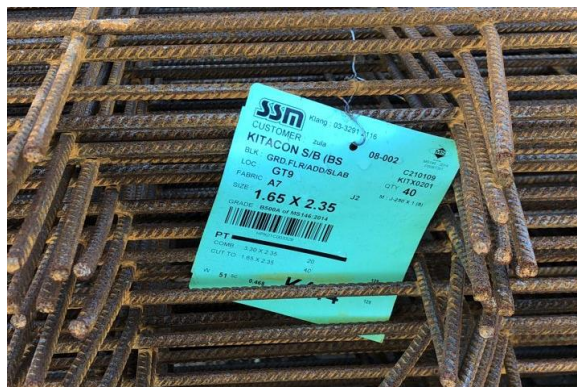
Figure 44 shows the sizes (meters) in a form of table for each item of BRC A7 ‘cut to size’ to be used for installation of reinforcements for ground floor slab in this project. The delivery of BRC A7 ‘cut to size’ was delivered by schedule planned by the Project Manager of this project. The sizes of BRC ‘cut to size’ was also shown by a tag during the delivery of this item to help barbender identify each item as shown in figure 45.

Figure 45: Image shows 'tag' attached to BRC delivered on site.

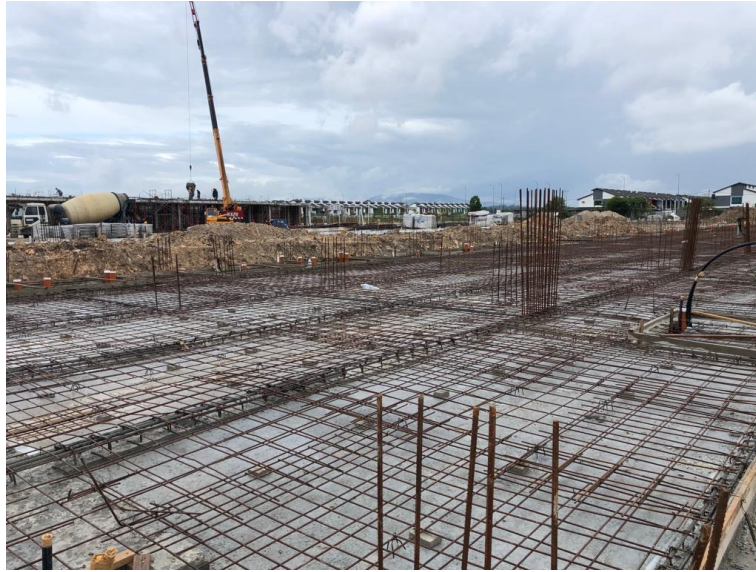
Figure 46: Image shows completed BRC installation for ground floor slab.

Figure 46 shows that the installation of BRC A7 for ground floor slab was installed completely with its concrete cover and steel bar chair (70mm) to distinguish the top layer and bottom layer of BRC A7 installed. Based on figure 33, it was shown that there are 2T16 (2 bars of 16mm diameter steel bar) layed on some areas of the house. Those 2T16's was installed in between the top layer and bottom layer of BRC A7 installed for ground floor slab. The purpose of the 2T16's was to act as a reinforcement bar holding the load of brickwalls that will be installed afterwards.

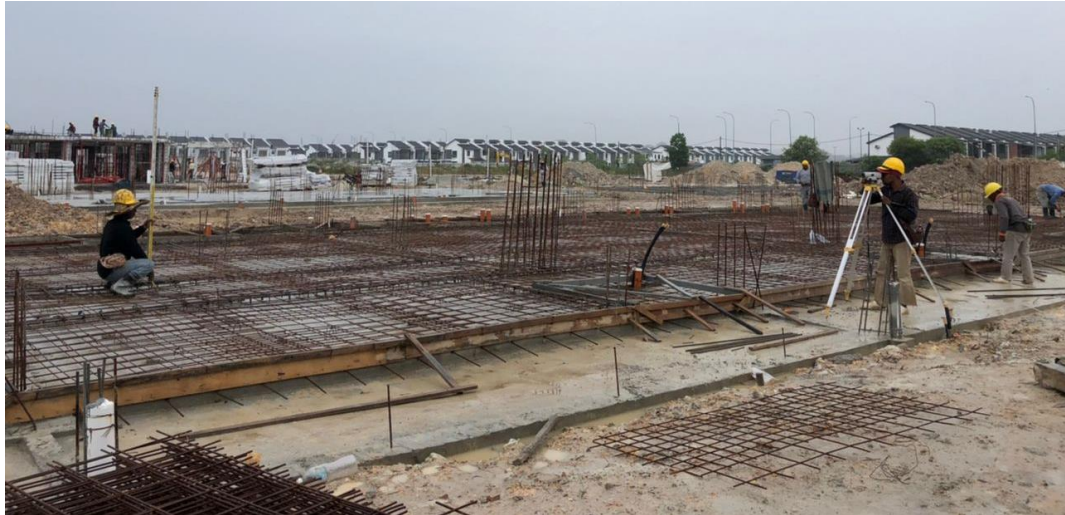
Before concreting of ground slab begins, a level of top of ground slab was taken by using theodolite and staff to help mason workers determine the top level of concrete as shown in figure 47. The level was marked by hammering a steel bar into the lean concrete and adjusting the steel bar to the level required shown in figure 48. Concreting of ground floor slab uses 120m³ of concrete mix grade 25 including the apron drains. Concretion of ground slab was vibrated thoroughly using an immersion vibrator shown in figure 22. Figure 49 shows the completed ground slab after formwork opening.

Figure 47: Image shows levelling taken for ground floor slab top surface.

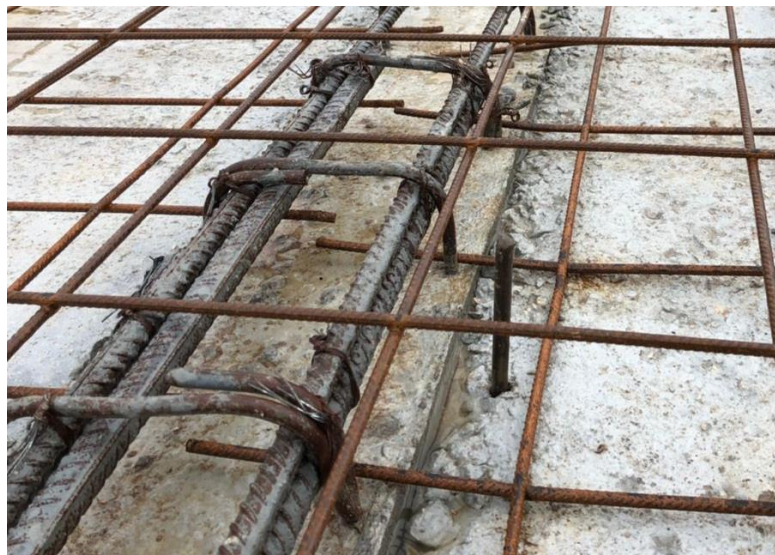
Figure 48: Image shows the steel bar indicator for mason workers.

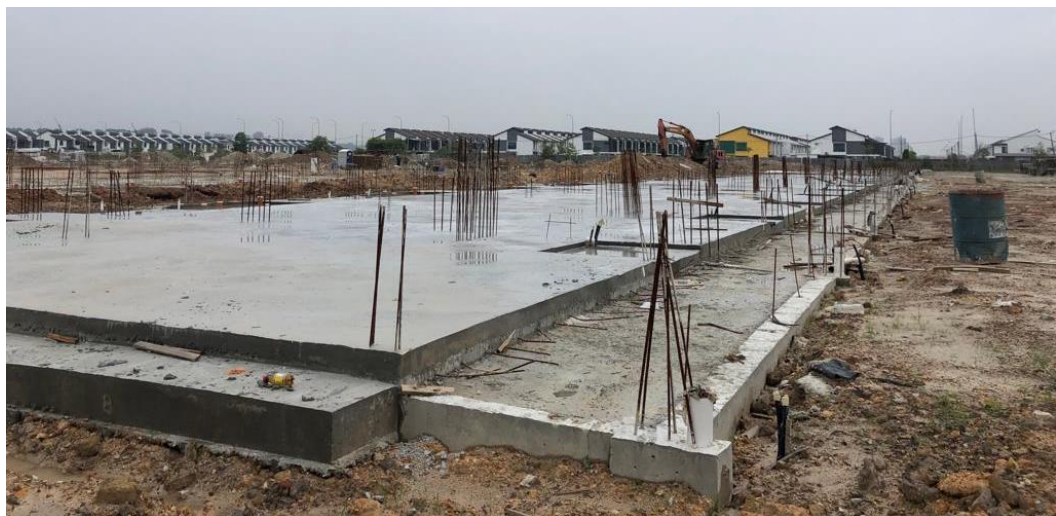
Figure 49: Image shows completed ground floor slab.

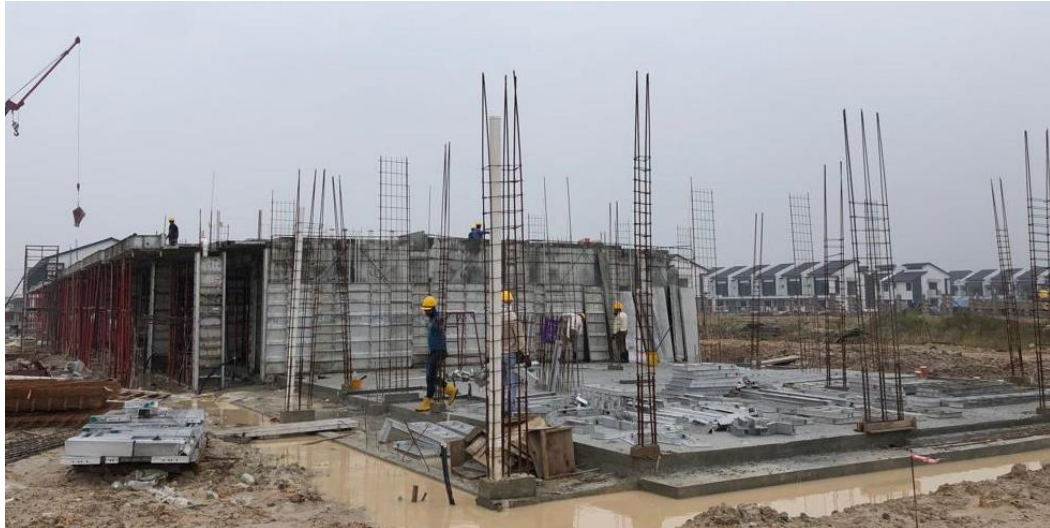
Figure 51: Image shows completed installation of reinforcement bars for ground column.

Figure 51 shows that the project observed in this study was using aluminium formwork for ground columns, shear walls, first floor beams and slabs. For that reason, the concreting of these elements was not done separately. Aluminium formworks used in this project was designed for one-time concreting after first floor slab reinforcement has been completely installed which was cost effective and not time-consuming.

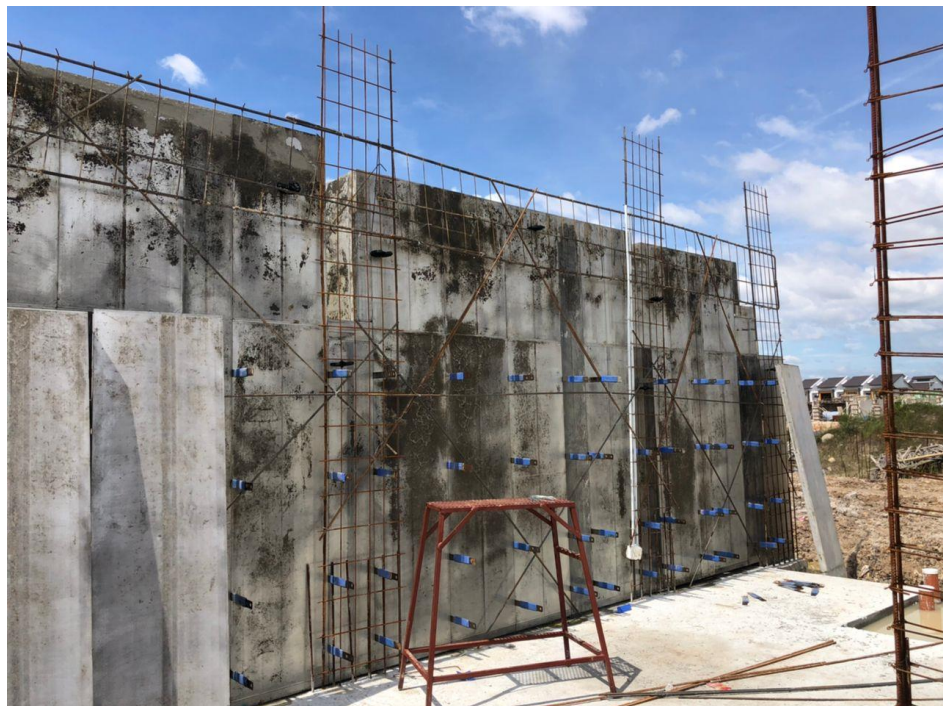
Figure 53: Image shows the complete installation of BRC and reinforcement bars for R.C wall.

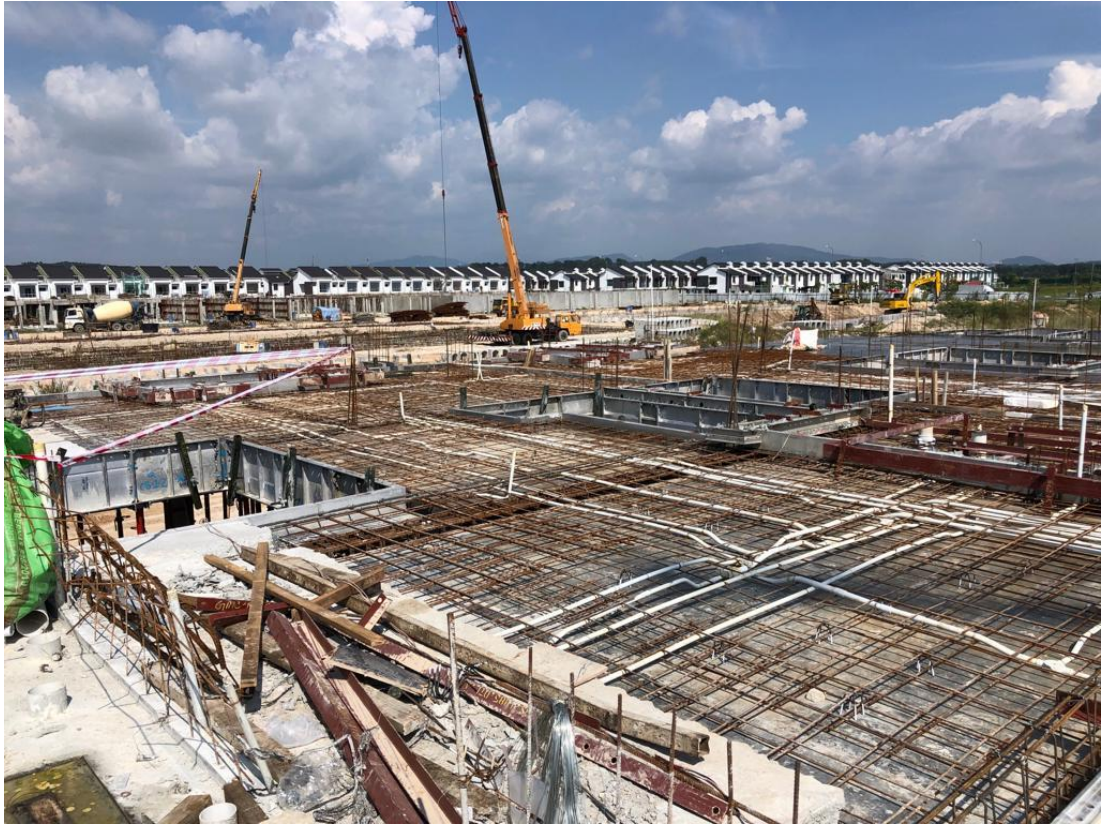
Figure 58: Image shows the completion of 1st floor beam and slab.

Figure above shows the use of steel bar chair (70 mm) as an equipment to distinguish top and bottom layer of BRC A7. Wiring conduit and piping was installed before the installation of BRC A7 for 1st floor slab. Similar to ground floor slab, 2T16's was shown in the drawing for first floor plan to indicate reinforcements for brickwall installation. The method of installation for 2T16's for 1st floor slab was similar to installation of 2T16's for ground floor slab.

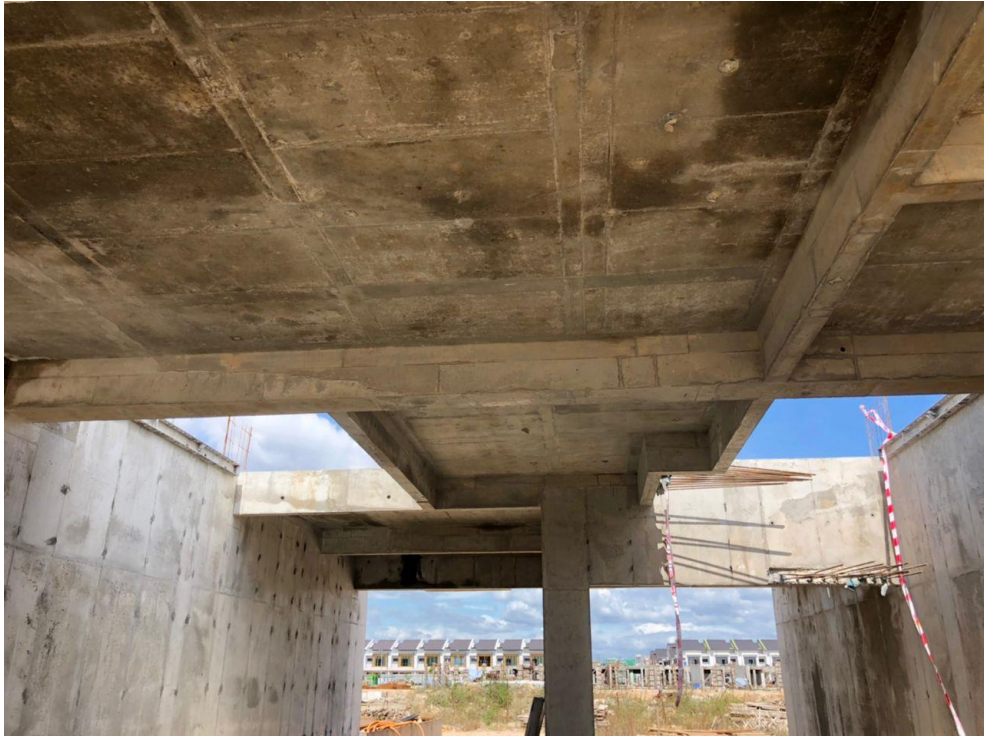
Figure 59: Image shows exposed soffit beams of 1st floor beam after opening of aluminium formwork.

Figure 59 shows the exposed ceiling showing the 1st floor beams and slab before skim coat works.

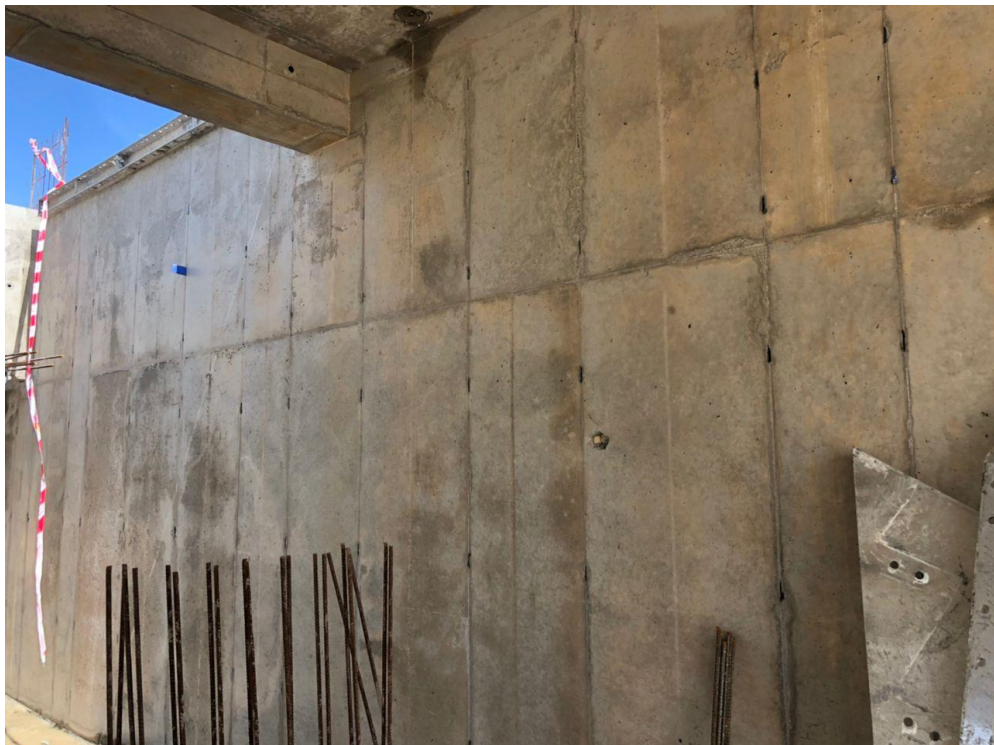
Figure 60: Image shows shear wall after opening of aluminium formwork.

Figure 59, 60 and 61 shows the completed casting of ground columns, shear walls and 1st floor beam and slab.
