BUILDING STRUCTURE

However, the aim of this study is to discuss and learn the typical structure design used and sequence of structural works for a 2-storey terrace houses located at Bandar Saujana Perdana.

CADANGAN MEMBINA & MENYIAPKAN 120 UNIT RUMAH TERES 2 TINGKAT
 DI ATAS SEBAHAGIAN PT 9148 (LOT 6240) DAN PT 9147 (LOT 6243), DI FASA 4C,
 MUKIM IJOK, DAERAH KUALA SELANGOR, SELANGOR DARUL EHSAN.
 UNTUK TETUAN KELANA KUALITI SDN. BHD.

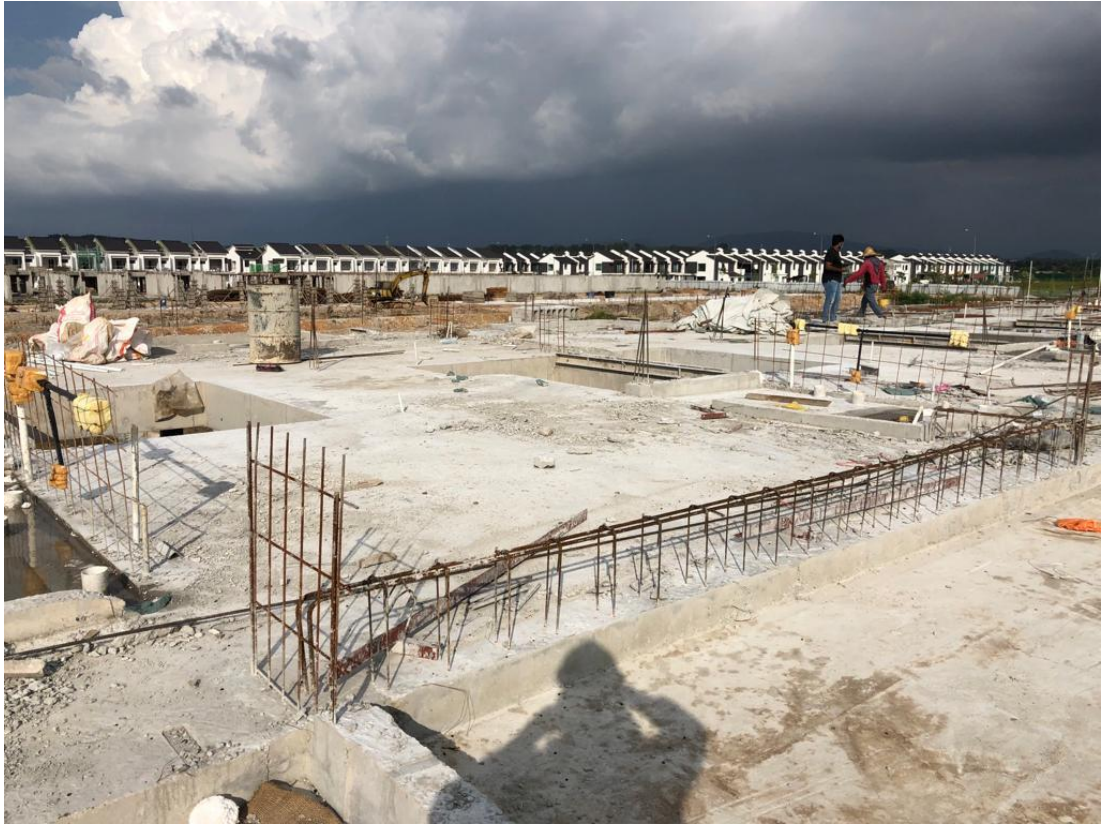
Figure 61: Image shows completed 1st floor slab.
