**REPLACEMENT OF FLOOR FINISHES FROM CARPET TO
TILES AT AKADEMI AUDIT NEGARA, BANDAR ENSTEK,
NILAI**

**DEPARTMENT OF BUILDING
FACULTY OF ARCHITECTURE, PLANNING AND SURVEYING
UNIVERSITI TEKNOLOGI MARA
(PERAK)**

FEBRUARY 2022

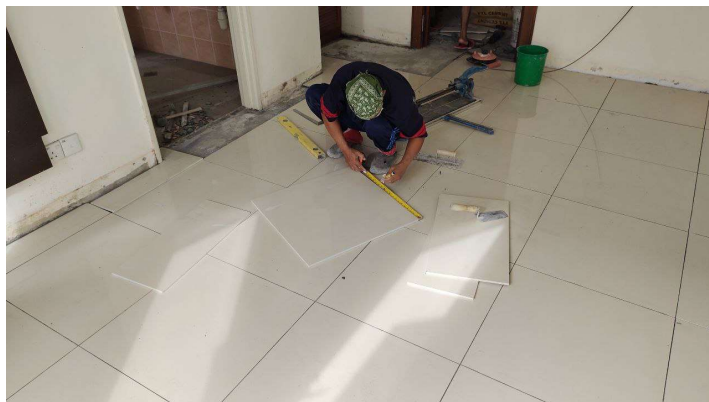
Photo 1.3: Photo shows tiles installation

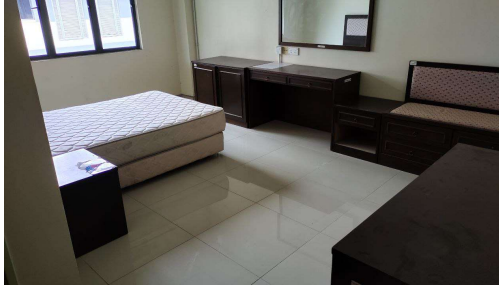
Photo 3.1: Photo shows a completed installation of ceramic tiles.

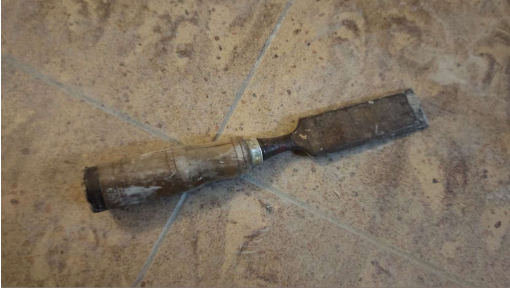
<p>Photo 3.2: Photo of Sculptor</p>	<p>A sculptor is use for skirting removing work. All the skirting needs to be removed before removing the carpet.</p>
<p>2. Drill</p>

The removal work is conducted to remove the skirting and the carpet beforehand. The skirting will be removed firstly just by using a sculptor and hammer. After that, the removal work will be continued to the carpet. The carpet is removed just by pulling it up. It is easier to be pull after the skirting removing work is completed. Even after the carpets are removed, there are still left some old glue of the carpet stick on the floor. For that, it will be remove using scrapper. For this removal work, there are at least two workers per room.

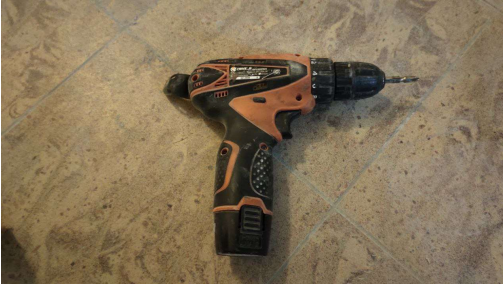
<p>Photo 3.3: Photo of Drill</p>	<p>A drill is use for removing door.</p>
<p>3. Grinder</p>

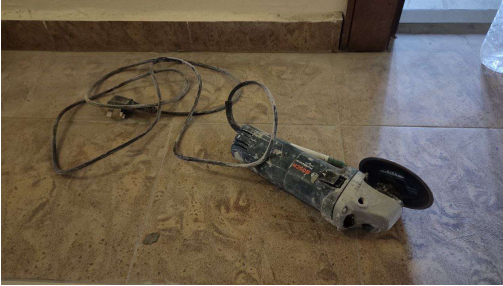
<p>Photo 3.4: Photo of Grinder</p>	<p>A grinder is used to cut a little piece of tiles to ease the installation. For example, to make sure it fit at the tiny space of the room's corner.</p>

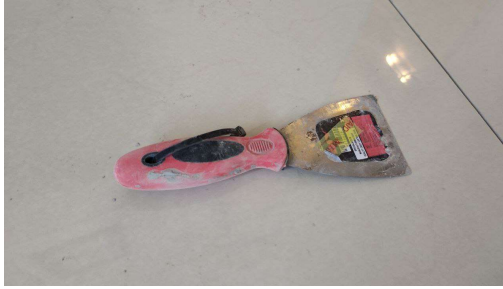
Photo 3.5: Photo of Scrapper

A scrapper mostly used at the clearance work which is to remove the stain on the floor after carpets removed.

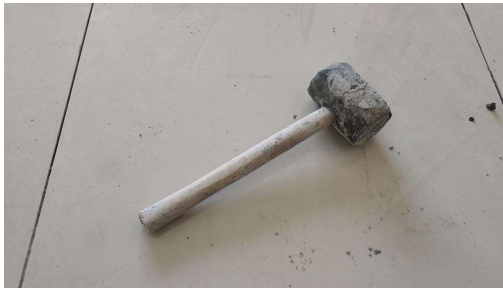
Photo 3.6: Rubber Mallet

Rubber mallet used on the tile's installation. It will be pair with spirit level to make sure the tiles are flat without any slope.

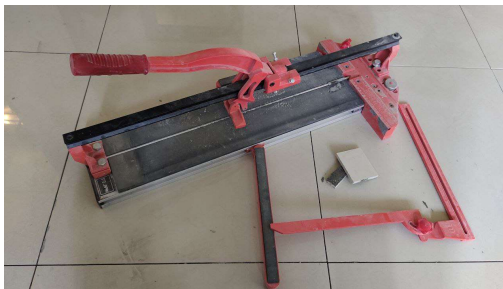
Photo 3.7: Photo of Ceramic Cutting Machine

Ceramic cutting machine is used to cut the tiles. Same function like grinder but its more effective and easier.

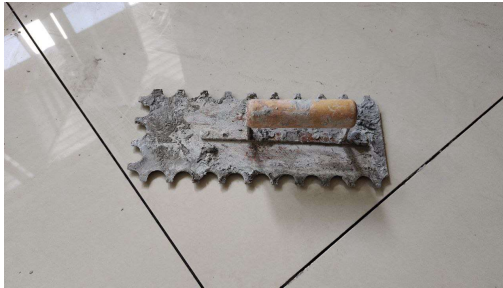
Photo 3.8: Photo of Trowel

Trowel is used for apply the cement mixture on floor before applying the tiles.

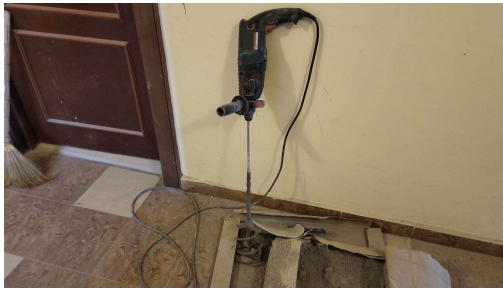
Photo 3.9: Photo of Electric Concrete Mixer

Electric concrete mixer uses to mix the concrete for tiles installation

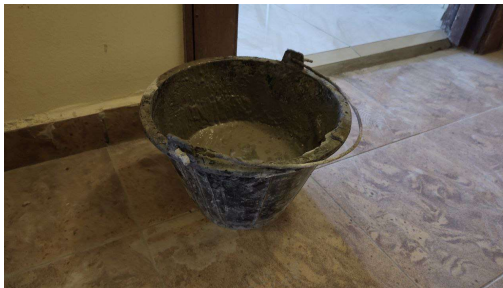
Photo 3.10: Photo of Plastic Concrete Bucket

Plastic concrete bucket used to carry the concrete mixture easily.

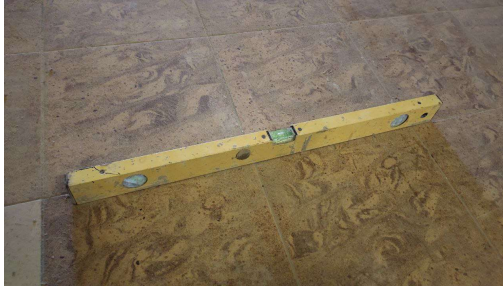
Photo 3.11: Photo of Spirit Level

Spirit level used to make sure the surface of tiles is flat without any slope.

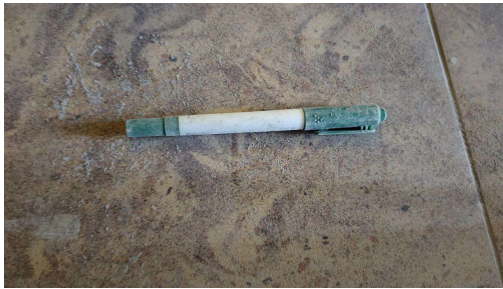
Photo 3.12: Photo of Marker Pen

Marker pen used to mark the line on tiles to ease the tiles cutting work.

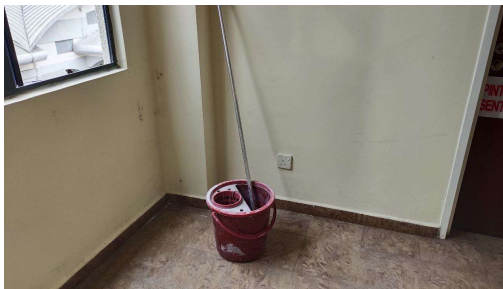
Photo 3.13: Photo of Floor Mops

Floor mops used for the work of cleaning all the dirt attached to the tile.

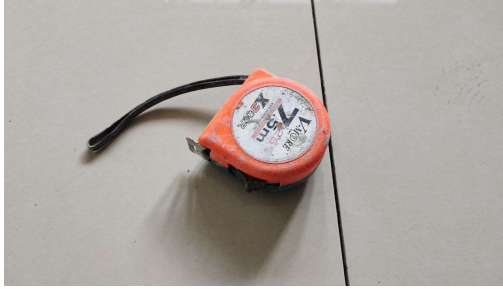
Photo 3.14: Photo of Measuring Tape

Measuring tape used to measure tiles that need to be cut, to make sure it fit to all over the floor especially at the corner of the room.

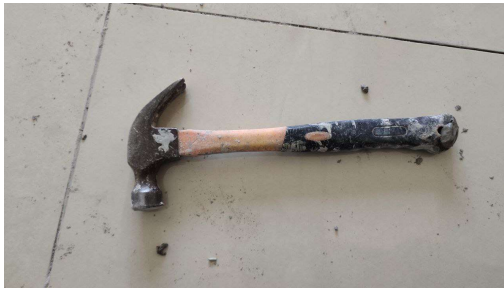
Photo 3.15: Photo of Hammer

Hammer will be use with sculptor for skirting removing work.

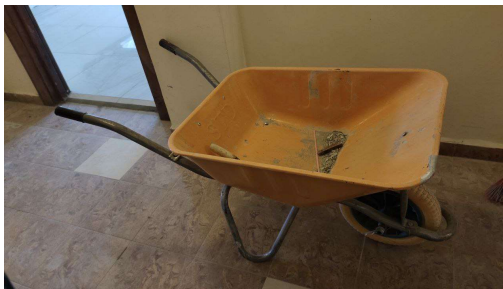
Photo 3.16: Photo of Wheelbarrow

Wheelbarrow used to reduce workload for lifting heavy objects.

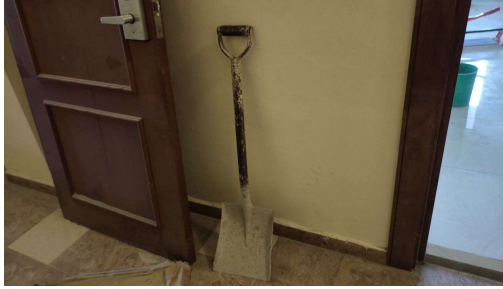
Photo 3.17: Photo of Shovel

Shovel used to scope cement into the bucket before mix the cement.

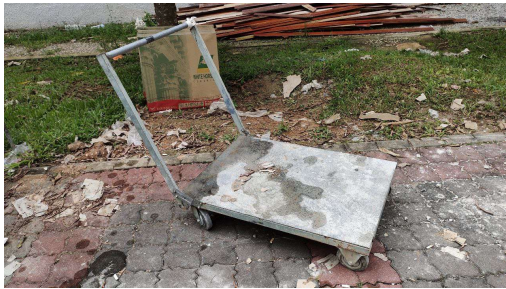
Photo 3.18: Photo of Trolley

Trolley used to reduce workload for lifting heavy materials.

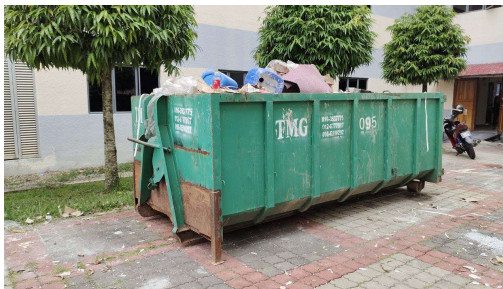
Photo 3.19: Photo of Disposal Bin

Disposal bin used to dispose all the waste to make sure the site is all clean and safe.

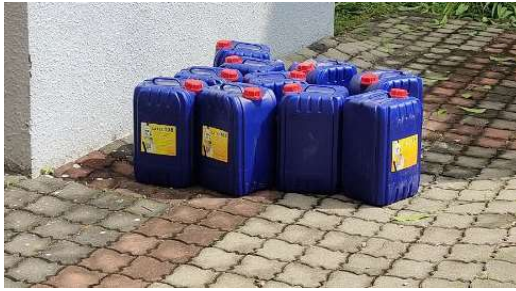
Photo 3.20: Photo of Latex-108

Latex-108 used as base coat for floor screeds as a flexible adhesive for tiles after mixing it with cement.

of base coat will be applied which using a mixture of cement and latex-108. Before that in order to prevent for any problem to occur during the tile installation work, the floor must be clean from any dust and debris which cause by the hacking work. For this floor preparation work, there are two workers needed per room.

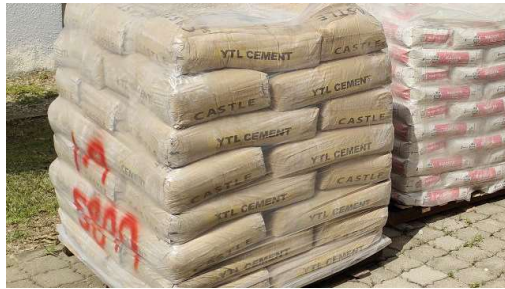
Photo 3.21: Photo of Cement

Cement used as main ingredients to create a base coat and bonding agent to make sure the tiles are stick to the floor.

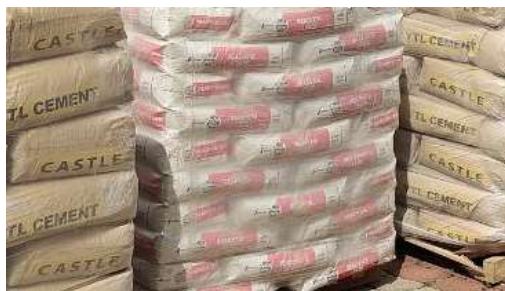
Photo 3.22: Photo of Cement Gum

Cement gum used for bonding ceramic tiles in continuous thin layer.

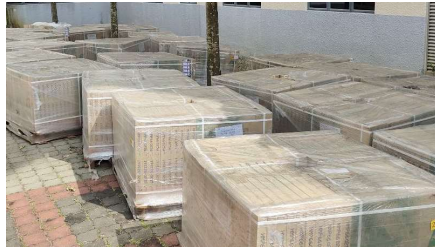
Photo 3.23: Photo of Tiles

White 2ft x 2ft ceramic tiles.

After the floor are prepared, then we will proceed with the tile installation. Tiles used for this project are ceramic tiles 2ft x 2ft with white colour. There are at least 50 pieces of tiles are using per room. Which means 5,000 pieces of tiles are been used for this project. There is only one skill worker needed for installation of tiles per room.

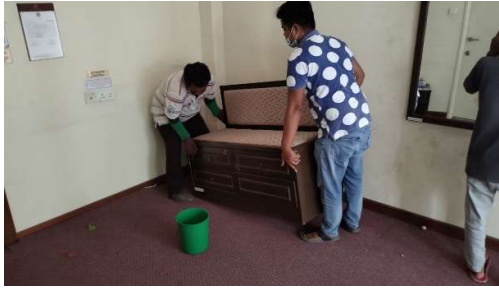
Photo 3.24: Photo of clearance work

Photo 3.3.1: Photo shows a removing work on one of the furniture in the room

Based on the observation, every room is completed with the furniture. Before any other work can be conducted, the furniture must be firstly moved to the other space to be placed such as the hall way of the hostel. Example of stuff that must be remove from the room is such as television, bed, chair, cabinet and some other stuff to easier the work. For this clearance work, there are at least two workers per room.

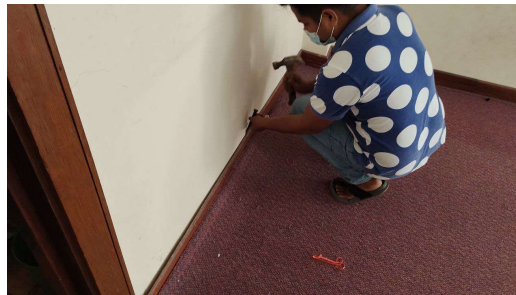
Photo 3.25: Photo of skirting removing work

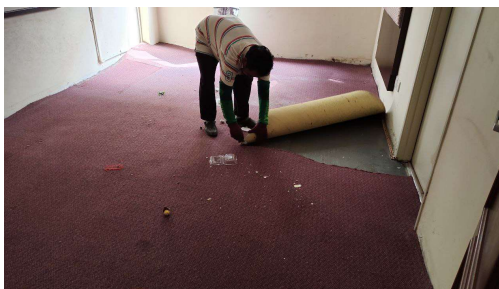
Photo 3.26: Photo of carpet removing work

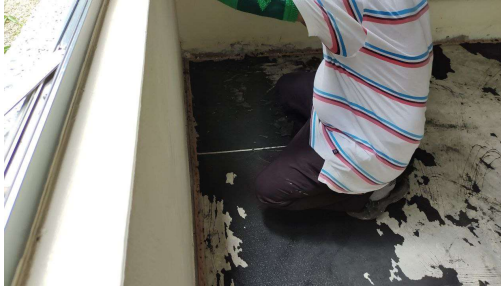
Photo 3.27: Photo of the removing works of old carpet's glue

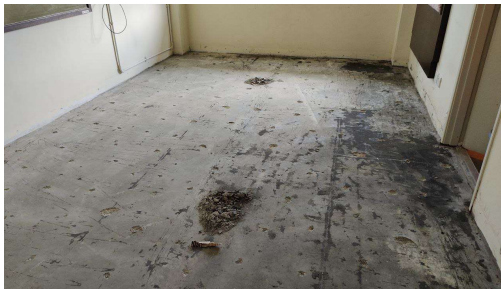
Photo 3.28: Photo of the floor that have been hack.

Floor preparations are to make sure the floor is ready for tiles installation. First, the floor will be hack using an appropriate tool. Then, a layer

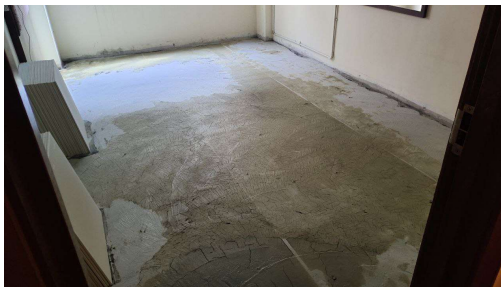
Photo 3.29: Photo of the base coat that have been applied to the floor.

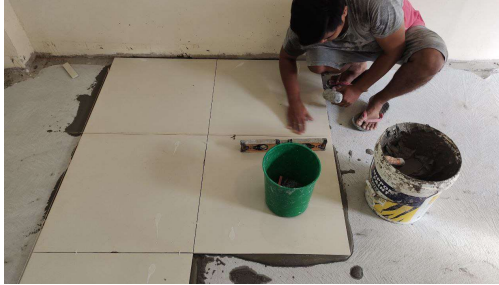
Photo 3.30: Photo of the installation of tiles

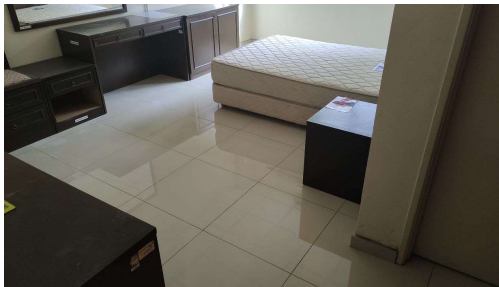
Photo 3.31: Photo of a completed installation of ceramic tiles.

Lastly after the tiles work are complete, we proceed to the last steps which is finishes. Before moved all the furniture back to the room, the surface of the tiles need to be clean up first. Using a broom and floor mops. This is to make sure there are no dust in the room. It is very important to make sure the surface of tiles is all clean and look shine and more attractive. After that, then

there are at least two workers will move all the furniture back to their place in the room. Even after moving in all the furniture, the floor tiles will be swept again to clean all the dust. For this finishes work, there are two workers needed per room.
