**THE WATERPROOFING PROCESS OF REINFORCED
CONCRETE FLAT ROOF ON TERRACE HOUSE AT TELUK
INTAN, PERAK**

PRACTICAL TRAINING REPORT

FEBRUARY 2022

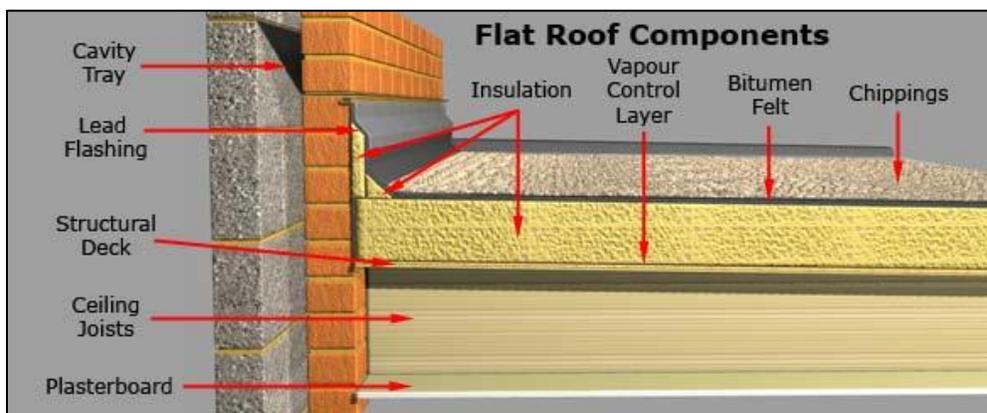
Figure 2:1 Flat roof components

A concrete slab flat roof is normally made up of a structural layer of concrete finished with a smooth screed onto which a water proof layer such as a membrane is laid. The roof should incorporate insulation and usually a vapor control layer to protect from interstitial condensation (Kvande & Lohne, 2018).

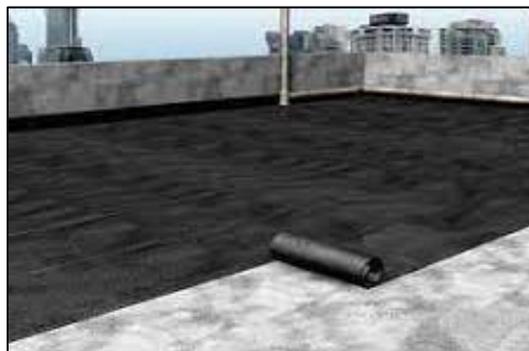
Photo 2:1 Illustration of waterproofing

Waterproofing is the process of making an object or structure waterproof or water-resistant so that it remains relatively unaffected by water or resisting the ingress of water under specified conditions.

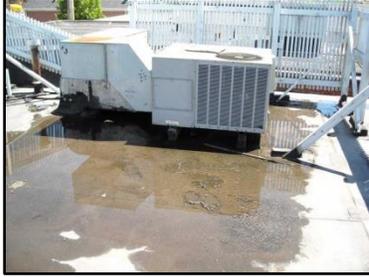
<p>Photo 2:7 Example of open roof penetration</p>

<p>Photo 2:6 Example of standing water</p>
<p>f) <u>Open roof penetrations.</u> Holes must be made in the roof membrane to accommodate vents, pipes, drains, and HVAC units. Over time, the gaps in these holes are no longer watertight. Water can seep into the membrane and the roofing system and cause leaks.</p>

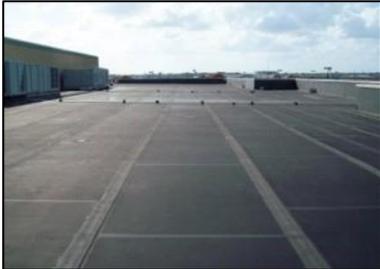
<p>Photo 2:8 Example of asphalt</p>
<p>ii. EPDM</p> <p>Ethylene propylene diene monomer rubber (EPDM) is a synthetic rubber most commonly used in single-ply roofing because it is simple to apply.</p>

<p>Photo 2:9 Example of EPDM</p>
<p>iii. CPE AND CSPE</p> <p>Chlorosulfonated polyethylene (CSPE) and chlorinated polyethylene (CPE) are non-vulcanized synthetic rubber roofing materials that were used for roofing materials.</p>

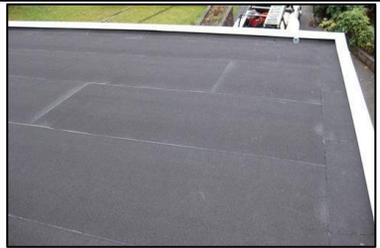
<p>Photo 2:10 Example of CPE & CSPE</p>
<p>iv. Modified bitumen</p> <p>Modified bitumen membranes are hybrid roof systems that combine the high technology formulation and prefabrication benefits of single-ply with the traditional roofing installation techniques used in built-up roofing.</p>

<p>Photo 2:11 Example of modified bitumen</p>

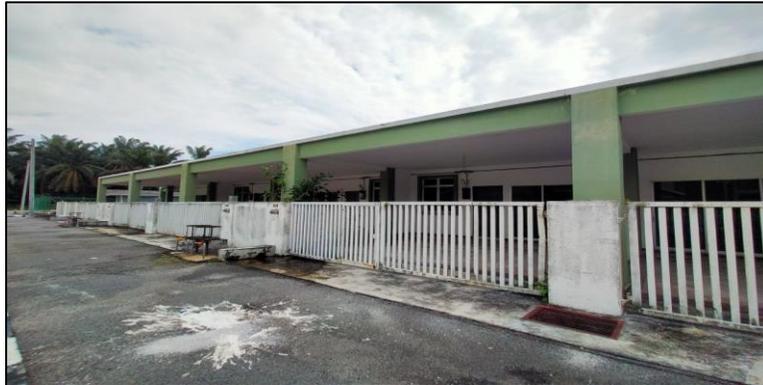
Photo 3:1 View of case study building

The project of terrace house named on project file as *“cadangan pindaan kepada pelan 22 unit rumah teres satu tingkat di atas plot 01 sehingga plot 22 (lot asal 8577) yang telah diluluskan (mpti (b) sp 03-2013) mukim durian sebatang daerah hilir perak”* . There are three houses that involved in the repairing work before deliver the house to their respective owner. These are the list of details about the involved house.

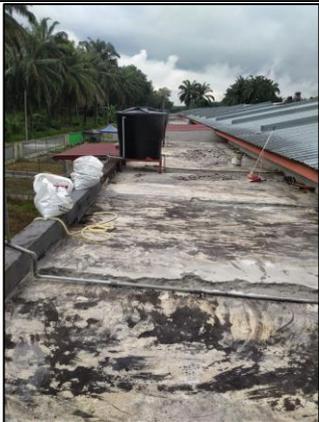
No	a) Defects found on the flat roof of three unit of terrace house	
1

<p data-bbox="495 1304 826 1329">Photo 3:6 Stain defect on flat roof</p>	<ul style="list-style-type: none"> • There are excessive ponding water on the flat roof visible during after rain • There are no visible curb and drain on the flat roof • There are also no slope on the surface of the flat roof • Fine crack in the concrete flat roof as a start • Fracture and failure • Stained slab
2

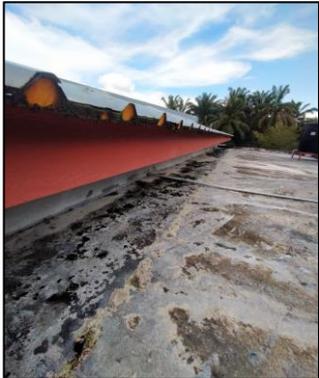
<p data-bbox="488 1850 833 1875">Photo 3:7 Mould defect on flat roof</p>	<ul style="list-style-type: none"> • Weeds growing under roof • Defects in the tail-ends • Defects in the fastening • Cracking defects • Improper roofing • Surface wear • Creasing and bulging

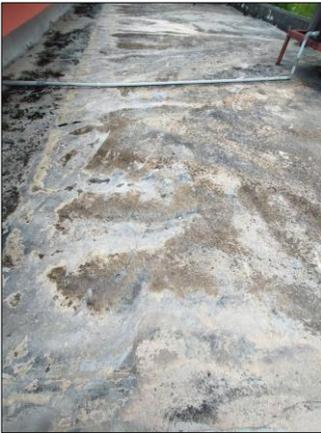
<p>Photo 3:10 Fine crack defects on flat roof</p>	<ul style="list-style-type: none"> • Membrane problems due to roof with no blister • Drainage problem and sufficient number of drain • Water retention on roof surface due to improper slope • Ponding water in several areas due to ineffective falls on flat • Disintegration defects found • Insufficient surrounding heights • Presence of water penetration due to the waterproofing covering is not intact • Ridging and cockles on roofing membrane

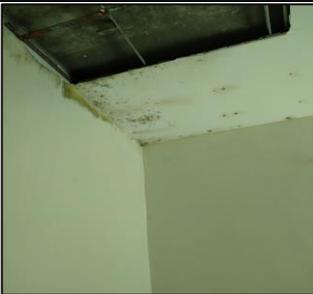
b) Defects found inside the three unit of terrace house		
1

<p>Photo 3:11 Moist defect on ceiling</p>	<ul style="list-style-type: none"> • Cracking • Moisture stain of condensation and leaks • The board is on the verge of falling since there is continuous presence of water element and dampness
2

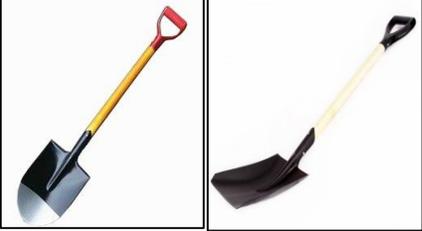
<p data-bbox="548 869 727 894">Photo 3:22 Shovel</p>	<p data-bbox="919 617 1438 743">Wooden Handle Shovel And Shovel Square Steel for digging, lifting, and moving bulk materials.</p>

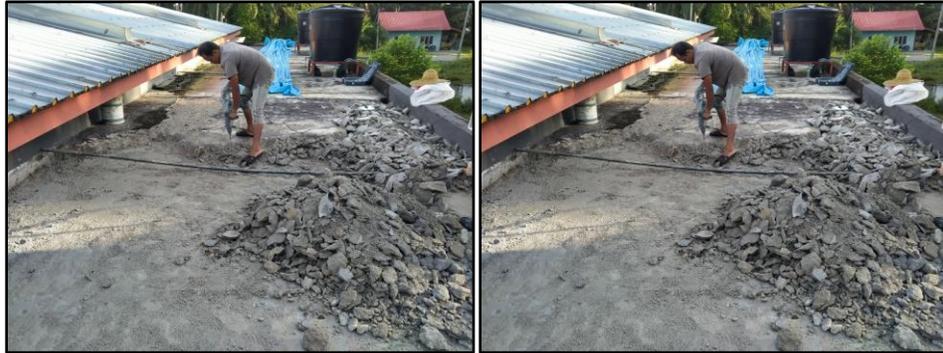
Photo 3:27 Process of hacking work

For the earlier work, the worker doing hacking job. The area of the hacking is all flat roof of the three unit of terrace house that have been affected of the leaking defects. The terrace house using terms house 3, house 4 and house 5. This is because the three units are attached and count in order to easier all involved worker to have a same code site. Hacking work is done on the flat roof of house no 3, 4 & 5. Hacking work is done as deep as 8 inches because the waterproofing must be done on the flat roof slab. The 8 inch depth was due to old flat roof repair work and did not succeed because the flat roof had leaked again. Hacking work was done for 8 days for 3 houses. Hacking works include cement plaster slope of house no 6 for the installation of beams in that section.

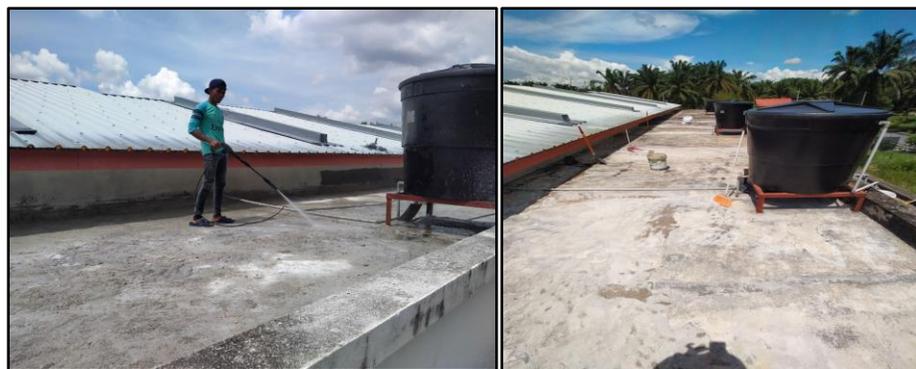
Photo 3:28 Process of claning flat roof

Next is the flat roof cleaning work before sweeping waterproofing work to slab roof. Washing works include sweeping sand residue due to hacking and leveling flat roof using water jet to remove old rendered cement left behind. This is to make sure that the surface of the flat roof is really clean from any debris before waterproofing works being done and applied to the flat roof slab. The weather for the rest of week are sunny day making the progress of work are quite fast than expected.

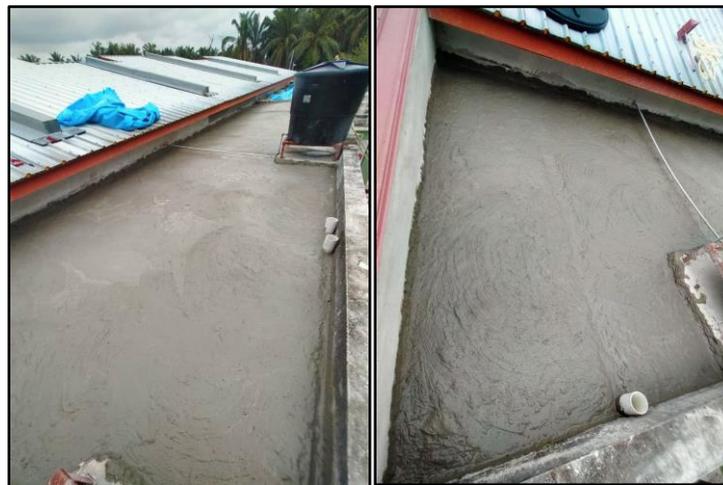
Photo 3:29 Process of waterproofing

After that, the waterproofing work on the flat roof started with house no 3, no 4 and no 5. The part of the flat roof that is suspected to be leaking has been waterproofed twice and has been tested. Next, all parts of the flat roof are waterproofed, including the corners of the slope roof. Waterproofing is applied evenly in hot weather in all areas and left to dry. Before the waterproofing work, the weather is rainy for two days straight. Waterproofing only is done in a hot weather. Waterproofing membranes must be cautiously selected based on environmental conditions such as rain, temperature variations, usage conditions, durability, and desired aesthetics. It is imperative to go through product literature to understand the benefits and limitations of a waterproofing system.

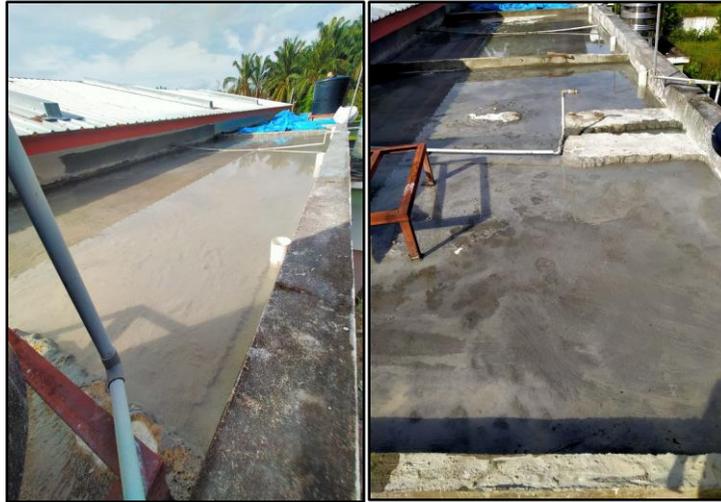
Photo 3:30 Process of testing water

Then, after the waterproofing work is done and left to dry for a day, all three area of the flat roof are allowed to hold water for several hours to ensure effective waterproofing sweep before the rendering work is done. The pipelines of rain water downpipe in each flat roof hole are closed during the water reservoir test using 6" white PVC pressure pipe 3 meter length. During the flat roof testing, it was found that there were no leaks on the roof slab in the house. The water used to retain water is clean water from the tank.

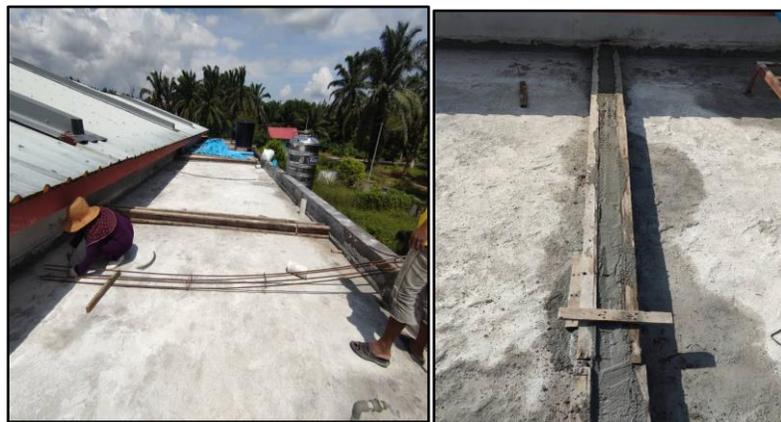
Photo 3:31 Process of create divider beam

houses no 3, no 4 and no 5. The beam measuring 6 inches high and wide and the beam steel also was inserted into each beam formwork prior to concrete. The beam between house no 3 and no 4 is close to the bricks of house no 4. There is no space for stagnant water between the beams of house no 3 and the bricks of house no 4.

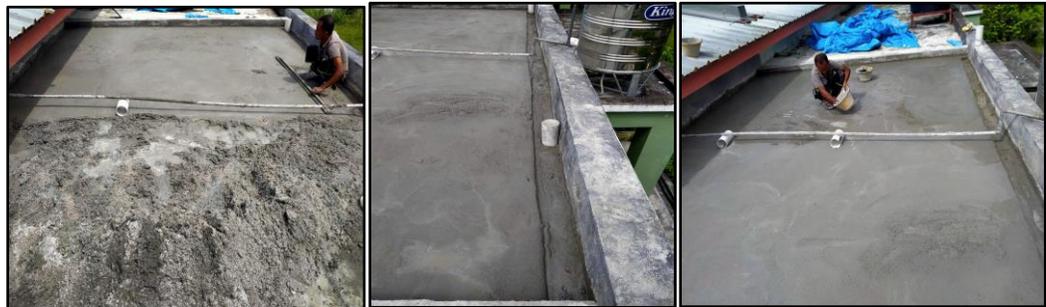
Photo 3:32 Process of rendering work

Next is sweeping work on waterproofing beams and leaking parts area. The slab roof has been rendered as high as 3 inches as well as finishing work such as sweeping smooth cement on slab roof area. The drains also are made and added towards the water pipes as well as have been waterproofed.

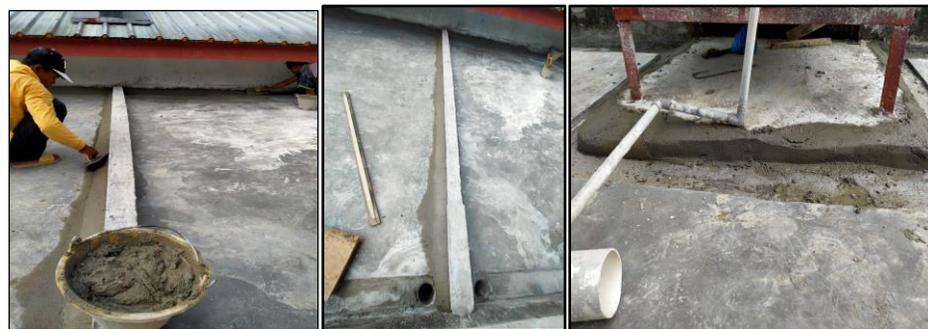
Photo 3:33 Process of smoothing work

is being call tidying work to making the whole area of flat area is nice. The area around the old rendered cement has been built a drain.

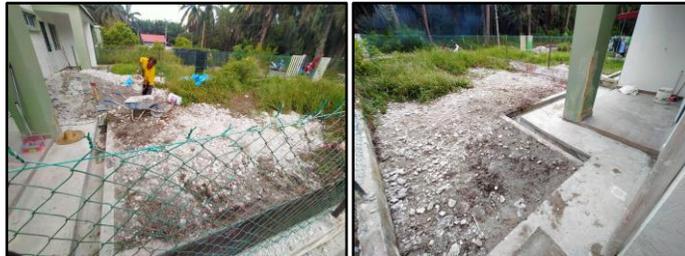
Photo 3:34 Process offsite cleaning

Moreover, the slopes around the flat roof have been made including the left and right beams. The slope has also been waterproofed after drying. The flat roof smoothing works include sweeping the flat roof from sand and smoothing the corners of old rendered cement at the bottom of the water tank in houses 4 and it

The last task and work on site is the cleaning work is done in the backyard of house no 4 and no 5. This is due to the hacking work at the earlier stage of work done making it need to be cleared to avoid any complaining from the owner and buyers. The cleaning work was done by 2 workers and a help of backhoe. The cleaning process taking one week due to rain heavily for straight 4 days. The help of backhoe is needed for two days since all the hacked concrete are pile up in the backyard. All fragments of old flat roof rendering cement have been removed to appropriate areas. The remaining fragments of old rendered cement are leveled in the backyard of house no 4.

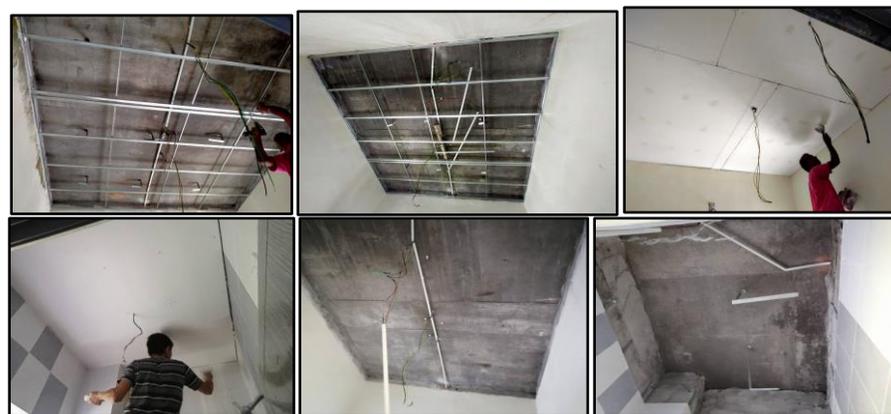
Photo 3:35 Process of ceiling installation

work, the roof slab has been ensured that there are no leaks and the company decide to called plaster ceiling installation experts to install the plaster ceiling towards the three units of terrace house. All old and rusty ceiling plaster irons have been replaced with new ones. Installation of plaster ceilings is in good condition after the scheme finishing is done.

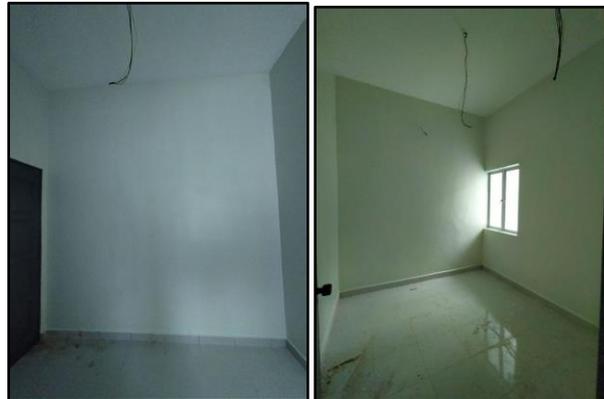
Photo 3:36 Process of painting work

Lastly, the painting works on house no 3, no 4 & no 5. The area to be repainted is room 2 in house 3, 4 and 5 as well as the outer wall of the room from room 2 to the back wall of the kitchen door. The paint used is the same paint color code. The ceiling of the rear toilet and the ceiling of room 2 of houses 3, 4 and 5 have also been painted since the area also is affected due to rusty door as well as blistering paint defects. The condition of the painting work after completion is in good condition.

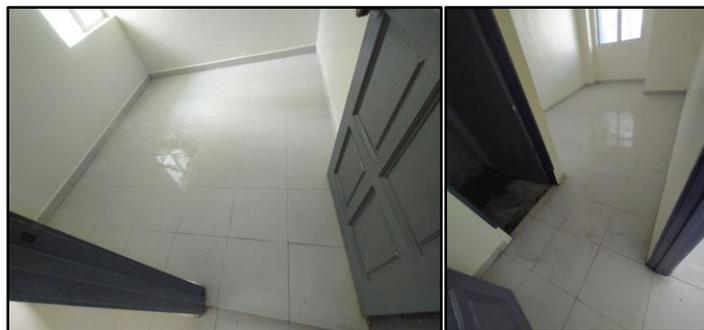
Photo 3:37 Process of cleaning work

Additionally, since the house will be in shortly noticed that it will be delivered by legal agreement later, the cleaning works on terrace houses No. 4 and No. 5 is done too. It is because all the old board plaster ceiling that is falling down are presence with the dust making the room affected are in mess and needed to be cleaned before delivery process. The cleaning area is all room space including living room, kitchen, toilet and porch. All areas have been swept and cleaned. The indoor area is in good condition after cleaning. Ceiling condition of terrace house 4 & 5 which has been repaired and painted - Kitchen toilet and room 3.

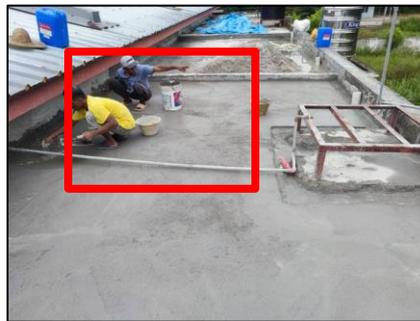
Photo 4:1 No application of safety

Based on observation, most of the workers during inspection are not wearing the Personal Protective Equipment's (PPE) at most of the time. They are only wearing common caps which not protecting their head at all. They are wearing the caps claiming that they only want to protect from sun but not because of the safety. This may and can be risk in getting injuries or casualties getting higher. Especially during project waterproofing on the flat roof which is at the high place need more safety concerned.

To overcome this problem, the company should provide their workers with safety equipment's (PPE) like gloves and safety helmet. The company also need to make them used this regulation such as the safety officer must take an action on the staff. Instruments are compulsory during work progress. If the staff cannot follow the safety, harsh action should be taken. Because construction work has a high level of danger, PPE will always be a critical safety measure, even with all of the other controls in place to protect you from these risks.

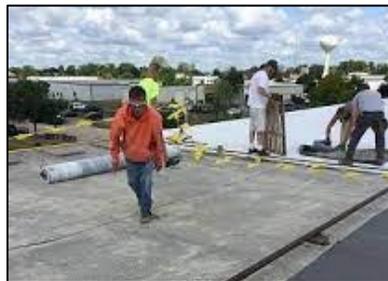
Figure 4:2 Unskilled worker doing work on flat roof

Shortage and difficulties in obtaining manpower resources will definitely affect the project productivity. Lack of local expertise that is has the knowledge and experiences in the field of roof and waterproofing job experience. The employees who handled the projects have not enough experiences in order to monitor the progress of the projects. Therefore, they are lack of quality in doing the job. The workers have repaired the flat roof for two times and there is still leaking happened making the company are loss money doing repair work only.

As recommendation, the company should hire a roofing specialist to seeking advice about the repairing work. There is because there is no at least one specialist of roofing making the repair work are being done more than once due to the same problem. The loss of repair work is so much than rather loss to hire a roofing specialist. From specialist, the knowledge about the good materials and right tools are being observed by them making the method procedure of the repair defect and waterproofing are on the right track and can be long last the maintenance for it.
