**DEFECT INSPECTION OF BUILDING ELEMENT WALL
AND FLOOR FOR ECONOMIC AND COMMERCIAL OFFICE SPAIN IN
MALAYSIA**

PRACTICAL TRANING REPORT

3.0 CASE STUDY: ECONOMIC AND COMMERCIAL OFFICE SPAIN IN MALAYSIA

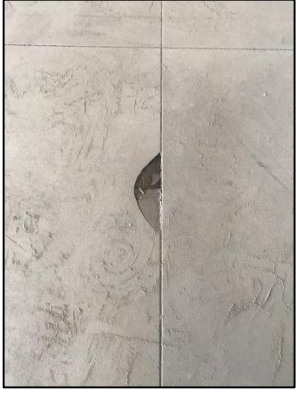
<p>Photo 2.0: Chipping</p>	<ul style="list-style-type: none"> • There is a defect of chipping found on the surface tiles with between jointing tiles. • When a heavy object accidentally drops tiles surface, it will cause the defect of chipped tiles. • May also caused due to the loading of heavy materials and not doing the protection for covering of tiles when completed display. Workers are still doing construction work in site and through this area. • Location at walkway area

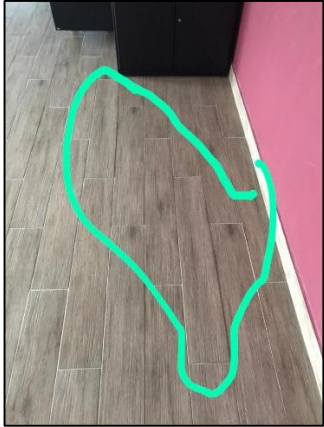
<p>Photo 2.1: Uneven Surface</p>	<ul style="list-style-type: none"> • The defect tiles that are uneven can see a difference between their heights or feel the difference while walking across them were generally installed incorrectly. • One of the most common problems is “lippage,” the uneven surface that occurs when a tile is higher than the one beside it. • Uneven application of thinnest or mortar, which holds the tiles in place, is another potential cause of uneven tiles. This typically happens when the contractor was rushed and didn’t take time to spread the adhesive evenly. • Uneven tiles aren’t something it should ignore. They present a tripping hazard and increase the likelihood the tile will chip on the edges. Tiles like these are also harder to keep clean. • The location of defect at Counsellor room
