BUILDING CONDITION ASSESSMENT AT PEJABAT DAERAH YAN

PRACTICAL TRAINING REPORT

FEBRUARY 2022

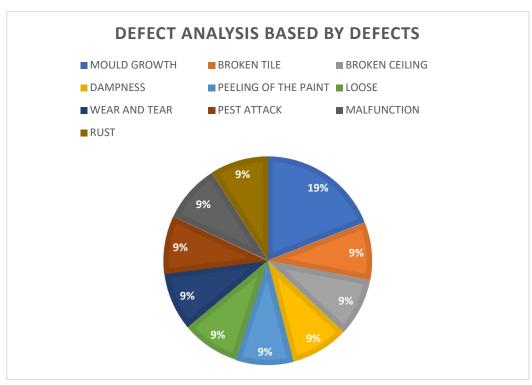
Figure 19: Defect Analysis by Defect

Based on the pie chart above, we can conclude that there are 11 types of defects which are mould growth, dampness, broken, peeling of the paint, rusty, pest attack, malfunction, loose, wear and tear. However, there are four major defects that detected in this building.

In our investigation, its diagnose that the mould growth (19%) are causes by the missing part of roof and poor ventilation, humidity, and condensation. While the other defects such as broken tile and ceiling, pest attack, dampness, peeling, rusty, malfunction, loose, wear and tear only 9%.

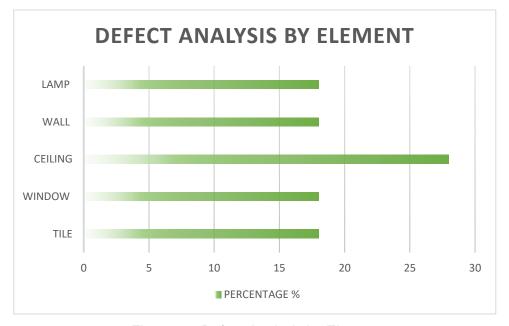
Figure 20: Defect Analysis by Element

Based on the bar chart, ceiling accurate the highest defect which is 28%. The defect has been found at the element such as dampness, mould growth and broken. Next, the elements of lamp, wall, window, ceiling, and tile recorded are the same which is 18% for each of them. The defect that has been found at lamp, wall, window, ceiling, and tile such as broken, wear and tear, malfunction, mould growth, dampness, loose, peeling and pest attack.
