**DEPARTMENT OF BUILDING
UNIVERSITI TEKNOLOGI MARA
(PERAK)**

BUILDING MAINTENANCE WORK

This case study is about building maintenance work. Among all the maintenance projects that I have discovered, I decided to choose one of the projects which is repair and maintenance of the internal piping system, water tank and fence and other related works at SMK Datin Onn Jaafar, Batu Pahat. Most of the residents in Batu Pahat called this school as *DOJ* or *Pesta*. As shown in the figure below, this school is located on a land area of 10 acres (4 hectares).

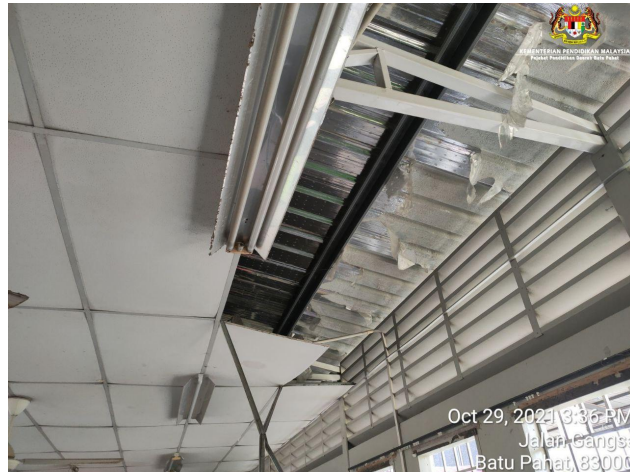
Figure 3.2.1 Damaged ceiling

For the ceiling work at SMK Datin Onn Jaafar, the teacher complained that their ceiling was sagging (as shown in Figure 3.2.1 and 3.2.2). When we observed, we found that the hanger wire which holds the ceiling also needed to change. This ceiling work was at Tiara Block and the ceiling used in the classroom.

Thus, this problem needs to be solved quickly since it might be dangerous for the students in the classrooms. The ceiling might have fallen on the students' head out of the blue. Since the classroom is having a good wind flow throughout the class, the ceiling cannot stand when it comes to heavy wind that makes it easily become sagging. Suspended ceiling is actually not suitable for outdoor use.

Luckily, not all the ceilings are broken. As a solution, the ceiling and the hanger wire will be replaced with the new one. After the observation, we take the measurement of the classroom area using the distance laser meter. There are three classes in the Tiara Block and most of the ceilings from the three classes are facing the sagging problems. The ceiling pieces were measured by numbers while the hanger wire was measured by square meter. The size of the ceiling is 2 feet \times 4 feet.

The hanger wire needs to change to new and the same goes to the damaged ceiling tiles. If it stays in that way it might be dangerous to the students. By doing regular maintenance work of the building, it is actually more cost saver compared to doing maintenance when it is already damaged.

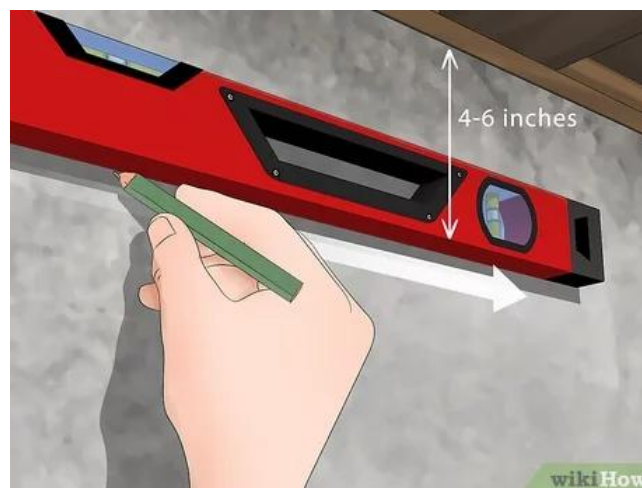
Figure 3.3.1 Level meter

For the installation, the damaged ceiling tiles were removed first. Then, the rails that run along the walls were checked to make sure they are not bent or loose. To confirm the rails were still straight and aligned, a level meter was used (refer Figure 3.3.1).

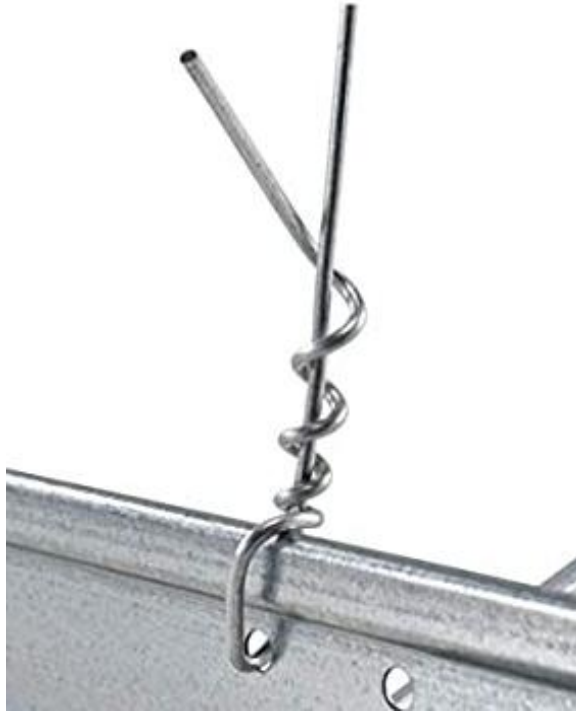
Figure 3.3.2 Twisted wire

Next, after identifying the failed wire hangers, the new wire was hung through an available hole on the rail and at the end of the wire was twisted up to keep it suspended. As shown in Figure 3.3.2 was an example of the situation.

After that, directly above where the hanger wire is, a wooden screw was screwed into the wooden joist. It is not necessary to screw it all the way into the joist. Next, the wire was pulled up and the hanger was wrapped around the screw where the rail begins to lift. The excess wire was cut away.

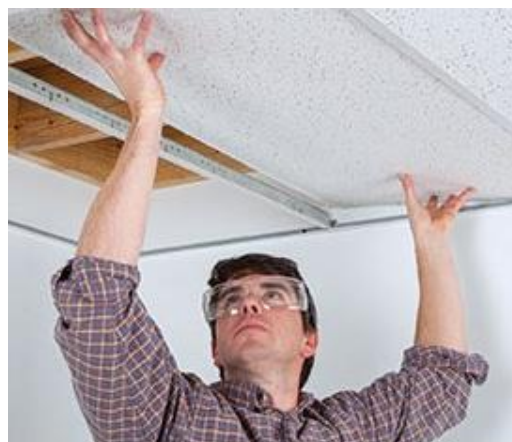
Figure 4.3.3 Placing the ceiling tiles

Lastly, the ceilings were placed as shown in Figure 3.3.3 and the rails were checked once again using the level meter. Any necessary adjustments were made to make the ceiling be level.
